Photo Documentation of the Removal Action

MRS Plating Site
310 Park Avenue
Lockport, Niagara County, New York

Removal Support Team 2
Weston Solutions, Inc.
Northeast Division
Edison, New Jersey, 08837

U. S. Environmental Protection Agency
Region II – Removal Action Branch
186 Exchange Street
Buffalo, NY 14203

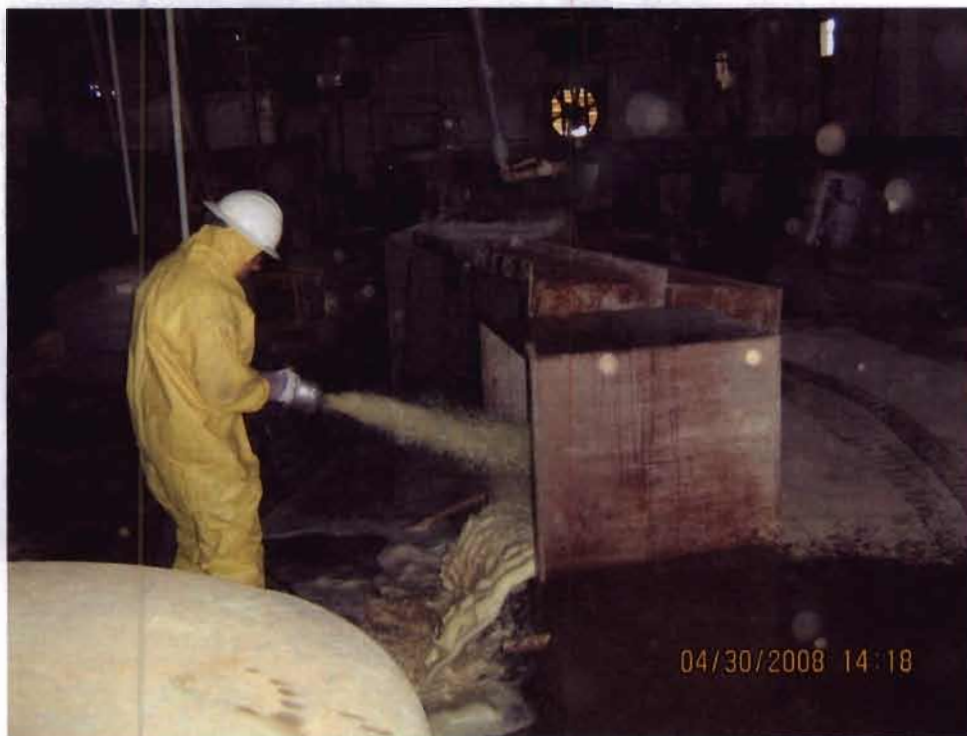
ERRS employee working inside the MRS Plating Shop cleaning a vat.

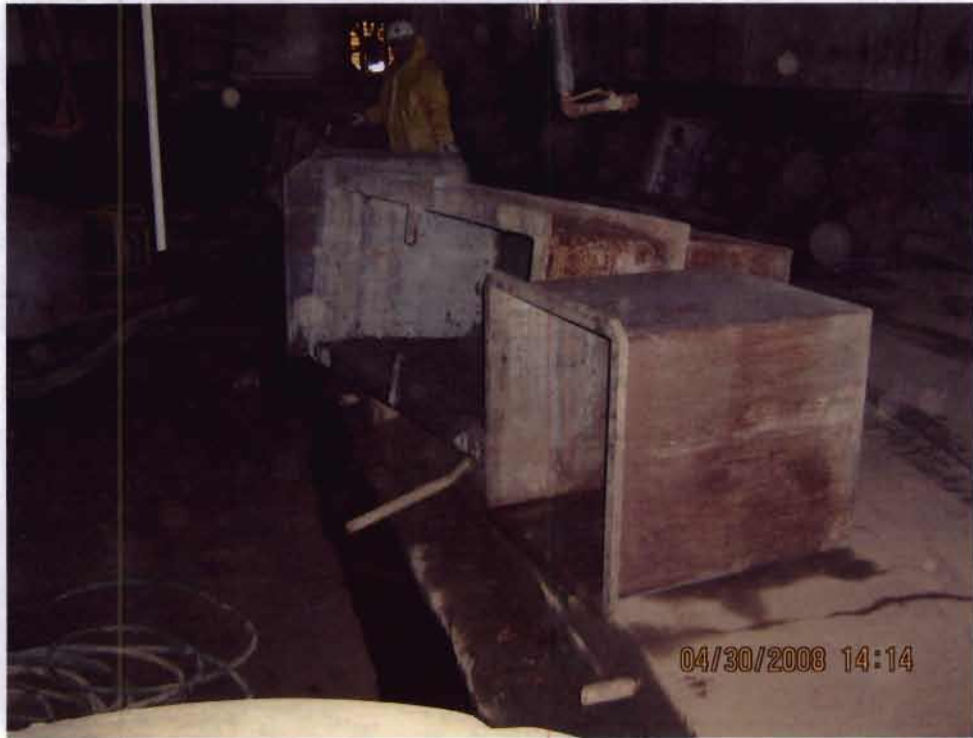
Empty vats inside the MRS Plating Shop.

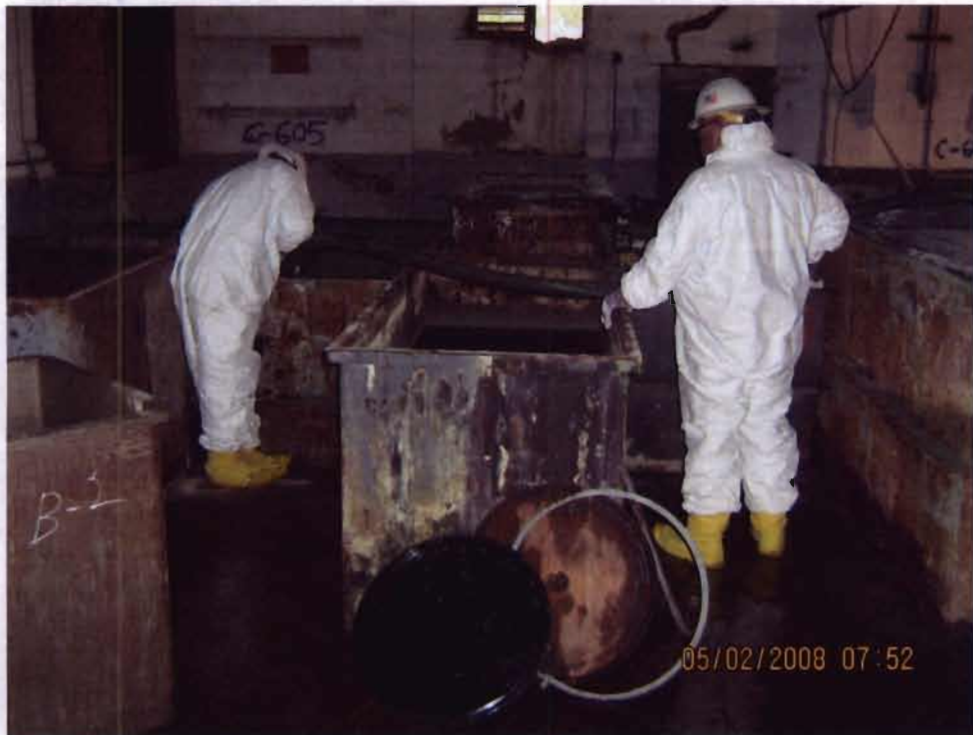
ERRS personnel cleaning vats.

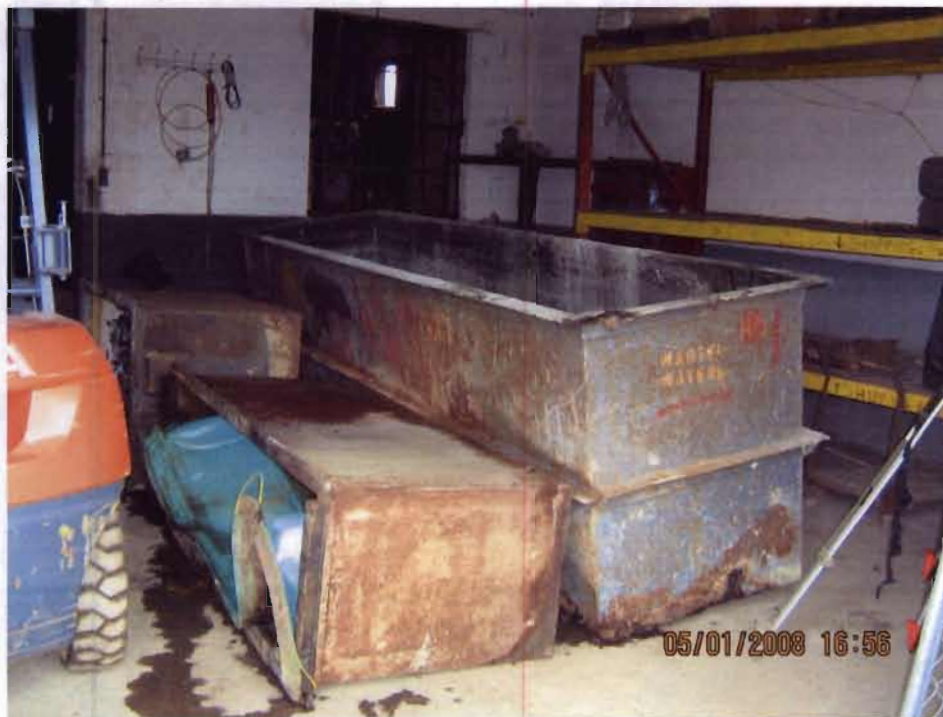
Wastewater storage vats located inside of the MRS Plating Facility.

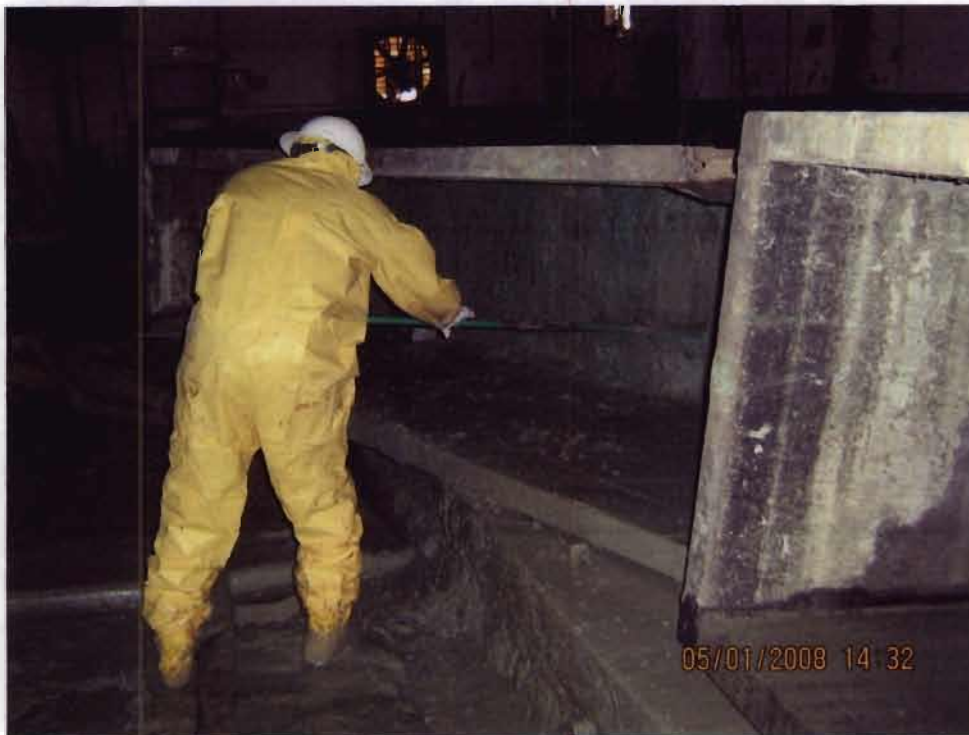
ERRS employee cleaning a vat.

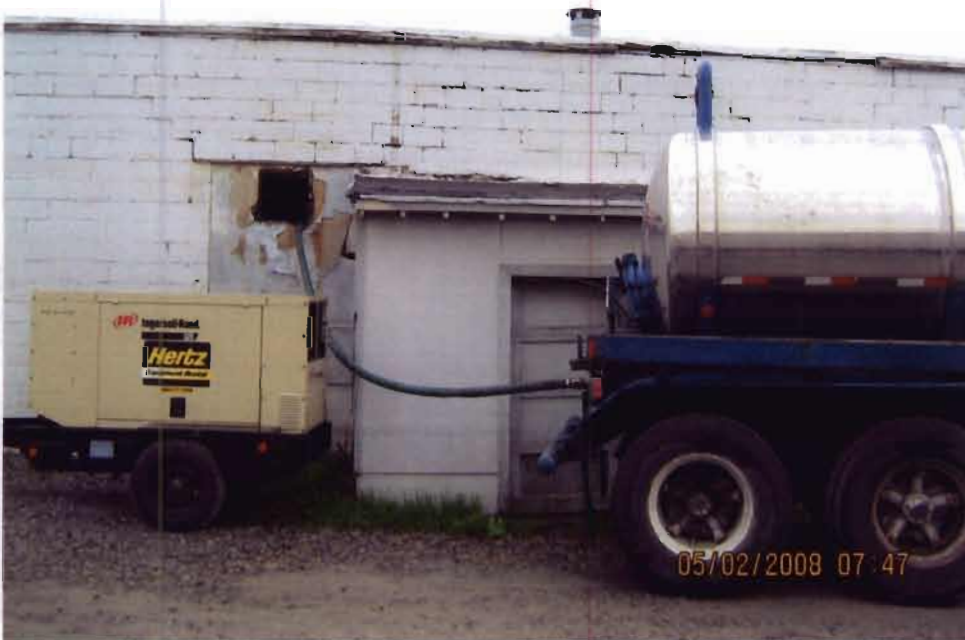
Extracting water from vats inside of the MRS Plating Shop.

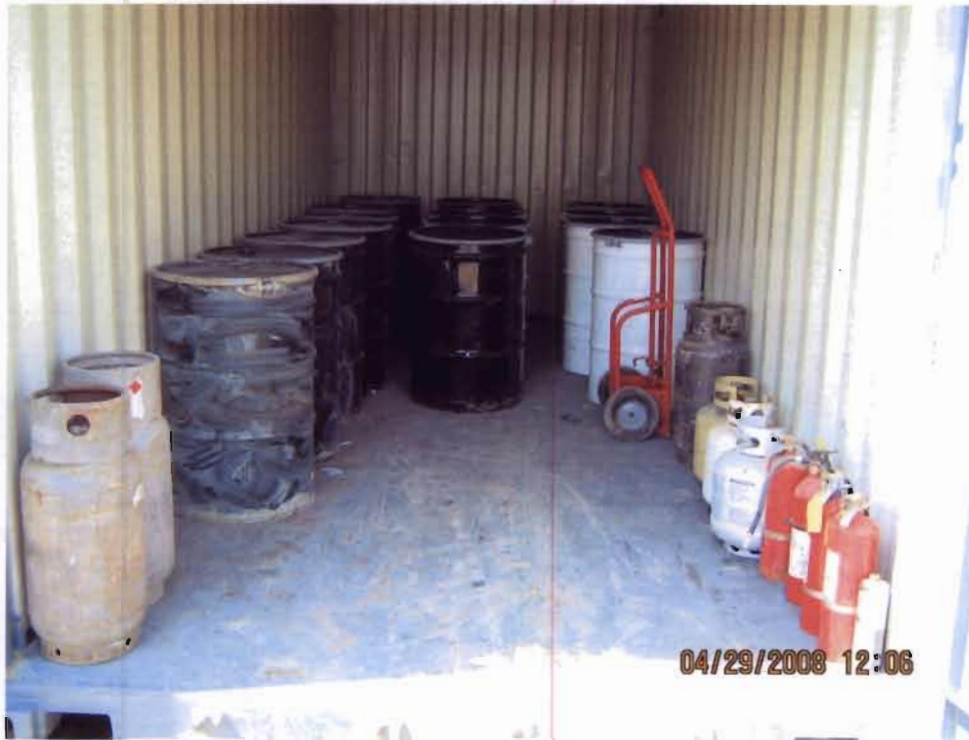
Drums containing waste from the MRS Plating Shop placed for storage.

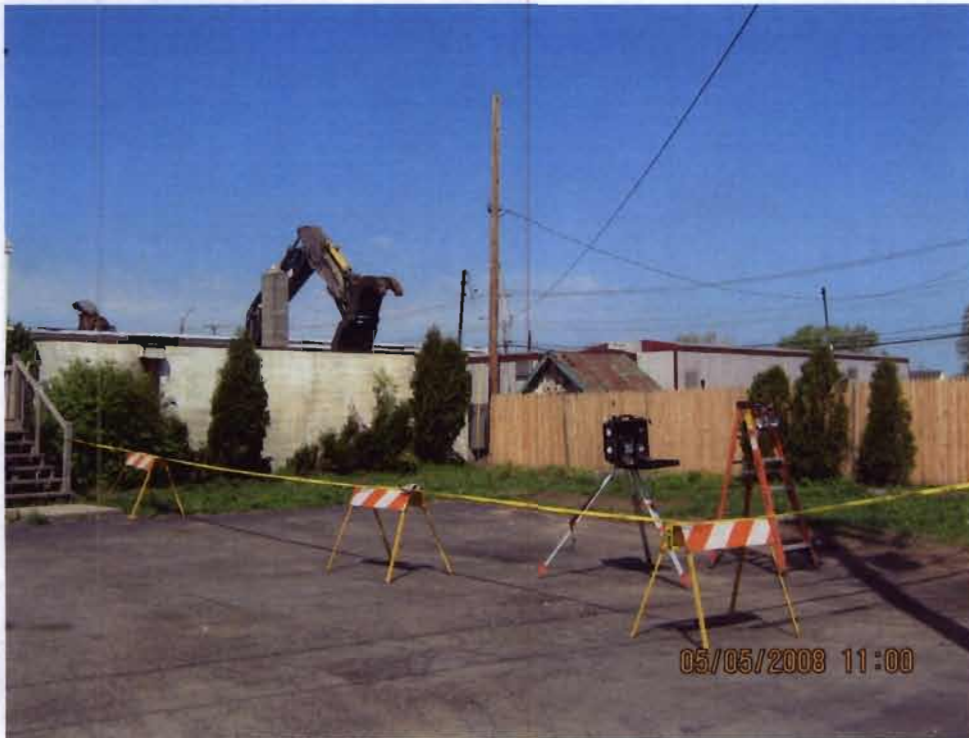
Demolition of the MRS Plating Office.

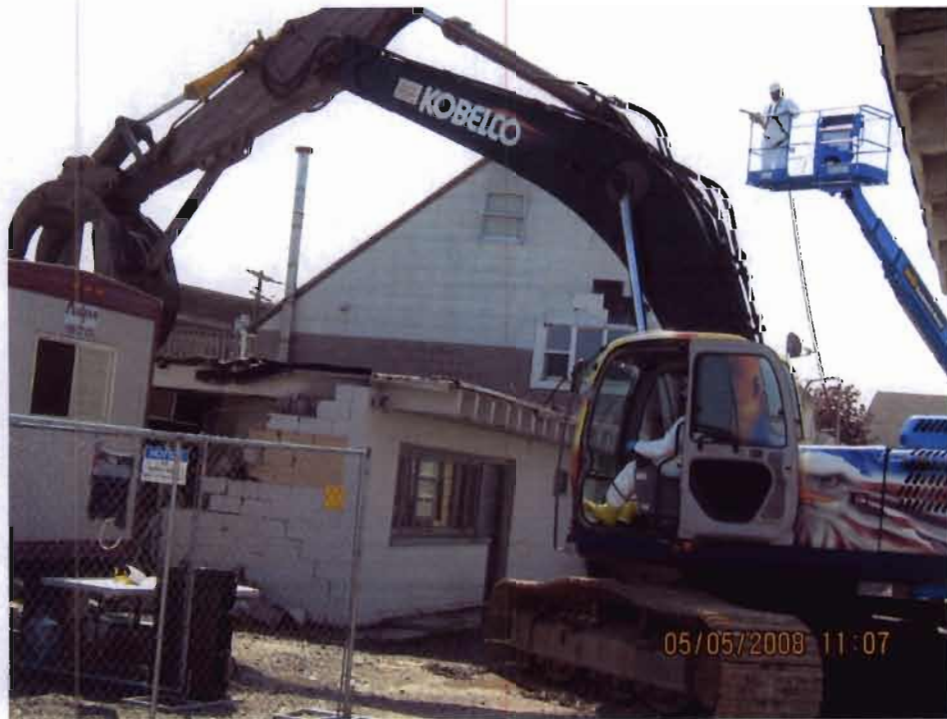
Demolition of the MRS Plating Office.

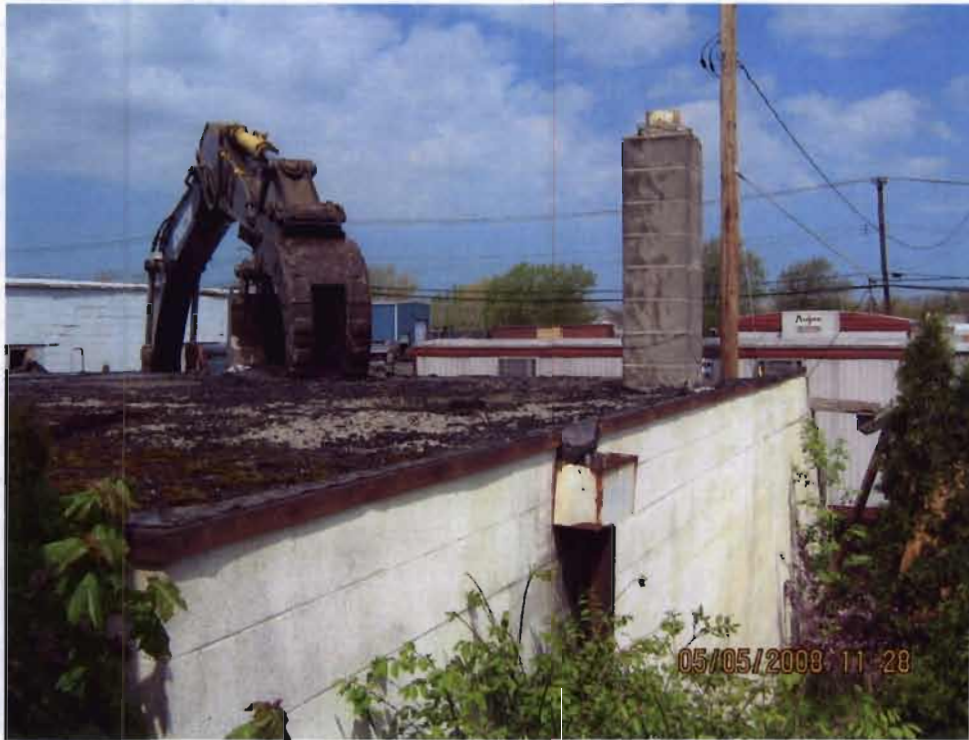
Demolition of the MRS Plating Office.

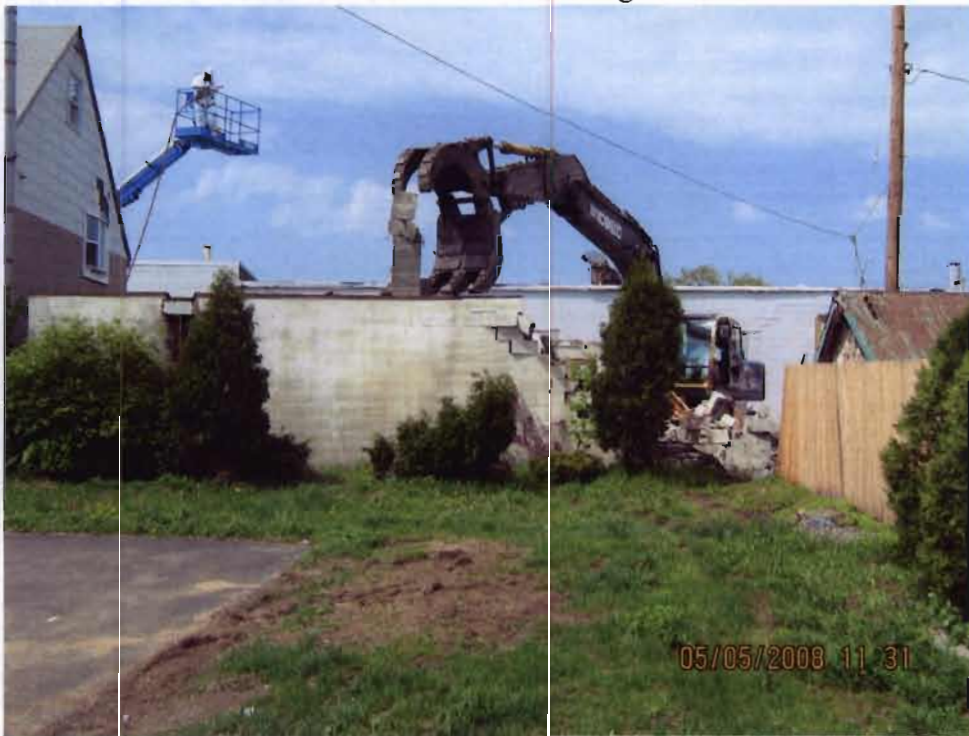
Demolition of the MRS Plating Office.

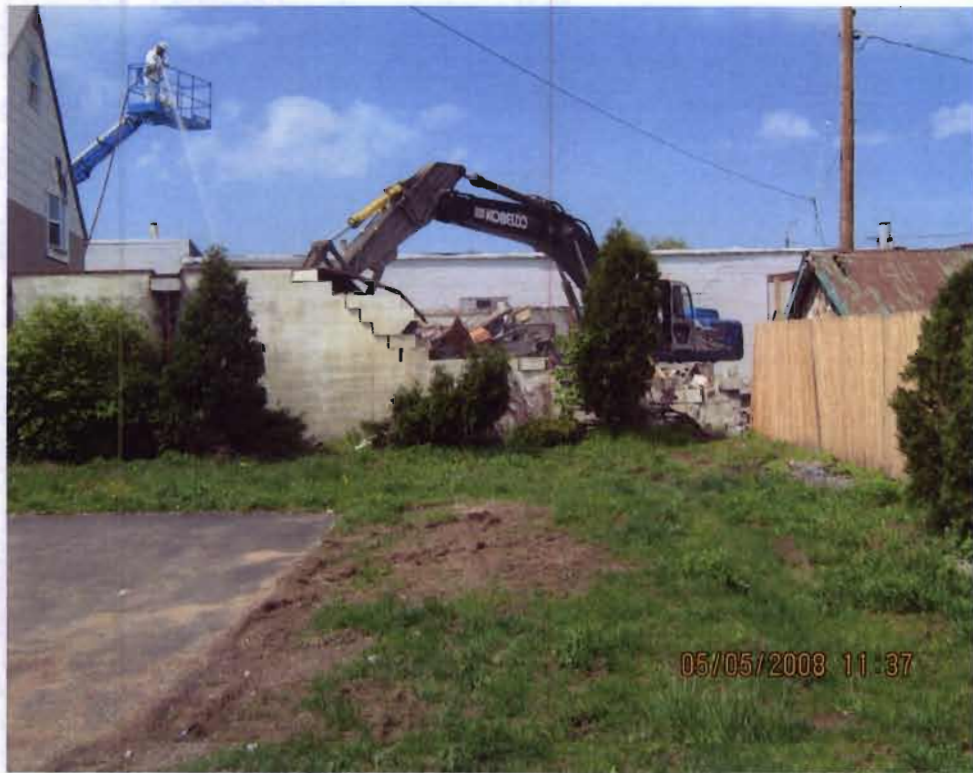
Demolition of the MRS Plating Office.

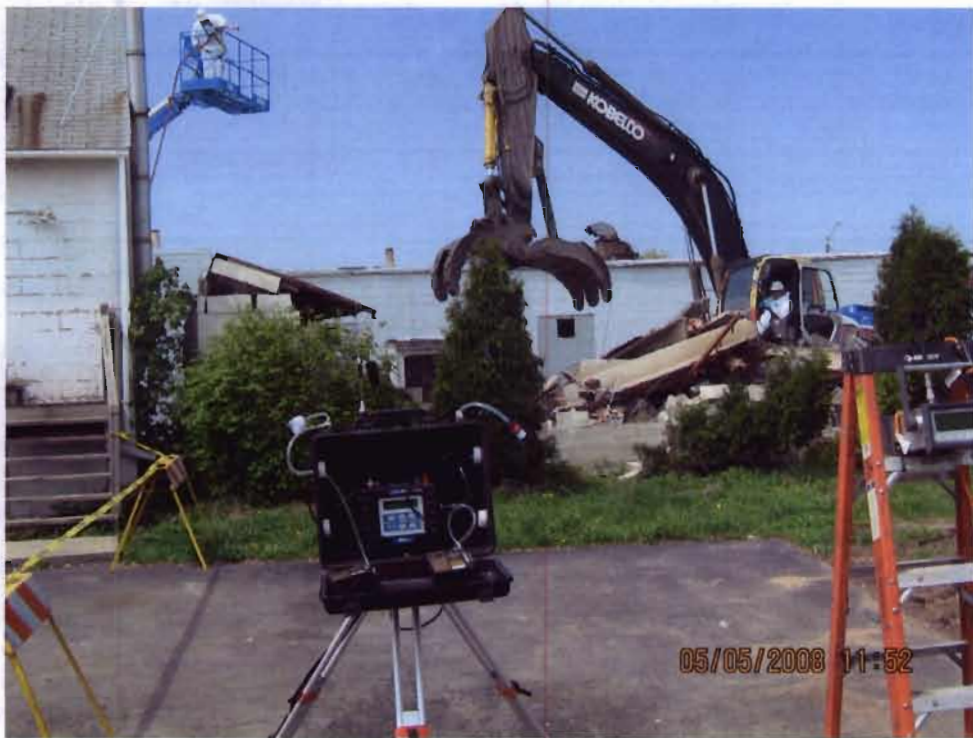
Demolition of the MRS Plating Office occurring behind Air Monitoring Station #2.

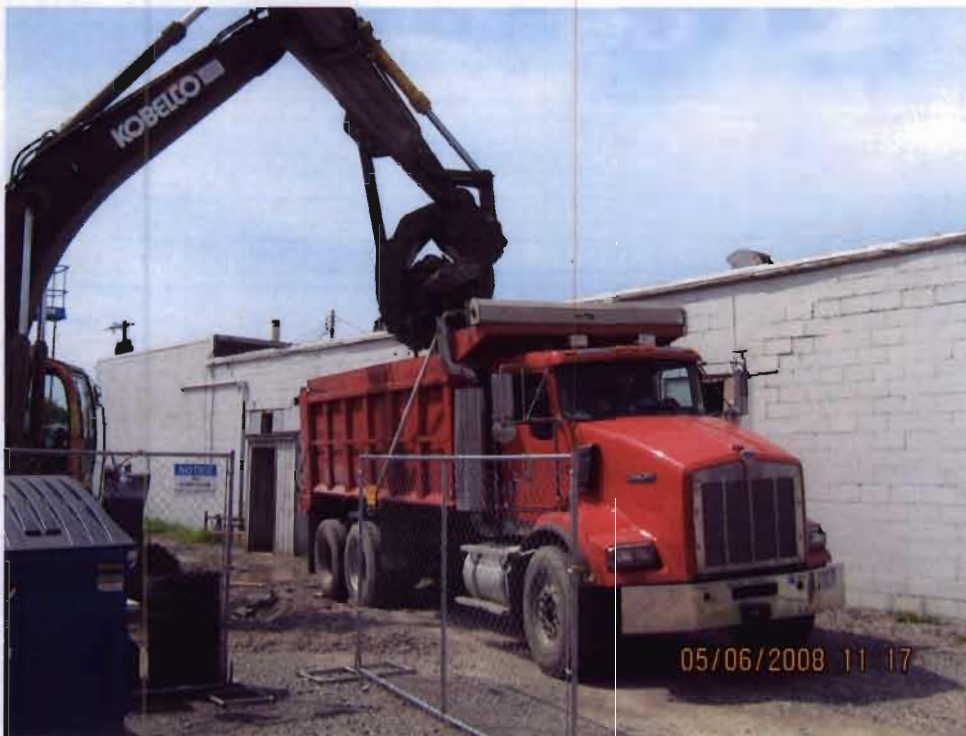
Loading of demolition debris for removal.

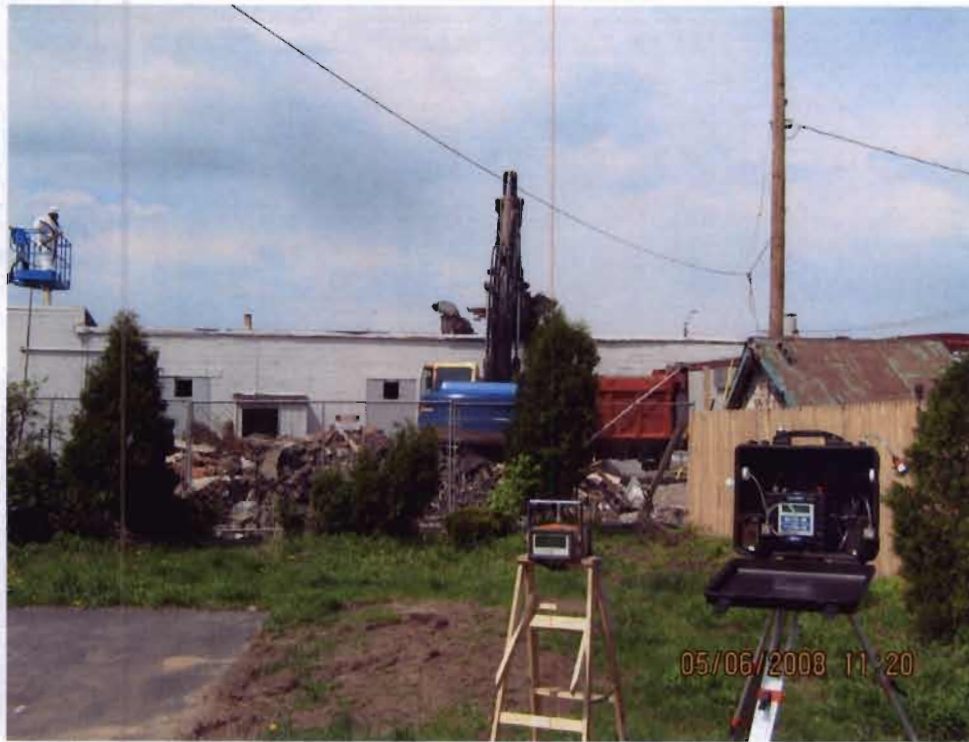
Demolition of the MRS Plating Office from Monitoring Station #2.

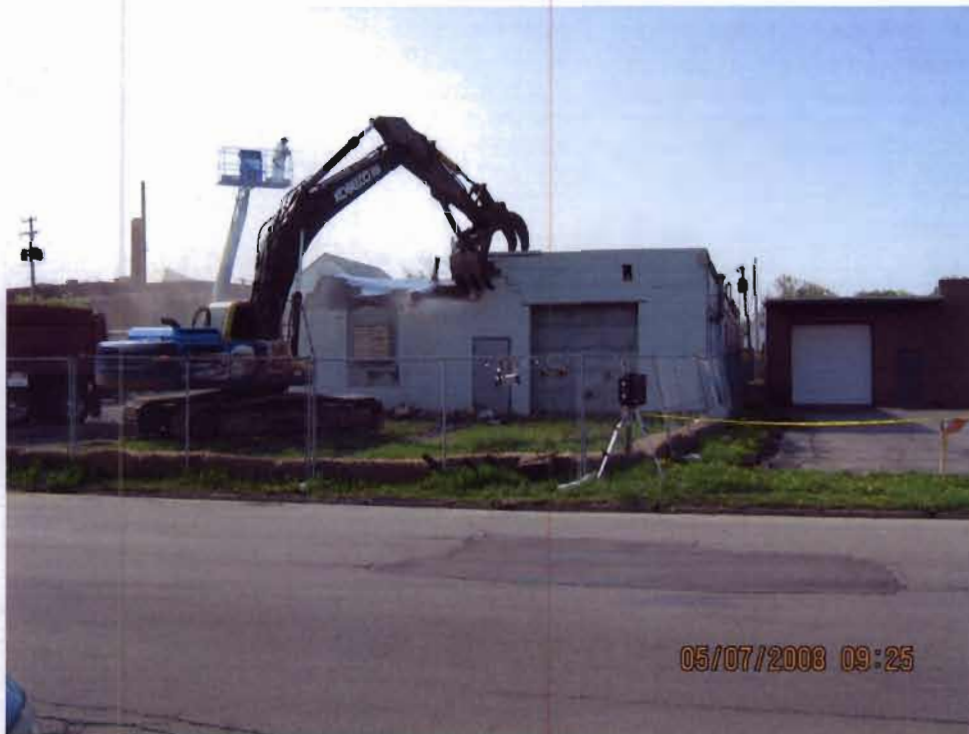
The beginning stages of demolition to the MRS Plating Shop.

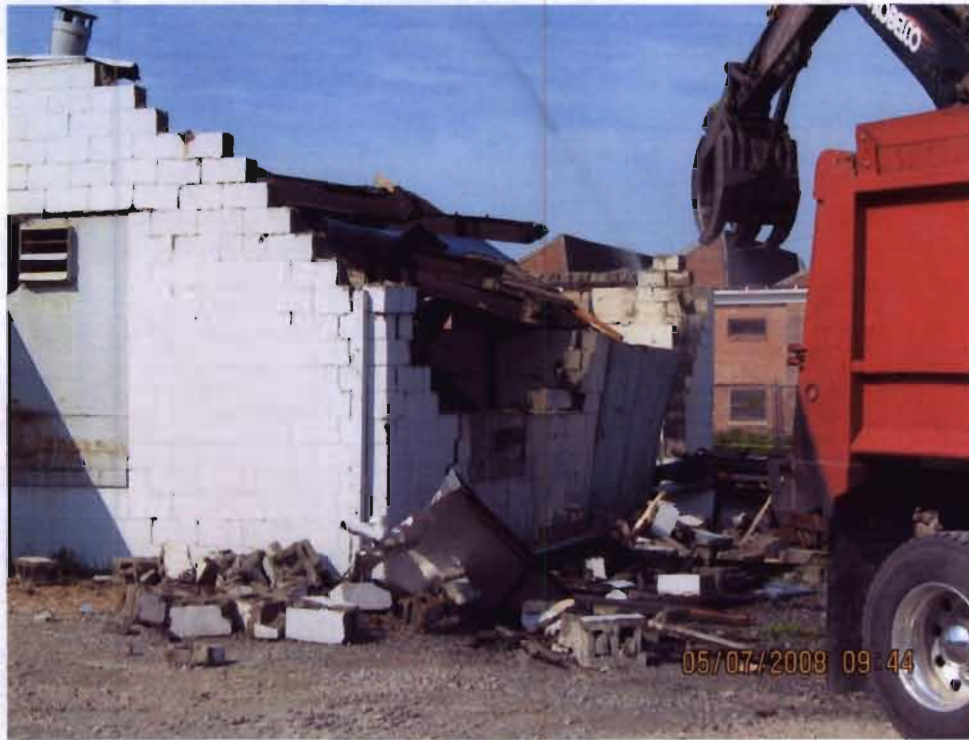
The demolition to the MRS Plating Shop.

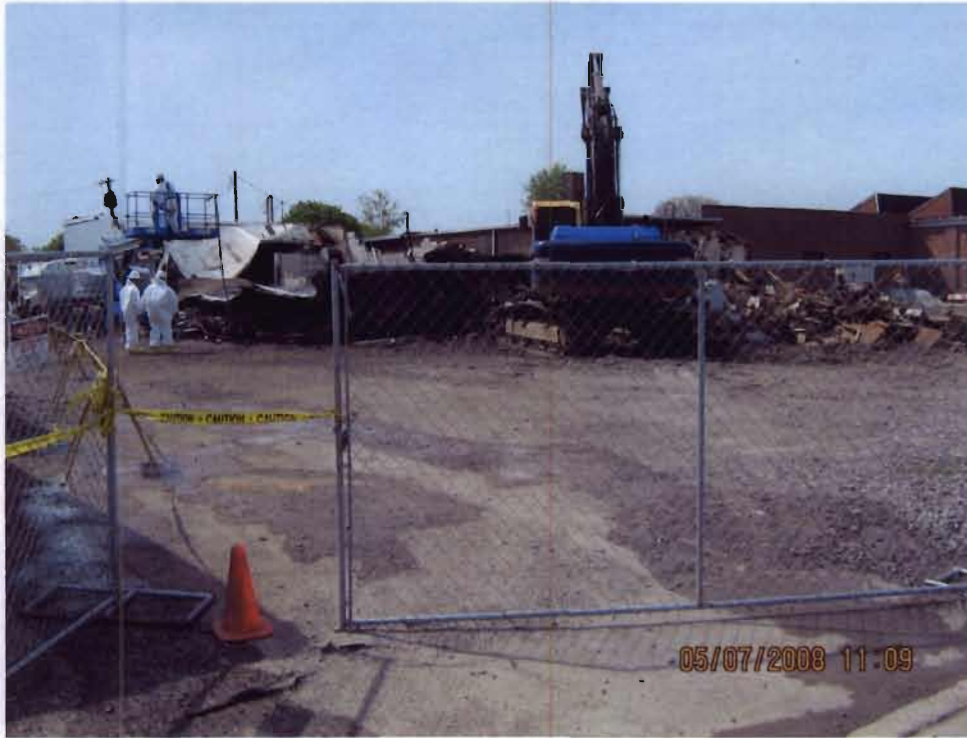
Demolition of the MRS Plating Shop, view from the front gate entrance.

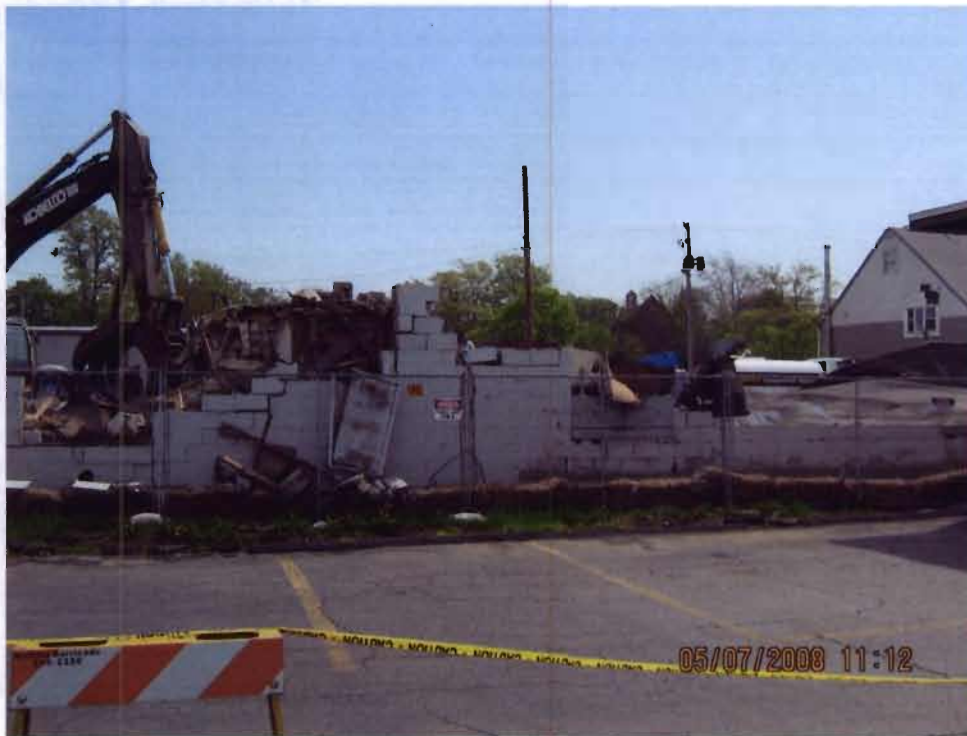
Demolition of the MRS Plating Shop, view from the furniture store parking lot.

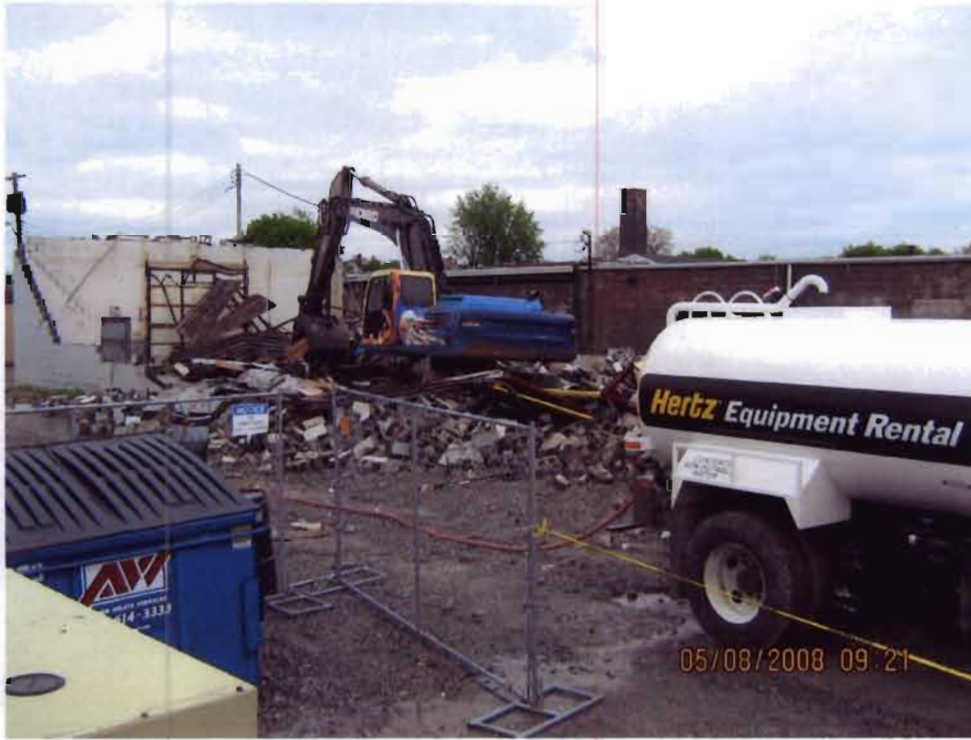
Demolition of the rear of the MRS Plating Shop.

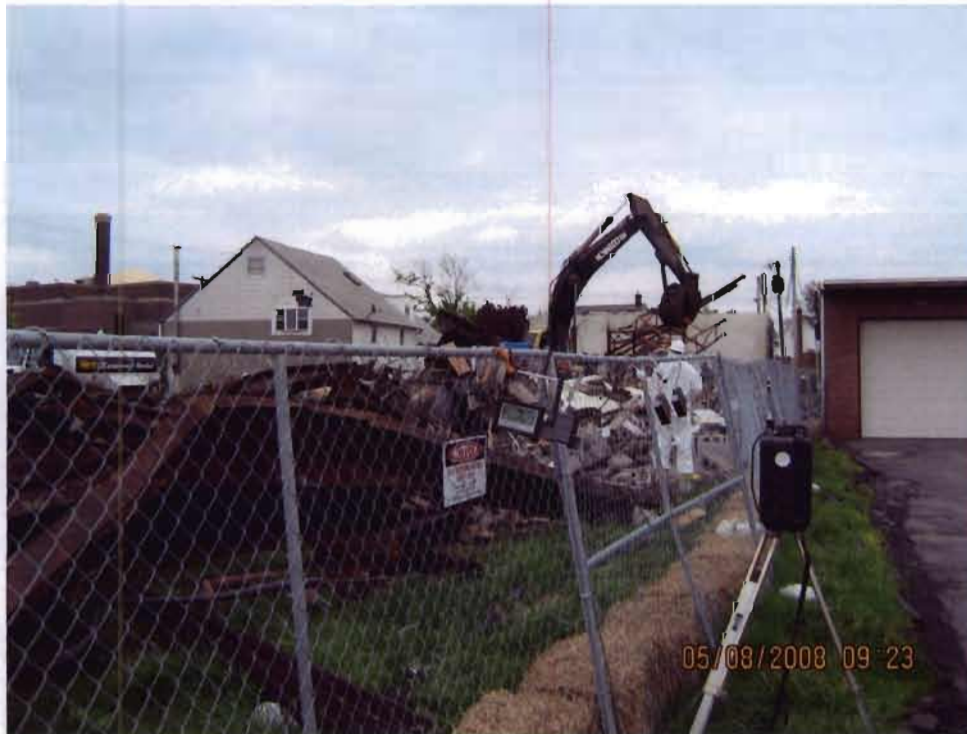
Demolition of the rear of the MRS Plating Shop.

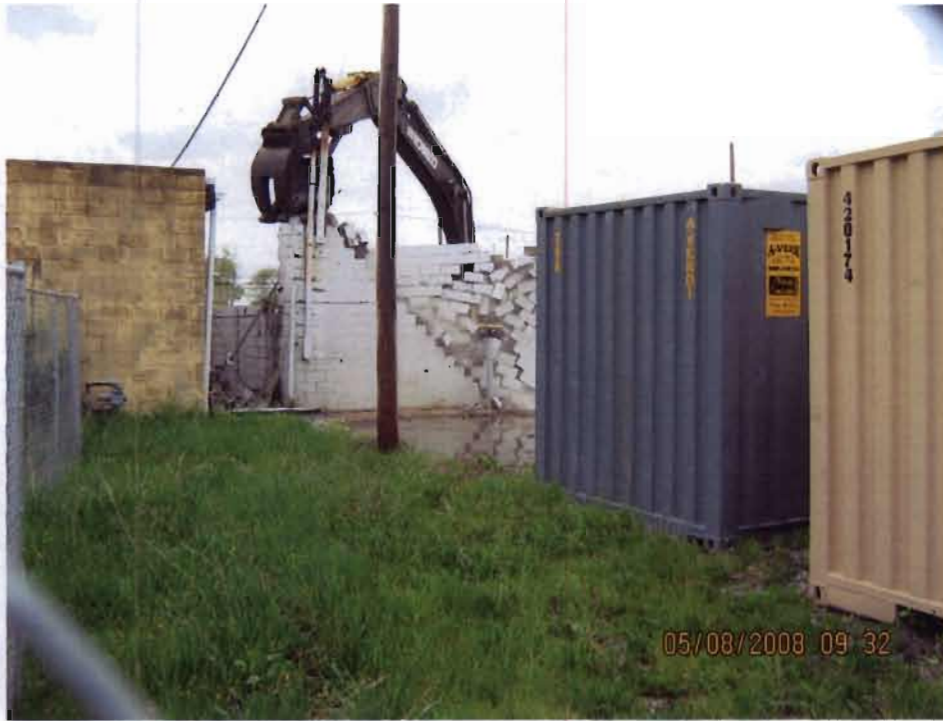
Demolition of the back wall of the MRS Plating Shop.

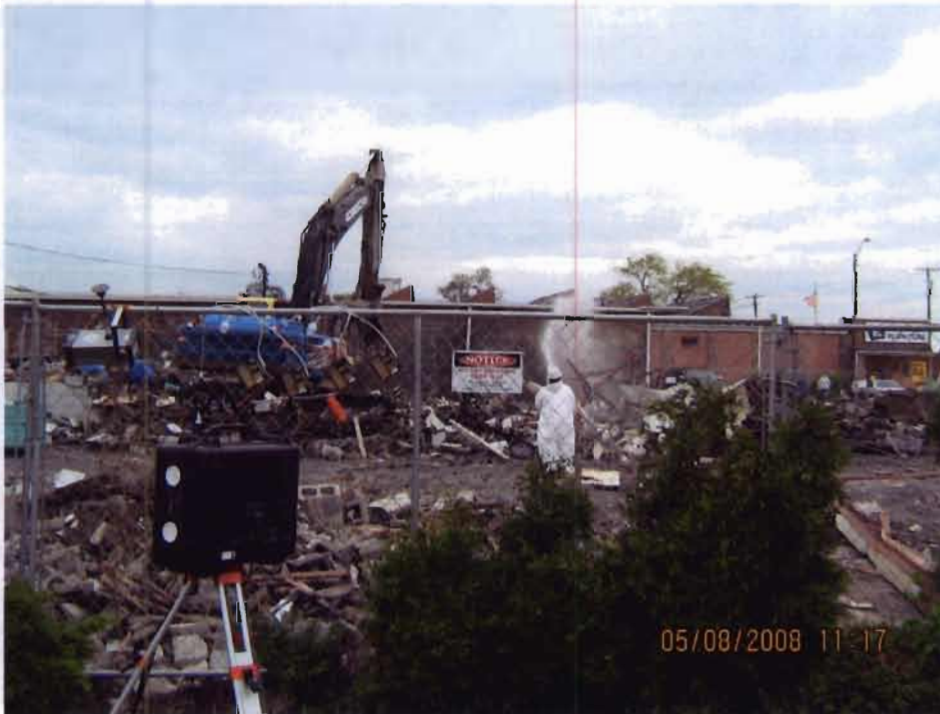
WRS Personnel conducting dust suppression during the demolition of the MRS Plating Shop.

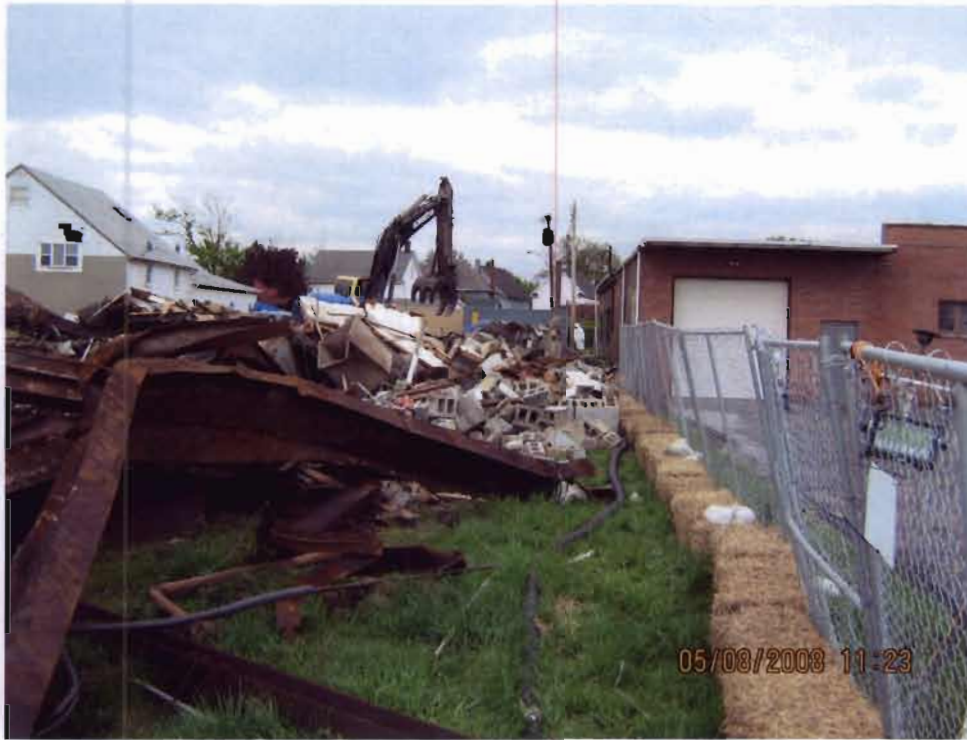
Following the demolition of MRS Plating Shop, WRS segregates building materials.

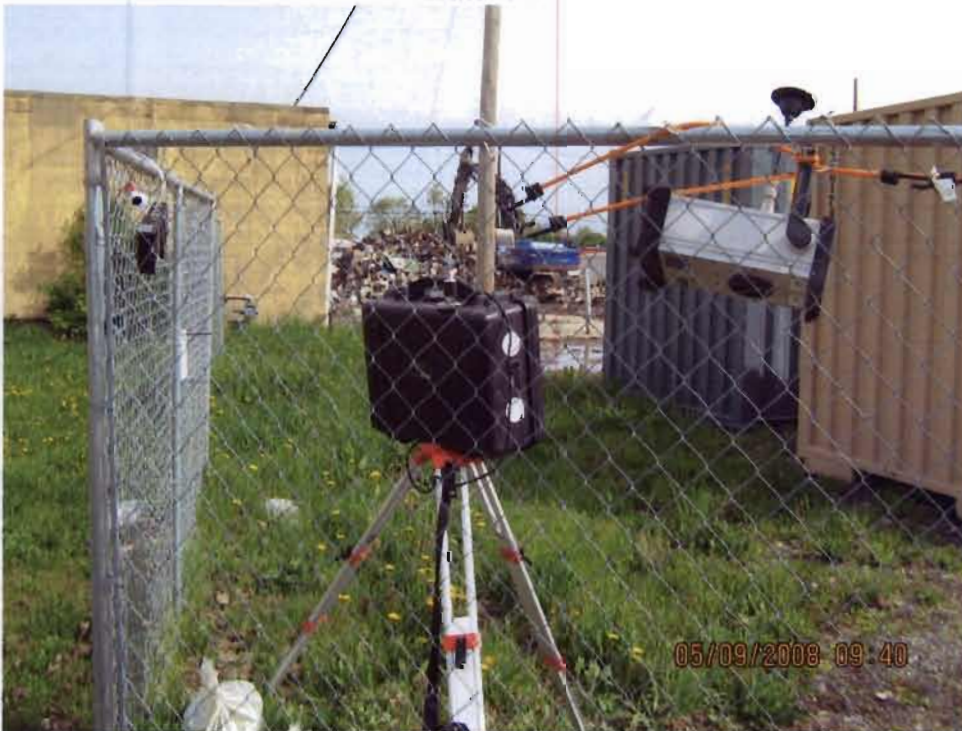
Air Monitoring Station #4, Picture displays Area-RAE, SKC Pumps and Data-RAM Monitor.

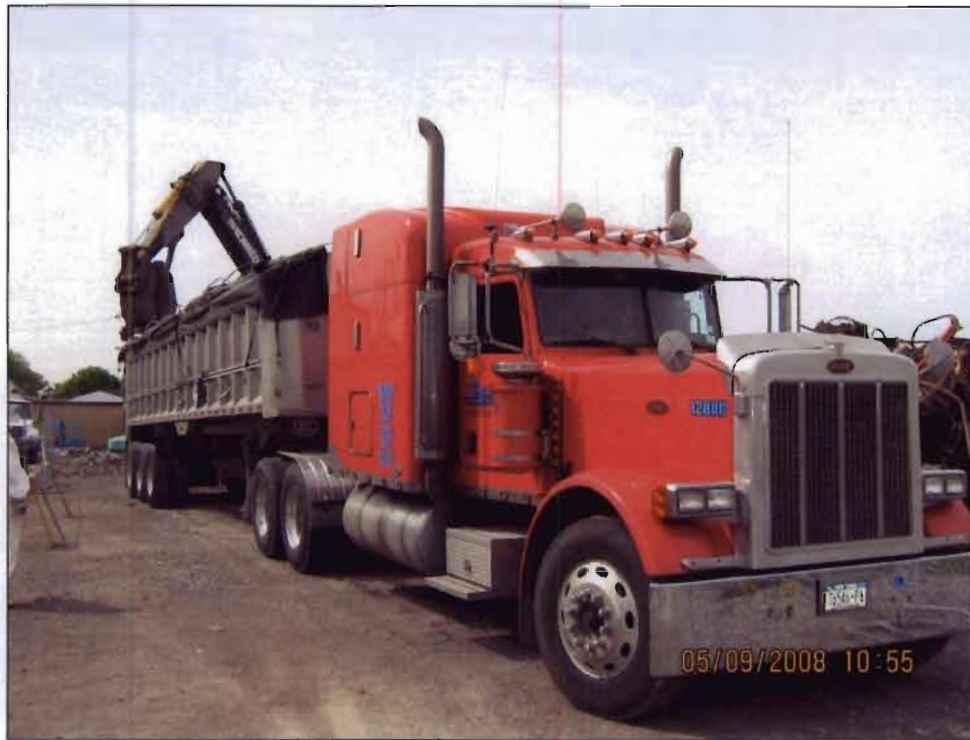
Loading of demolition debris for removal and off-site disposal.

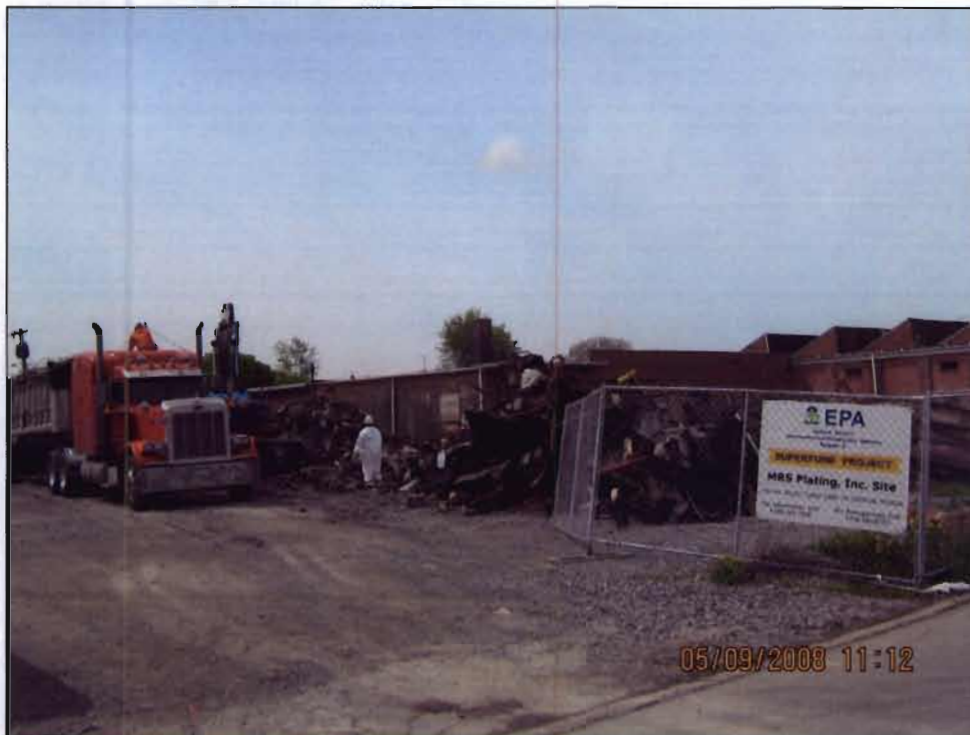
Loading of demolition debris for removal and off-site disposal.

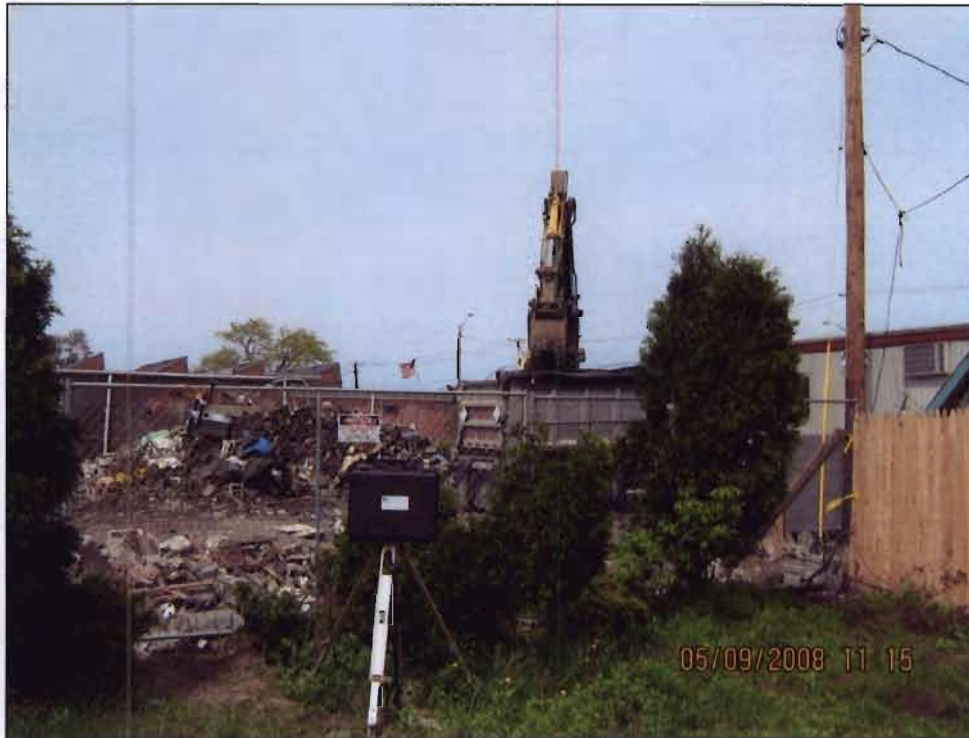
Air Monitoring Station #2 located at the eastern site fence.

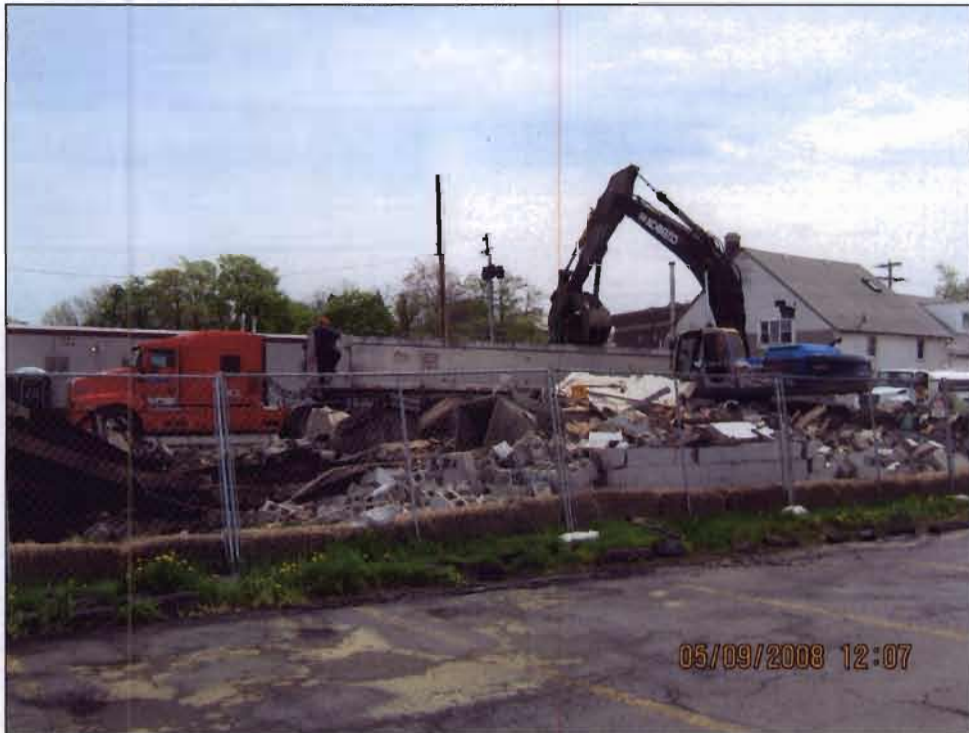
Loading of demolition debris for removal and off-site disposal.

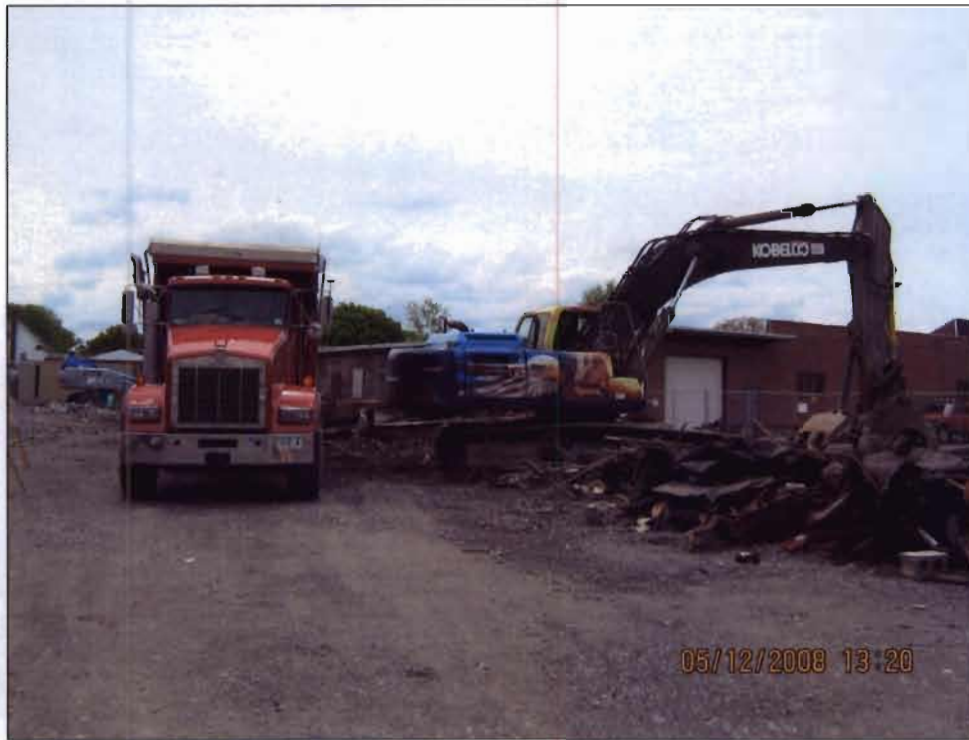
Loading of demolition metal debris for removal.

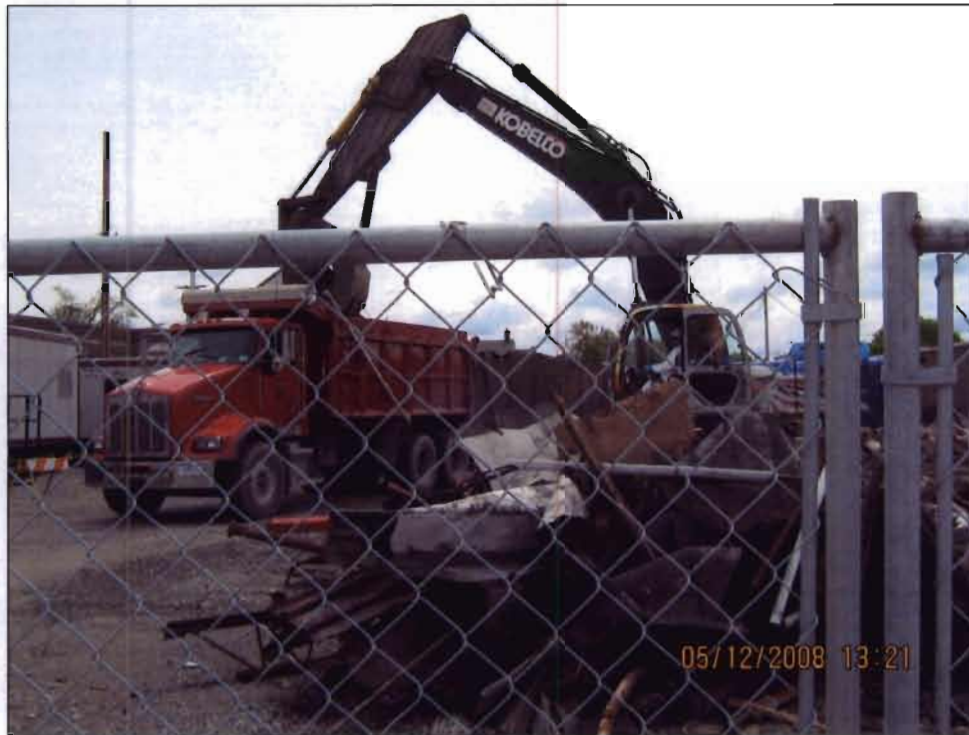
Loading of demolition metal debris for removal and off-site recycling.

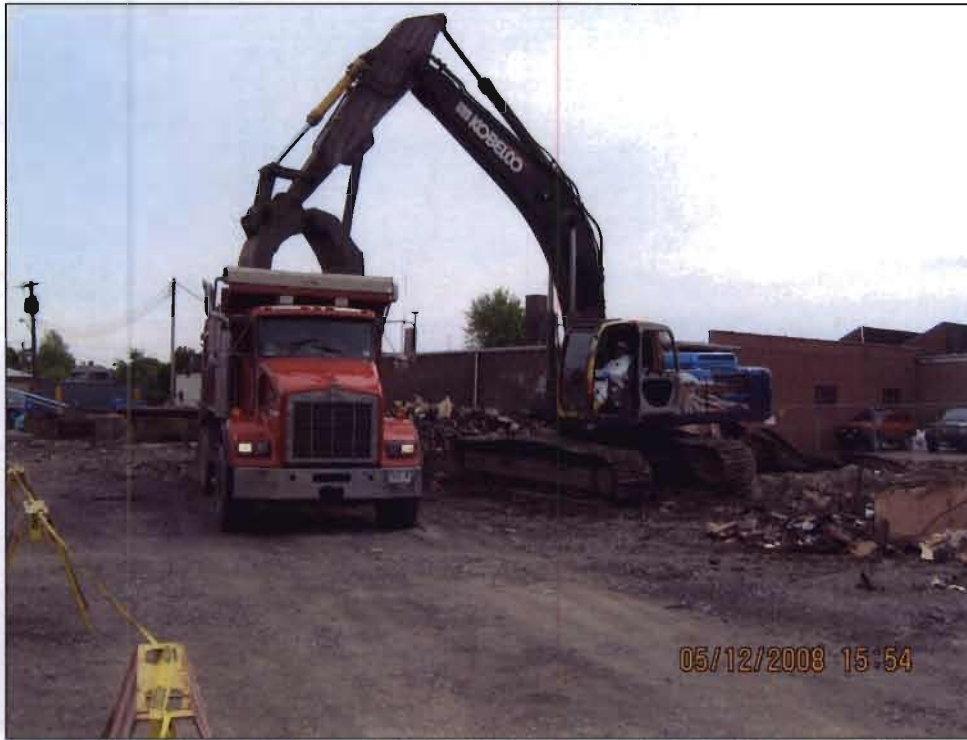
Loading of demolition metal debris for removal and off-site recycling.
