Photo Documentation of the Removal Action

MRS Plating Site
310 Park Avenue
Lockport, Niagara County, New York

Removal Support Team 2
Weston Solutions, Inc.
Northeast Division
Edison, New Jersey, 08837

U. S. Environmental Protection Agency
Region II – Removal Action Branch
186 Exchange Street
Buffalo, NY 14203

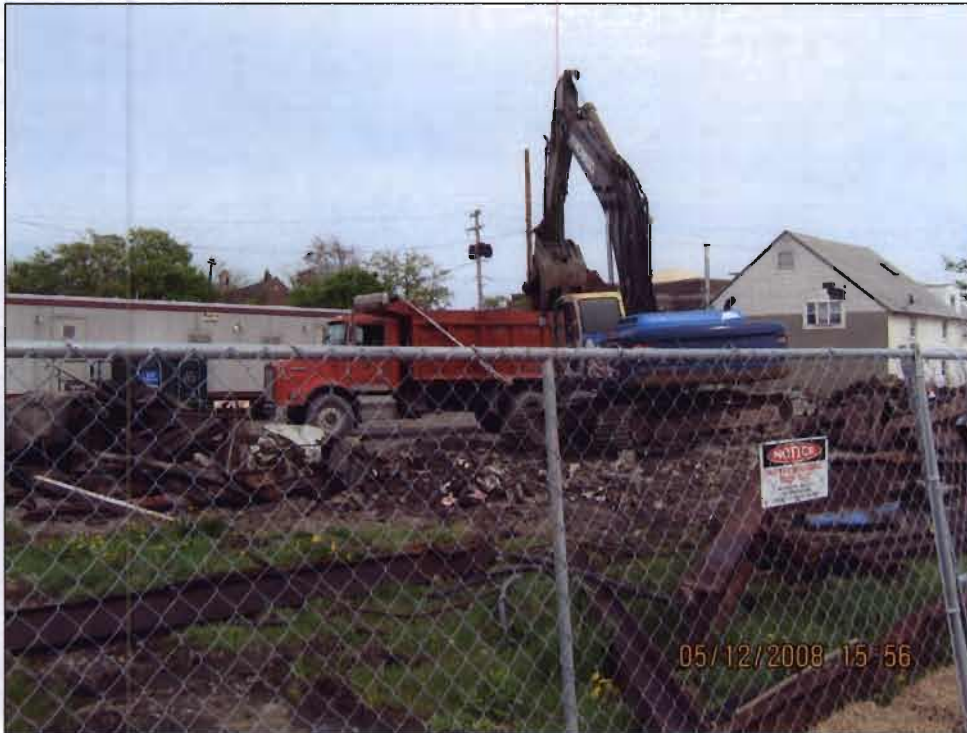
Loading of demolition metal debris for removal and off-site recycling.

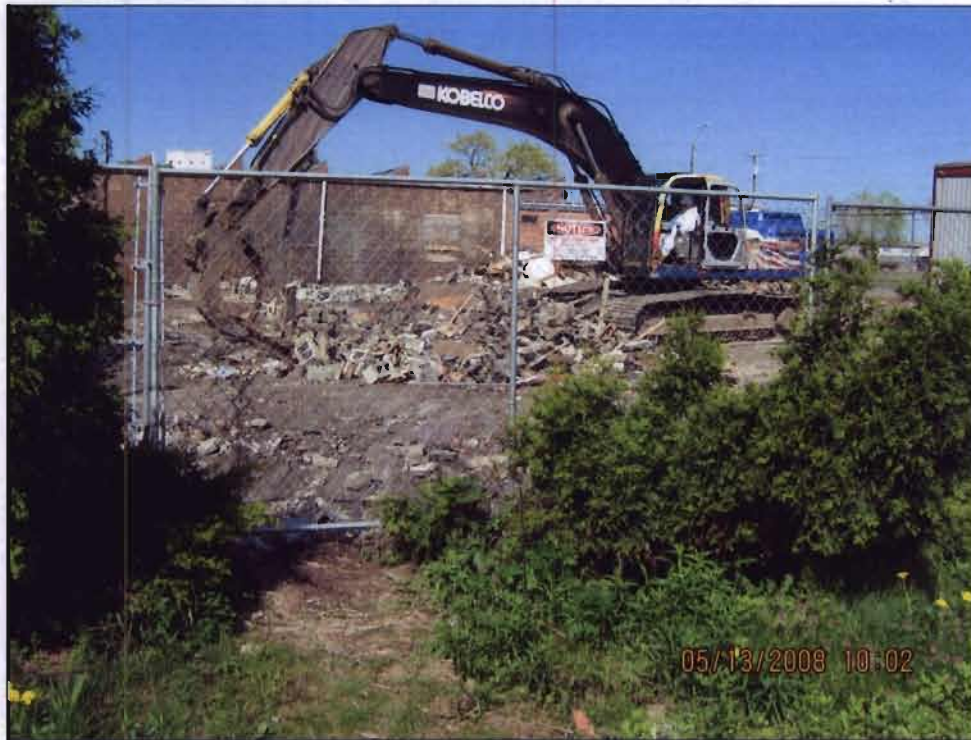
WRS segregates demolition debris of the MRS Plating Shop building materials.

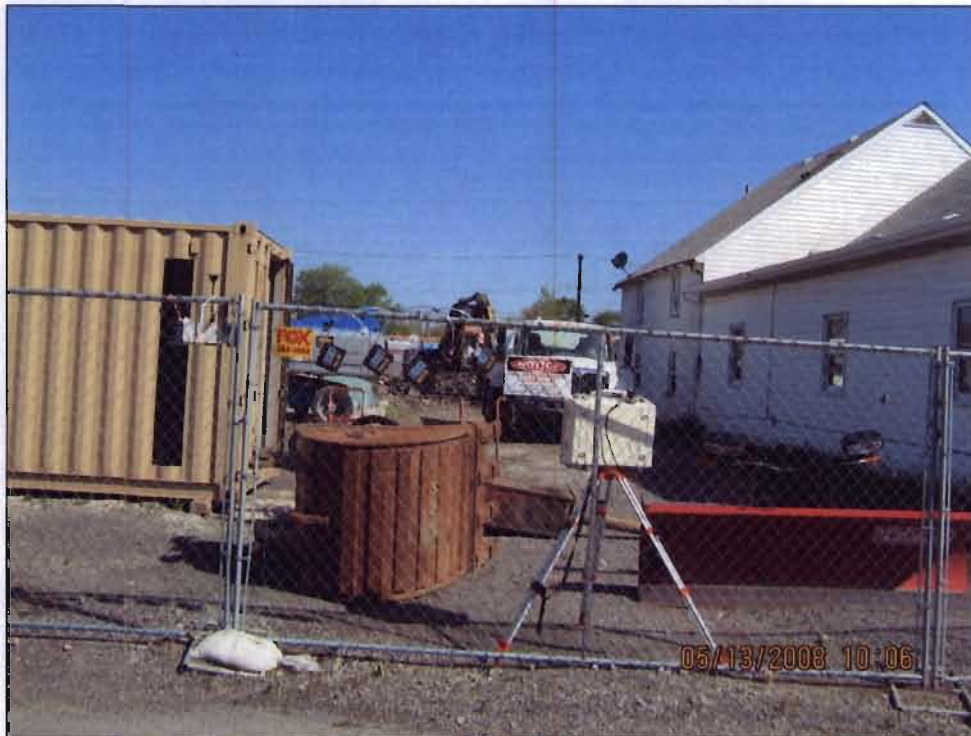
Air Monitoring Station #3 located at southern facility fence along the Rene Place road.

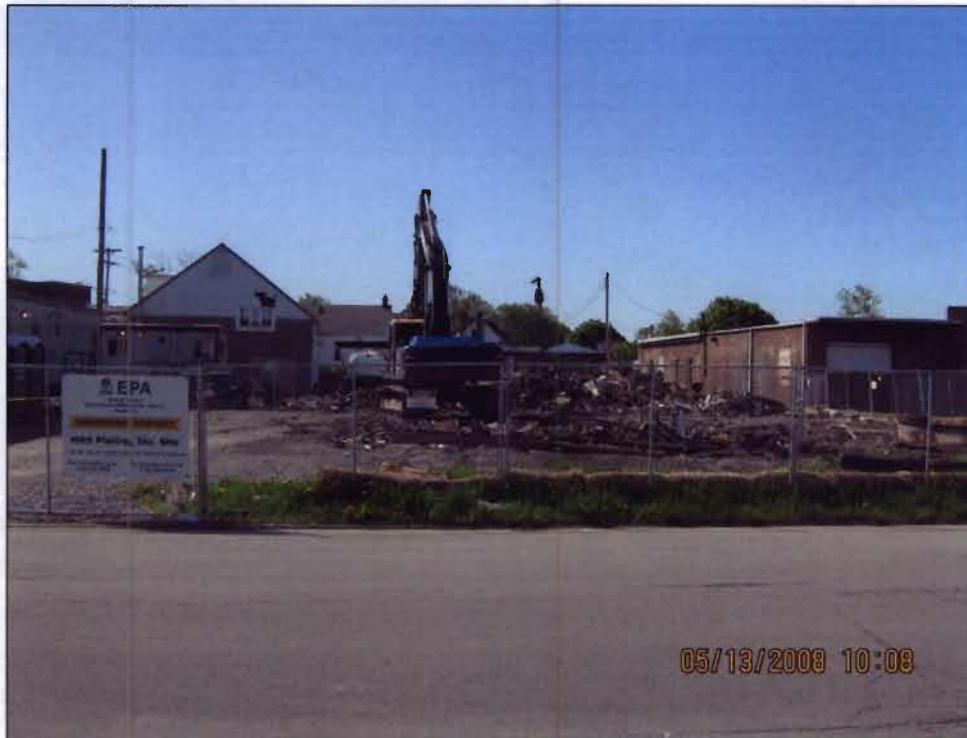
WRS segregates demolition debris of the MRS Plating Shop building materials.

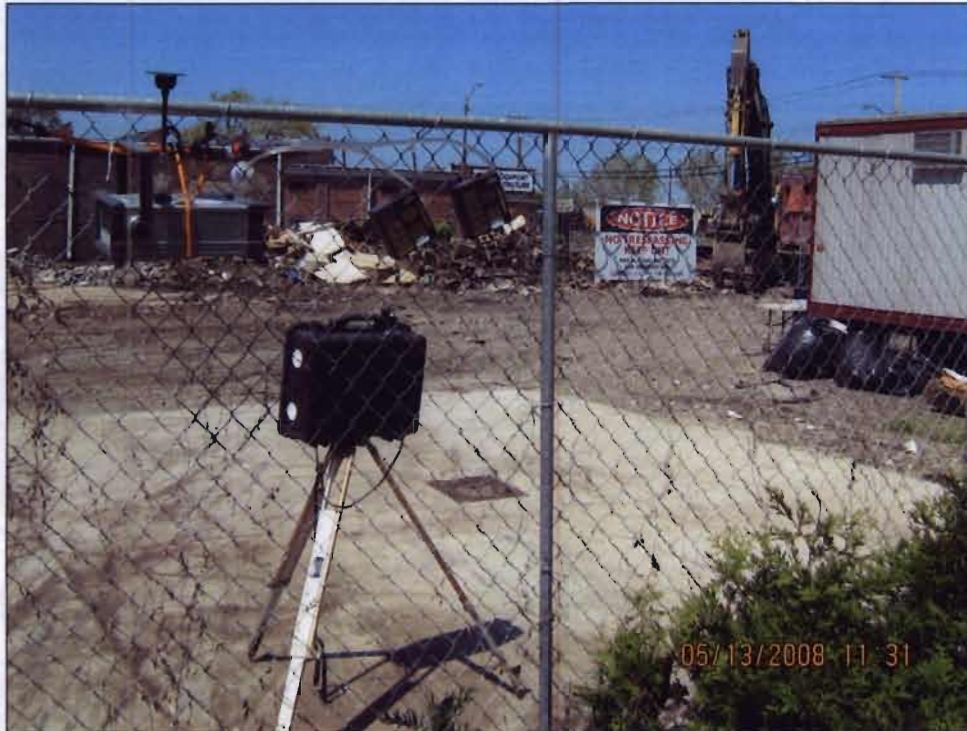
Air Monitoring Station #2 located at eastern facility fence next to a Residential Property.

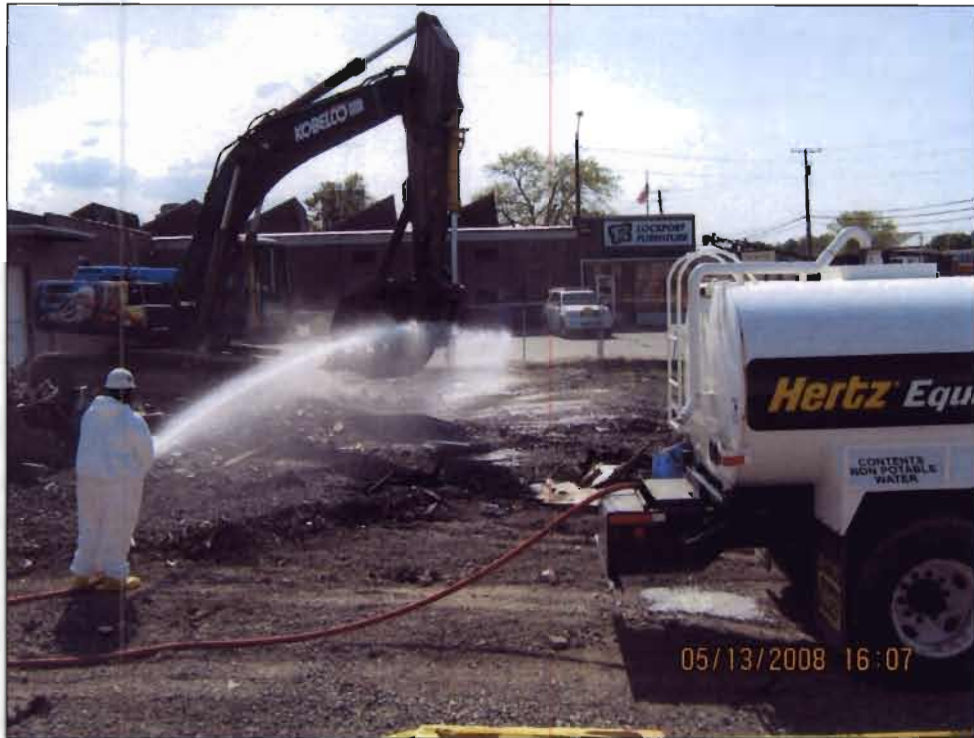
WRS Personnel conducting dust suppression during the MRS Plating Shop building's demolition debris segregation.

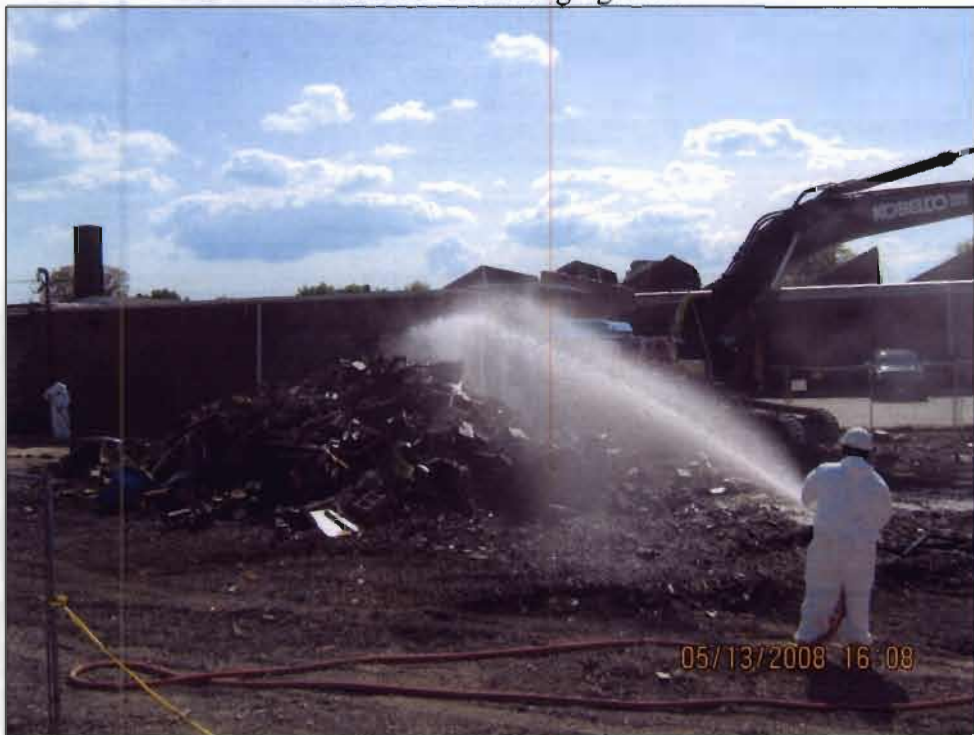
WRS Personnel conducting dust suppression during the MRS Plating Shop building's demolition debris segregation.

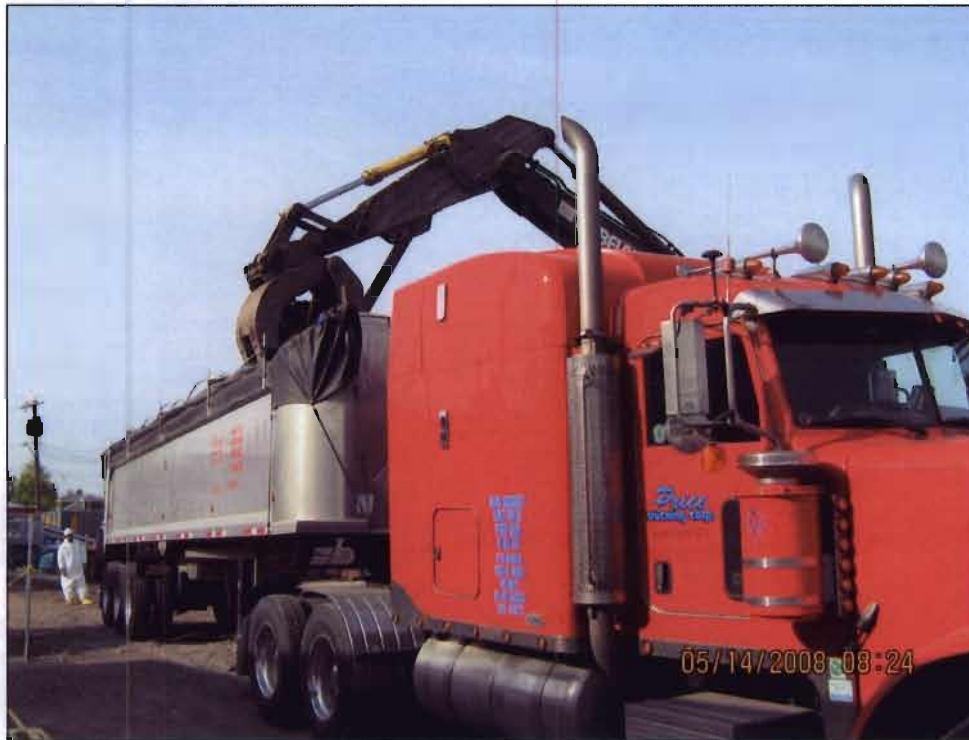
Loading demolition debris for removal and off-site disposal.

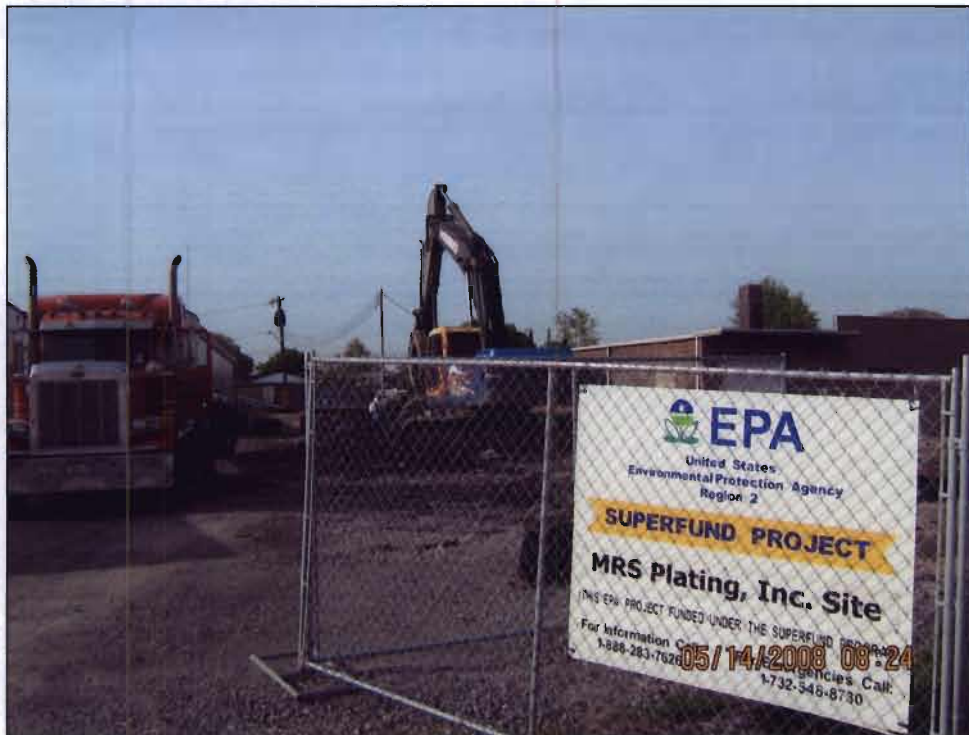
Loading demolition debris for removal and off-site disposal.

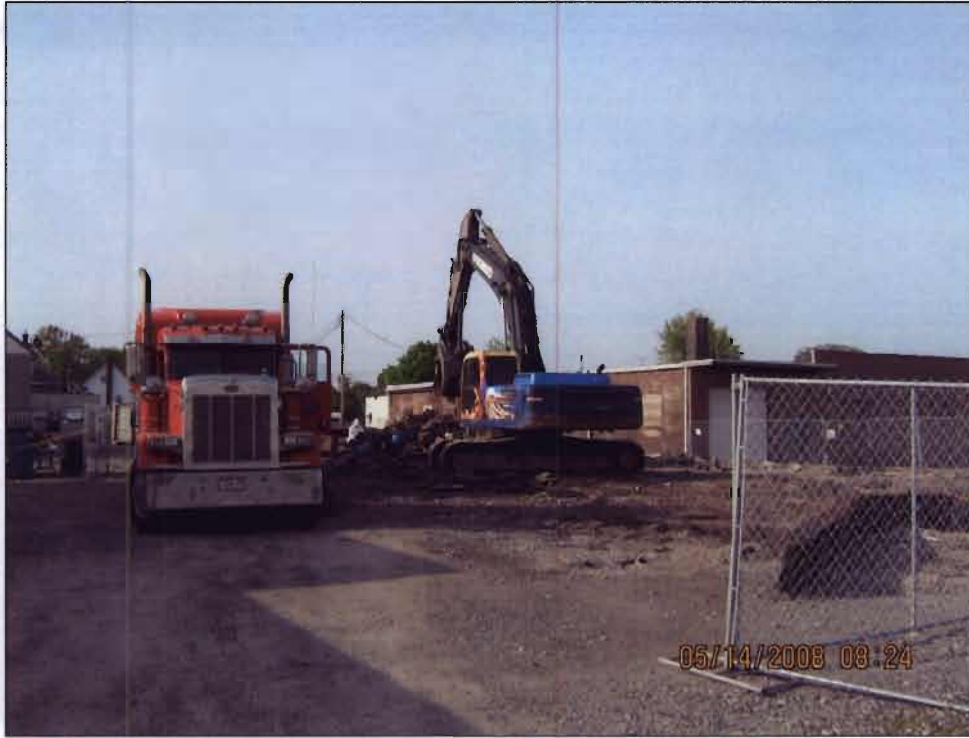
Loading demolition debris for removal and off-site disposal.

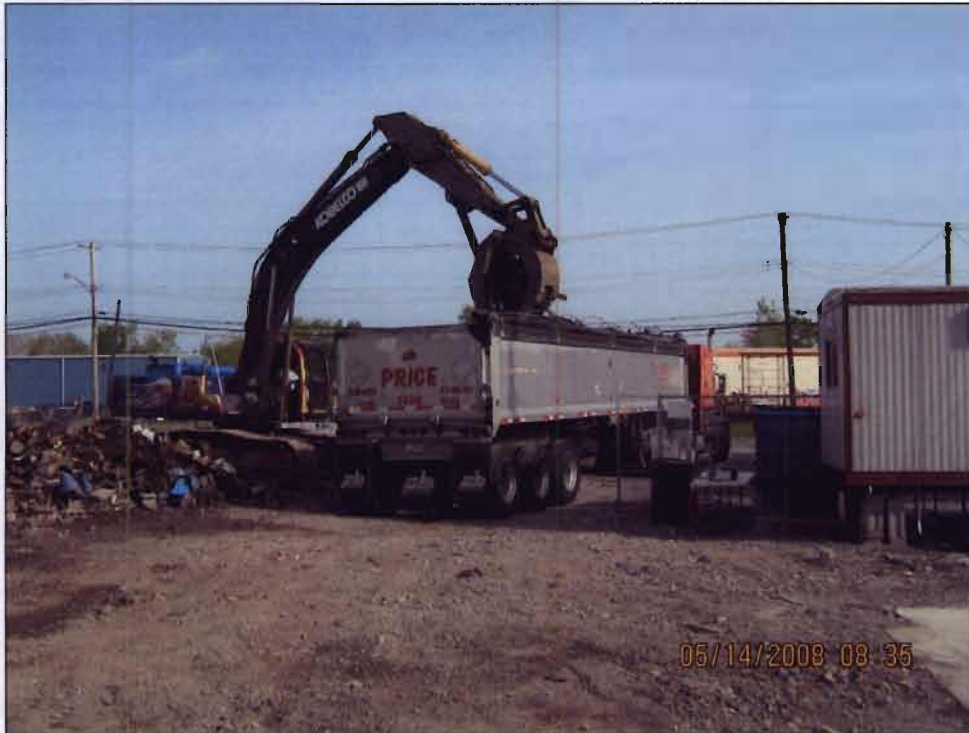
Loading demolition debris for removal and off-site disposal.

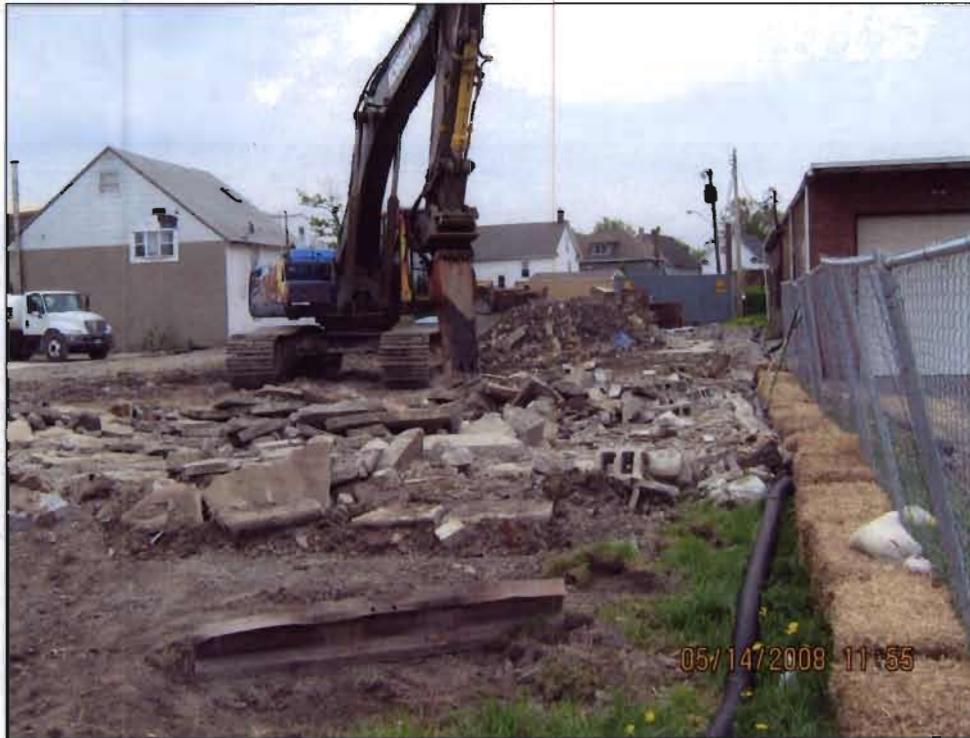
WRS removing concrete flooring and footers of the former MRS Plating Shop building.

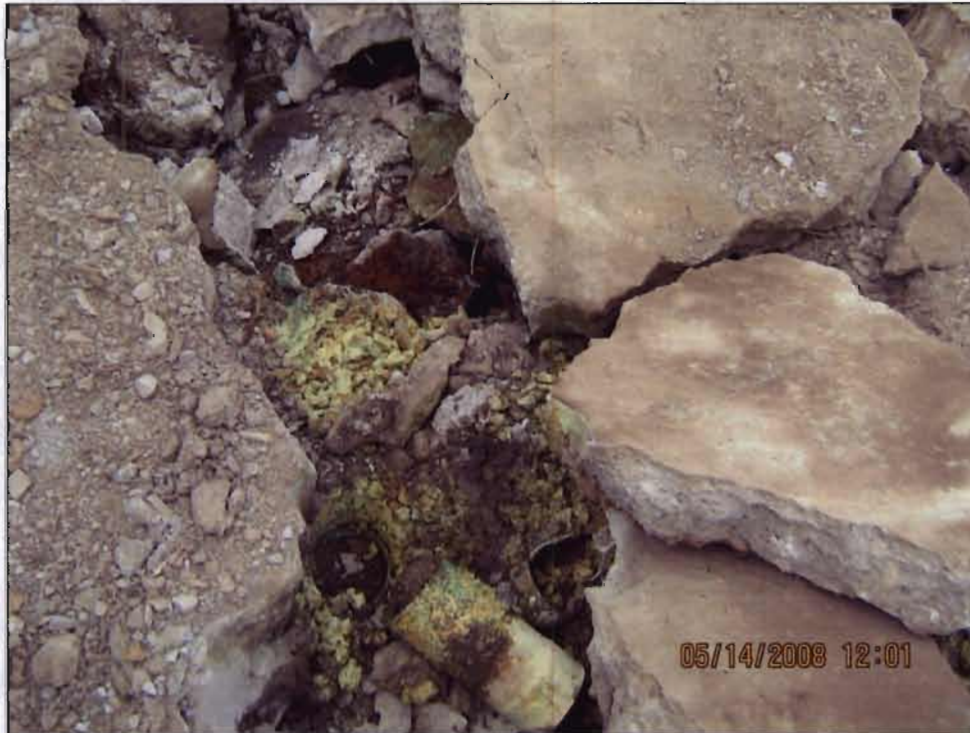
A view of discolored concrete floor removed from the MRS Plating Shop building area.

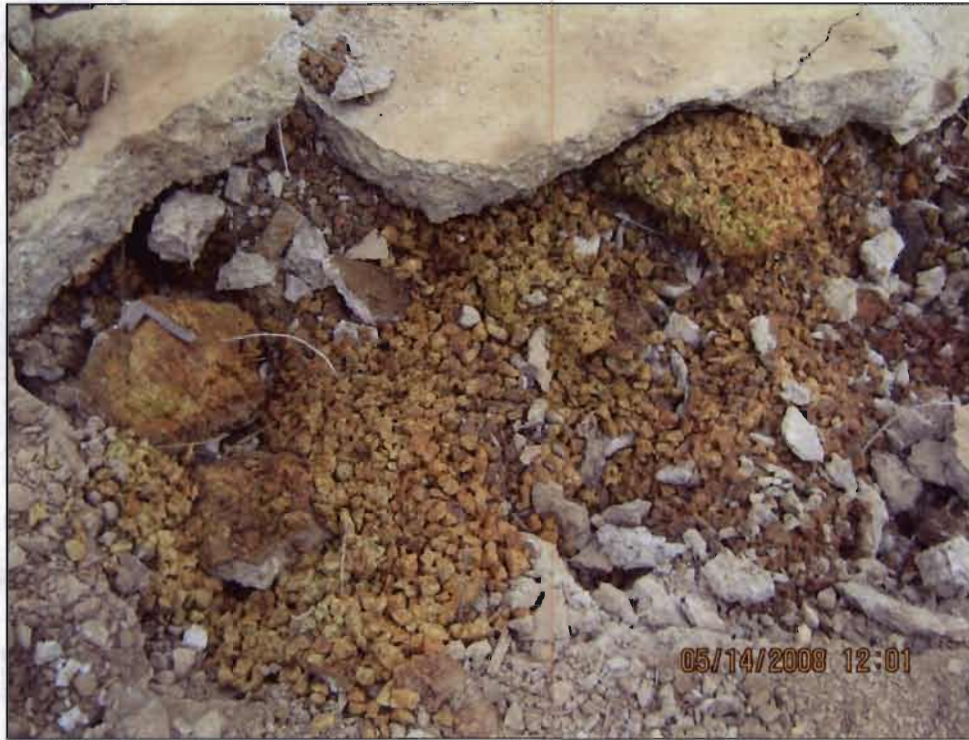
A view of discolored concrete floor removed from the MRS Plating Shop building area.

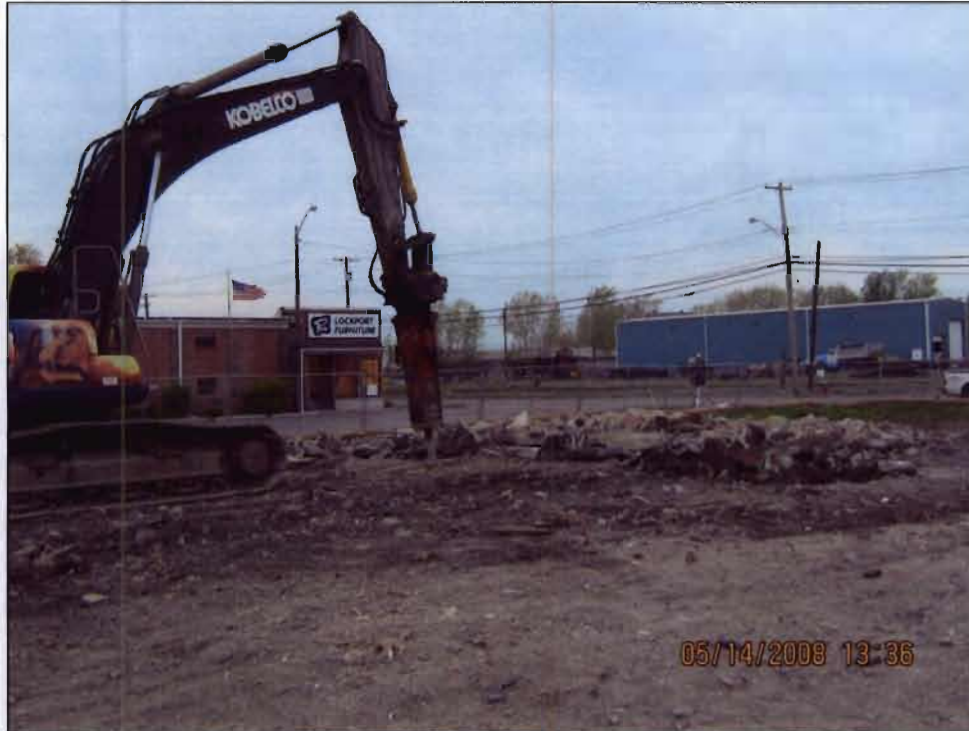
WRS removing concrete flooring and footers of the former MRS Plating Shop building.

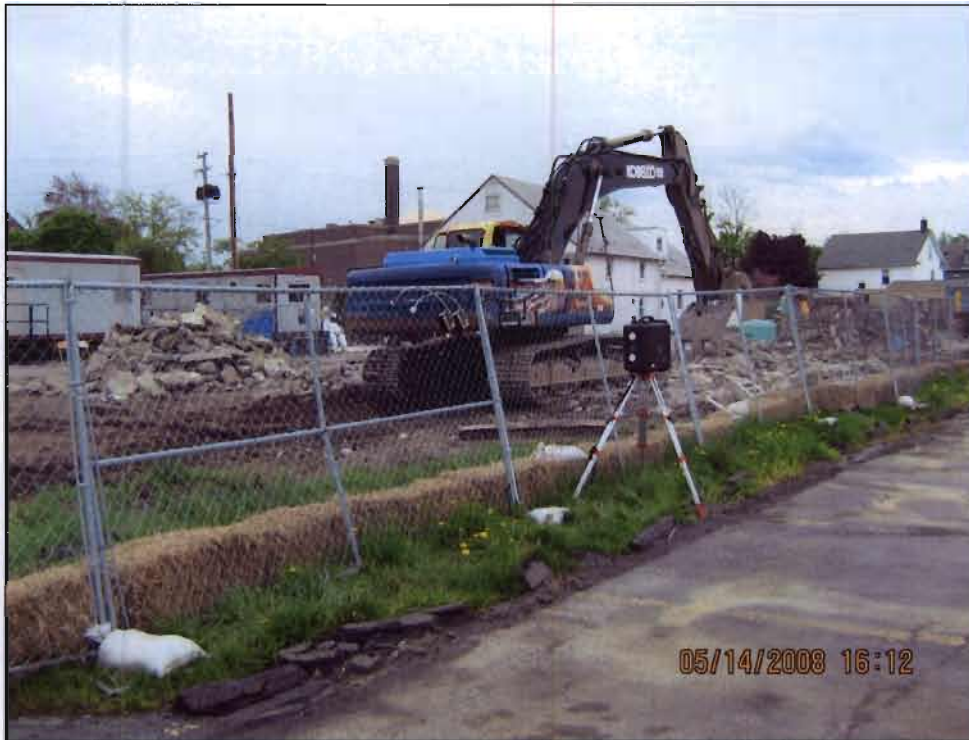
WRS removing concrete flooring and footers of the former MRS Plating Shop building.
Air Monitoring Station #1 is shown in the foreground.

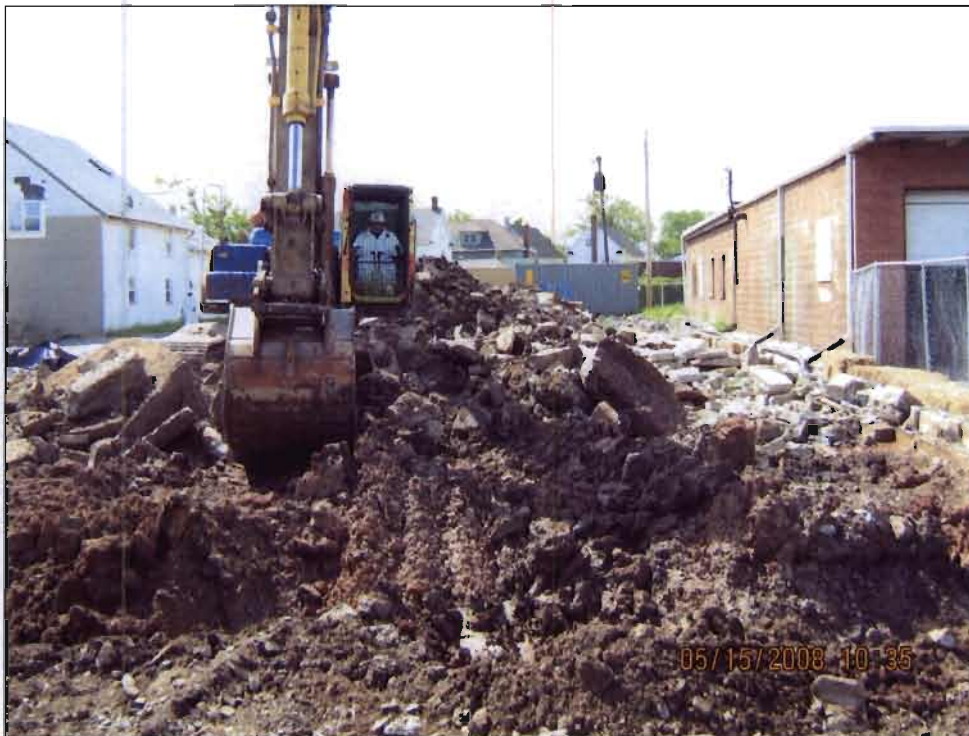
WRS removing concrete flooring and footers of the former MRS Plating Shop building.

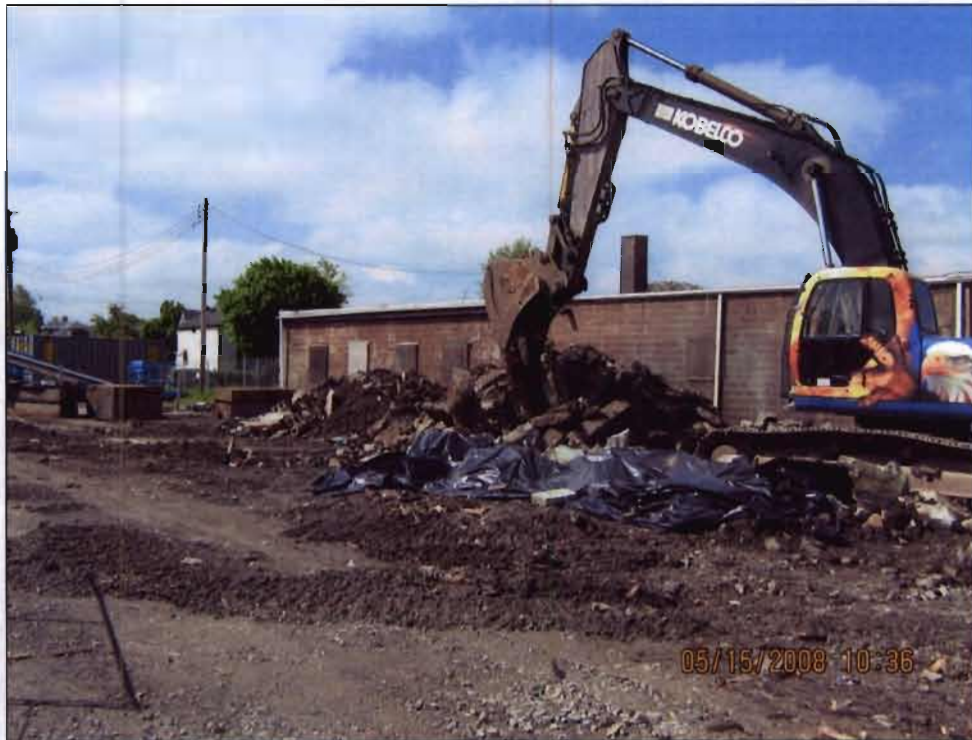
WRS segregating debris of the concrete flooring and concrete footers removed from the demolished MRS Plating Shop building.

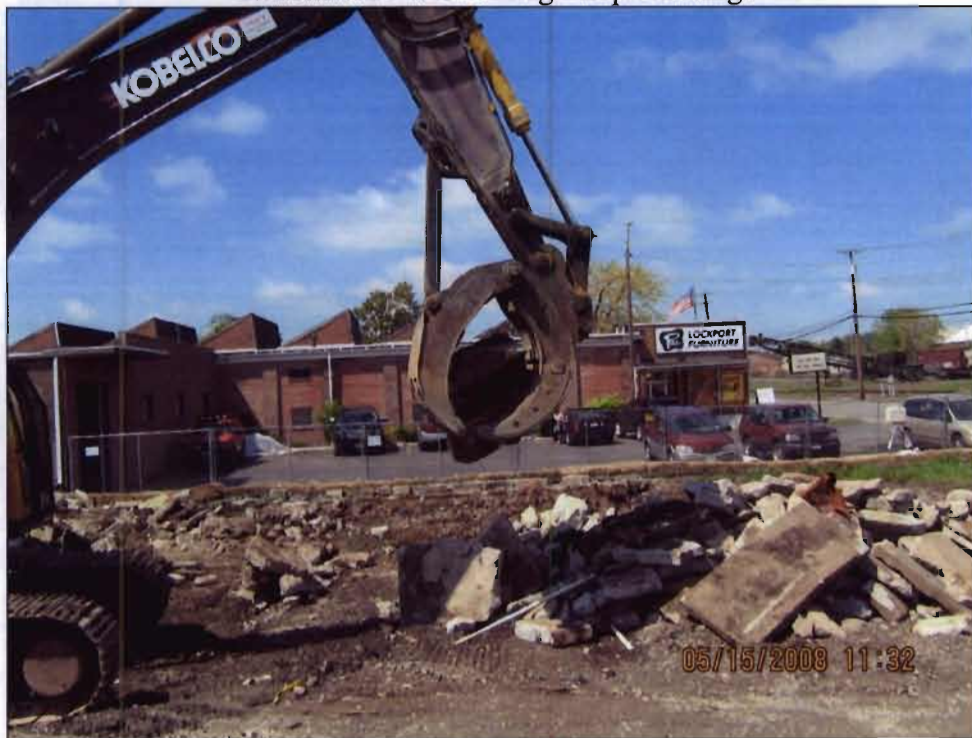
WRS segregating debris of the concrete flooring and concrete footers removed from the demolished MRS Plating Shop building.

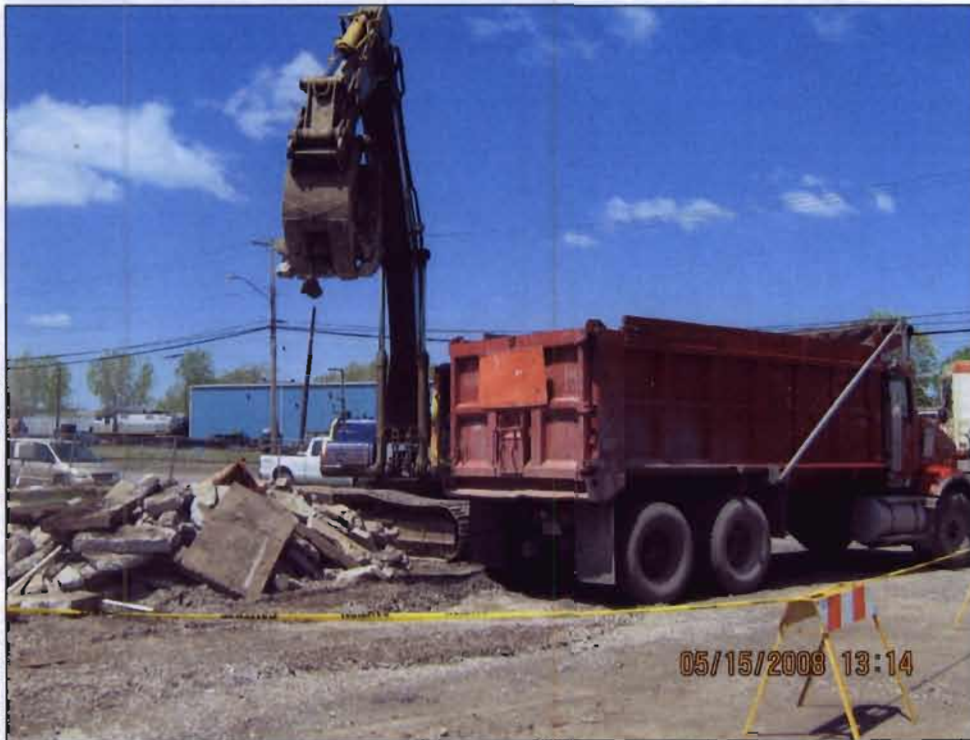
Loading of concrete debris removed from the MRS Plating Shop building floors and footers for removal.

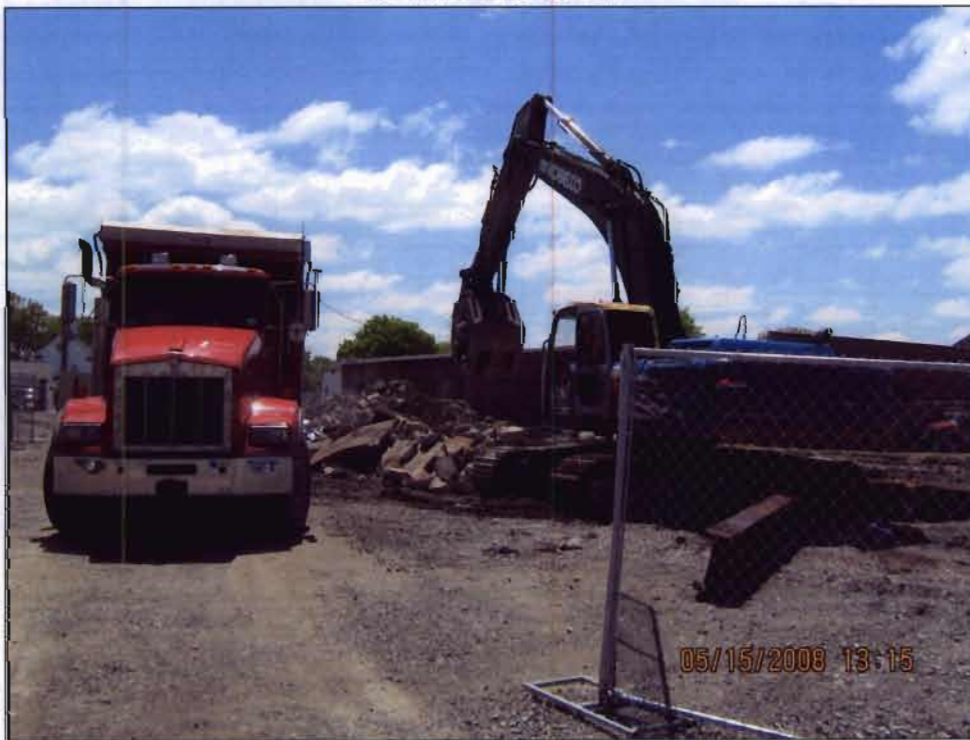
Loading of concrete debris removed from the MRS Plating Shop building floors and footers for removal.

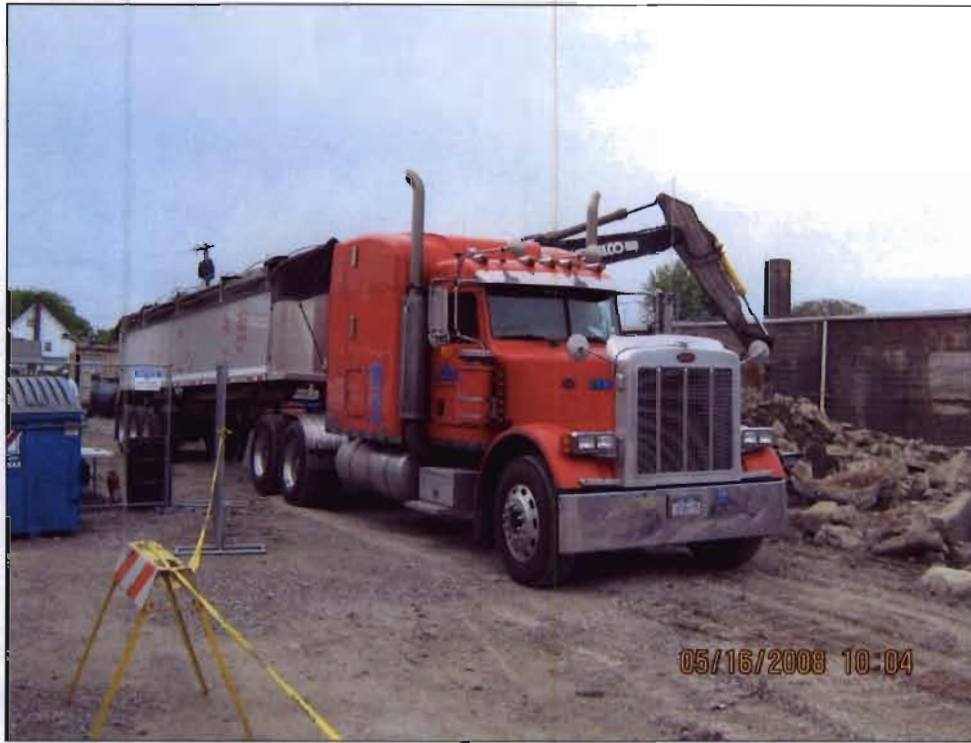
Loading of concrete debris removed from the MRS Plating Shop building floors and footers for removal.

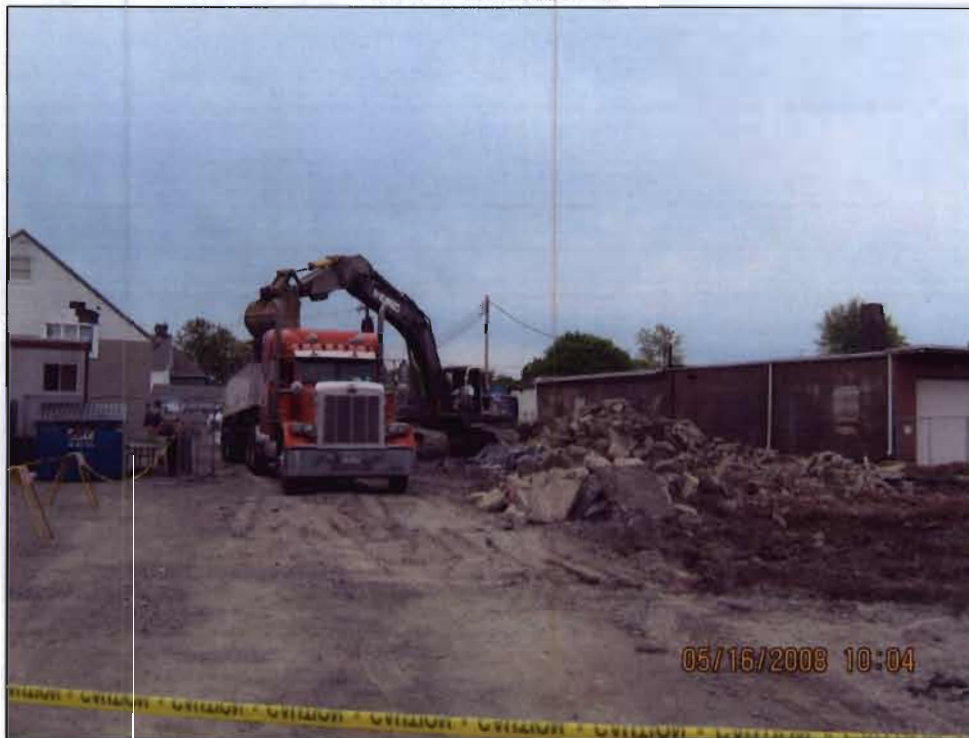
Loading of concrete debris removed from the MRS Plating Shop building floors and footers for removal.

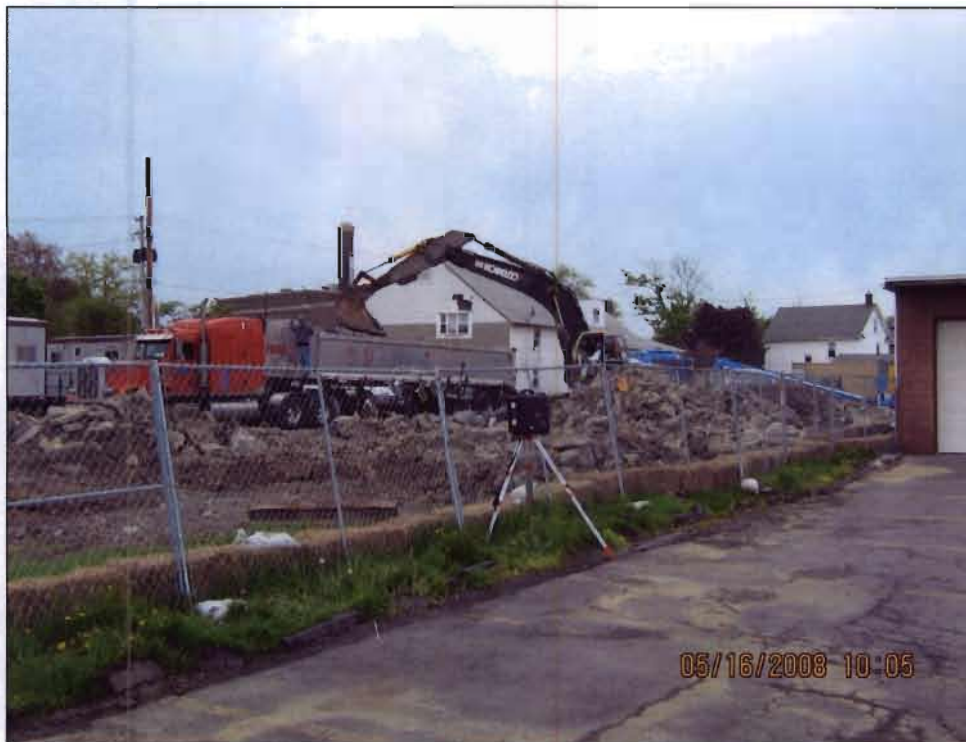
Loading of concrete debris removed from the MRS Plating Shop building floors and footers for removal. Air Monitoring Station #1 is shown in the foreground.

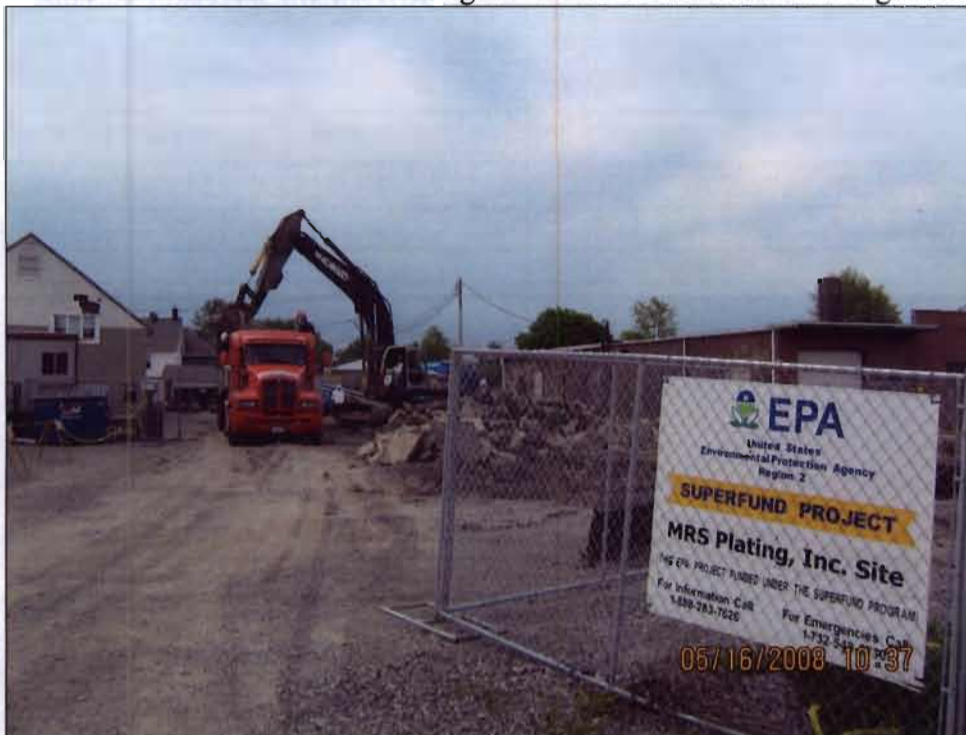
Loading of concrete debris removed from the MRS Plating Shop building floors and footers for removal.

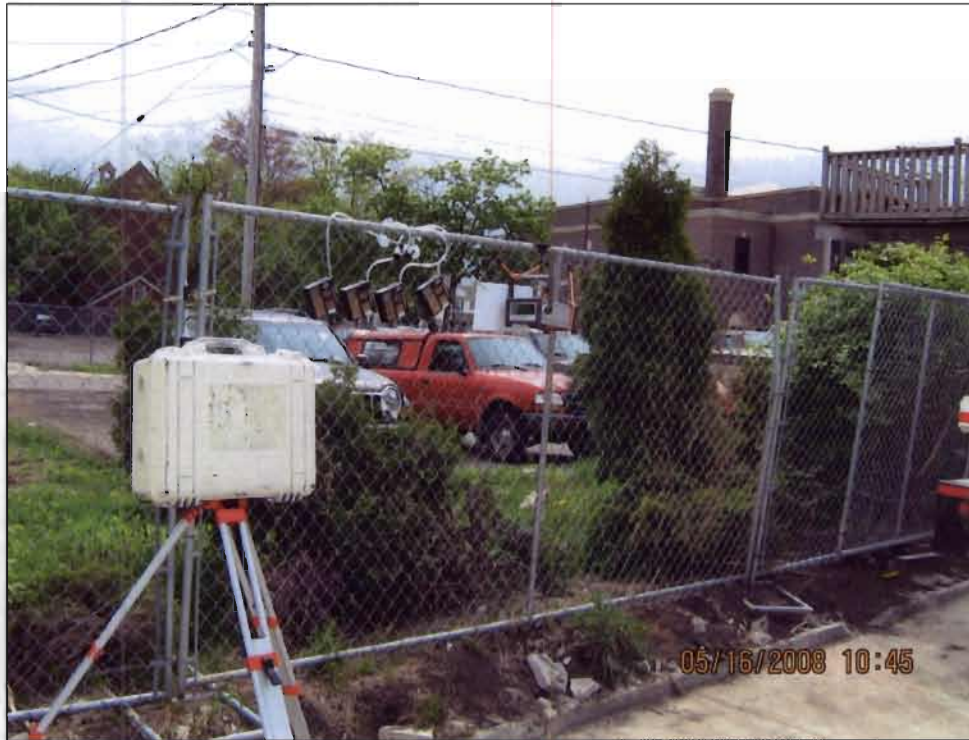
Air Monitoring Station #2 located at eastern facility fence next to a Residential Property.

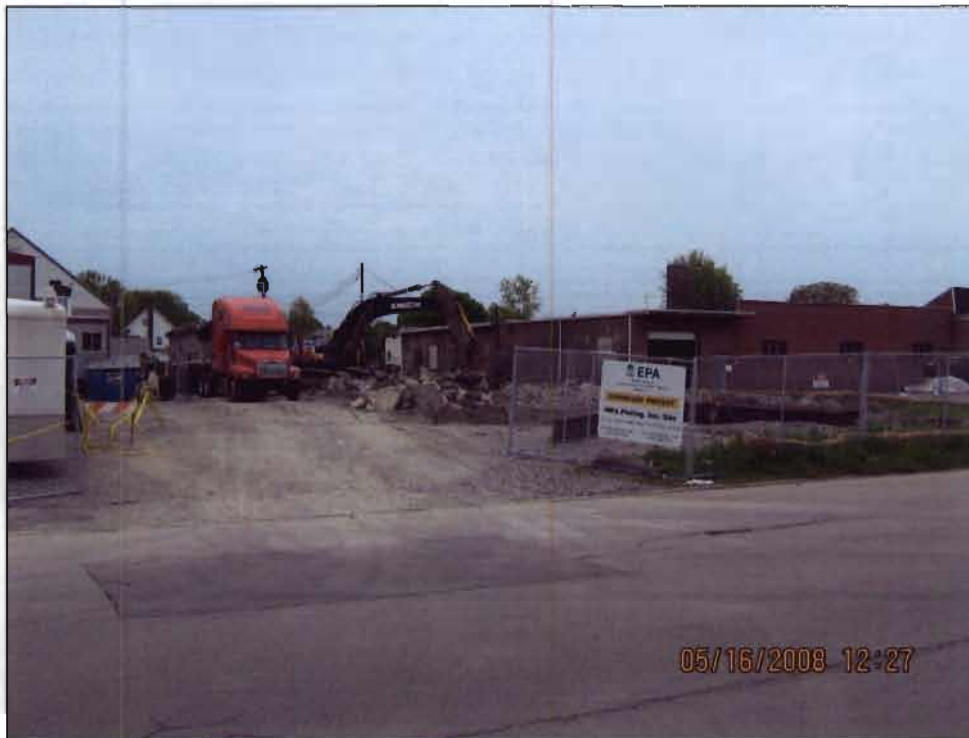
Loading of concrete debris removed from the MRS Plating Shop building floors and footers for removal.

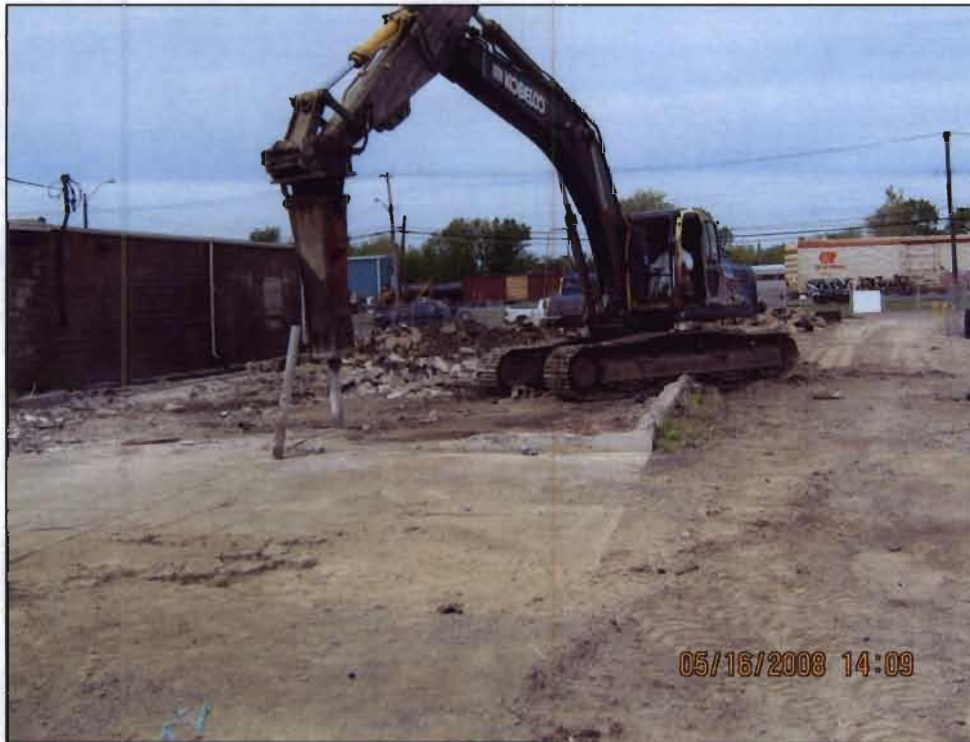
WRS removing concrete flooring of the demolished MRS Plating Shop building for off-site disposal.

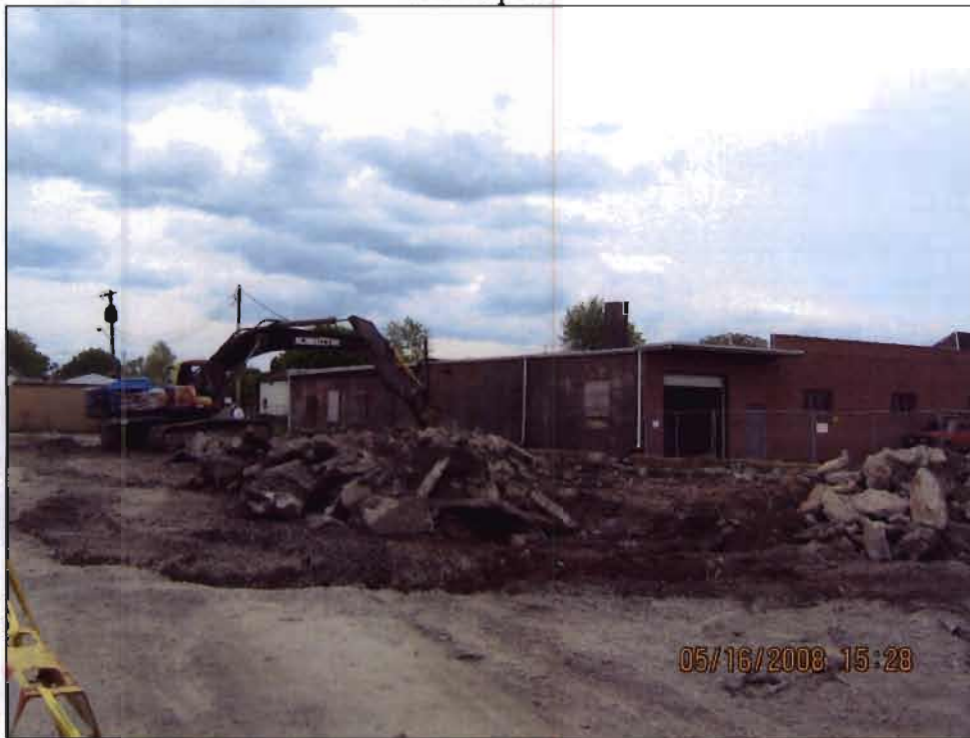
WRS crushing large concrete pieces into manageable small for load out.

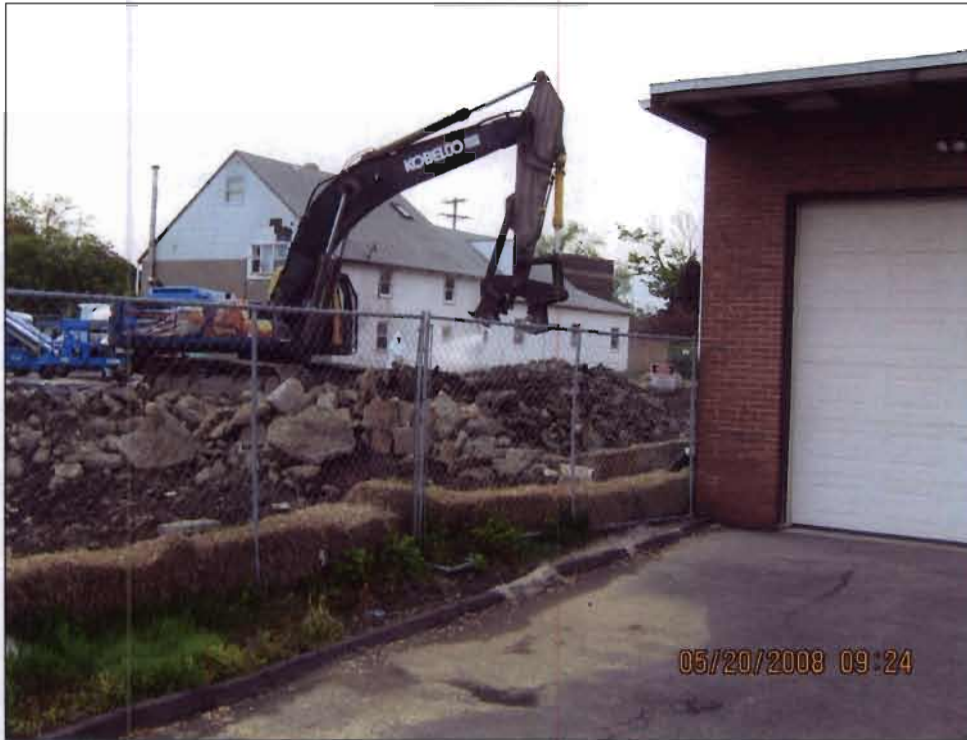
WRS crushing large concrete pieces into manageable small pieces for load out.

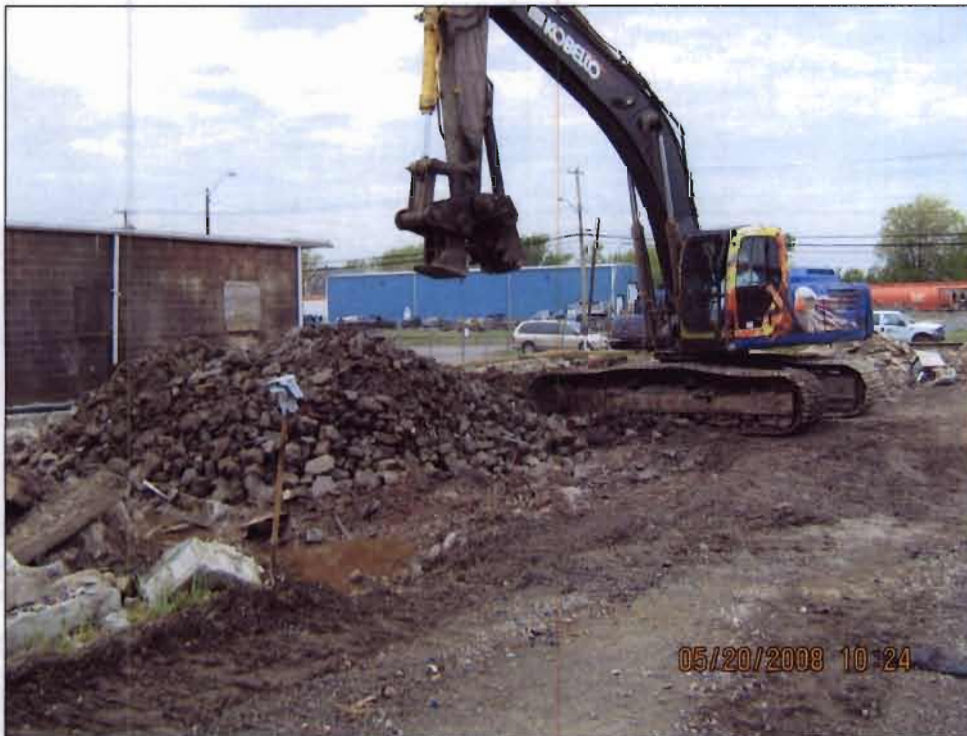
WRS continued to crush large concrete pieces into manageable small pieces for load out.
