Photo Documentation of the Removal Action

MRS Plating Site
310 Park Avenue
Lockport, Niagara County, New York

Removal Support Team 2
Weston Solutions, Inc.
Northeast Division
Edison, New Jersey, 08837

U. S. Environmental Protection Agency
Region II – Removal Action Branch
186 Exchange Street
Buffalo, NY 14203

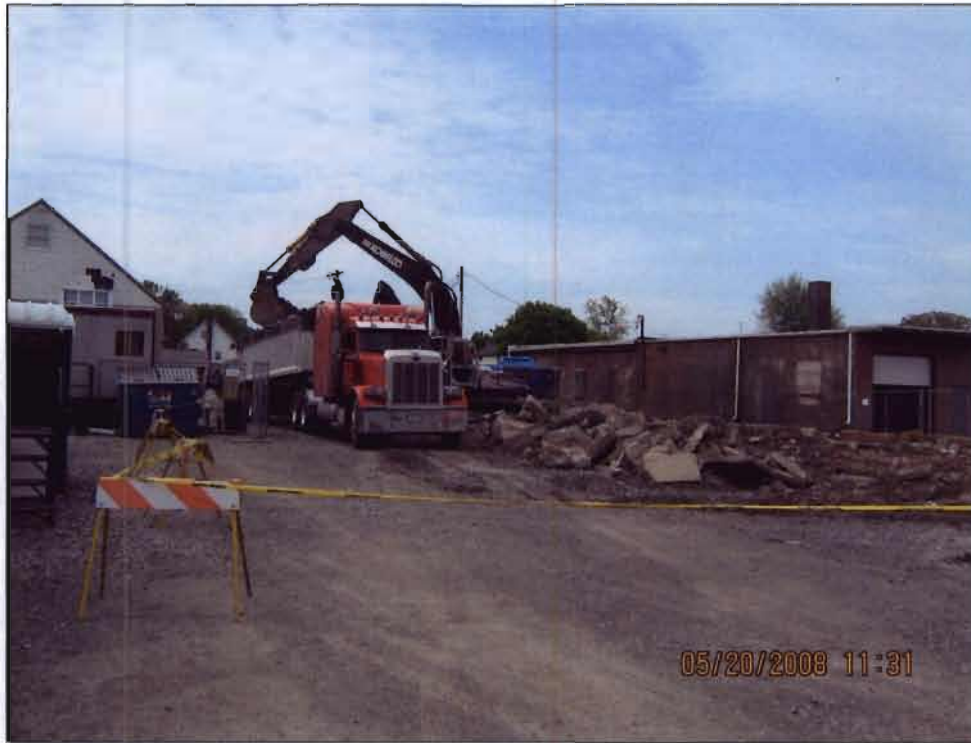
Loading of concrete debris removed from the MRS Plating Shop building floors and footers for removal.

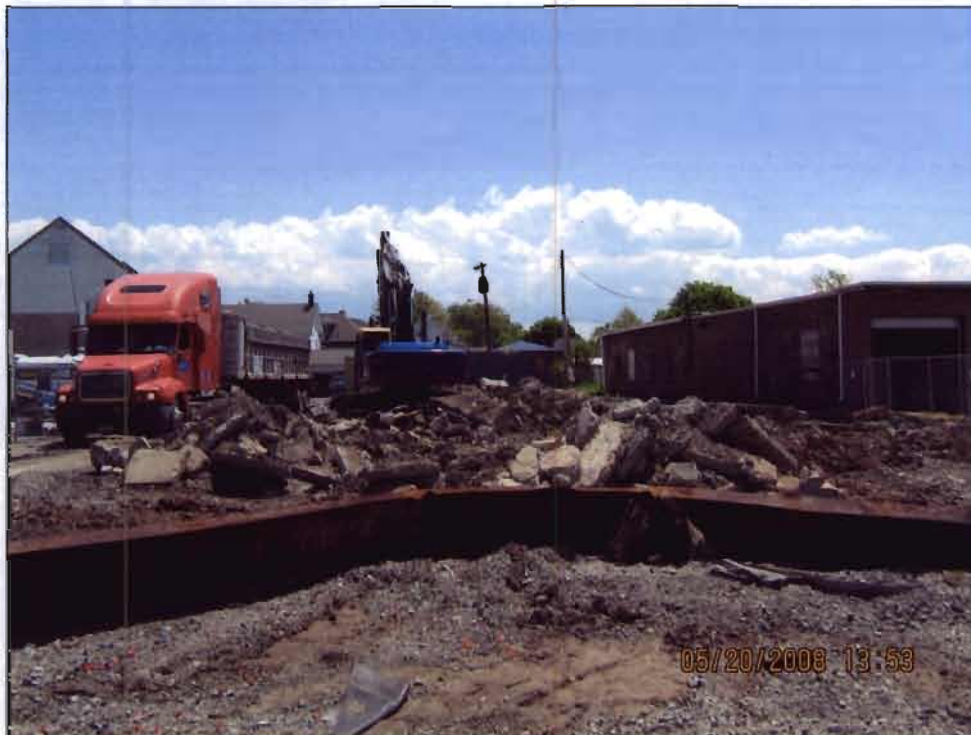
Loading of concrete debris removed from the MRS Plating Shop building floors and footers for removal.

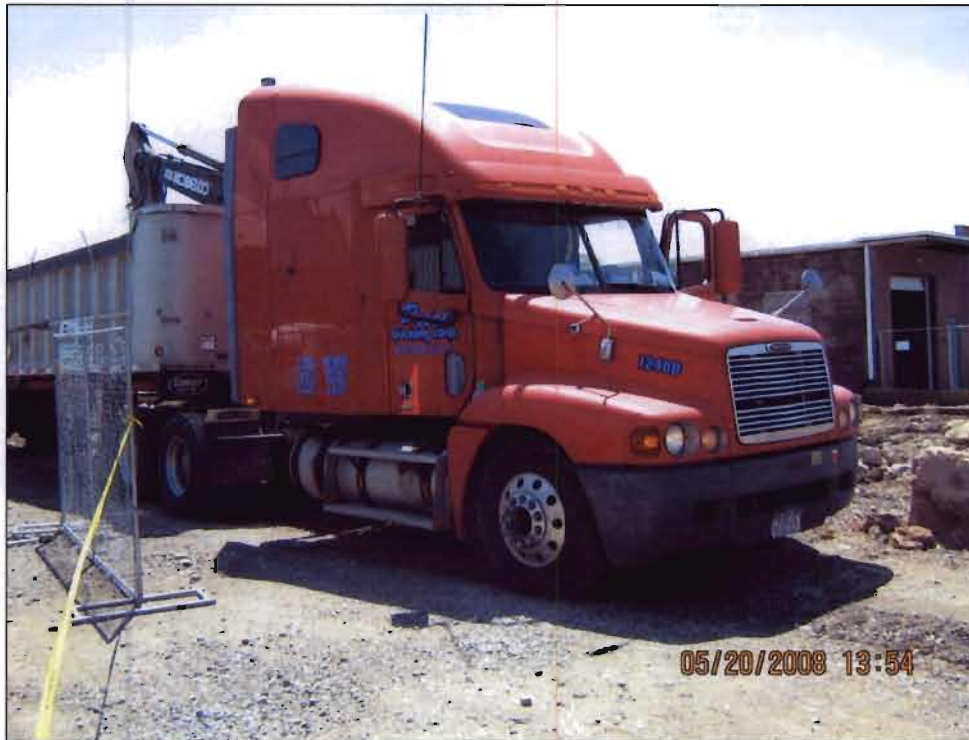
Loading of concrete debris removed from the MRS Plating Shop building floors and footers for removal.

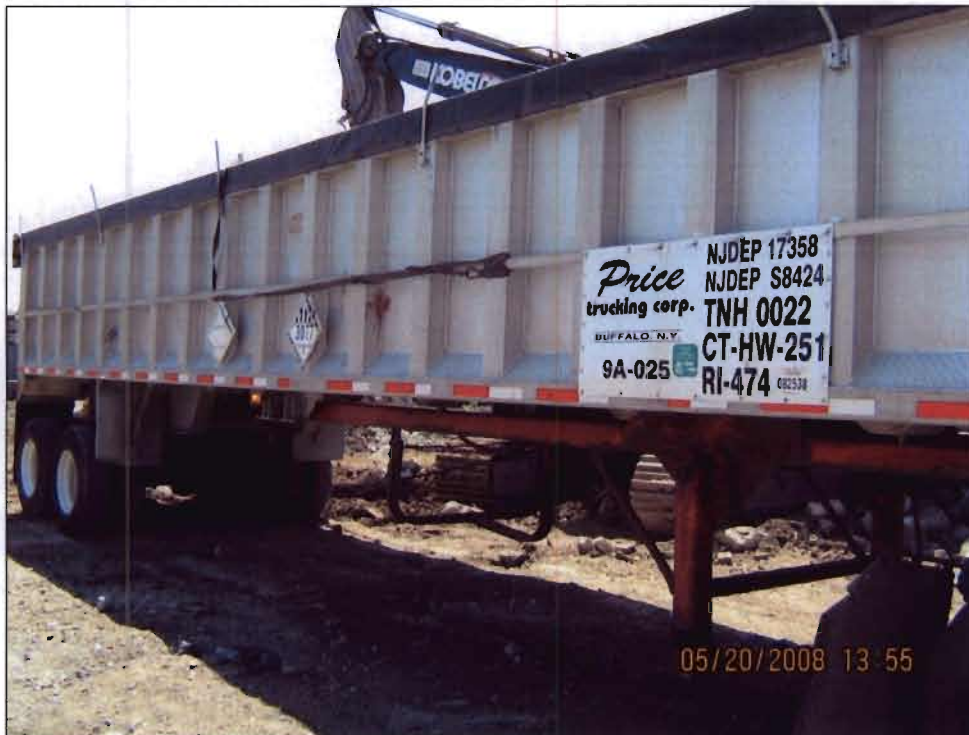
Loading of concrete debris removed from the MRS Plating Shop building floors and footers for removal.

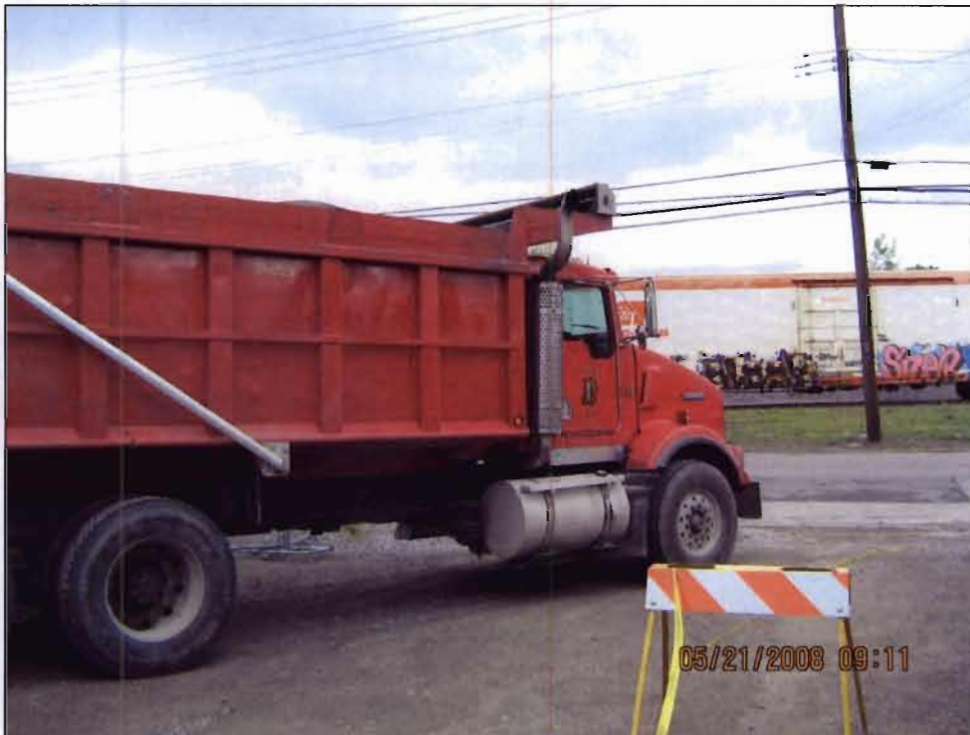
Loading of concrete debris removed from the MRS Plating Shop building floors and footers for removal.

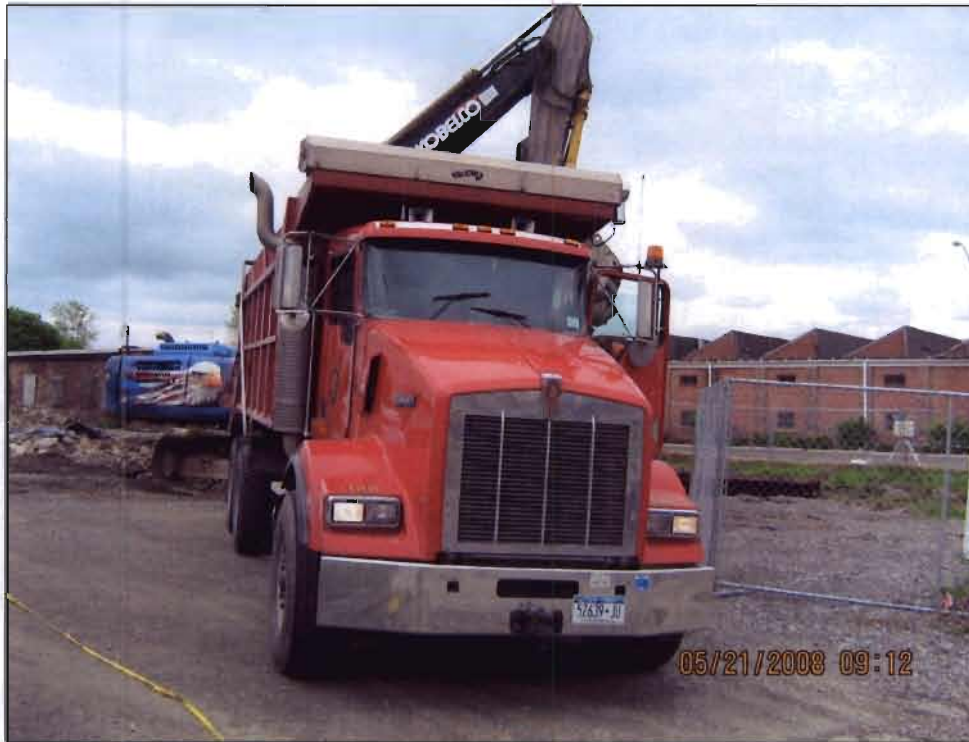
Loading of concrete debris removed from the MRS Plating Shop building floors and footers for removal.

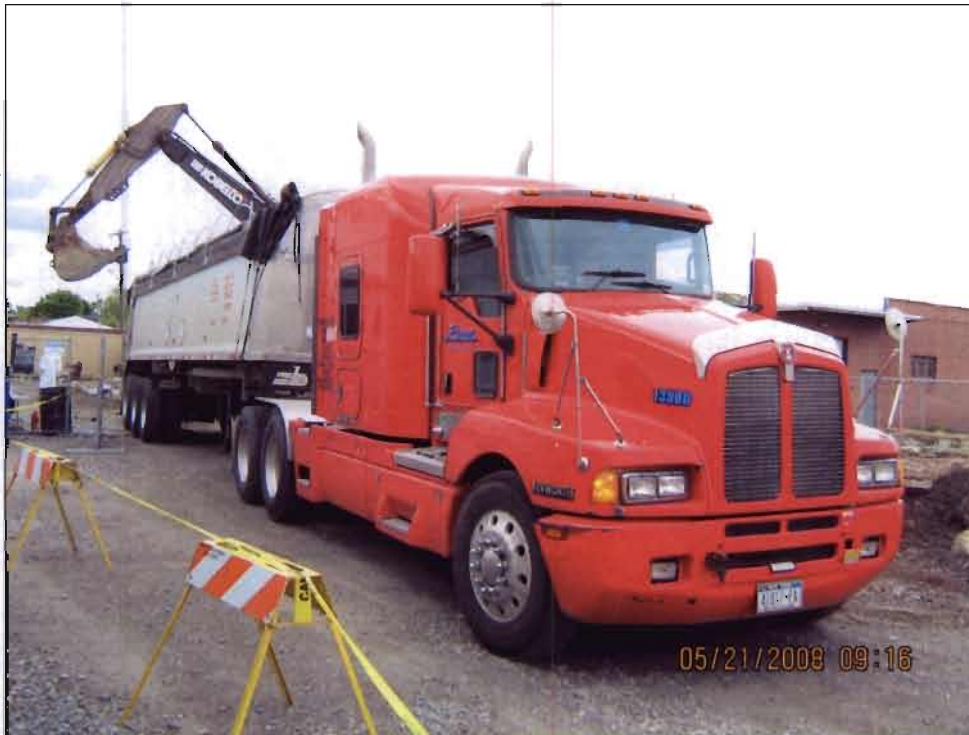
Loading of concrete debris removed from the MRS Plating Shop building floors and footers for removal.

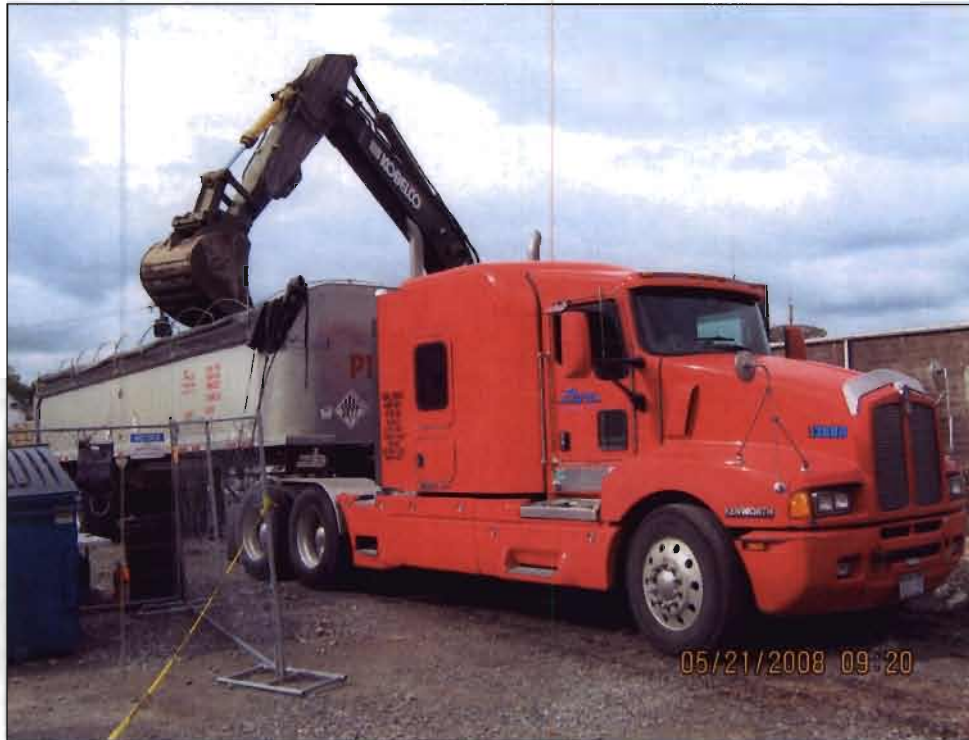
Loading of concrete debris removed from the MRS Plating Shop building floors and footers for removal.

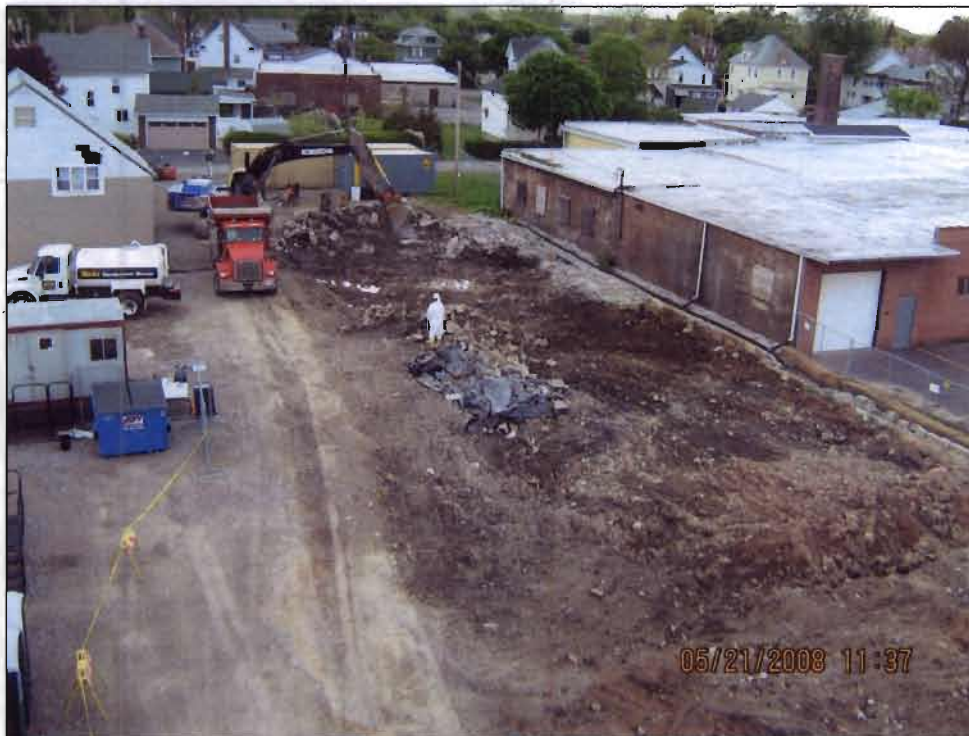
Overview of the MRS Plating Facility looking towards Rene Place. Loading of concrete debris removed from the MRS Plating Shop building floors and footers for removal.

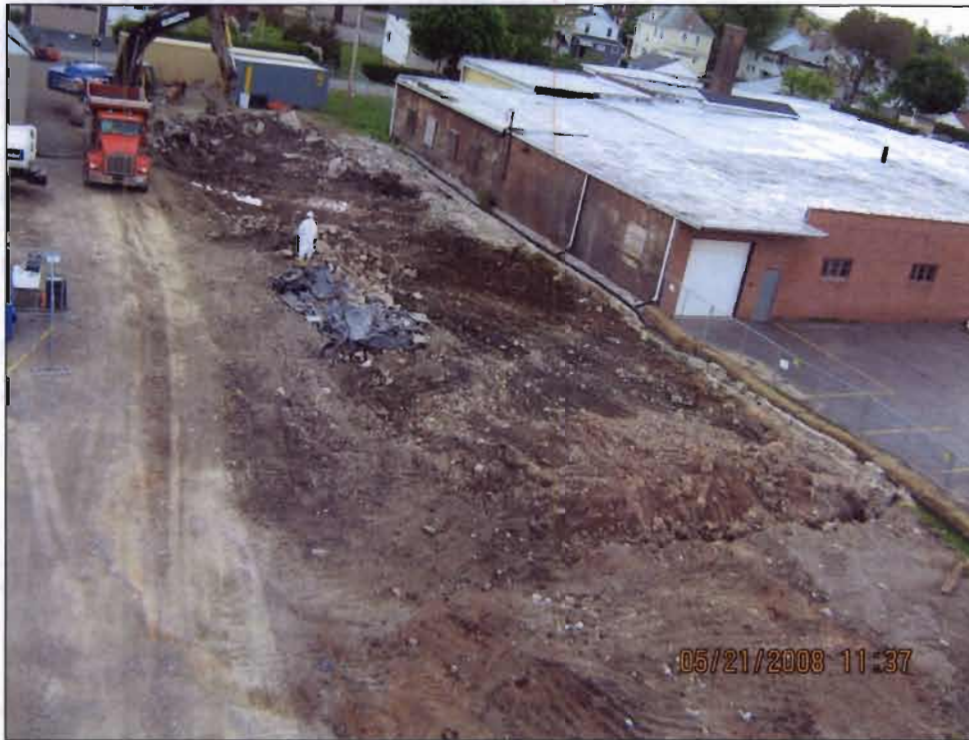
Overview of the MRS Plating Facility looking towards Rene Place. Loading of concrete debris removed from the MRS Plating Shop building floors and footers for removal.

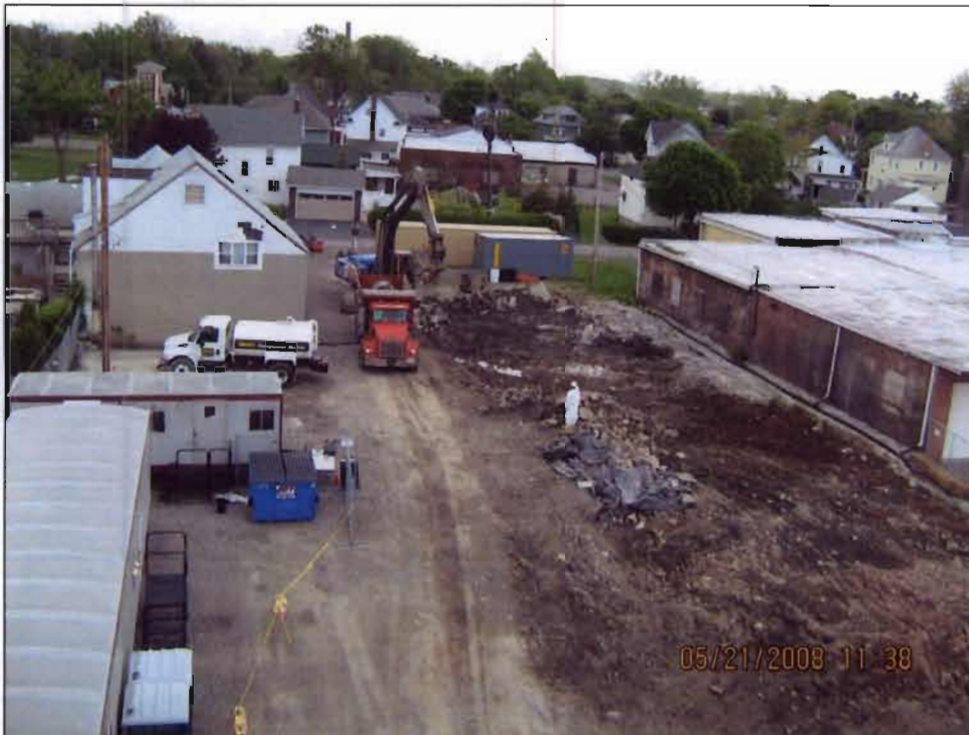
Overview of the MRS Plating Facility looking towards Rene Place. Loading of concrete debris removed from the MRS Plating Shop building floors and footers for removal.

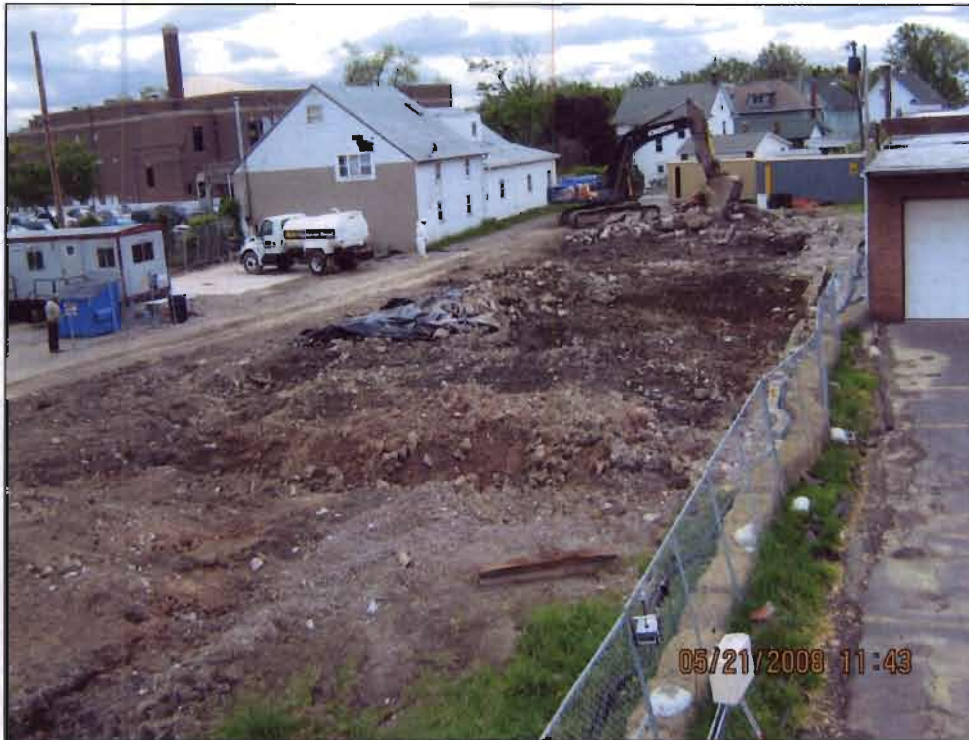
Overview of the MRS Plating Facility looking towards Rene Place. The private residences and the Elementary School are located in the background.

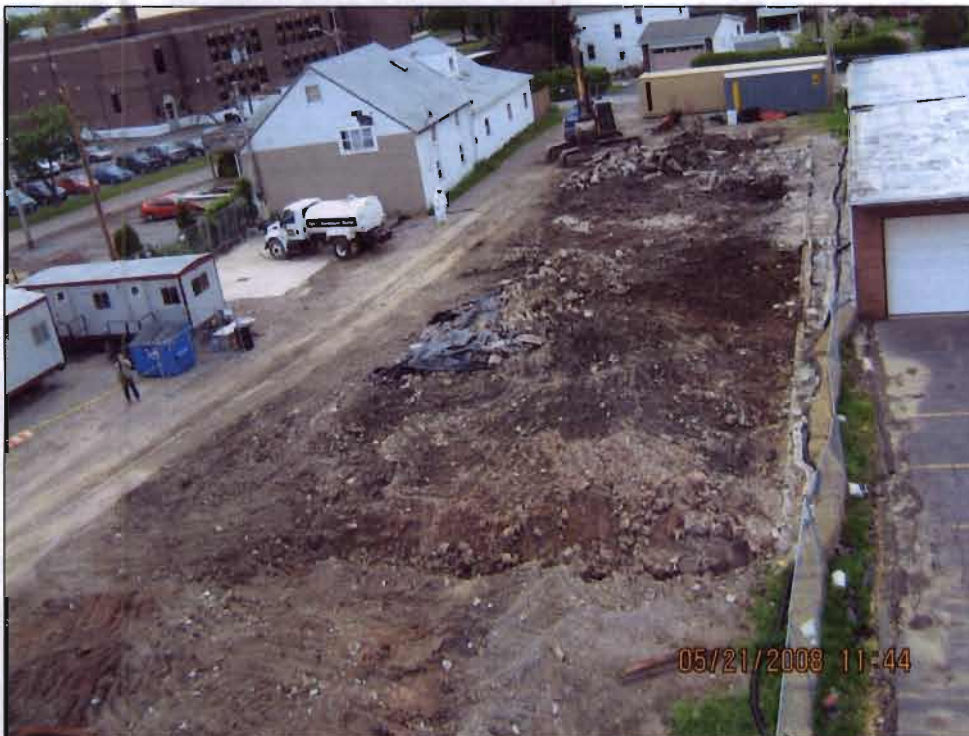
Another overview of the MRS Plating Facility looking southeast. The private residences and the Elementary School are located in the background.

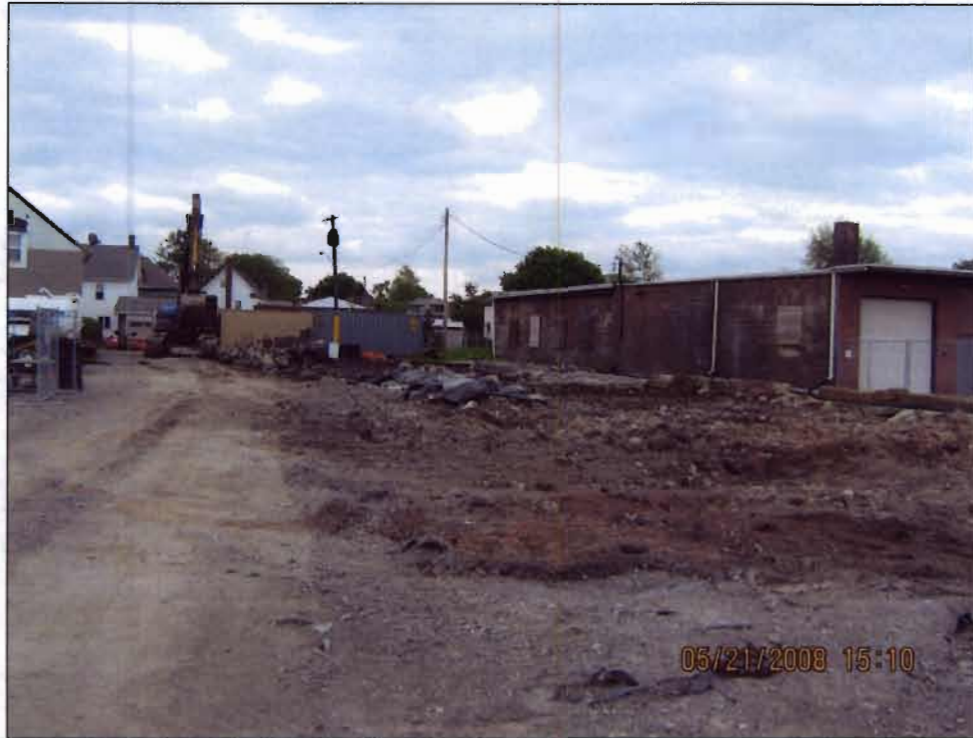
A view of the MRS Plating Facility looking towards Rene Place during the removal activities.

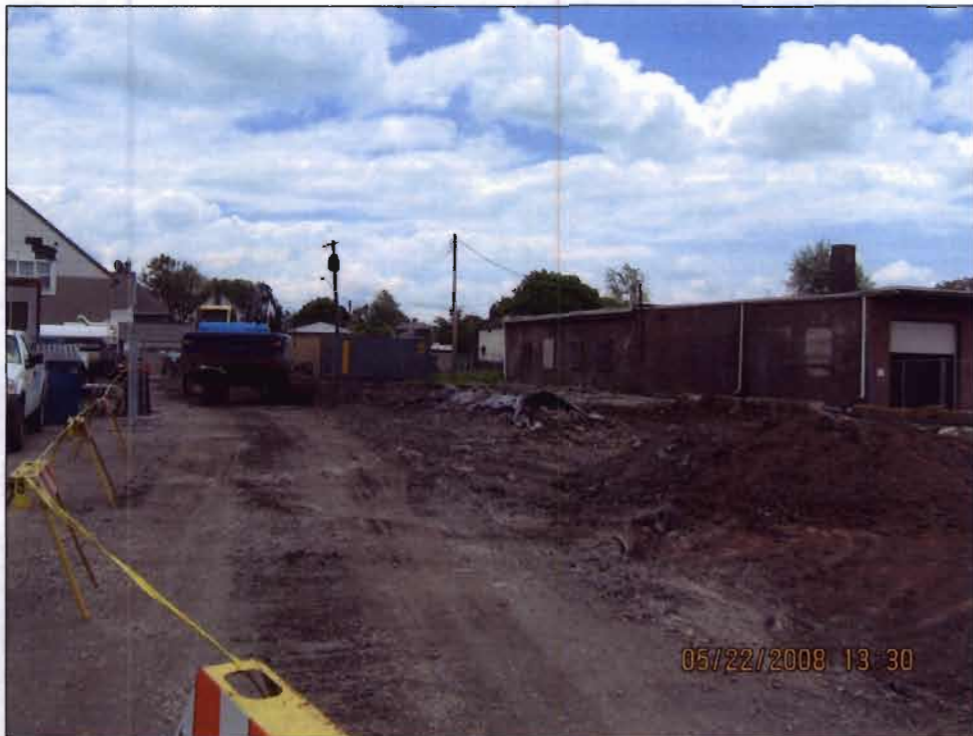
A view of the MRS Plating Facility looking towards Rene Place during the removal activities.

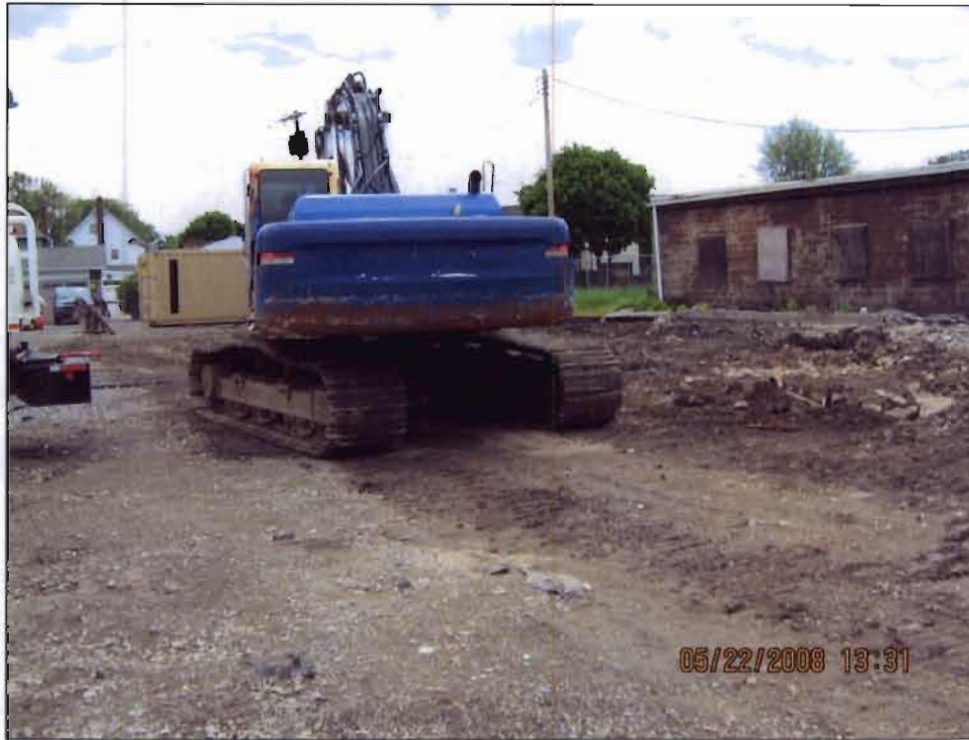
A view of the MRS Plating Facility looking towards Rene Place during the removal activities.

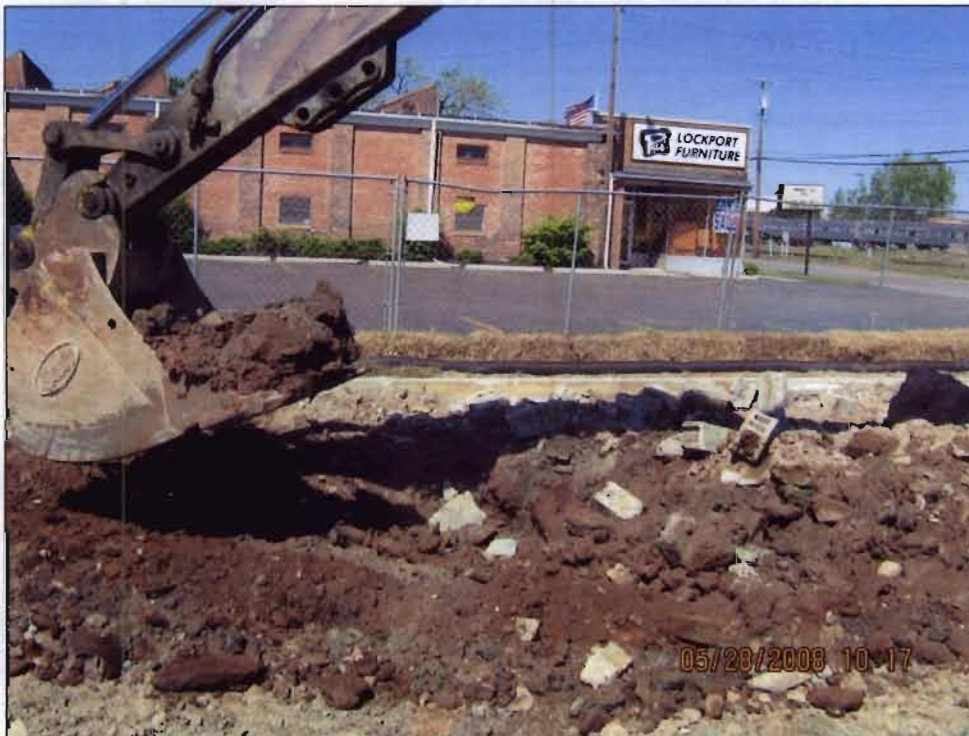
WRS excavating test pits for soil screening and sampling within the Plating Shop building area. Soil screening and sampling were performed by the RST 2 team members.

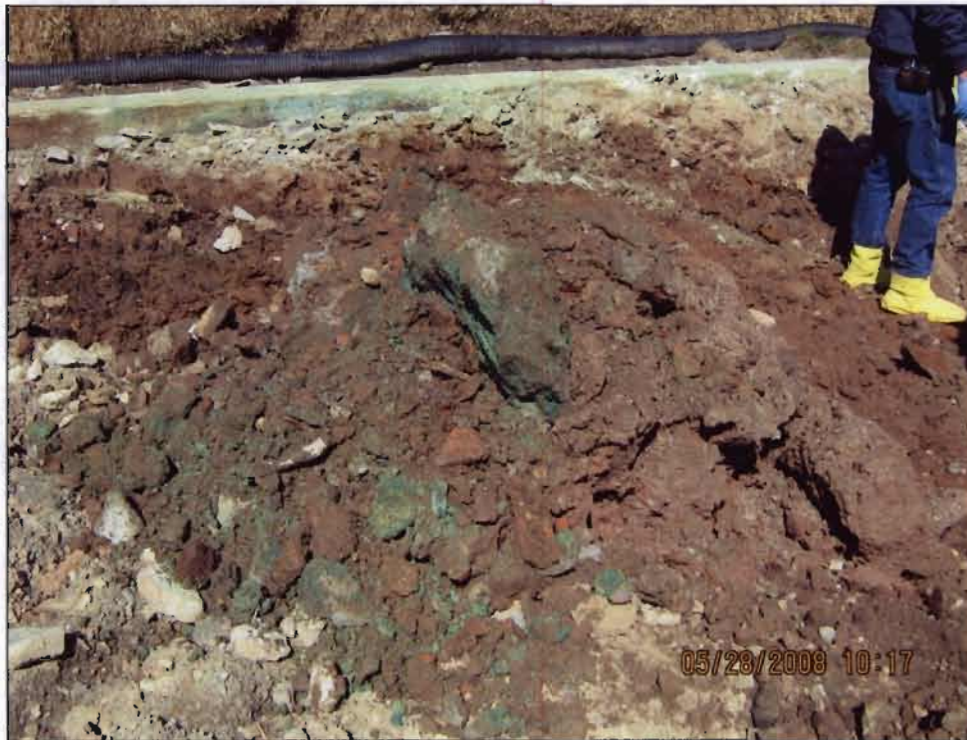
The discolored soils at the former MRS Plating Shop building area were sampled and analyzed for waste classification parameters for disposal purposes.

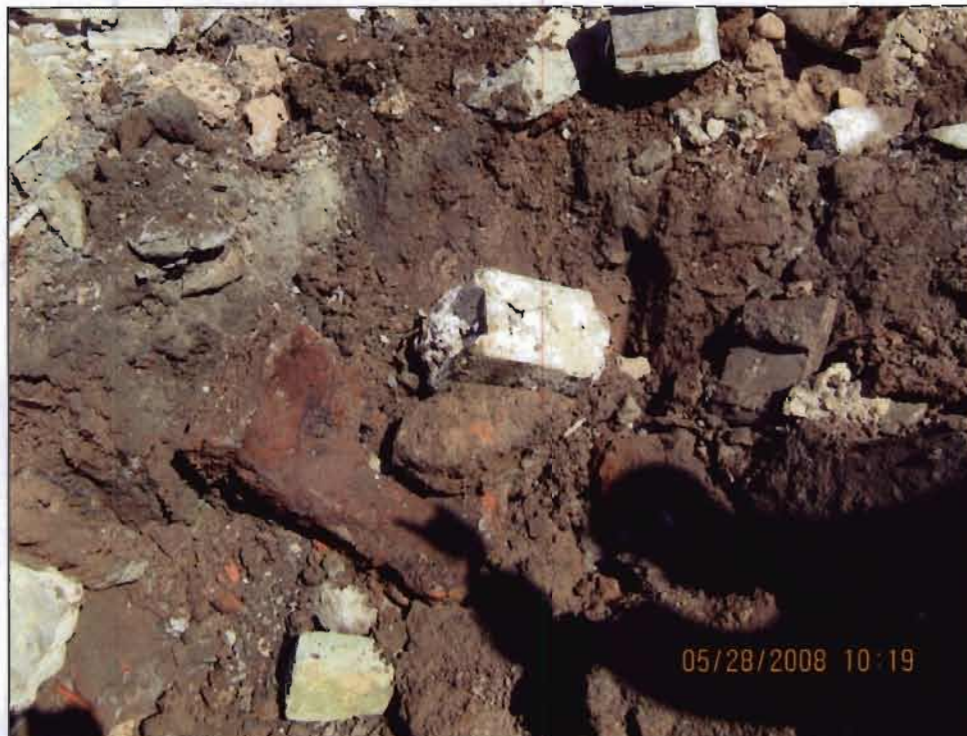
View of a large drain metal manhole piece uncovered during the test pit excavation at the former MRS Plating Shop building area.

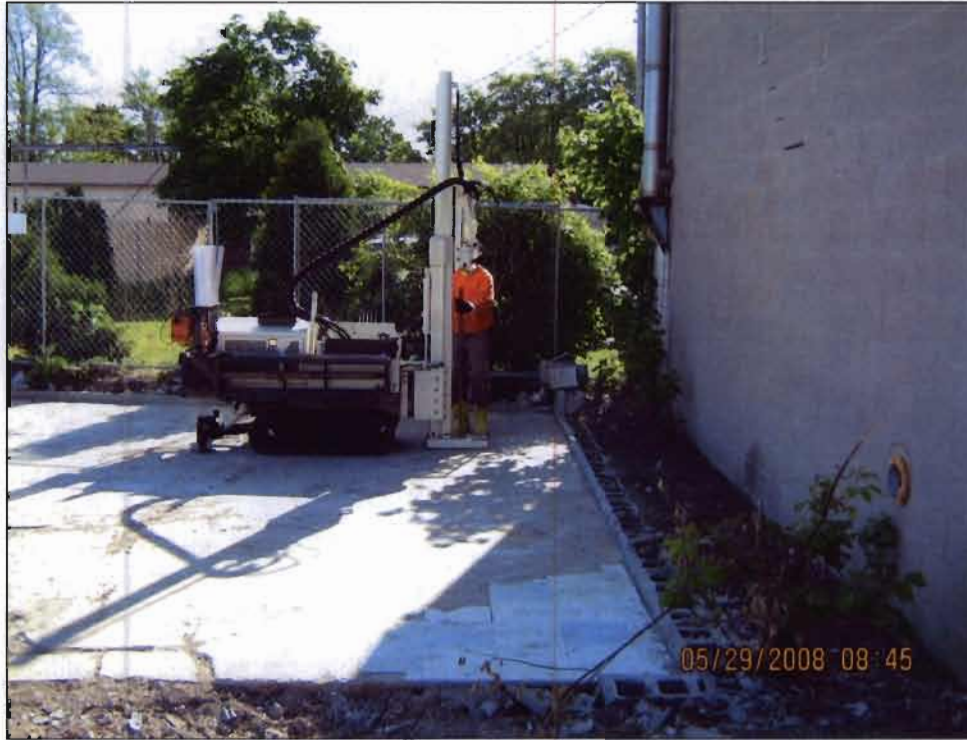
View toward east showing Geoprobe® setup. Soil boring and sampling performed at the former MRS Plating Office building area and north of the private residential property.

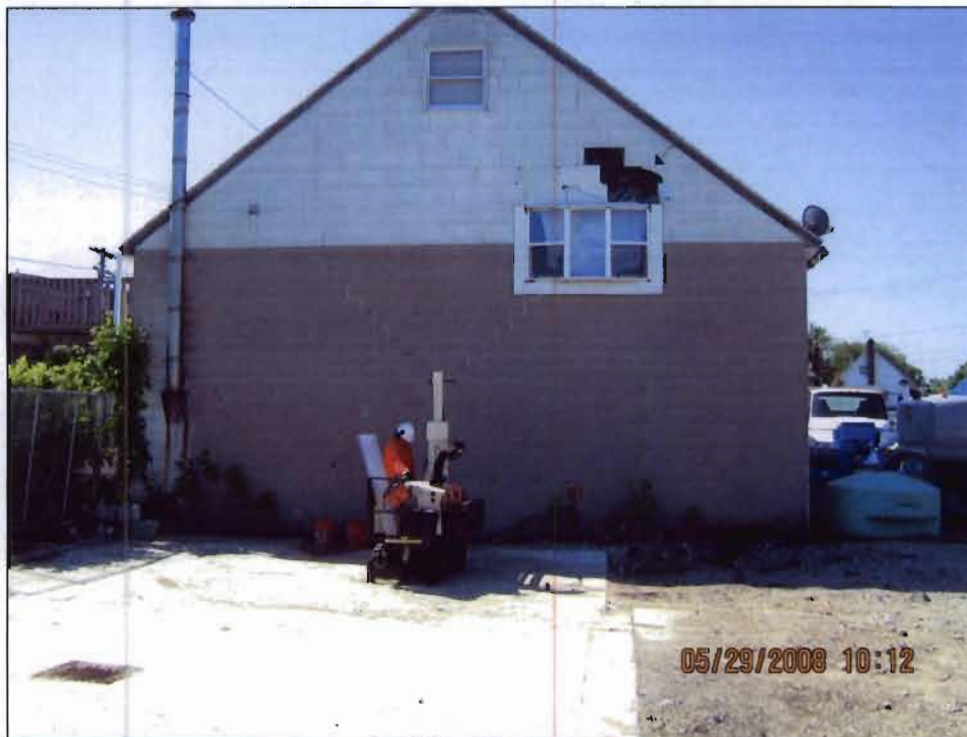
View toward south showing Geoprobe® setup. Soil boring and sampling performed at the former MRS Plating Office building area and north of the private residential property.

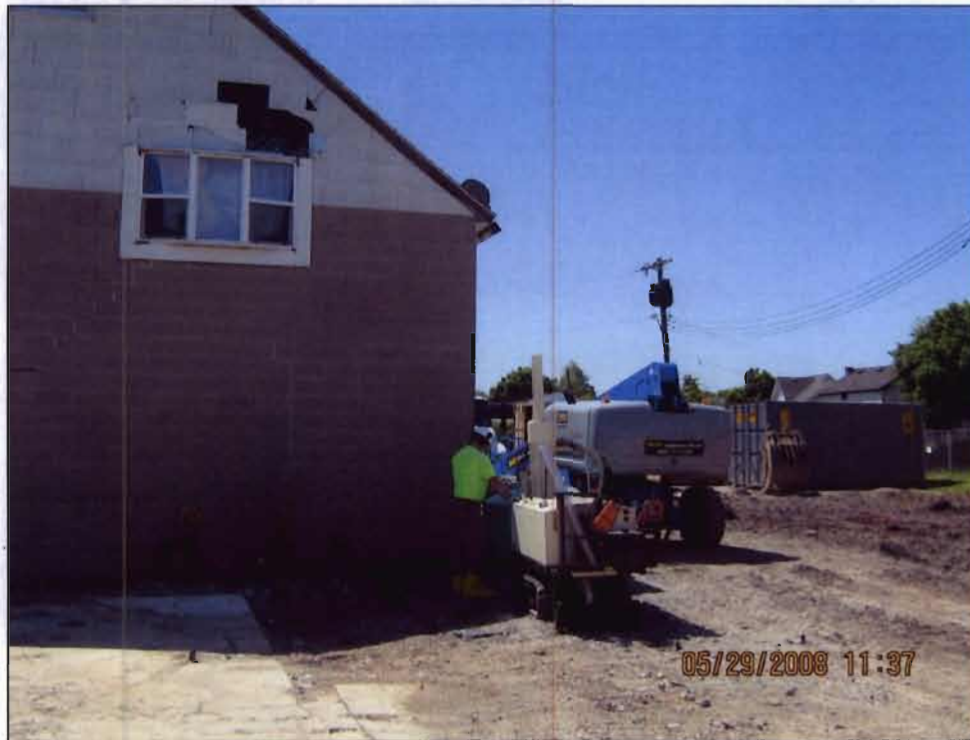
View toward south showing Geoprobe[®] setup. Soil boring and sampling performed at the former MRS Plating Office building area and north of the private residential property.

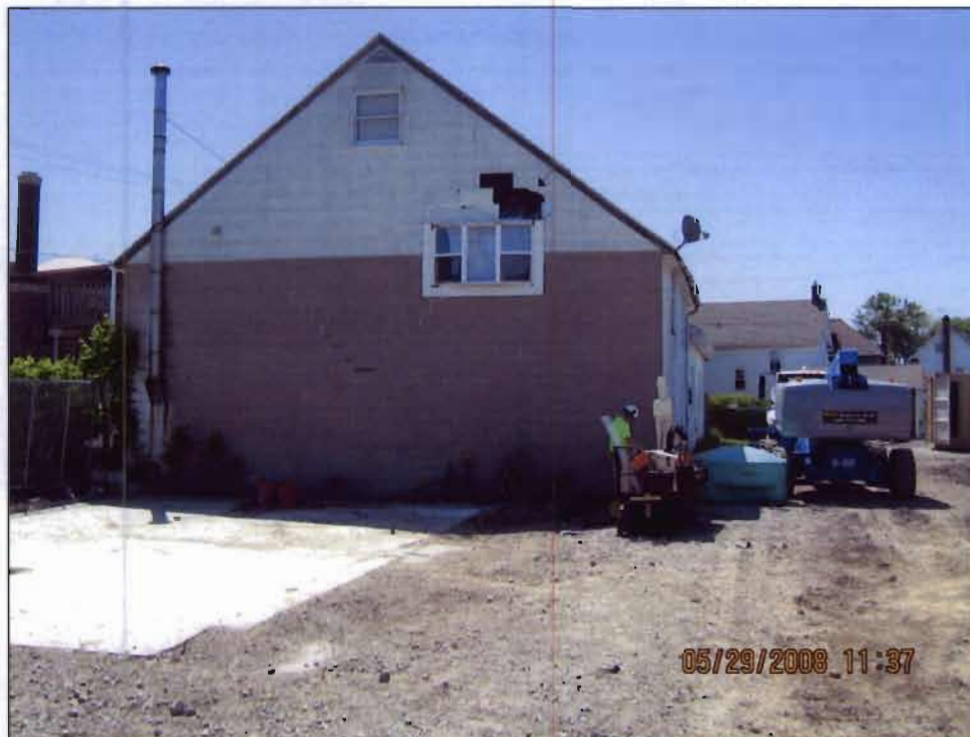
View toward south showing Geoprobe[®] setup. Soil boring and sampling performed at the former MRS Plating Office building area and north of the private residential property.

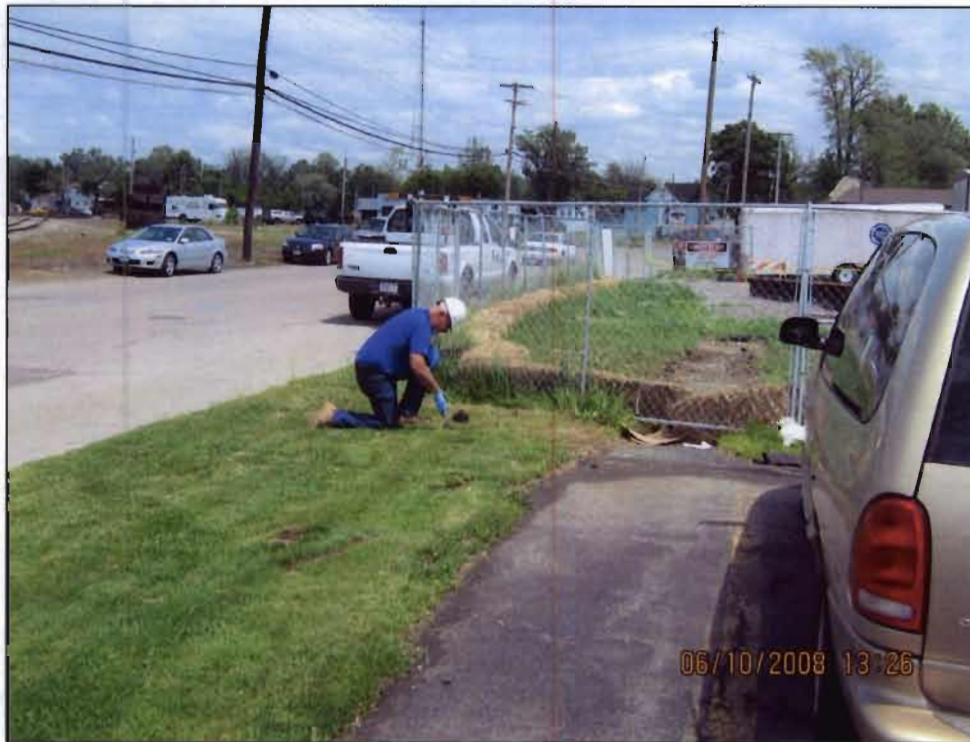
WRS personnel collecting non-hazardous soil samples along the Park Avenue and on the adjacent property located west of the MRS Plating Site.

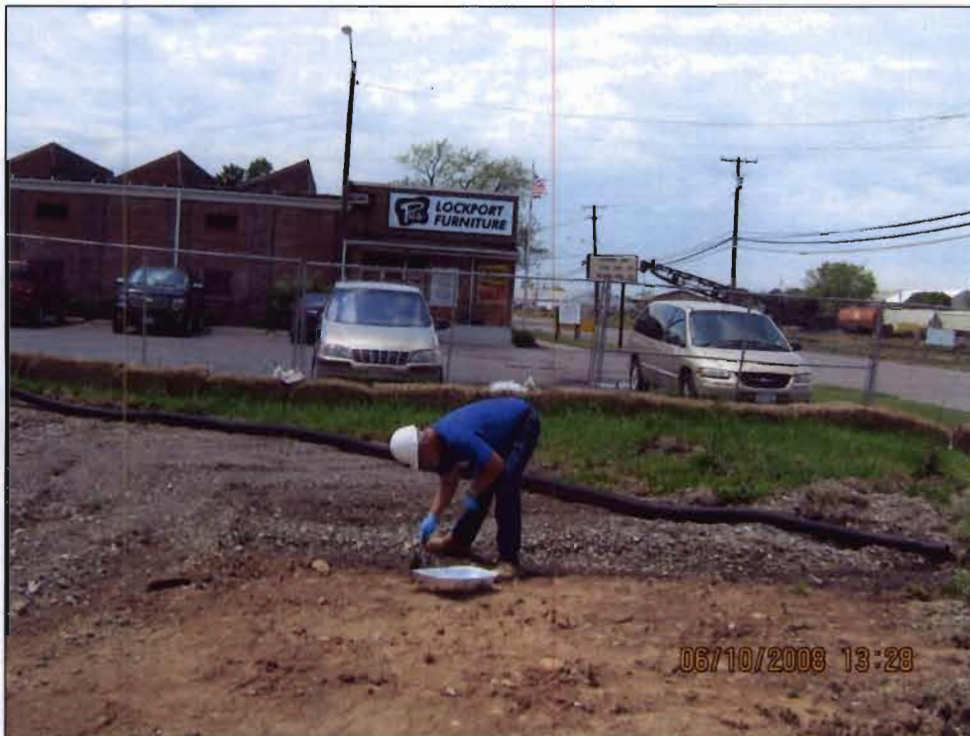
WRS personnel collecting non-hazardous soil samples from the area located north of the former Plating Shop Building and along the Park Avenue.

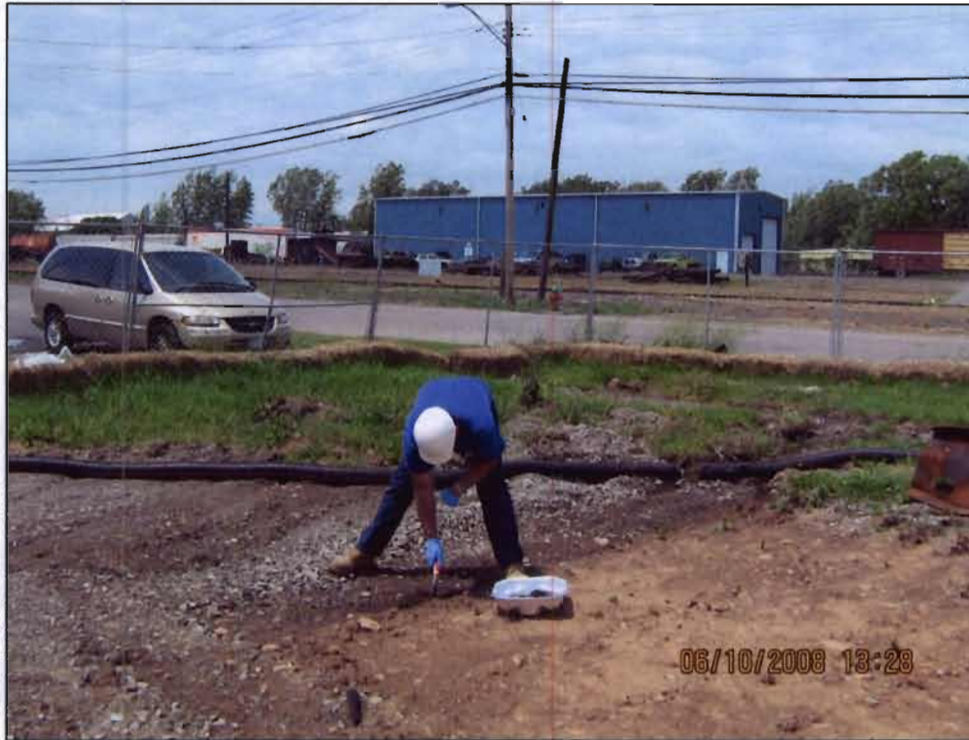
WRS personnel collecting non-hazardous soil samples from the area located north of the former Plating Shop Building and along the Park Avenue.

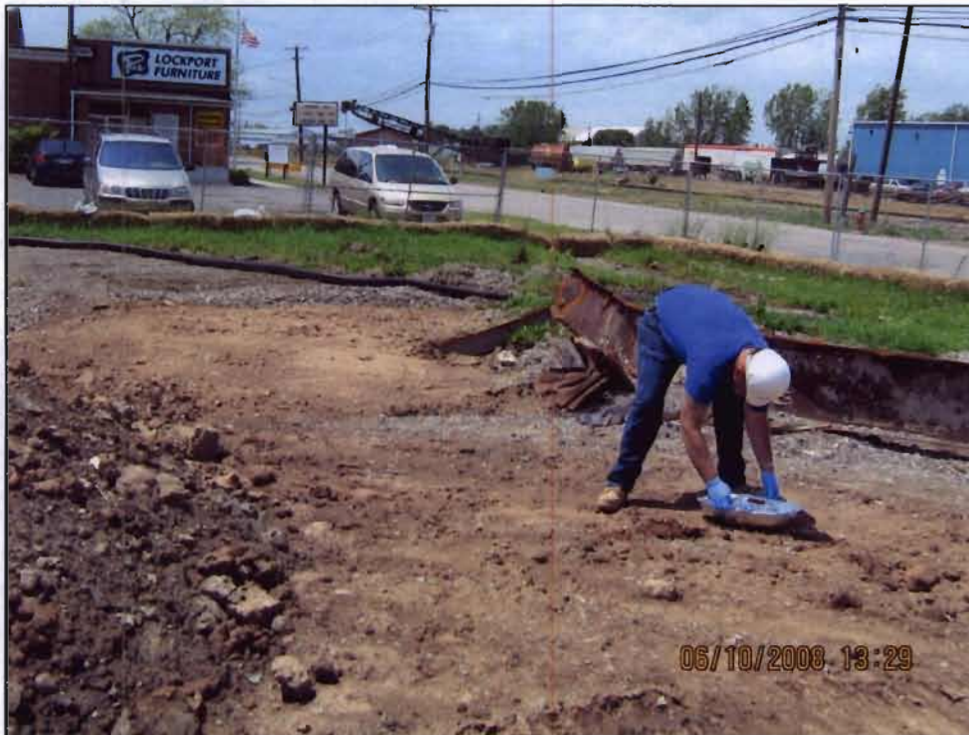
WRS personnel collecting non-hazardous soil samples from the area located north of the former Plating Shop Building and along the Park Avenue.

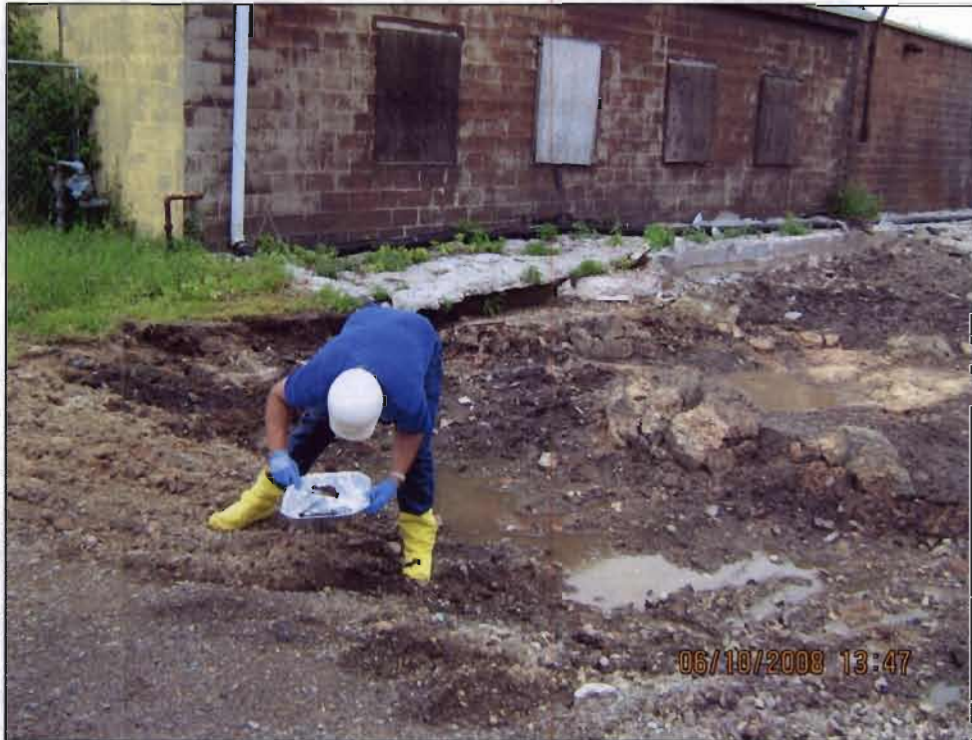
WRS personnel collecting non-hazardous soil samples from the area located between south of the former Plating Shop Building and the Rene Place.

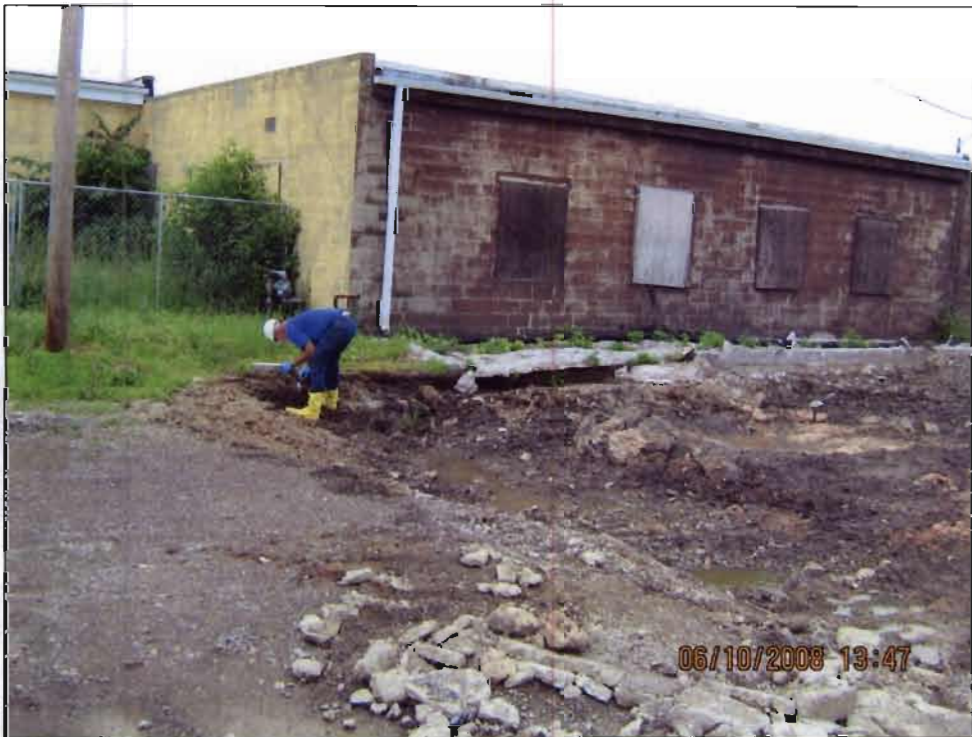
WRS personnel collecting non-hazardous soil samples from the area located between south of the former Plating Shop Building and the Rene Place.

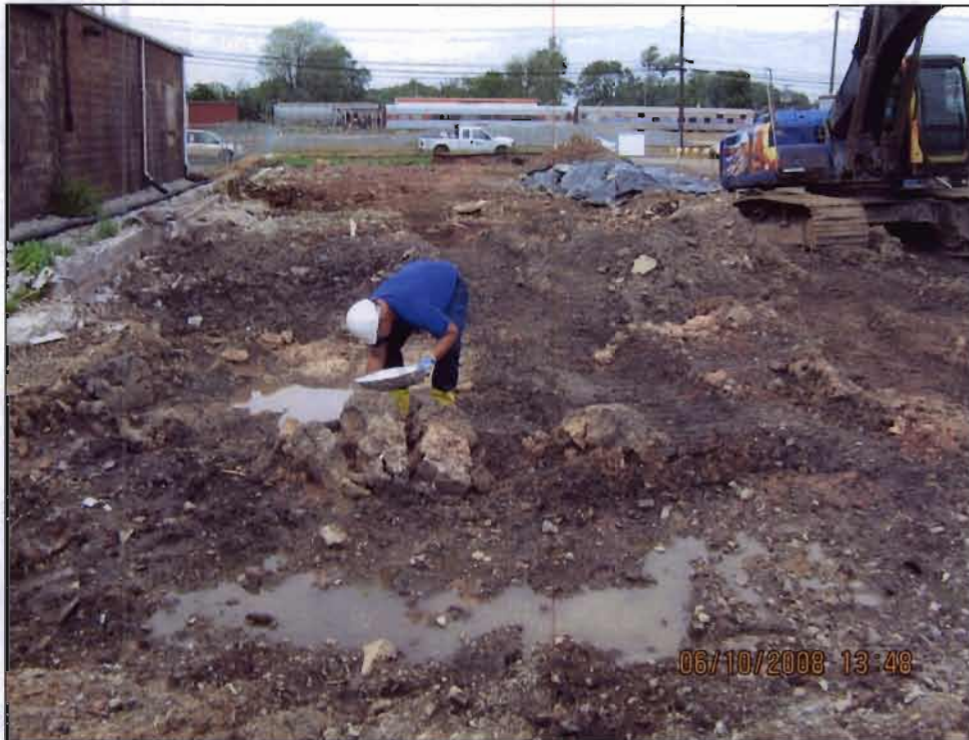
WRS personnel collecting non-hazardous soil samples from the area located between south of the former Plating Shop Building and the Rene Place.
