Photo Documentation of the Removal Action

MRS Plating Site
310 Park Avenue
Lockport, Niagara County, New York

Removal Support Team 2
Weston Solutions, Inc.
Northeast Division
Edison, New Jersey, 08837

U. S. Environmental Protection Agency
Region II – Removal Action Branch
186 Exchange Street
Buffalo, NY 14203

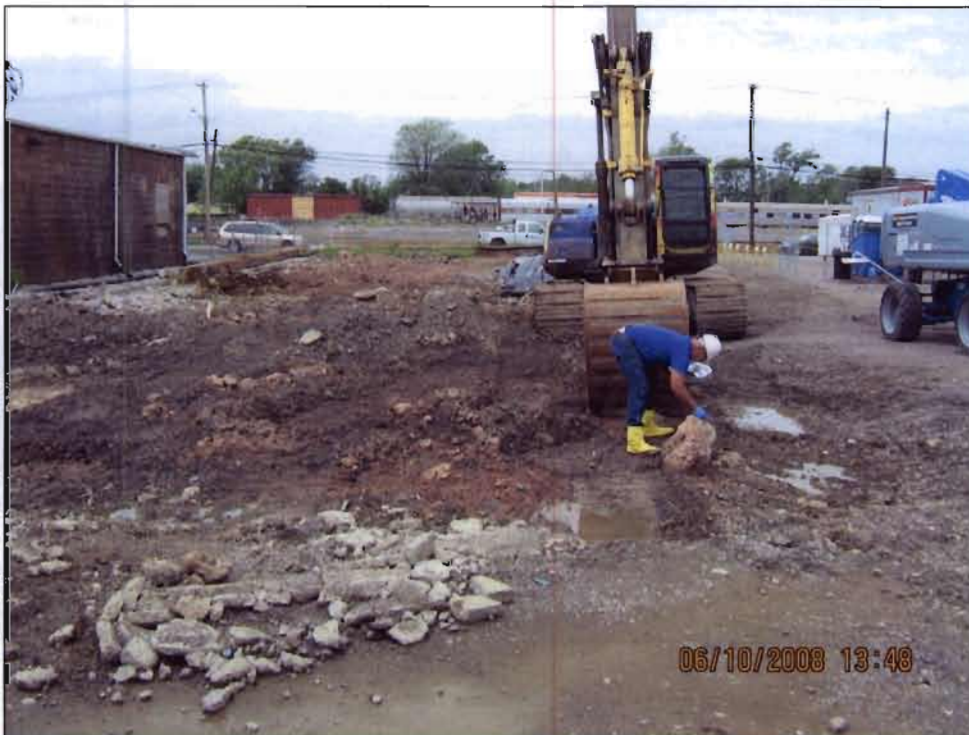
WRS personnel collecting non-hazardous soil samples from the area located between south of the former Plating Shop Building and the Rene Place.

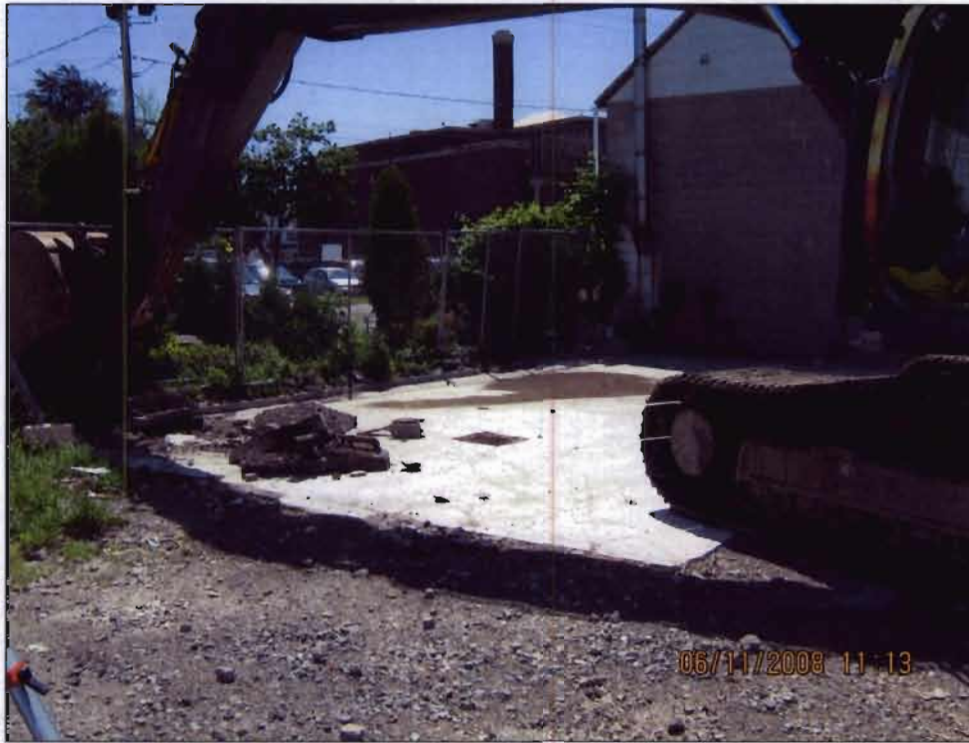
WRS removing the concrete floors and footers, view of the former office building location.

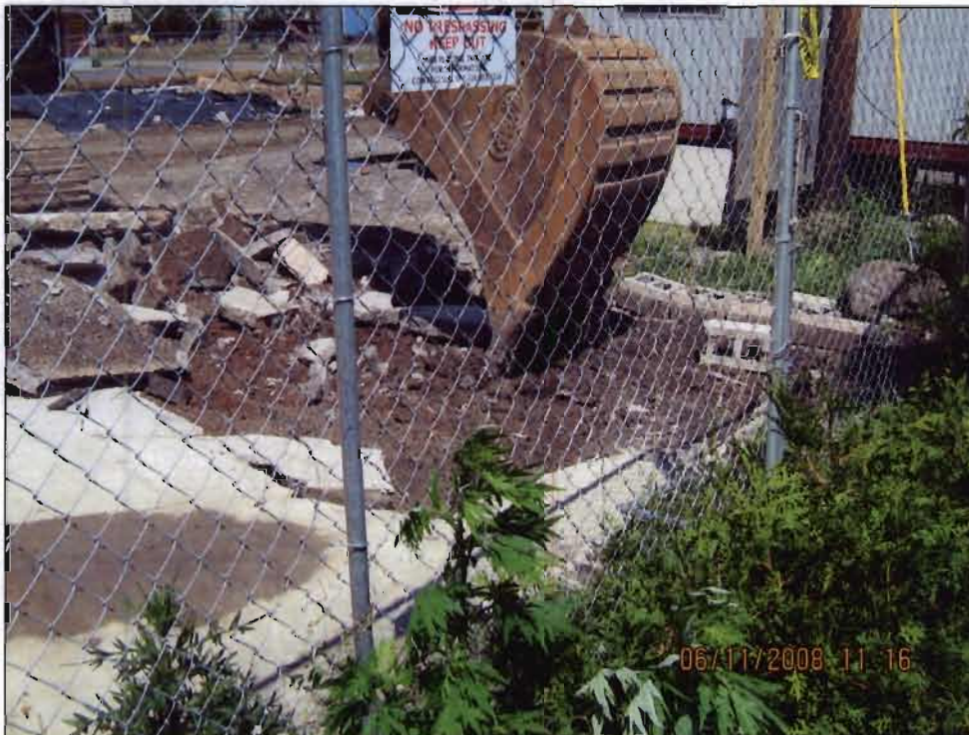
WRS removing the concrete floors and footers, view of the former office building location.

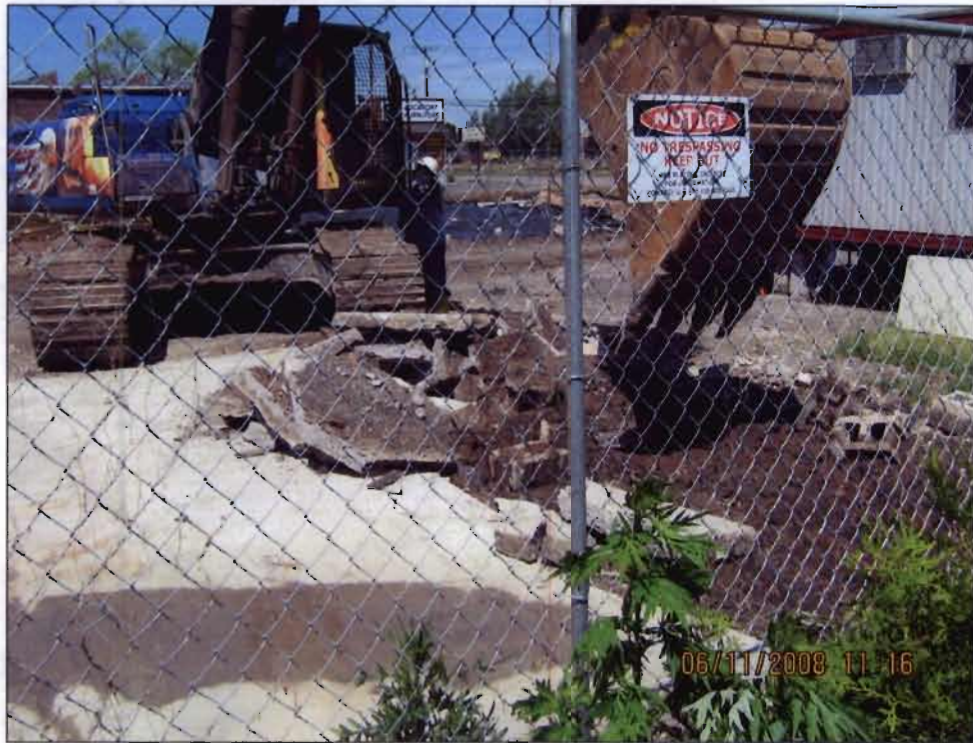
WRS removing the concrete floors and footers, view of the former office building location.

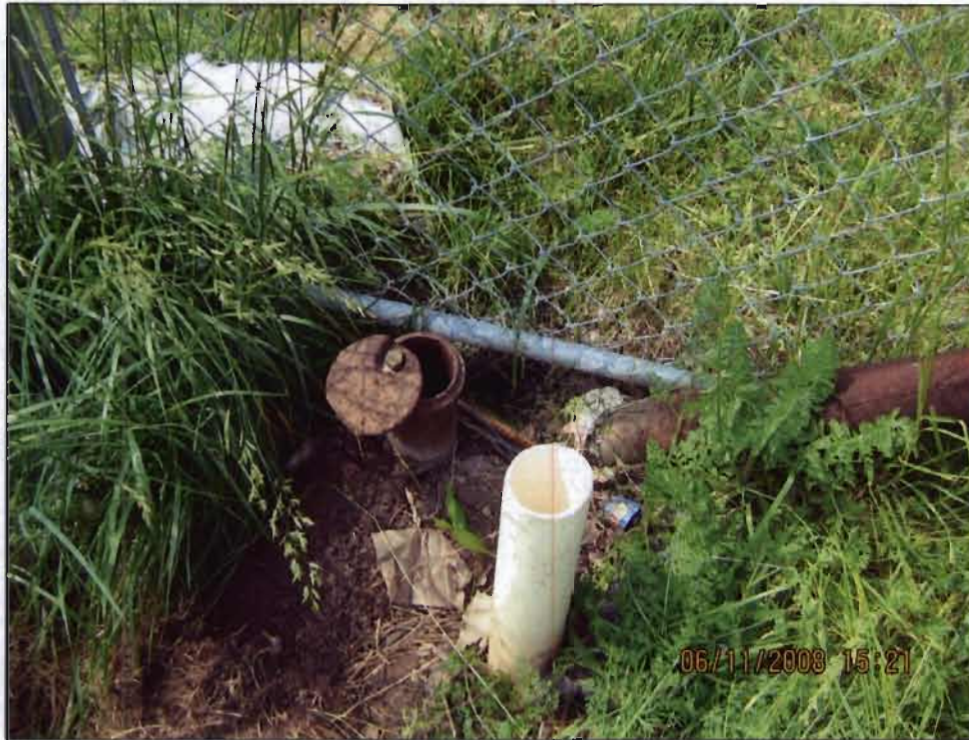
View of the MRS Plating facility's sewer discharge vent pipe located along the Park Avenue.

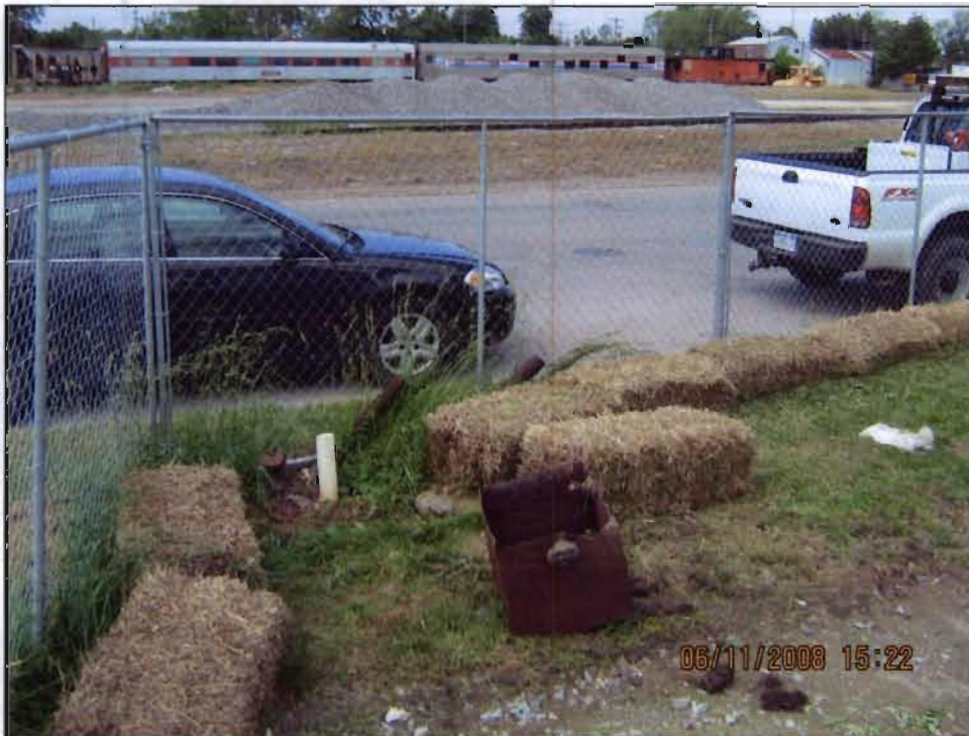
View of the MRS Plating facility's sewer discharge vent pipe located along the Park Avenue. Also, visible the city sewer manhole cover in the middle of the street.

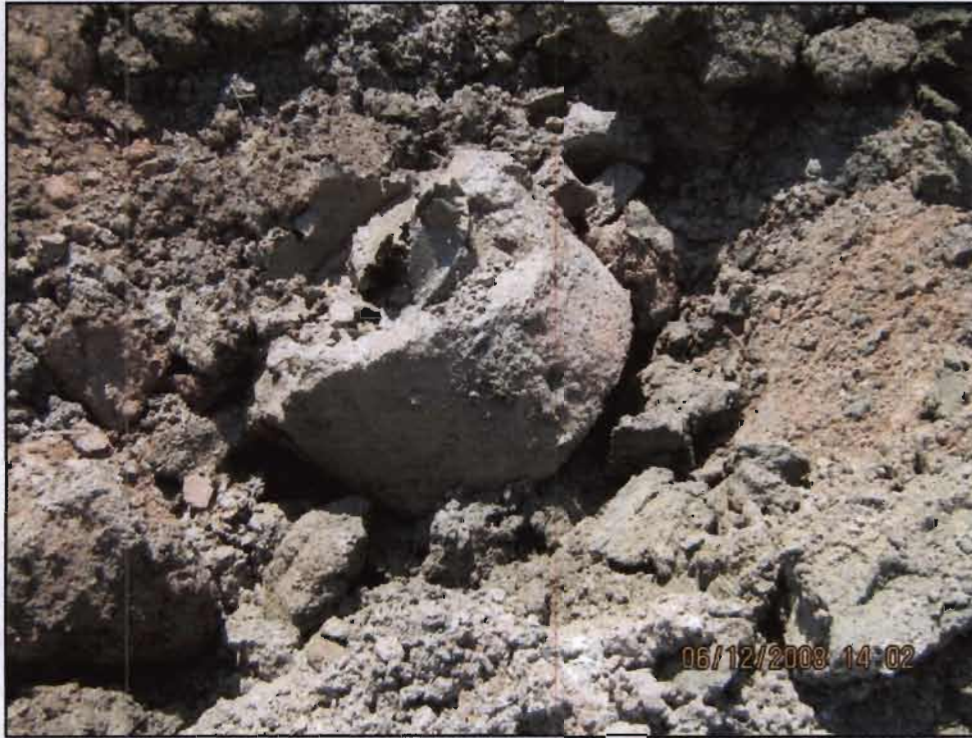
View of a tank (55-gallon) encased within concrete was uncovered during the excavation of the contaminated soil.

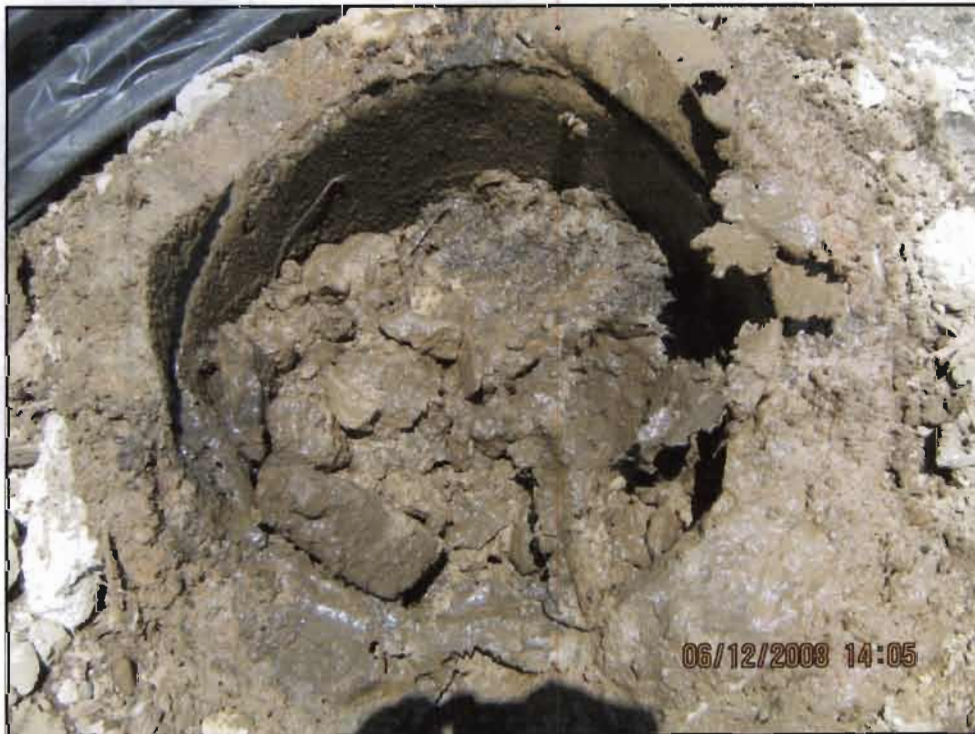
An inside view of a metal container (approximately 55-gallon capacity) encased within concrete was uncovered during the excavation of the contaminated soil.

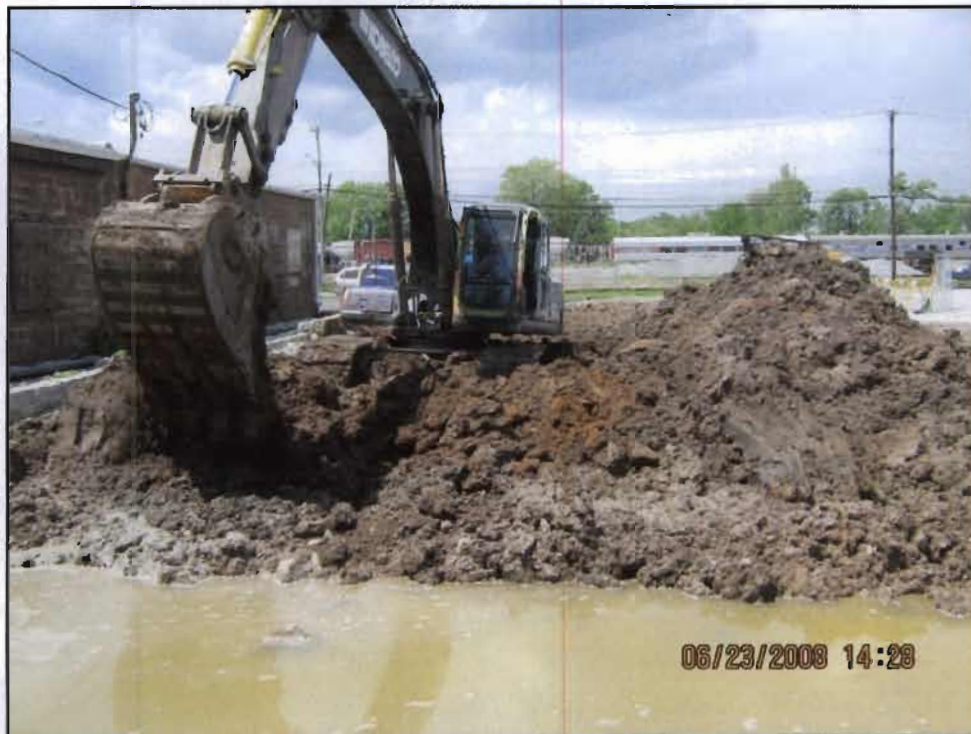
WRS personnel removing contaminated soil from the former Plating shop building area for off-site treatment and disposal. Also, showing rain water accumulation in excavation.

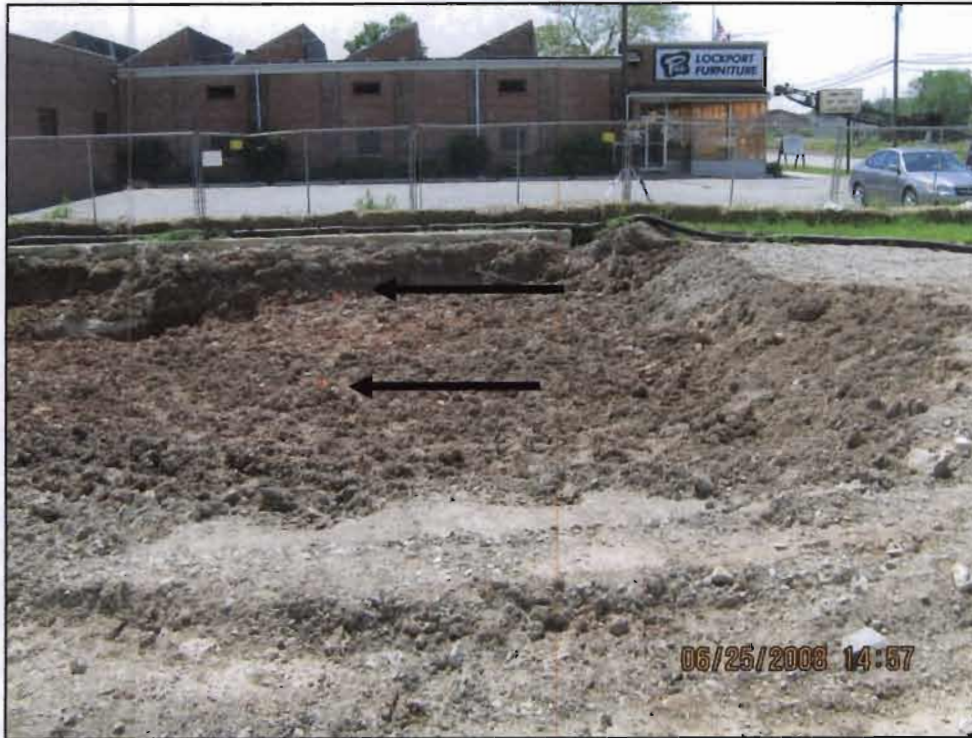
View of the northern section of the excavation along the Park Avenue. Locations of the two Confirmation (post-excitation) soil sample collected for laboratory analysis.

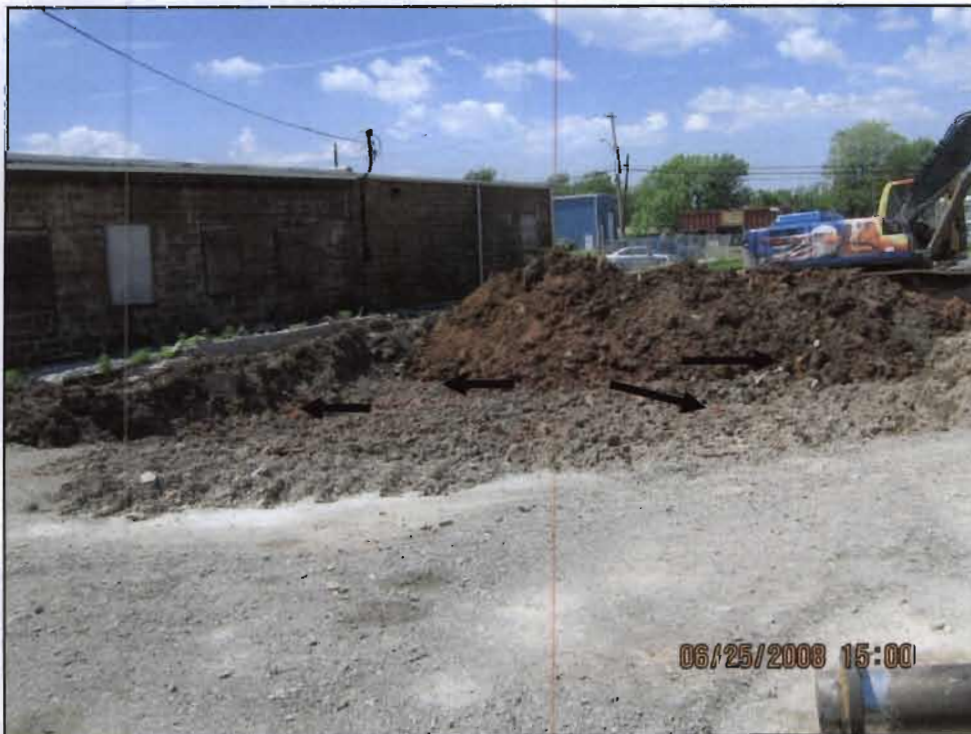
View of the southern section of the excavation along the Rene Place. Locations of the four Confirmation (post-excitation) soil sample collected for laboratory analysis.

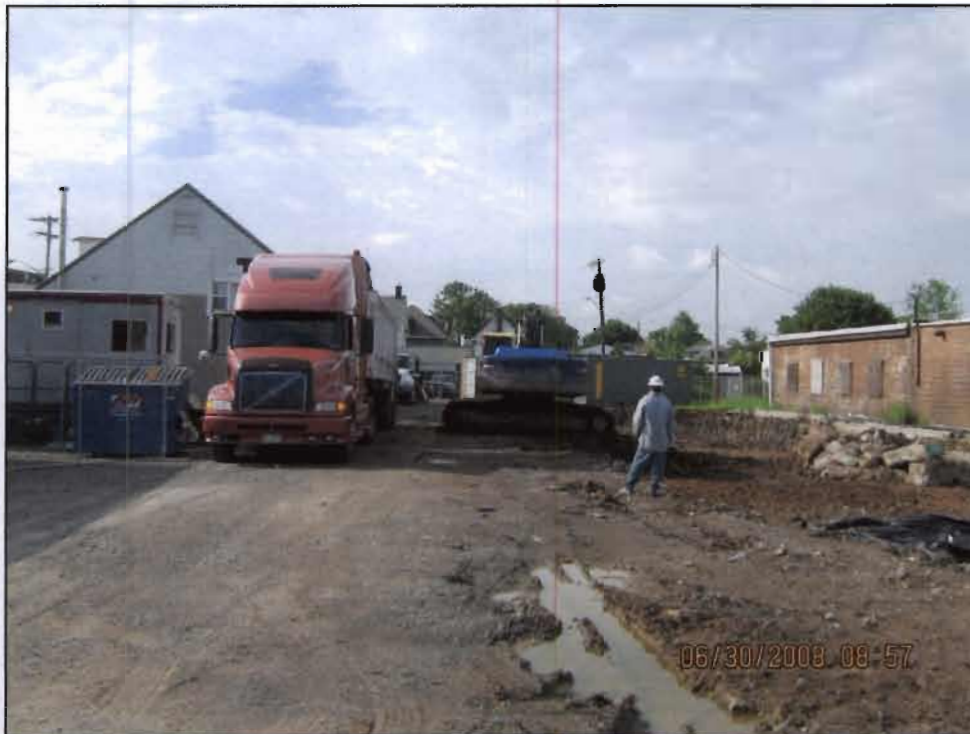
Loading of the contaminated soils, removed from the former MRS Plating Shop building area for the off-site treatment and disposal at Michigan Disposal facility, Belleville, MI.

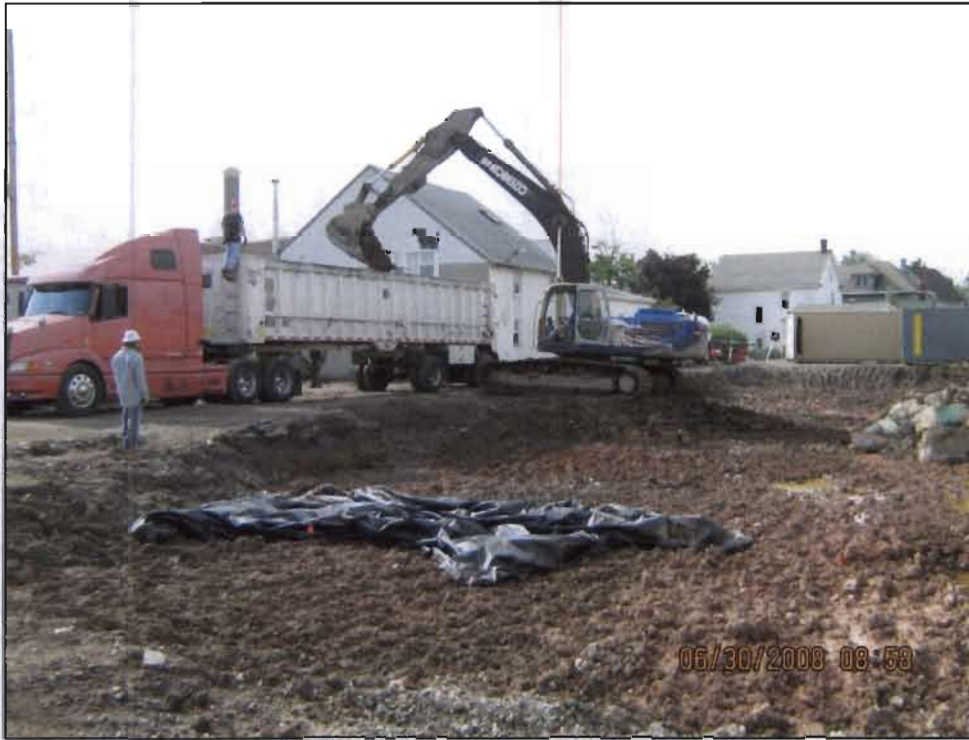
Loading of the contaminated soils, removed from the former MRS Plating Shop building area for the off-site treatment and disposal at Michigan Disposal facility, Belleville, MI.

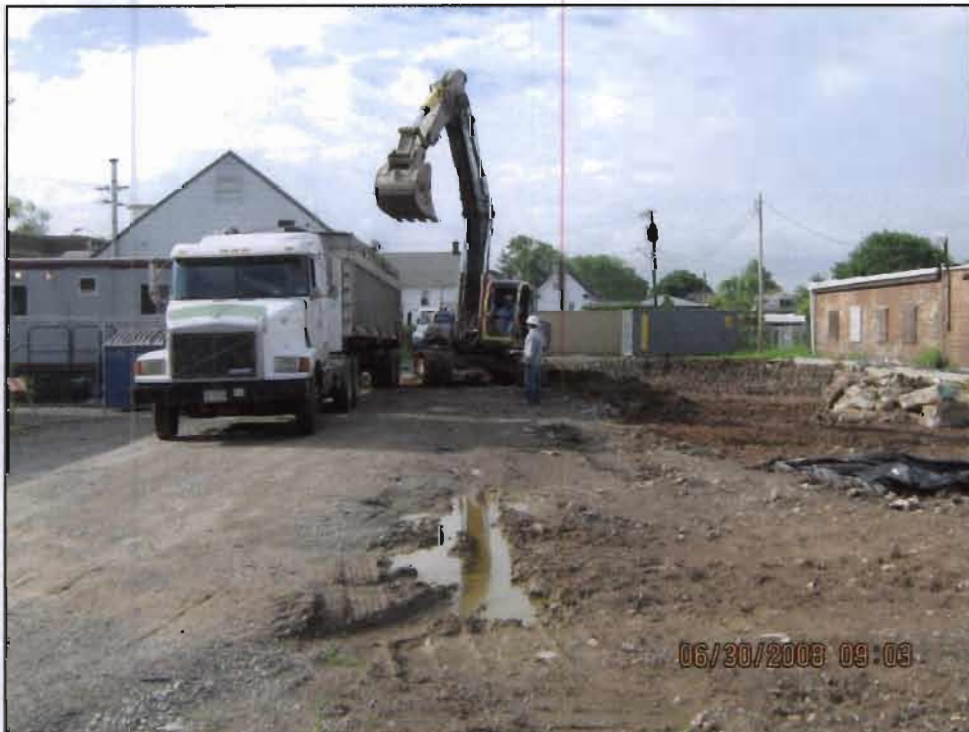
Loading of the contaminated soils, removed from the former MRS Plating Shop building area for the off-site treatment and disposal at Michigan Disposal facility, Belleville, MI.

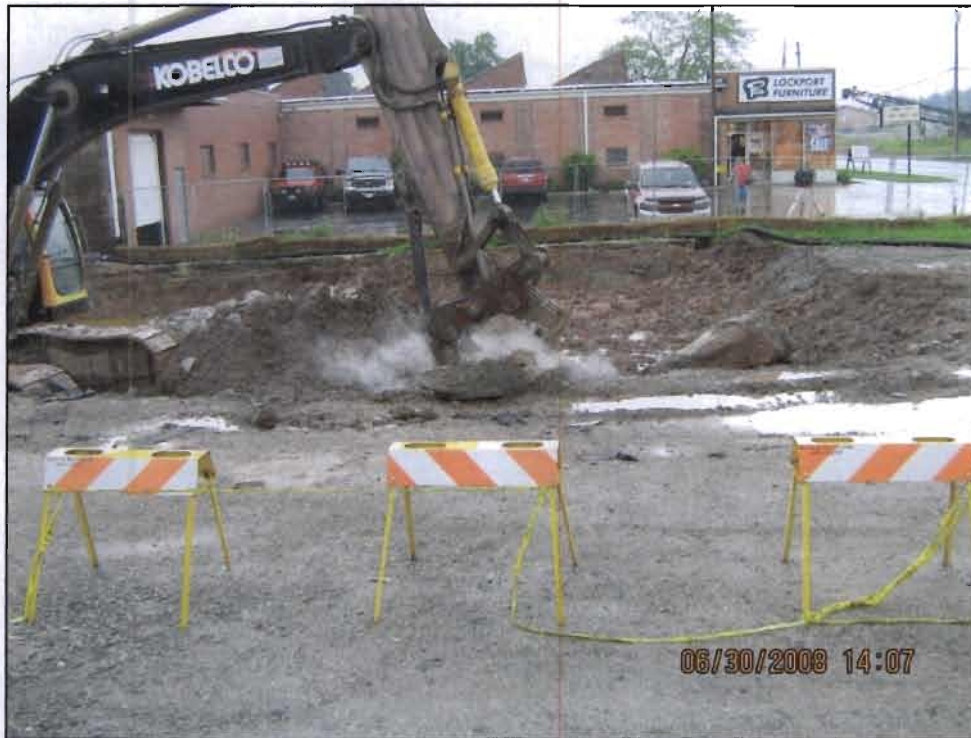
WRS crushing large concrete pieces into manageable small pieces for load out for off-site shipment, recycling and disposal at the Allied Waste facility.

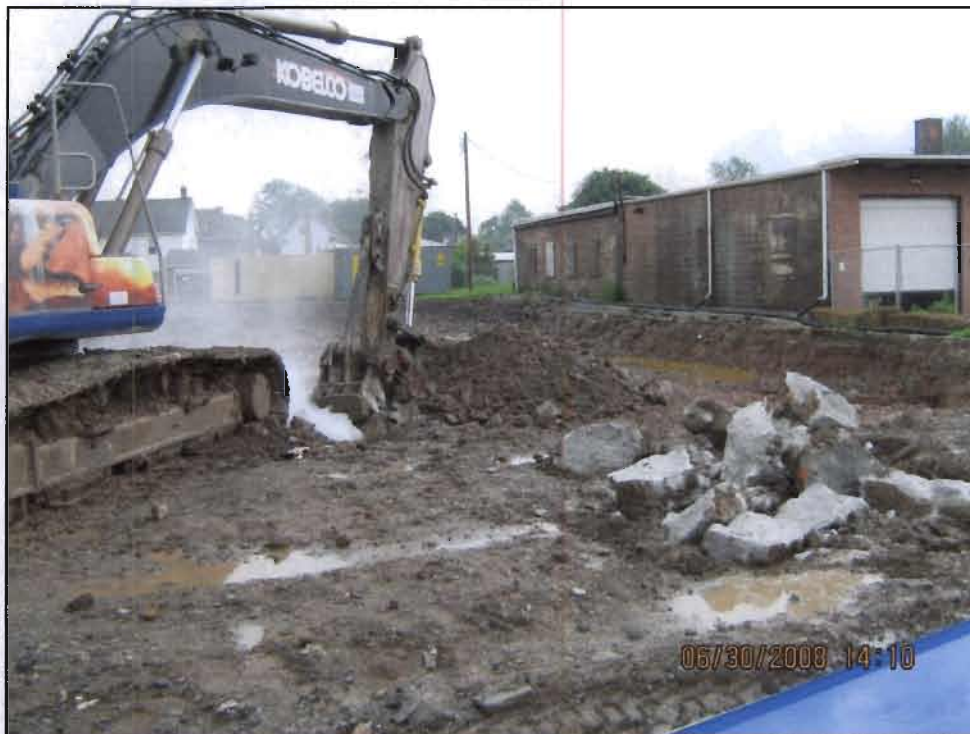
WRS crushing large concrete pieces into manageable small pieces for load out for off-site shipment, recycling and disposal at the Allied Waste facility.

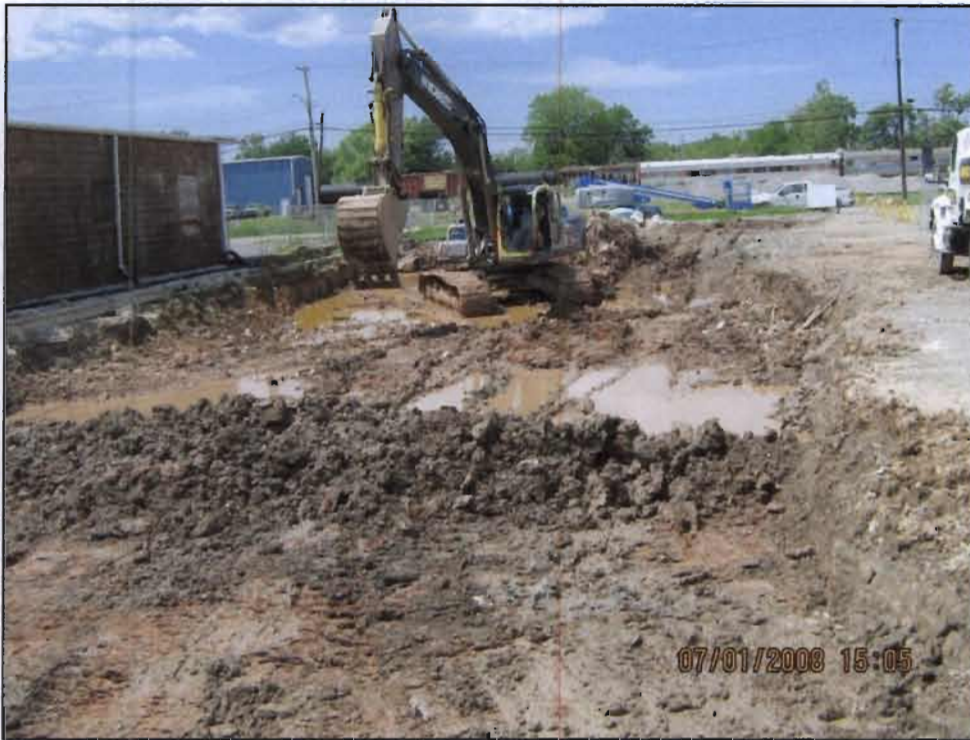
WRS removing soils at the former Plating Shop building location along the adjacent furniture store building (located west) for off-site shipment and disposal.

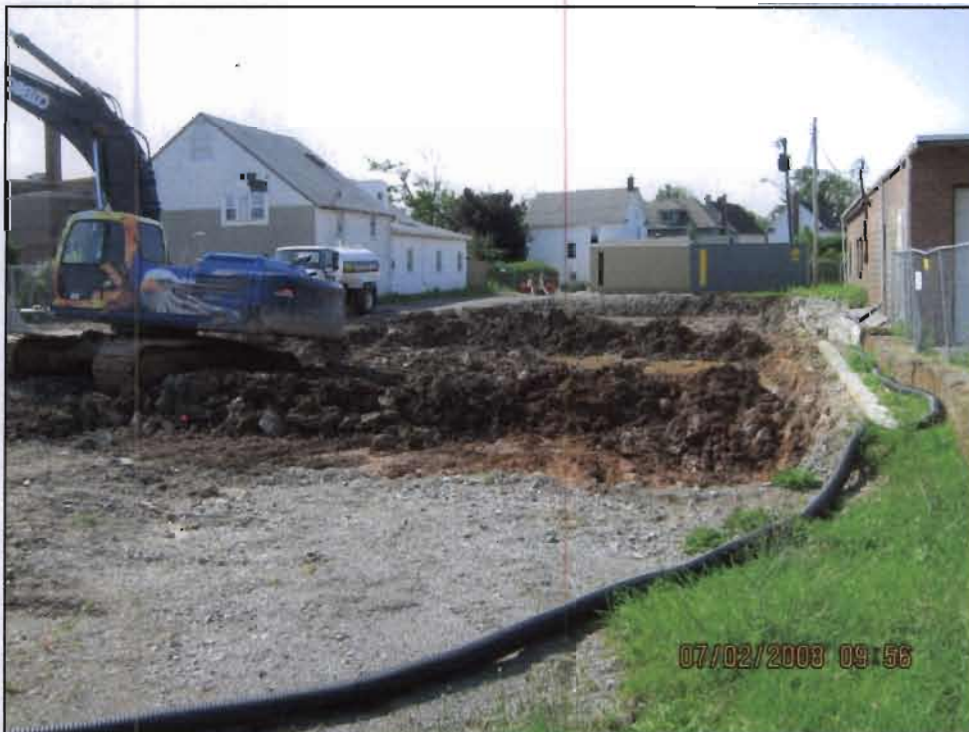
WRS removing soils at the former Plating Shop building location along the adjacent furniture store building (located west) for off-site shipment and disposal.

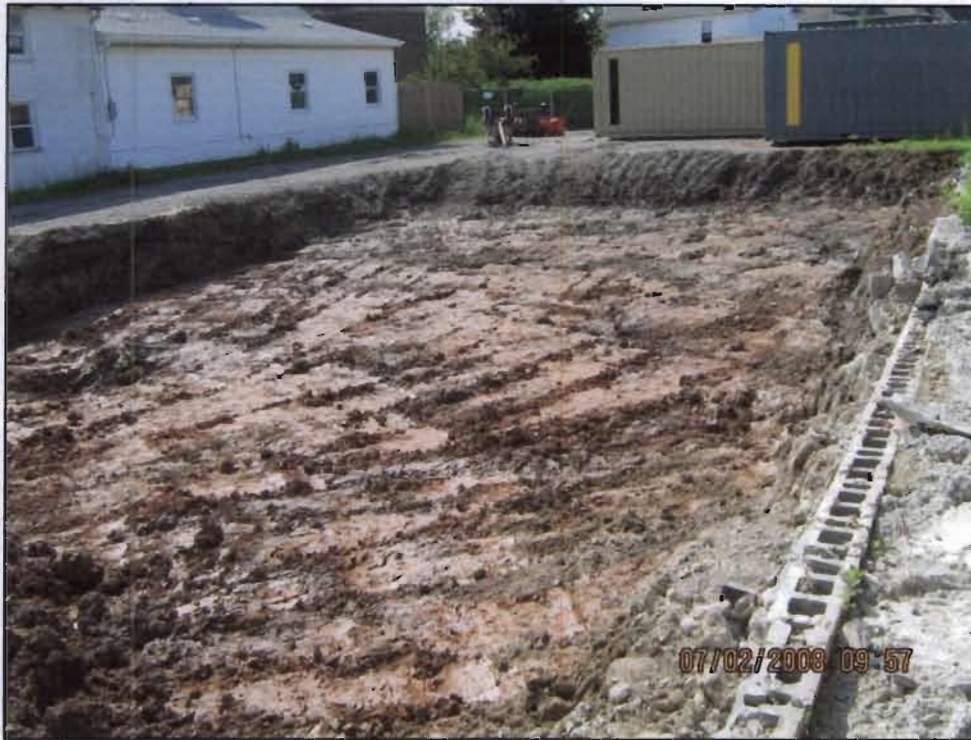
View of the southern half excavation at the former Plating Shop building location after the removal of the contaminated soils. Looking southeast towards Rene Place.

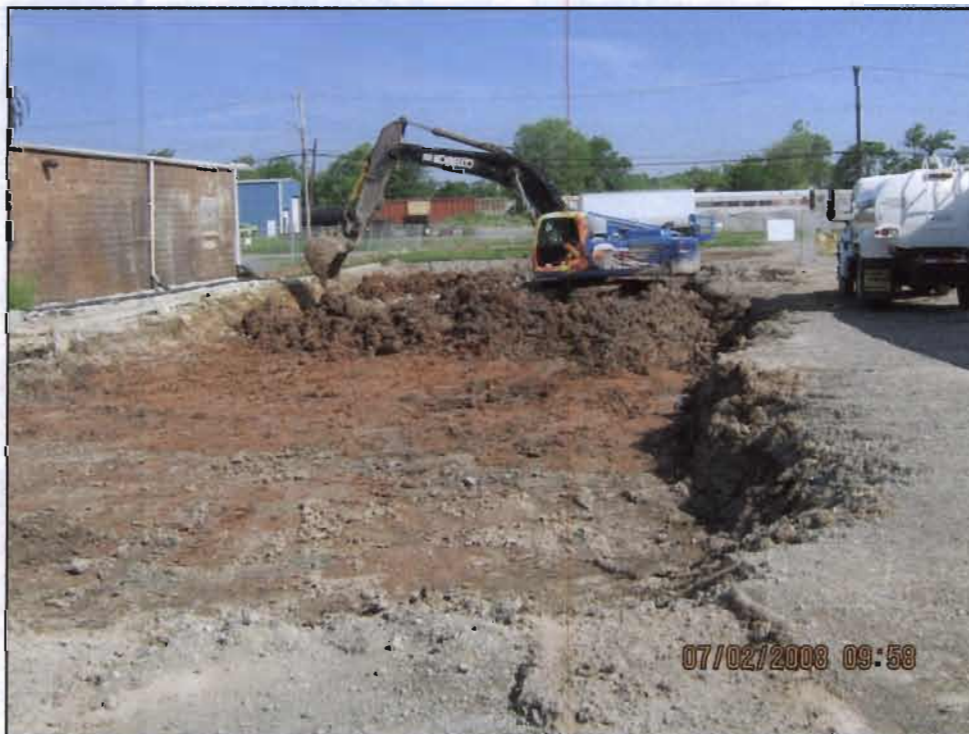
View of the excavation at the former Plating Shop building location during the removal of the contaminated soils. Looking north towards Park Avenue.

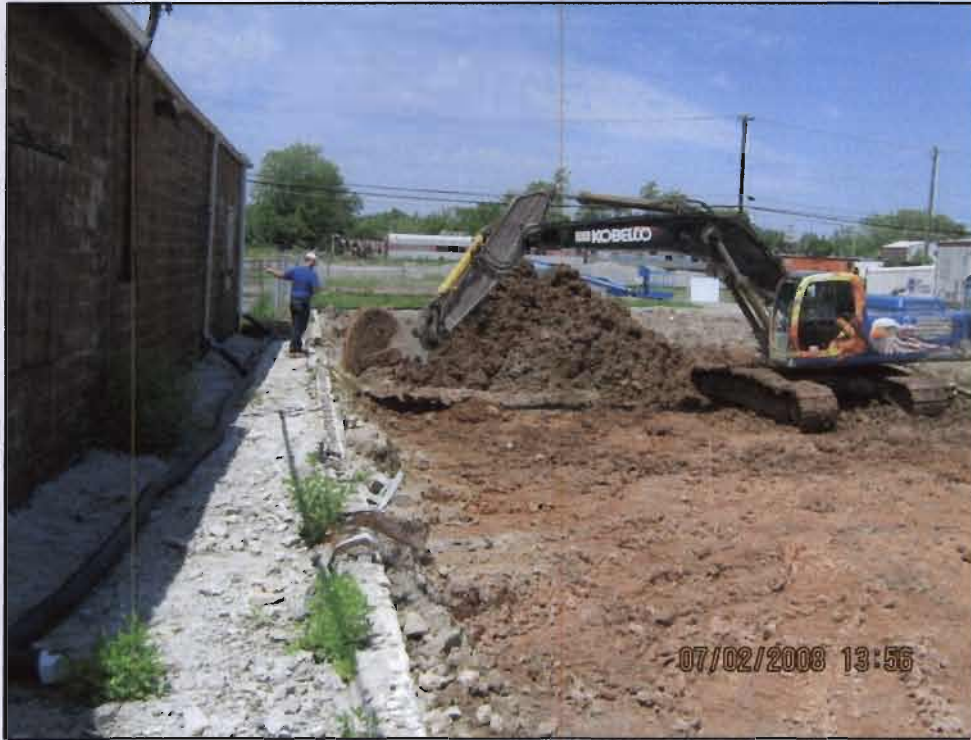
WRS removing soils at the former Plating Shop building location along the adjacent furniture store building (located west) for off-site shipment and disposal.

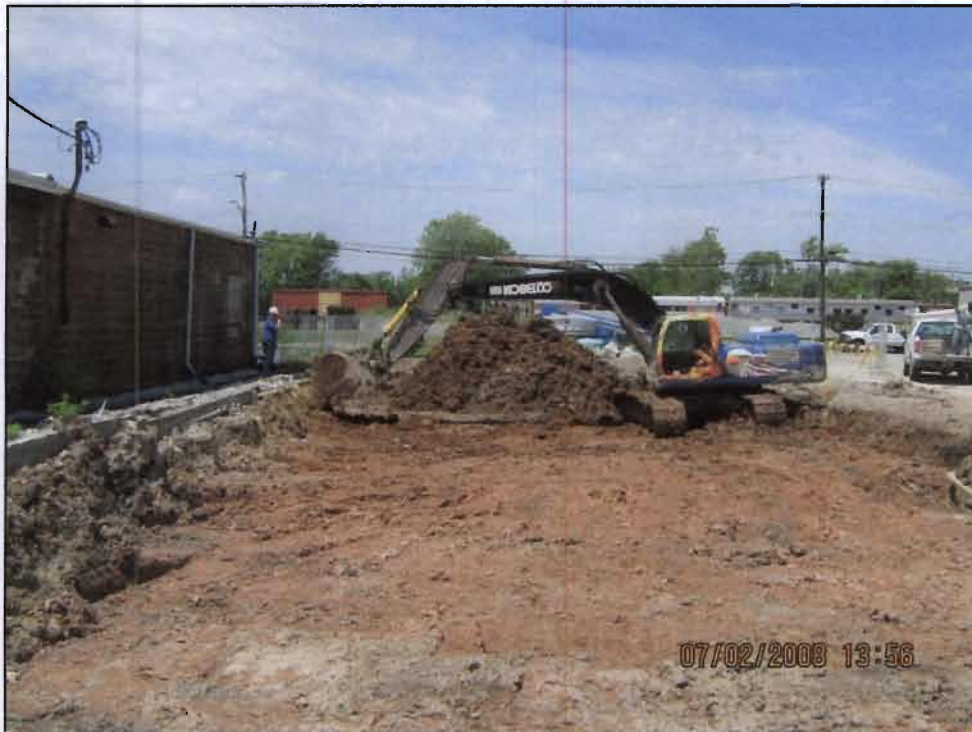
WRS removing soils at the former Plating Shop building location along the adjacent furniture store building (located west) for off-site shipment and disposal.

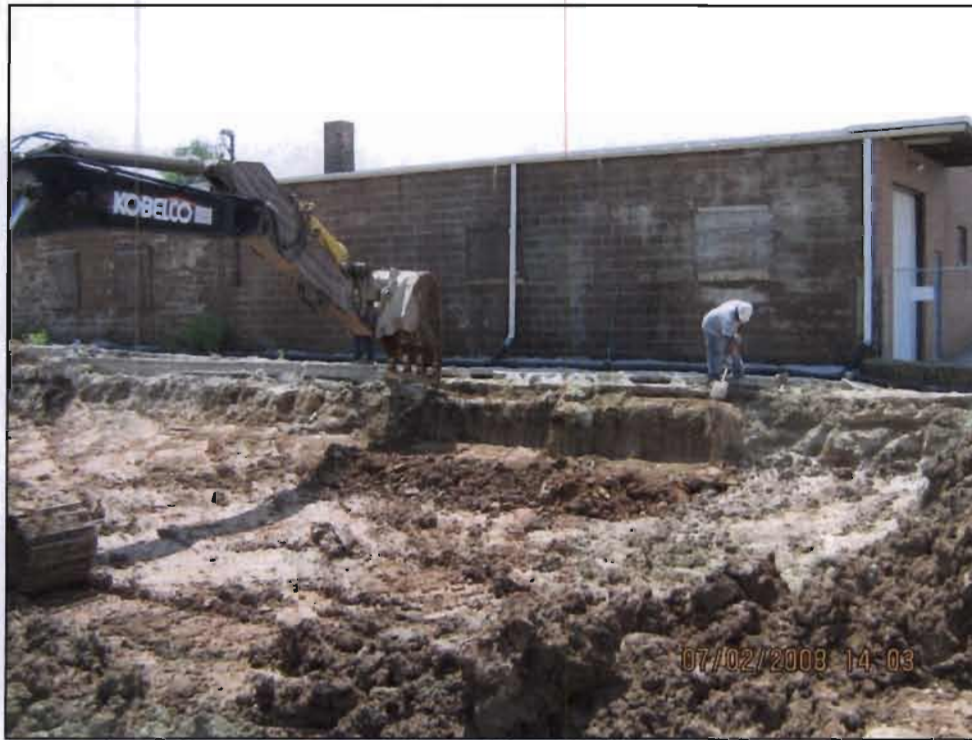
WRS removing soils at the former Plating Shop building foundation located along the adjacent furniture store building (located west) for off-site shipment and disposal.

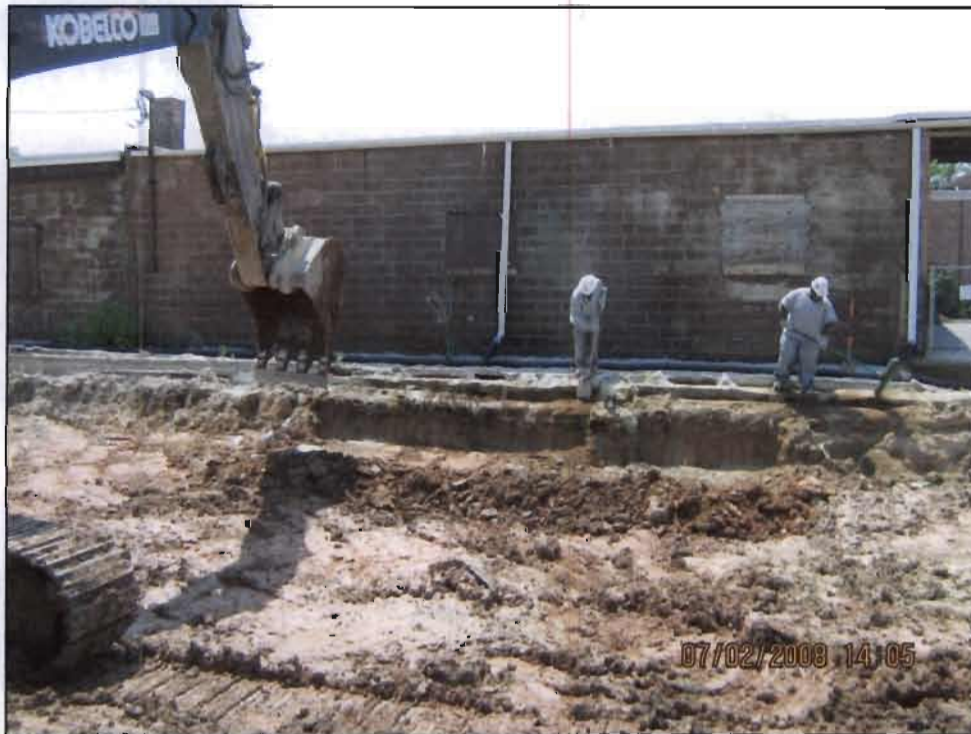
WRS removing soils at the former Plating Shop building foundation located along the adjacent furniture store building (located west) for off-site shipment and disposal.

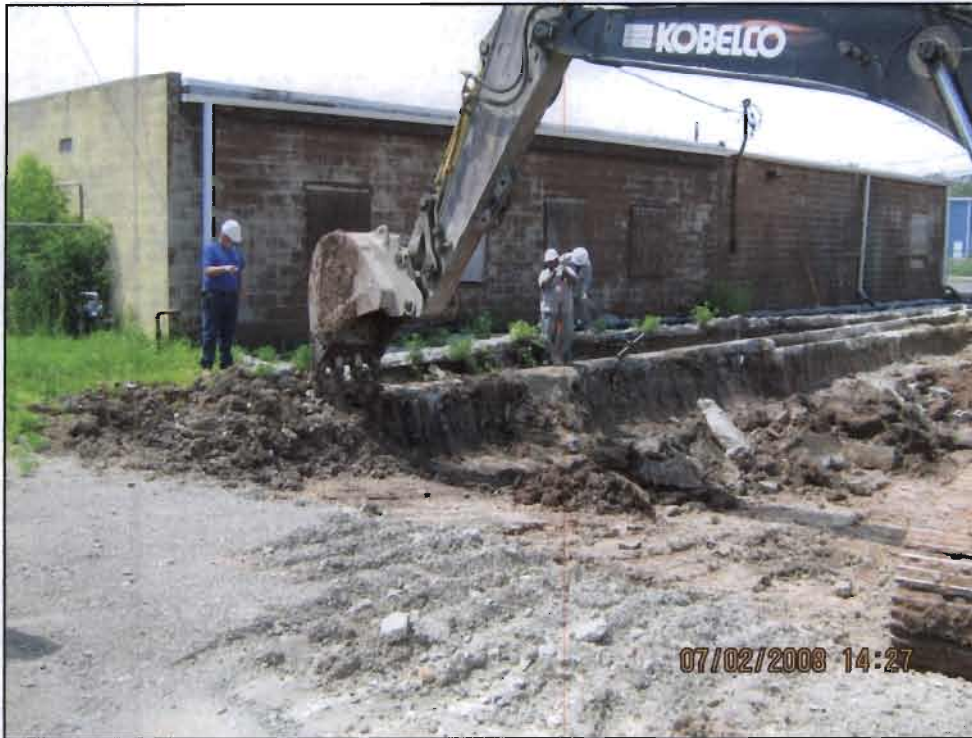
WRS removing soils at the former Plating Shop building foundation located along the adjacent furniture store building (located west) for off-site shipment and disposal.

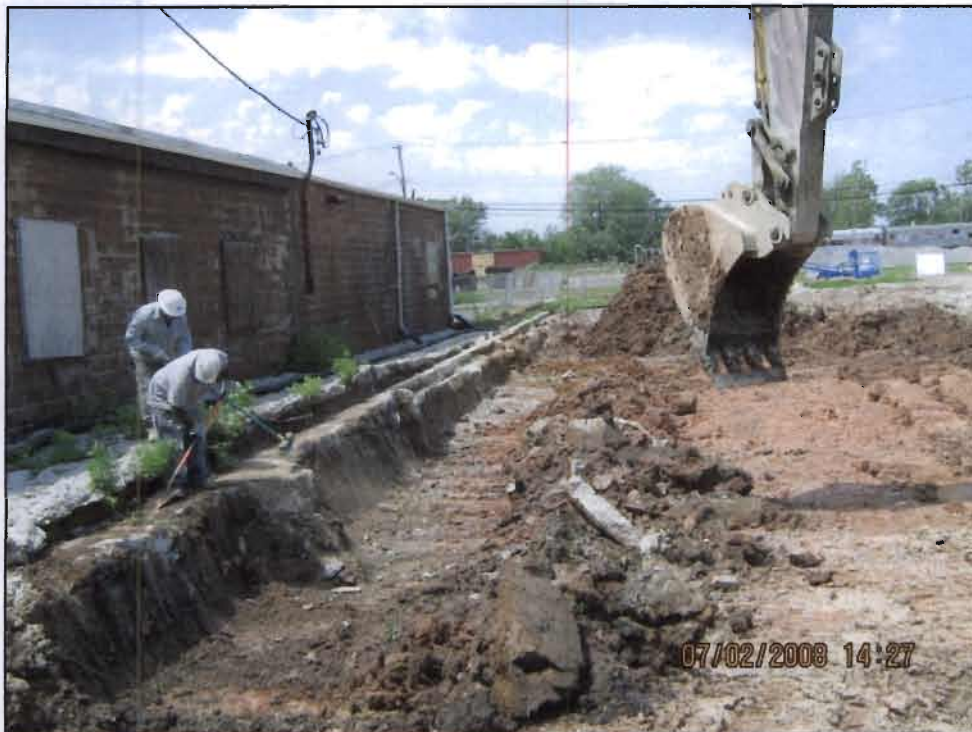
WRS removing soils at the former Plating Shop building foundation located along the adjacent furniture store building (located west) for off-site shipment and disposal.

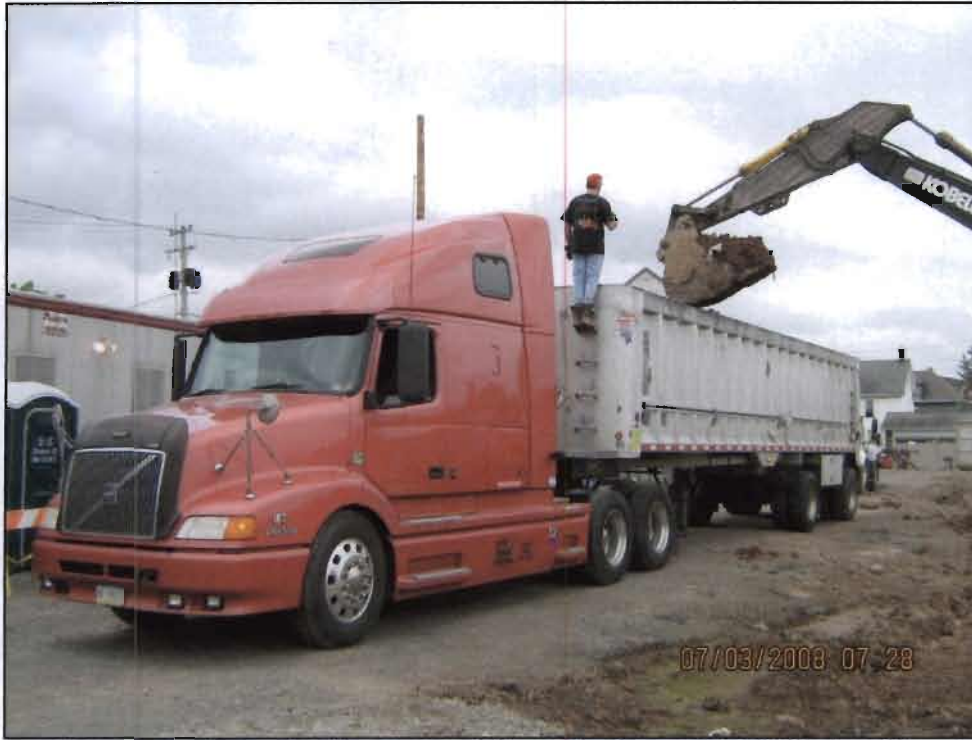
Loading of the contaminated soils, removed from the former MRS Plating Shop building area for the off-site treatment and disposal at Michigan Disposal facility, Belleville, MI.

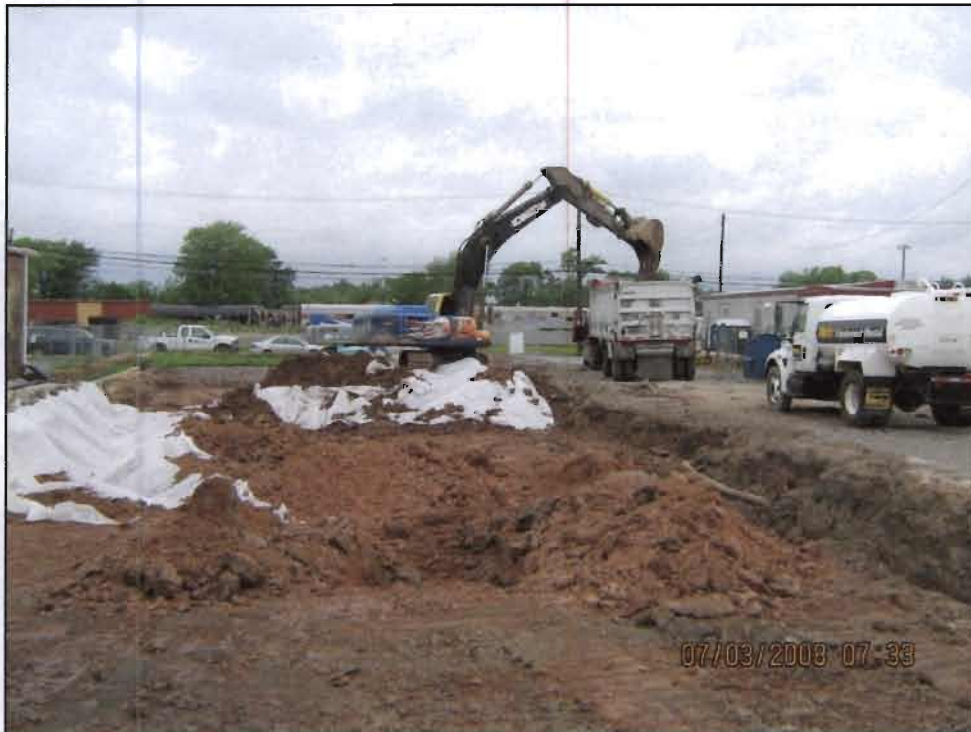
Loading of the contaminated soils, removed from the former MRS Plating Shop building area for the off-site treatment and disposal at Michigan Disposal facility, Belleville, MI.

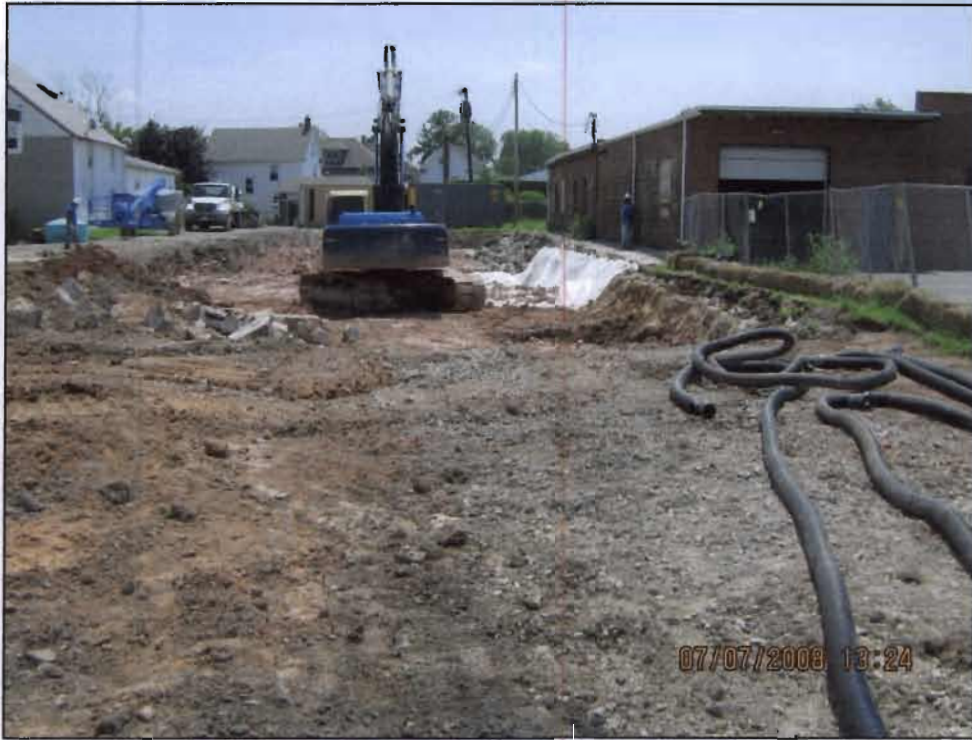
View of the facility, looking south, towards Rene Place. The adjacent private residence to the south and east and the furniture store building to the west are in the background.

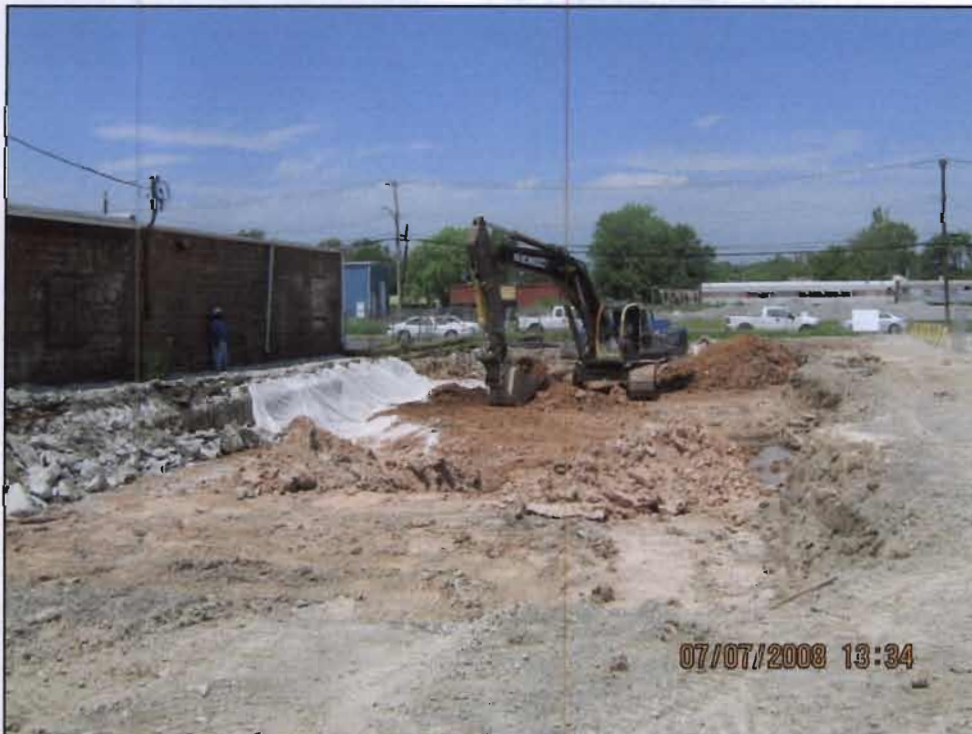
View of the facility, looking north, towards Park Avenue. Stockpiling soils, removed from the former MRS Plating Shop building area for the off-site treatment and disposal.
