Photo Documentation of the Removal Action

MRS Plating Site
310 Park Avenue
Lockport, Niagara County, New York

Removal Support Team 2
Weston Solutions, Inc.
Northeast Division
Edison, New Jersey, 08837

U. S. Environmental Protection Agency
Region II – Removal Action Branch
186 Exchange Street
Buffalo, NY 14203

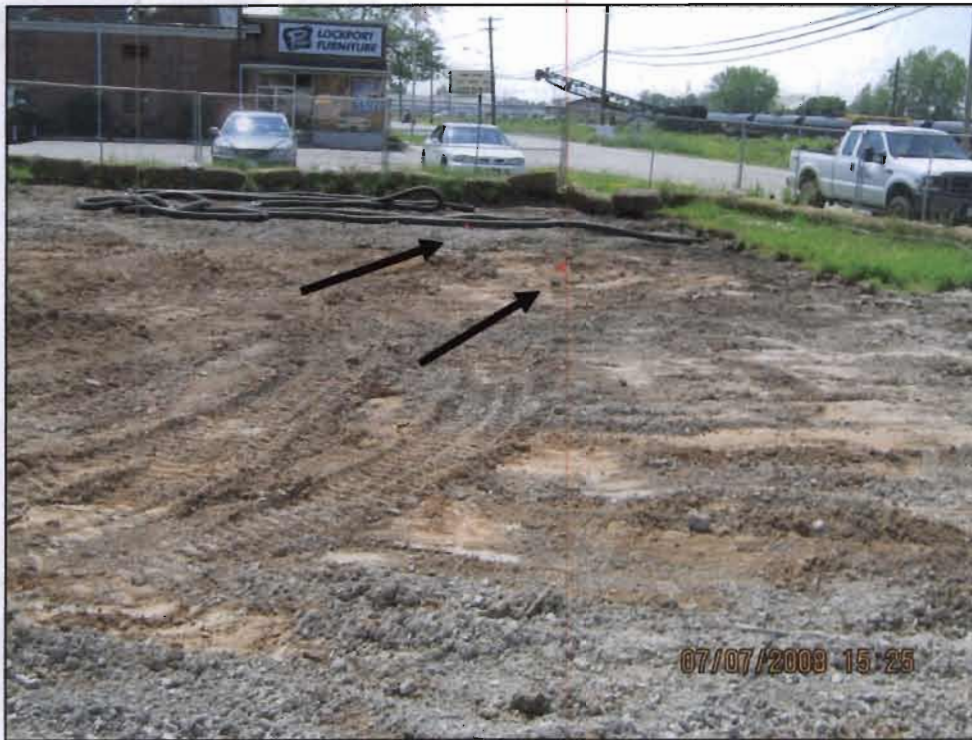
View of the area located between the former plating shop building and Park Avenue. Note locations (red flags) of the two confirmation/post-excitation soil samples.

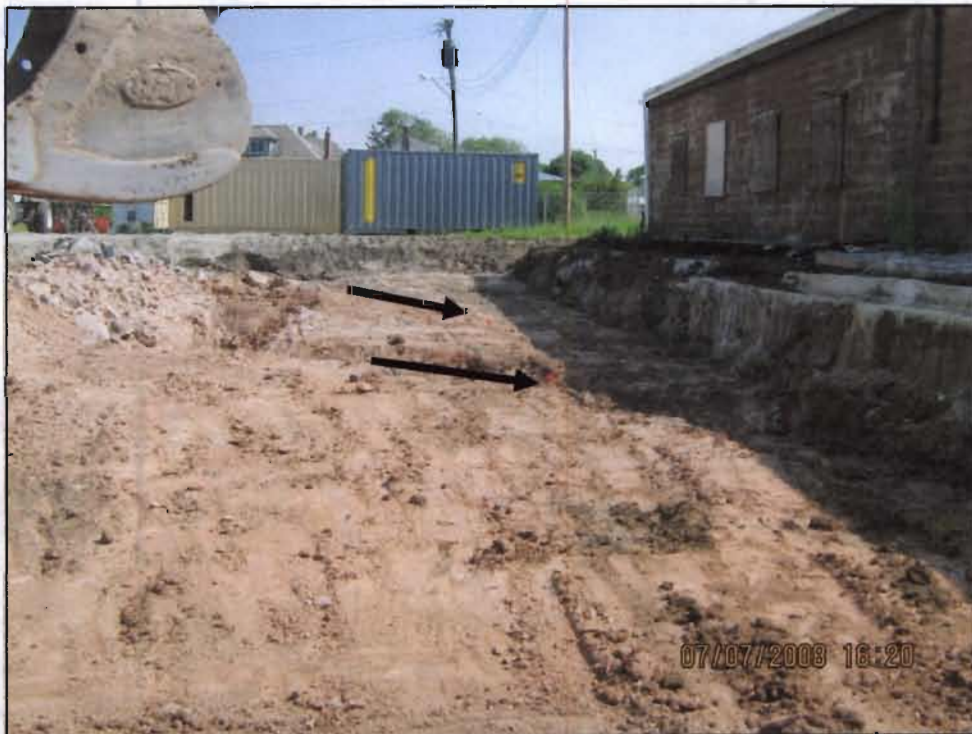
View of the excavation at the former plating shop building location. Note locations (red flags) of the two confirmation/post-excitation soil samples.

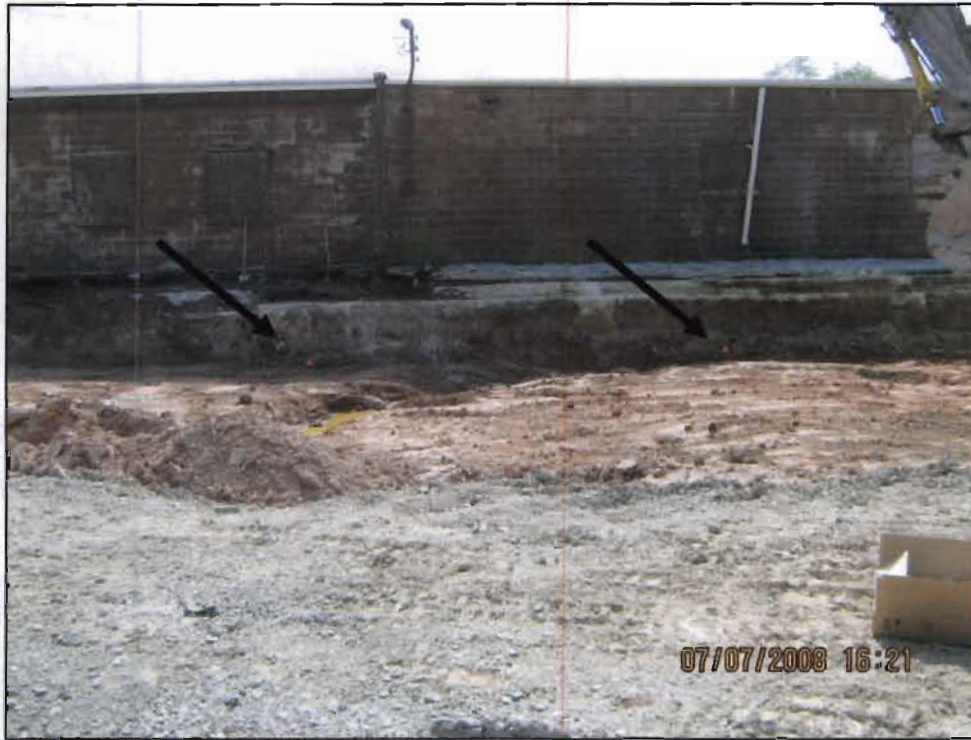
View of the excavation at the former plating shop building location. Note locations (red flags) of the two confirmation/post-excavation soil samples, looking west.

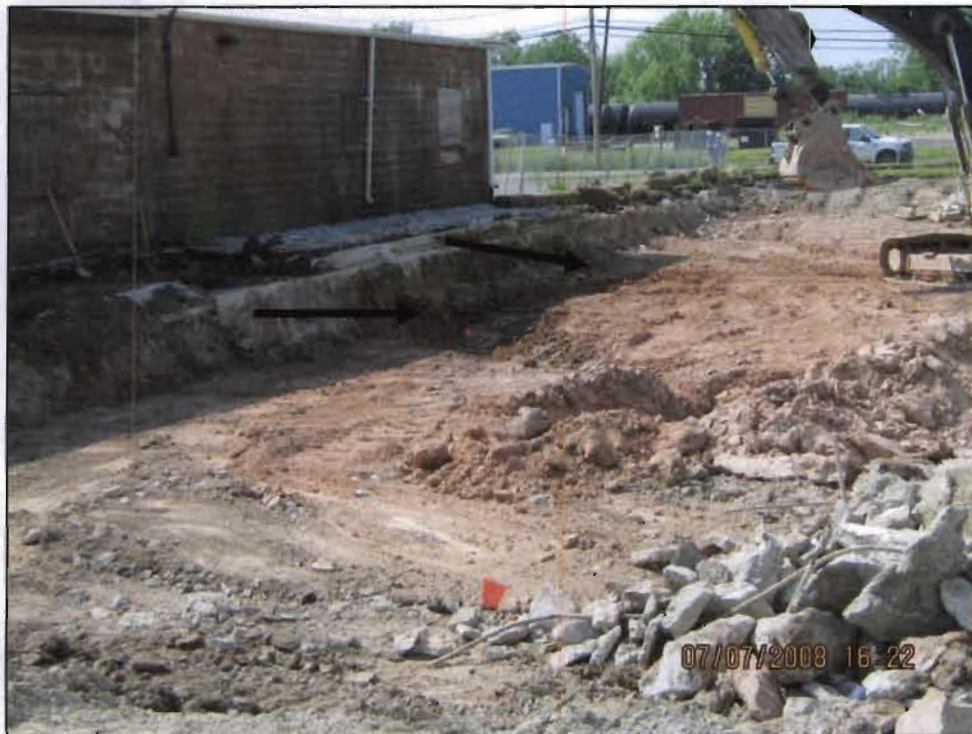
View of the excavation at the former plating shop building location. Note locations (red flags) of the two confirmation/post-excavation soil samples, looking northwest.

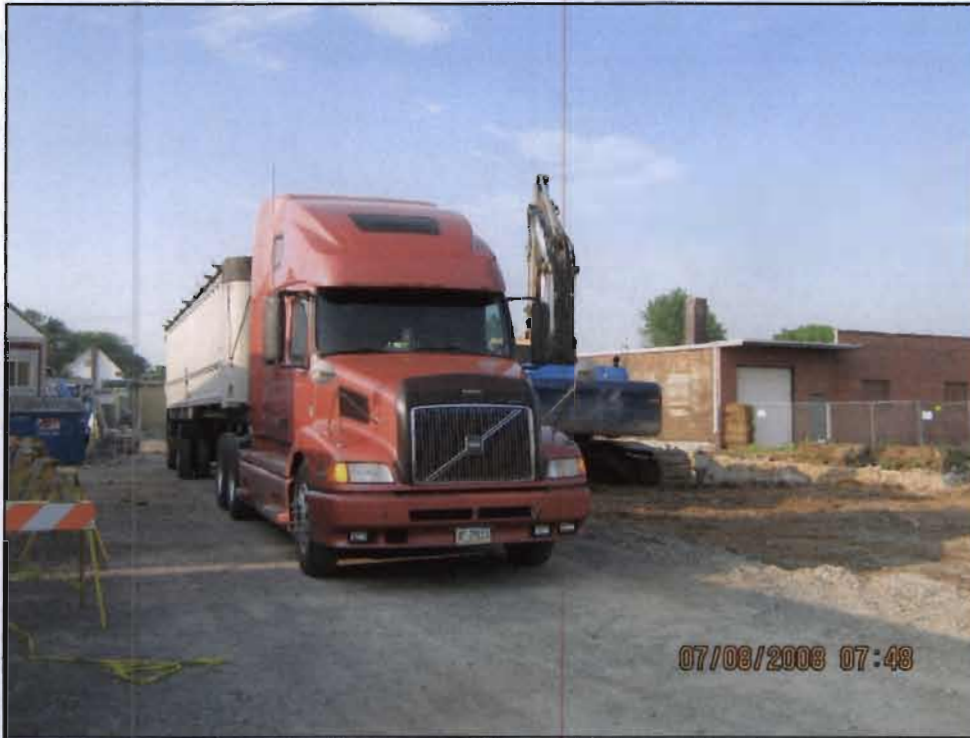
Loading of the contaminated soils, removed from the former MRS Plating Shop building area for the off-site treatment and disposal at Michigan Disposal facility, Belleville, MI.

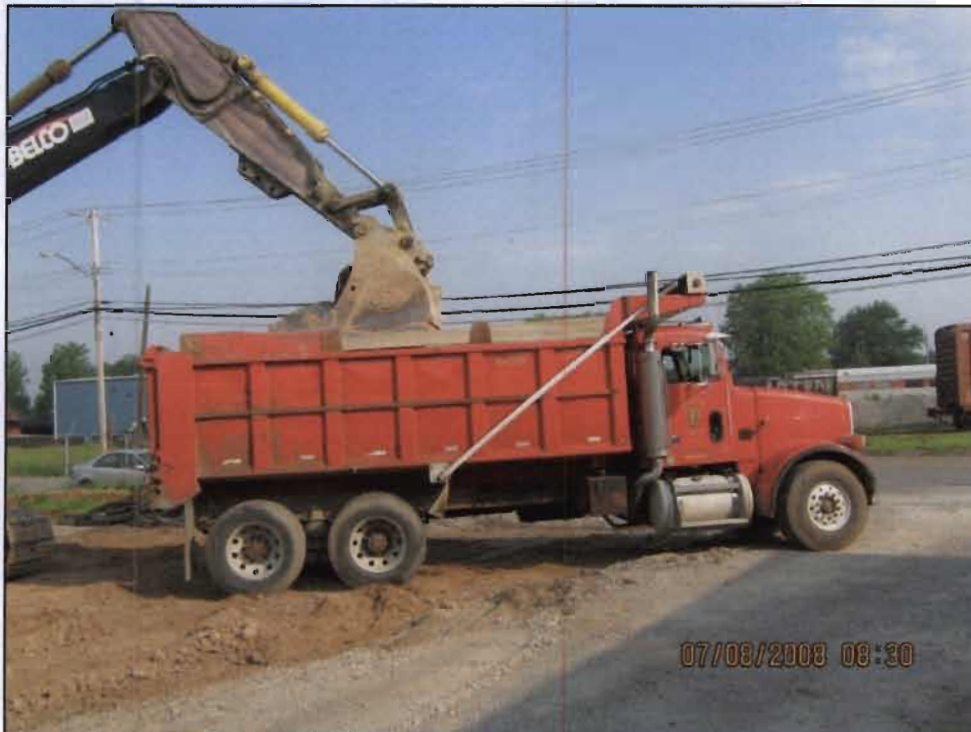
Loading of the non-hazardous soils, removed from the former MRS Plating Shop building area for the off-site treatment and disposal at Allied Waste facility.

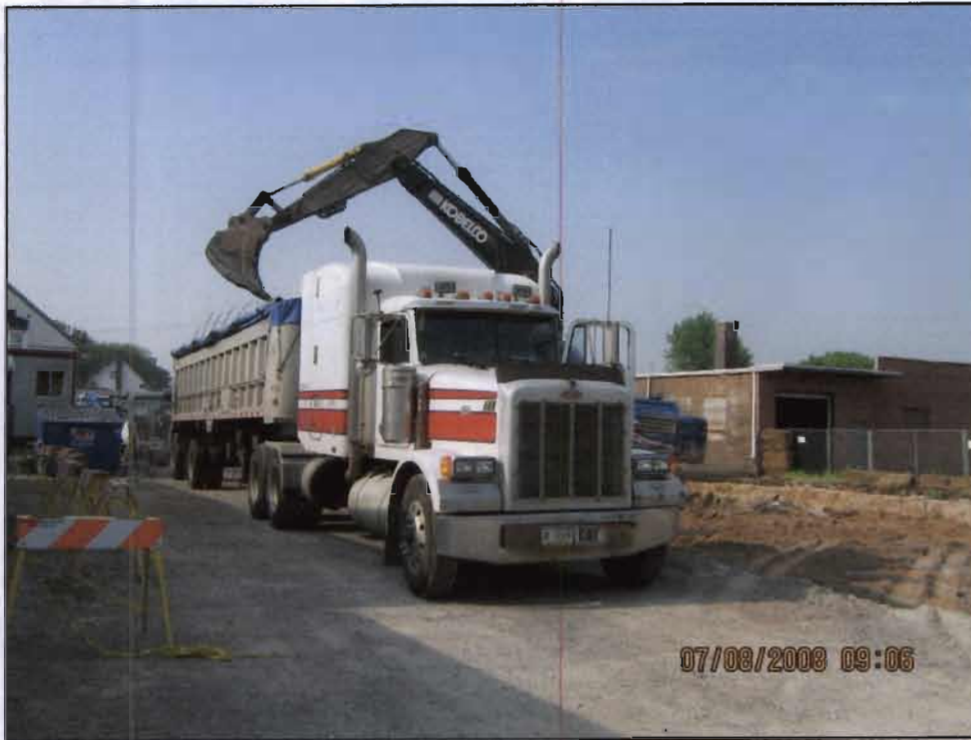
Loading of the contaminated soils, removed from the former MRS Plating Shop building area for the off-site treatment and disposal at Michigan Disposal facility, Belleville, MI.

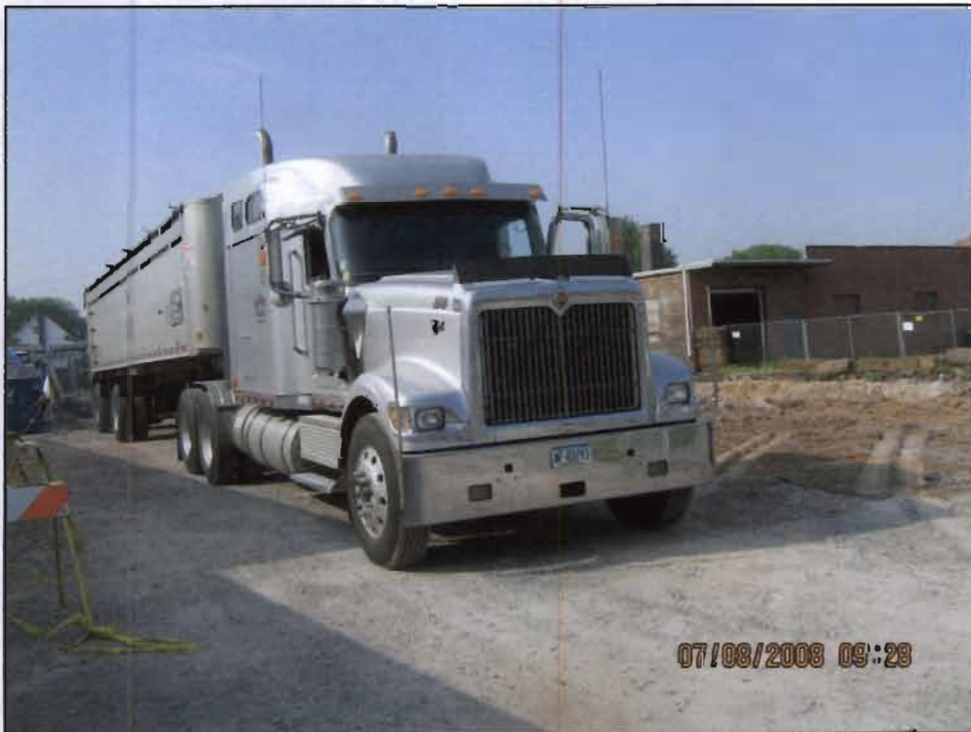
Loading of the contaminated soils, removed from the former MRS Plating Shop building area for the off-site treatment and disposal at Michigan Disposal facility, Belleville, MI.

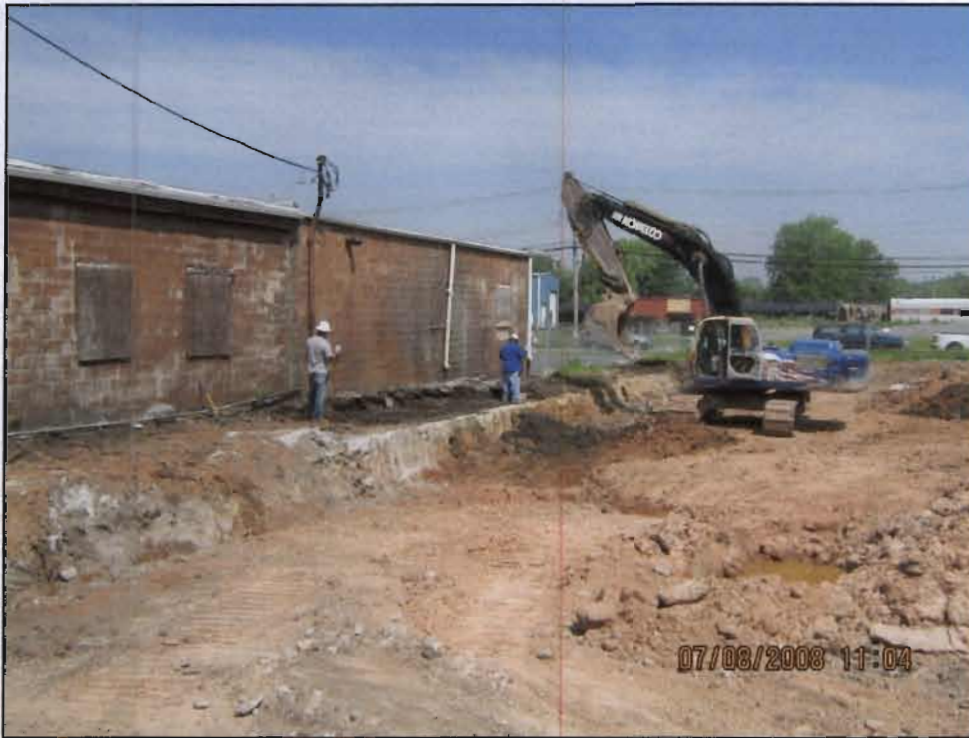
WRS removing top soils (approximately 12 inches) from the area between the furniture store building and the western property line and replacing with clean fill.

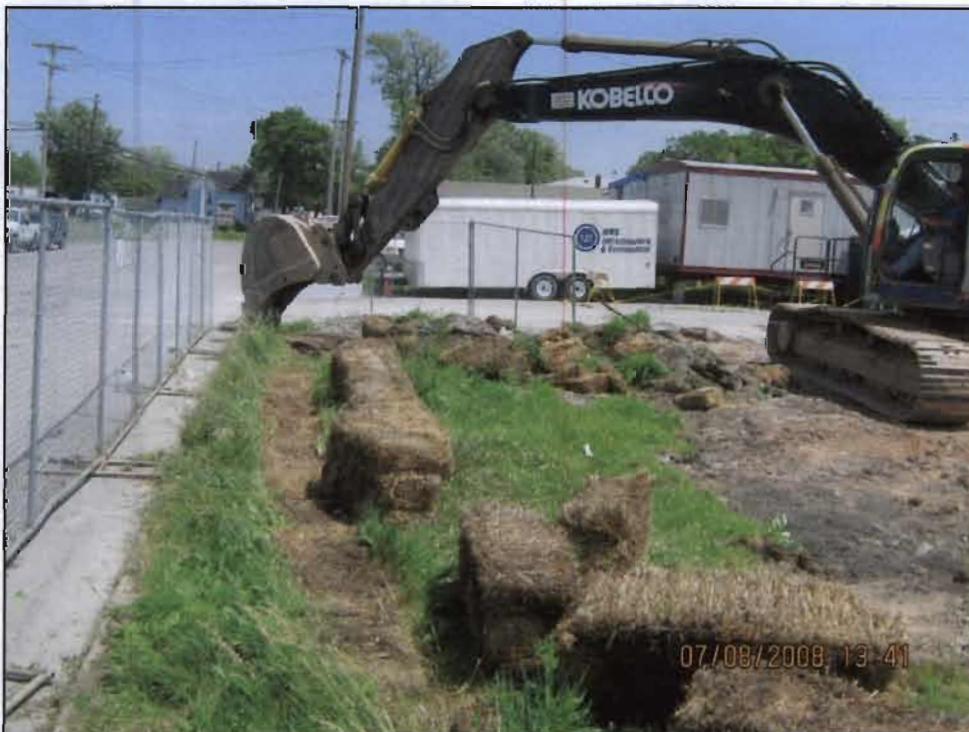
WRS removing top soils (approximately 6 inches) from the northern property area along the Park Avenue for the purpose of grading and replacement with clean fill.

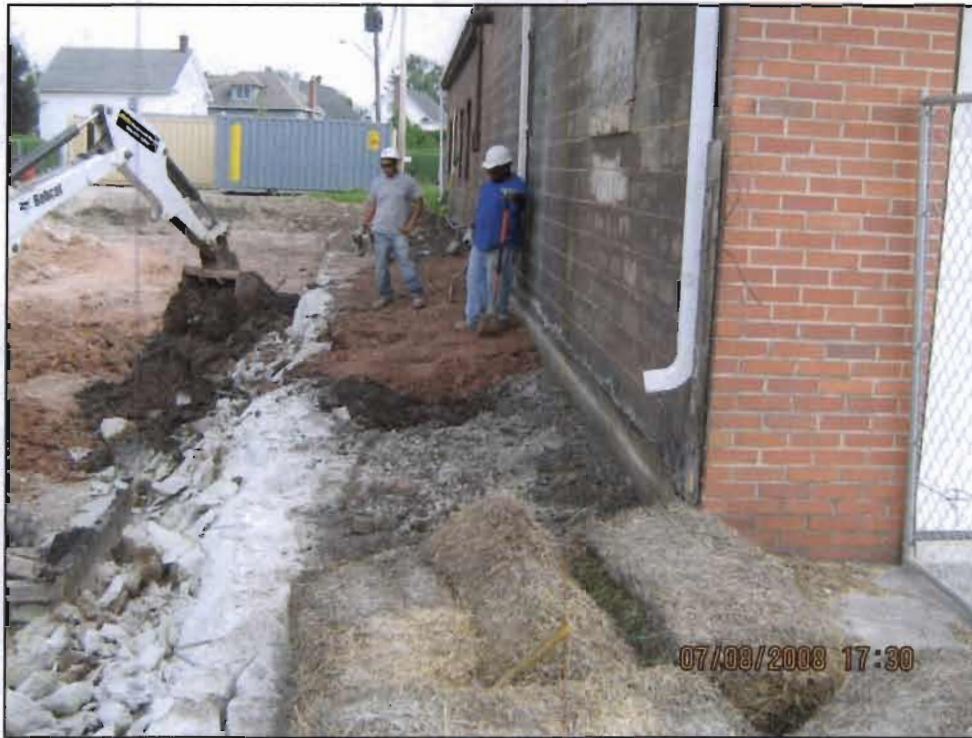
WRS placing clean fill area between the remaining western foundation wall of the former plating shop building and adjacent furniture store building along the west.

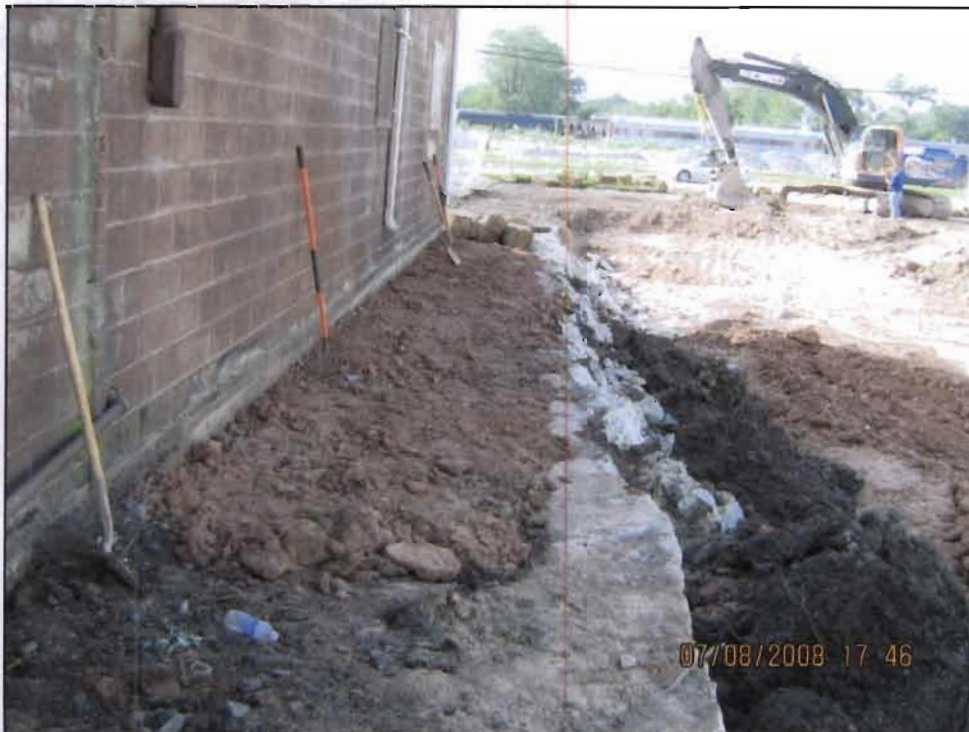
WRS placing clean fill area between the remaining western foundation wall of the former plating shop building and the adjacent furniture store building along the west.
