# A

## Survey Figures

# B Survey Data Tables

**Table B-1 Sediment Thickness Points, Eighteenmile Creek, Niagara County, New York**

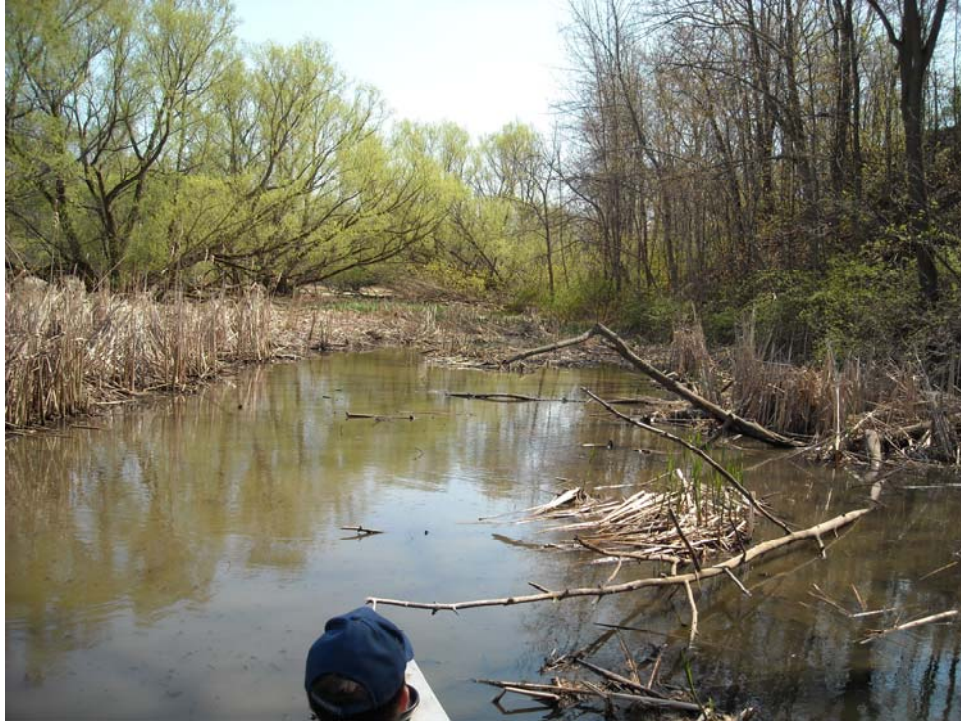
Photo: P94

Description: Extent of cattail marshes.

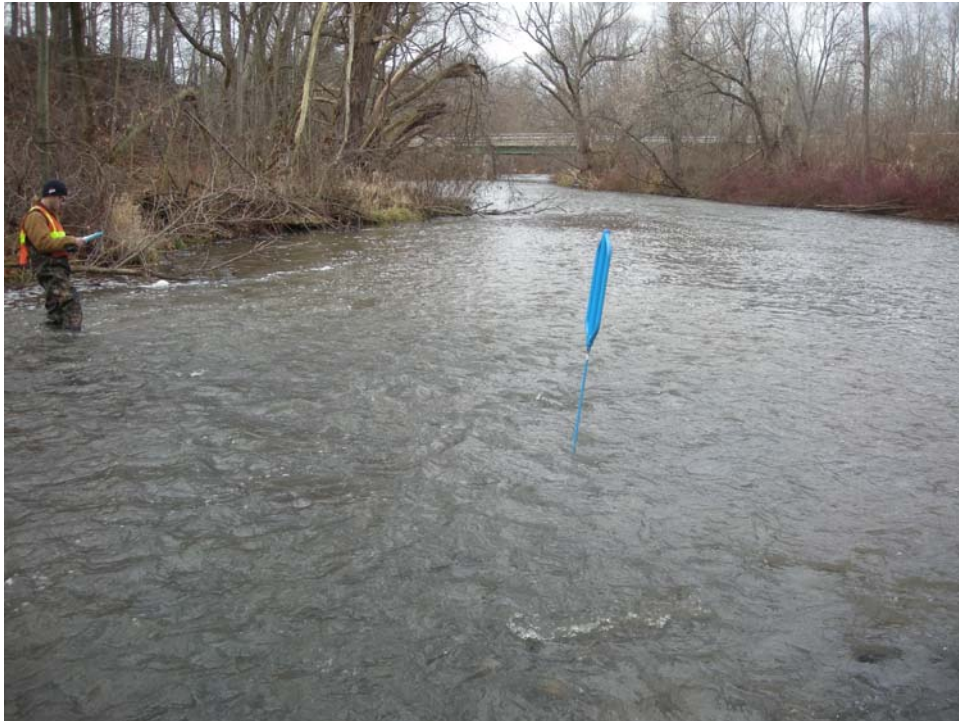
Photo: P31A  
Direction of view: N  
Description: Left channel, downstream view.

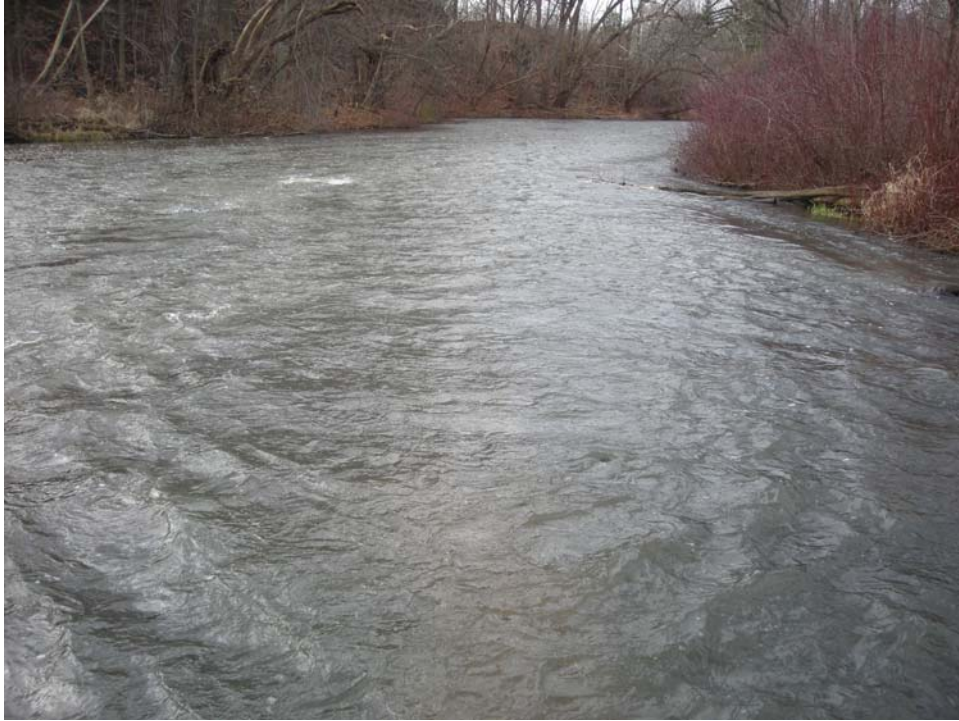
Photo: P34A

Description: Right channel, downstream view.

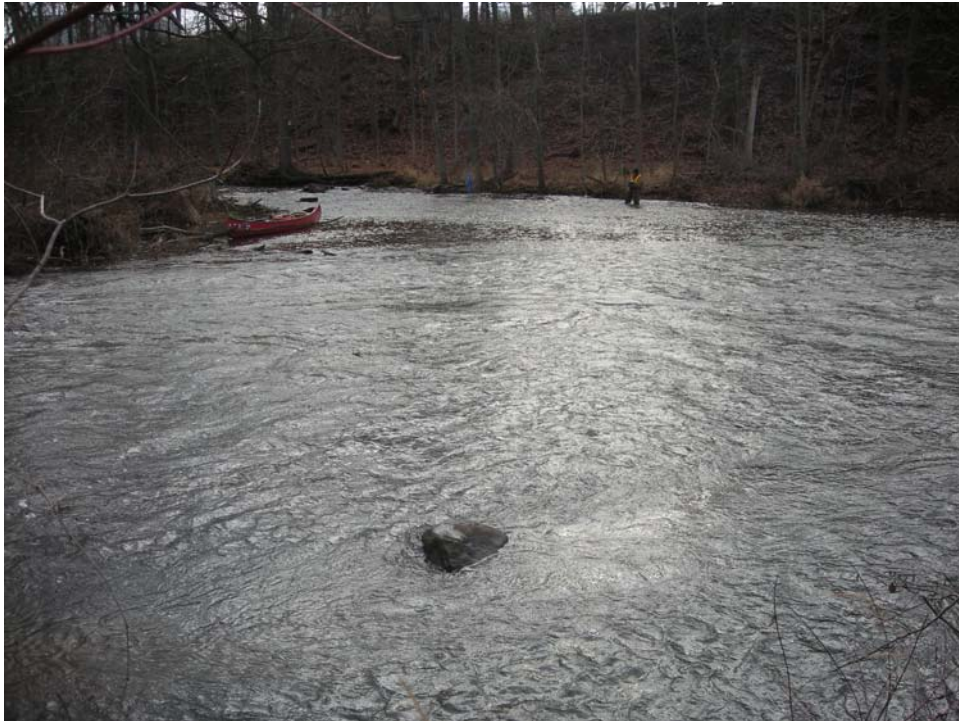
Photo: P35A

Description: View from LDB to RDB, along right channel.

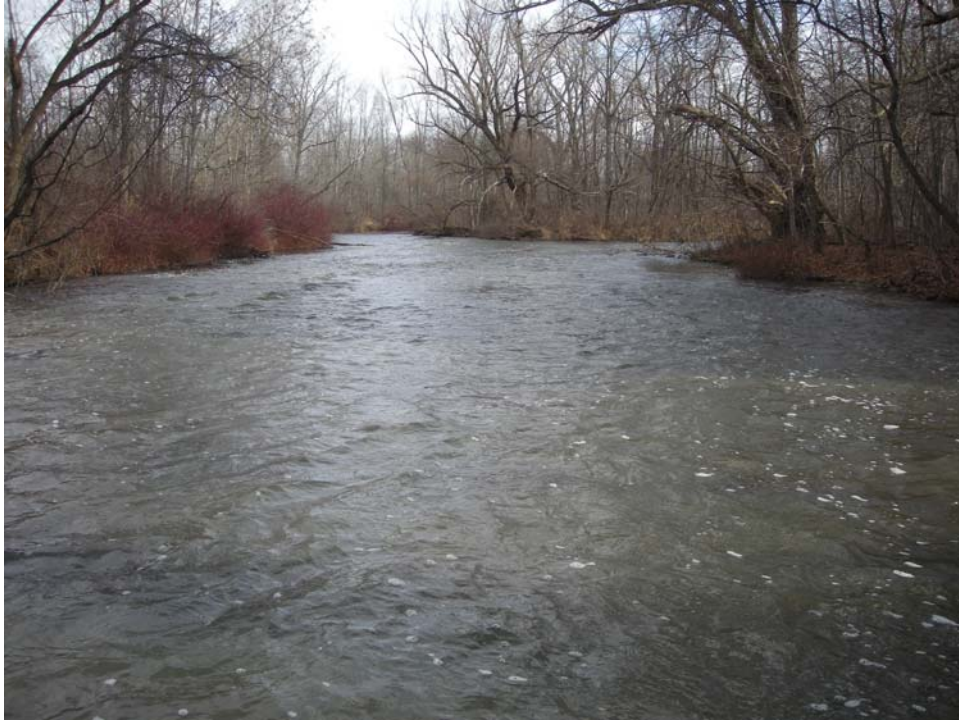
Photo: P36A

Description: At SED 5 upstream view.

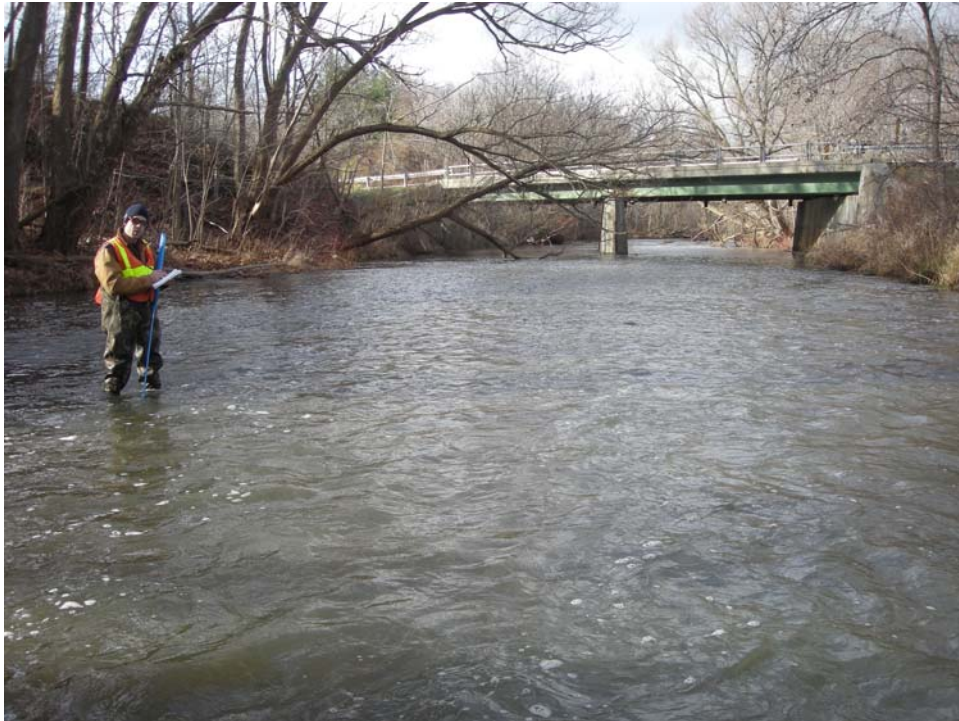
Photo: P37A

Description: At SED 5 downstream view.

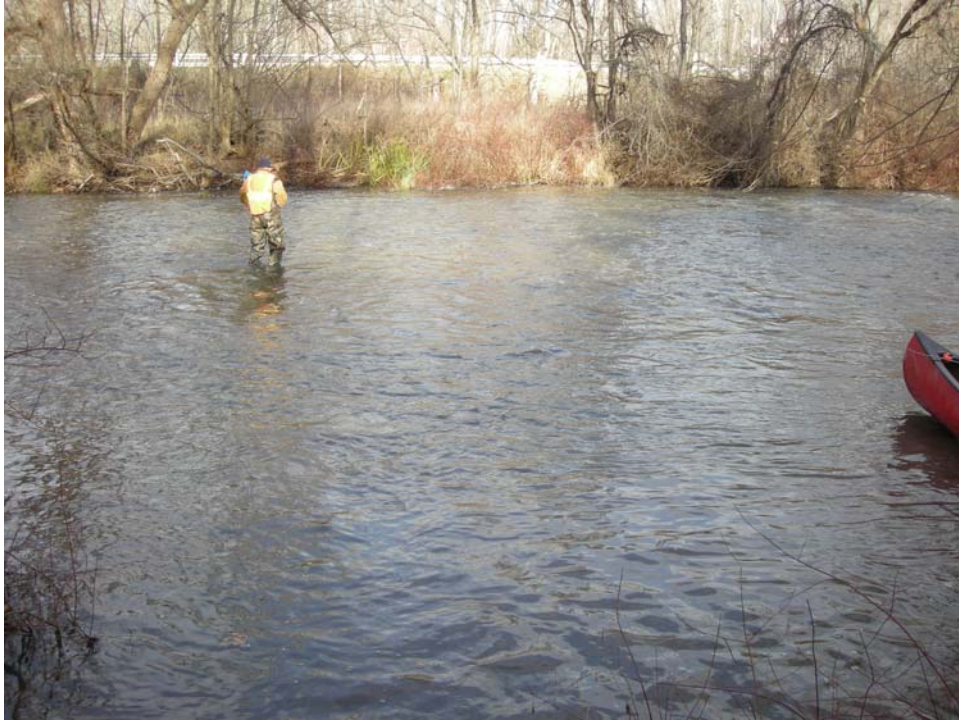
Photo: P38A

Description: At SED 5, view of LDB.

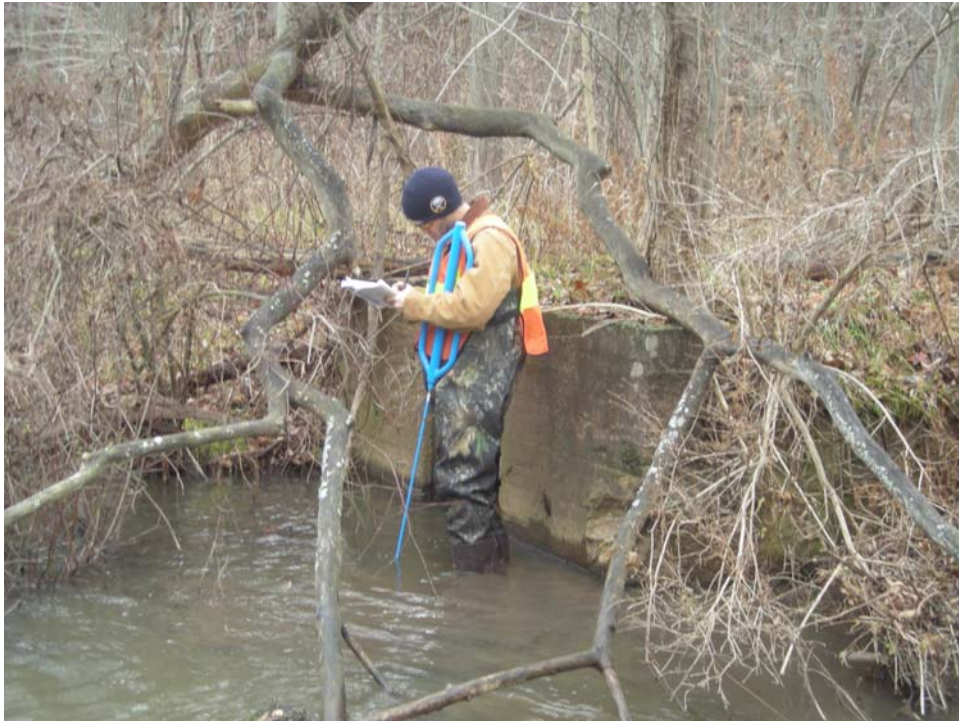
Photo: P39A

Description: Storm sewer along LDB.

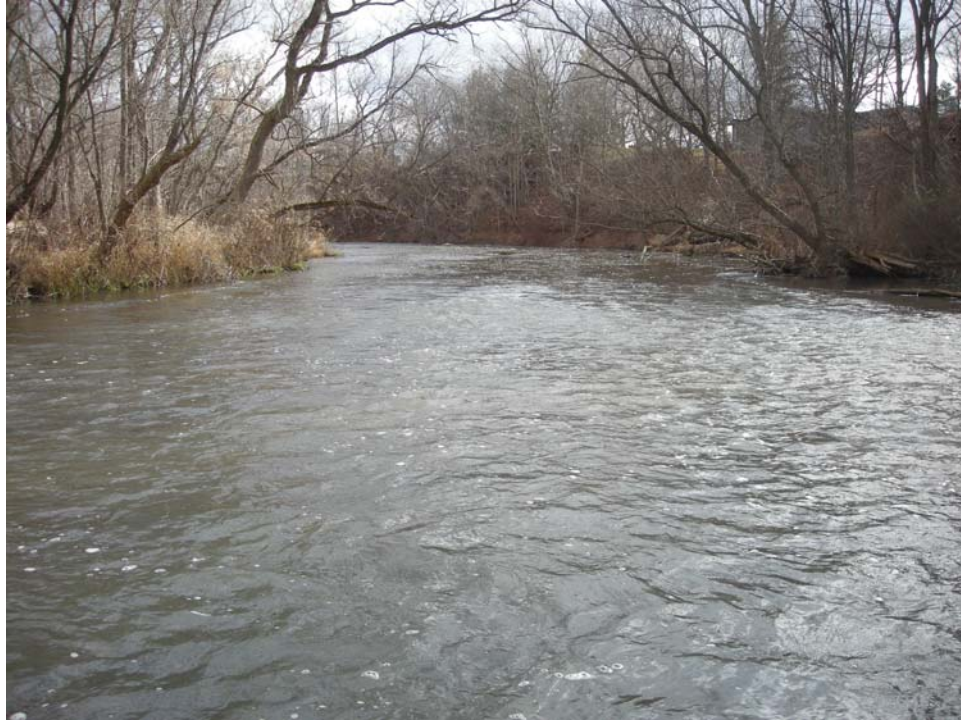
Photo: P40A

Description: At SED 6, upstream view.

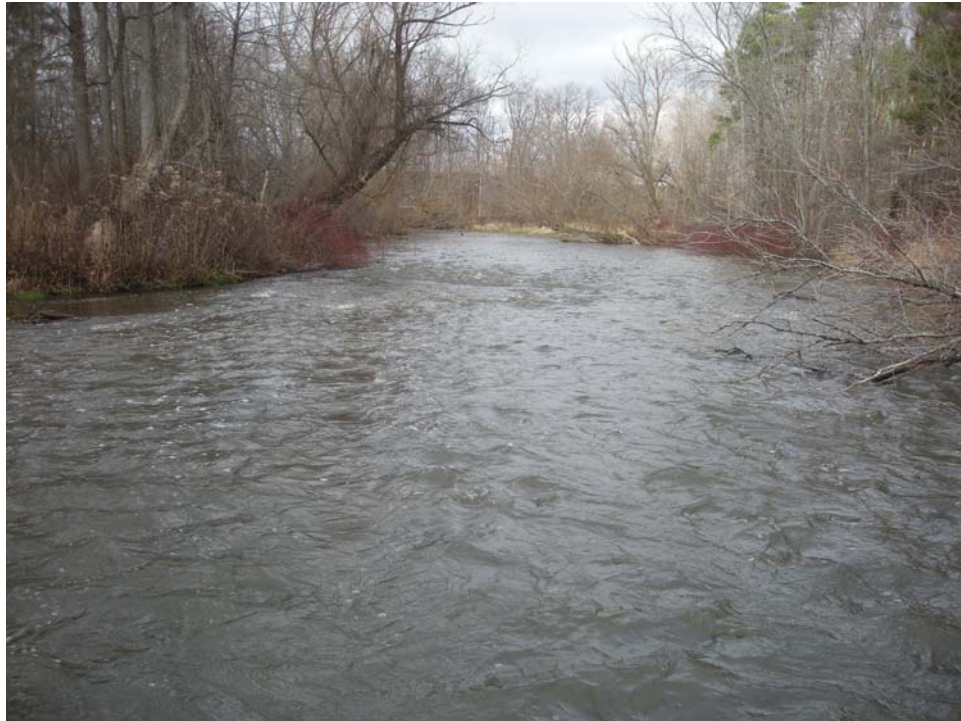
Photo: P41A

Description: At SED 6, downstream view.

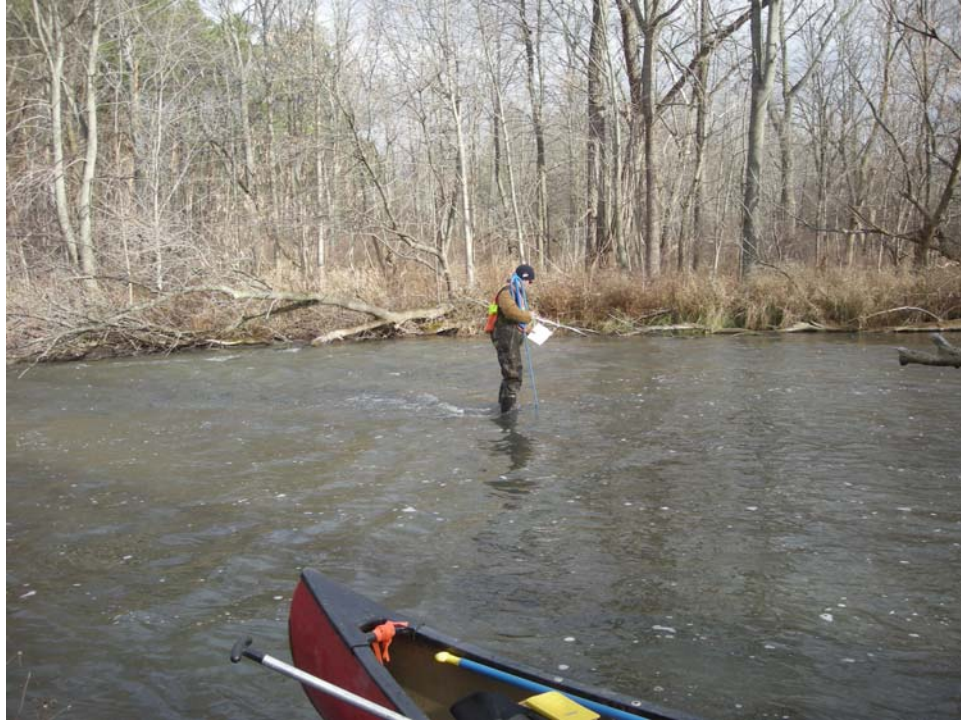
Photo: P42A

Description: At SED 6, view from LDB to RDB across creek.

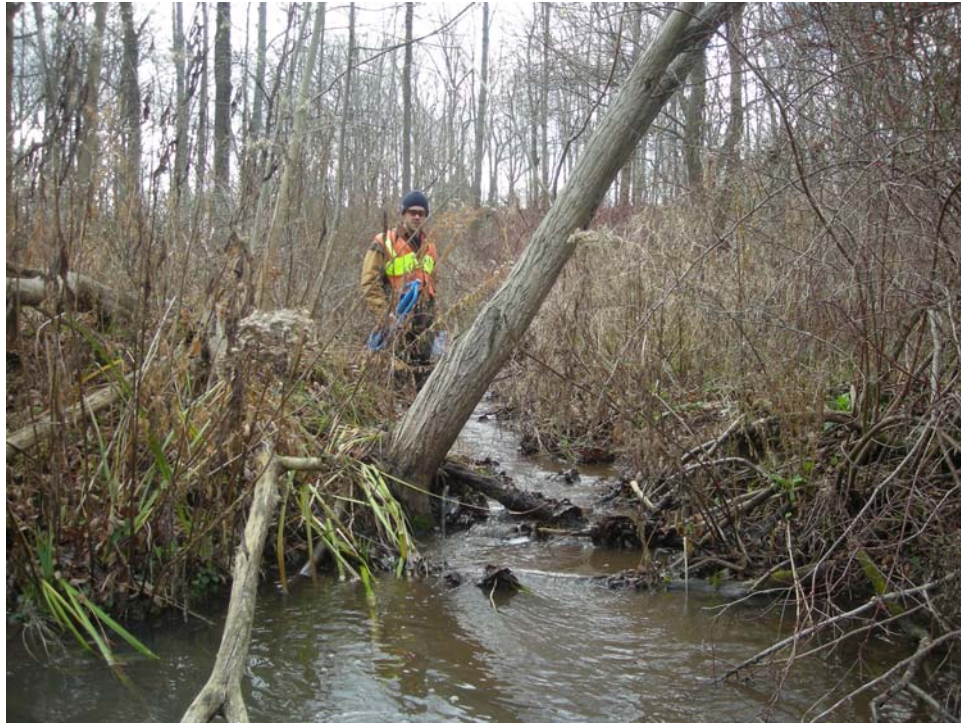
Photo: P43A

Description: Tributary along LDB.

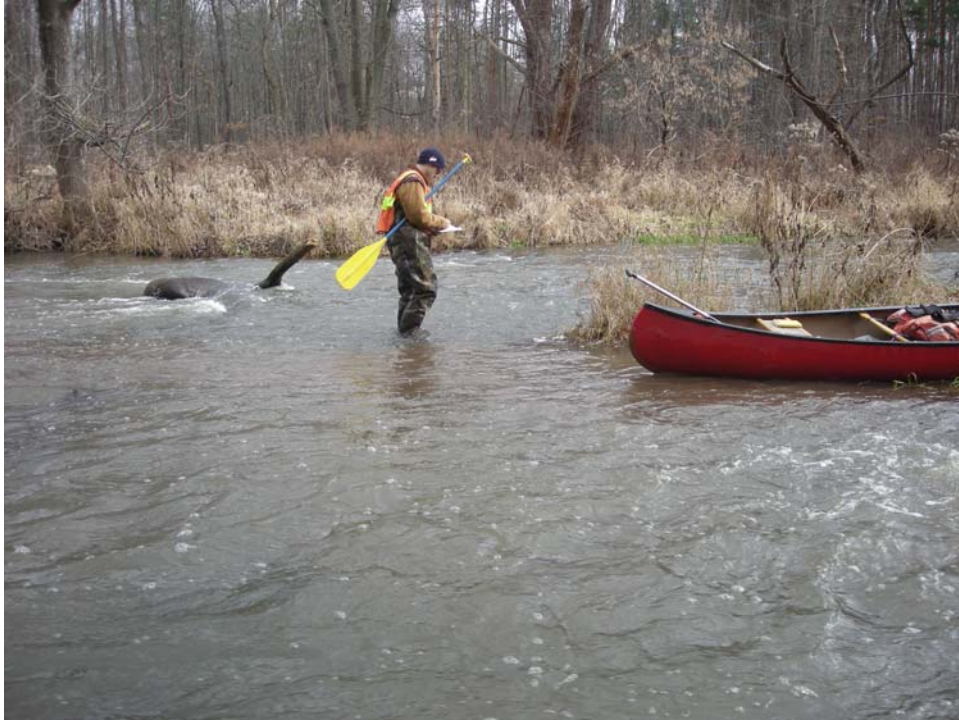
Photo: P44A

Description: View from LDB to RDB across creek at BNK 5.

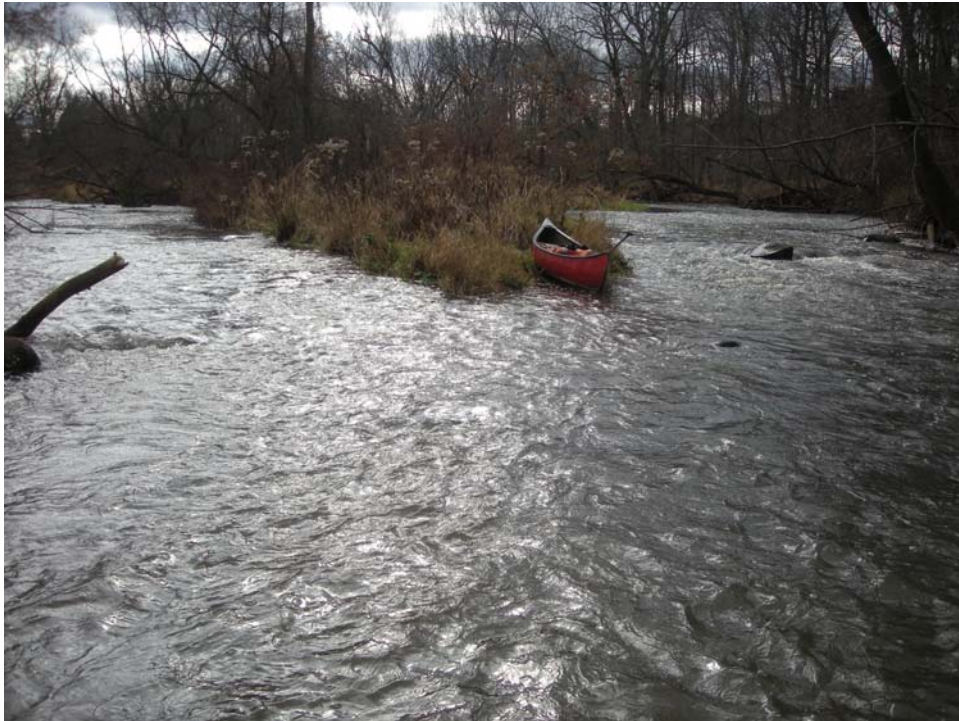
Photo: P45A

Description: Upstream view at BNK 5.

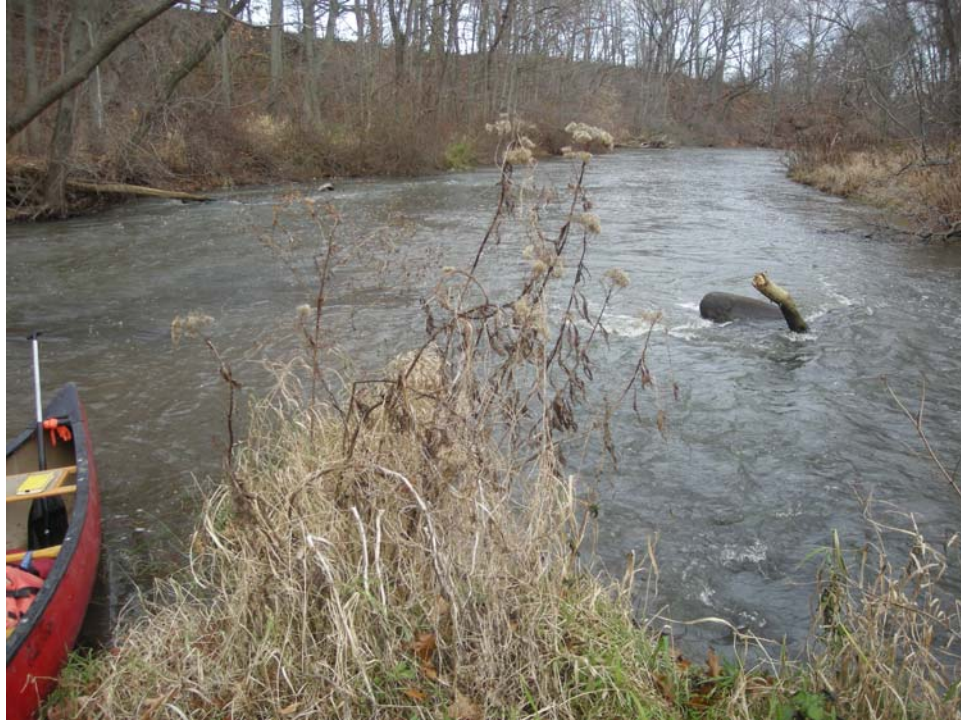
Photo: P46A

Description: Downstream view at BNK 5.

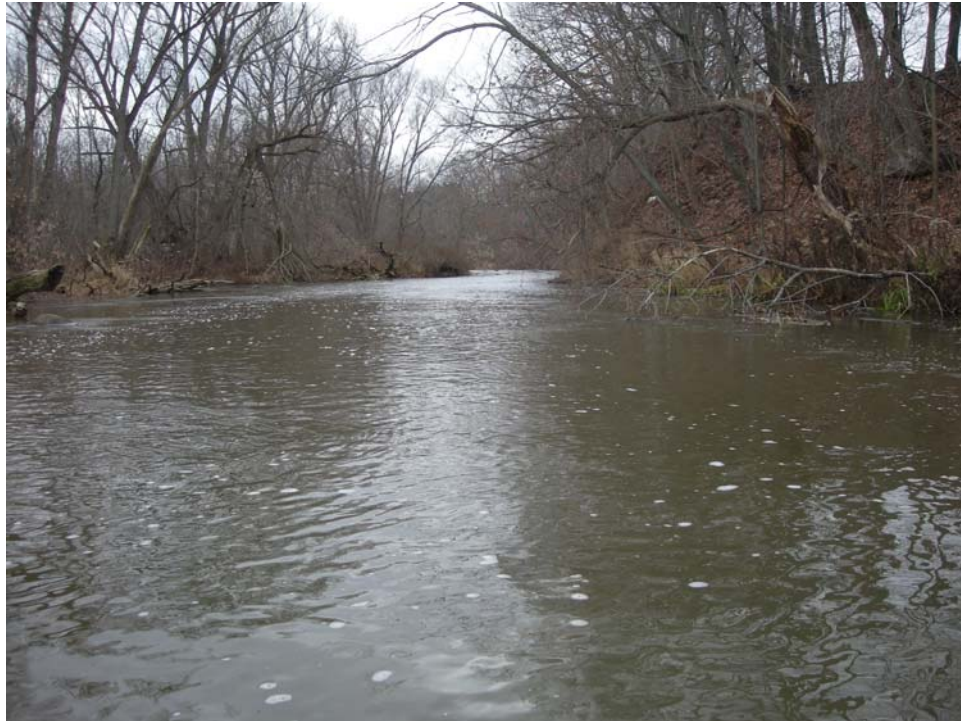
Photo: P47A

Description: At SED 8, upstream view.

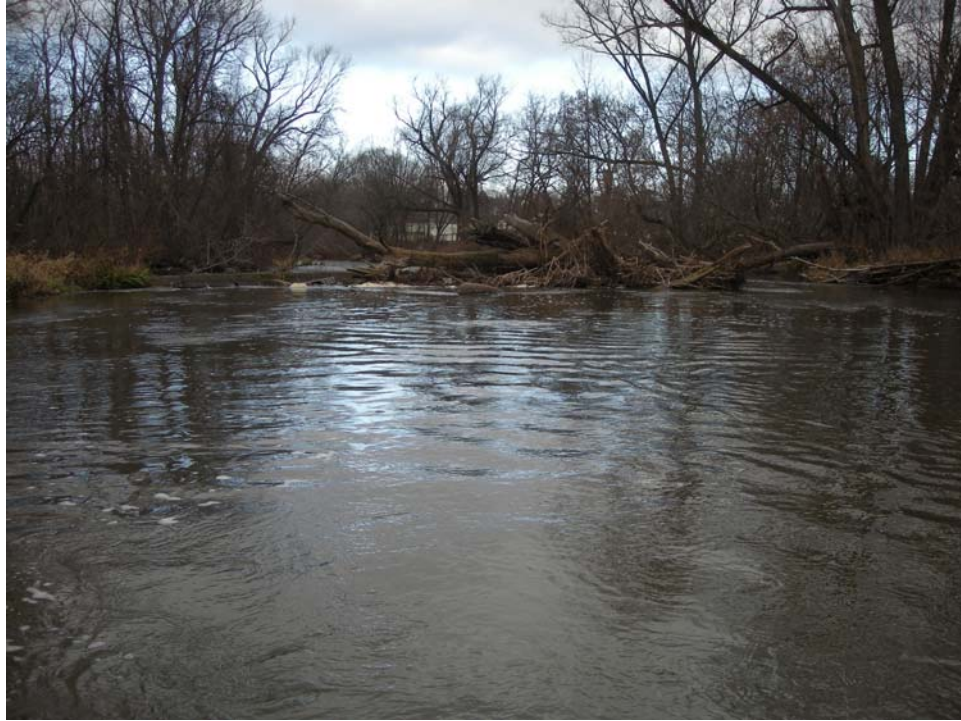
Photo: P48A

Description: At SED 8, downstream view.

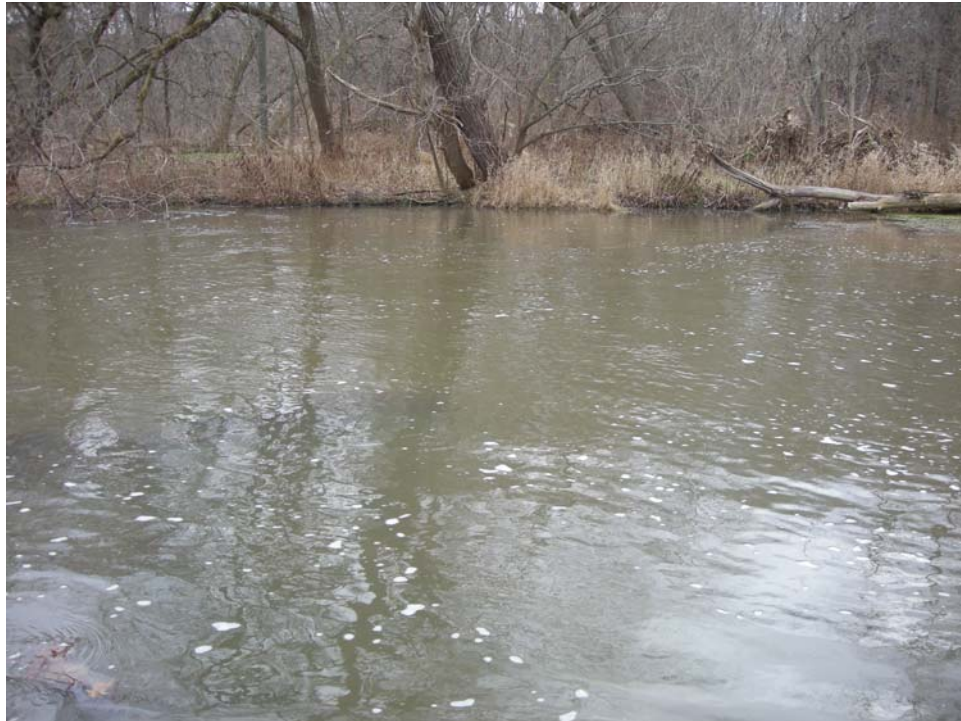
Photo: P49A

Description: At SED 8 view from LDB to RDB across creek.

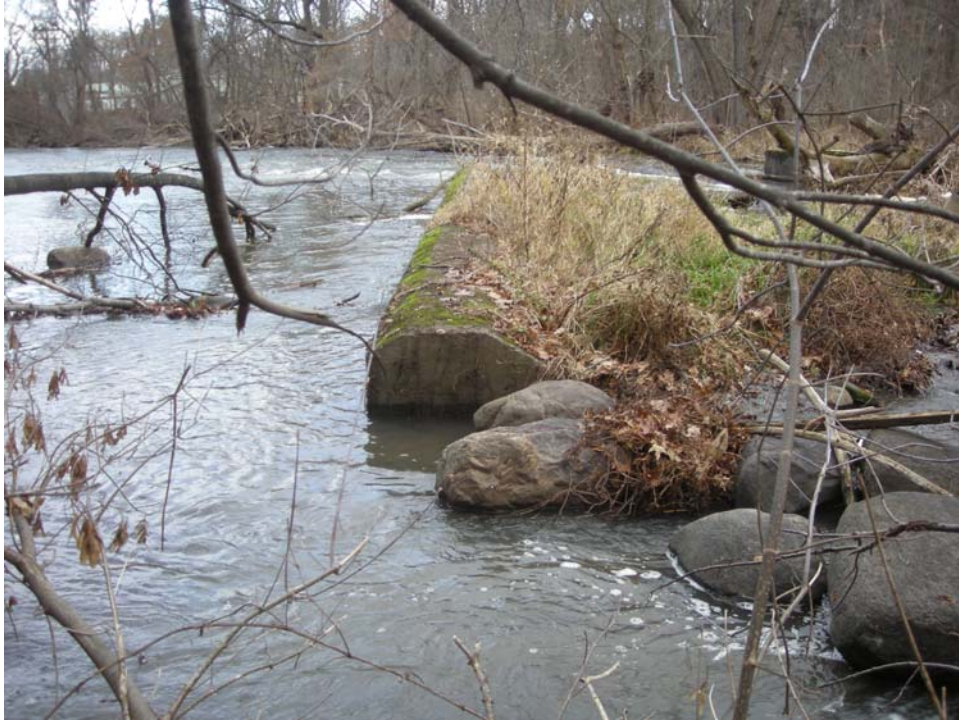
Photo: P50A  
Direction of view: NE  
Description: View of impoundment along LDB.

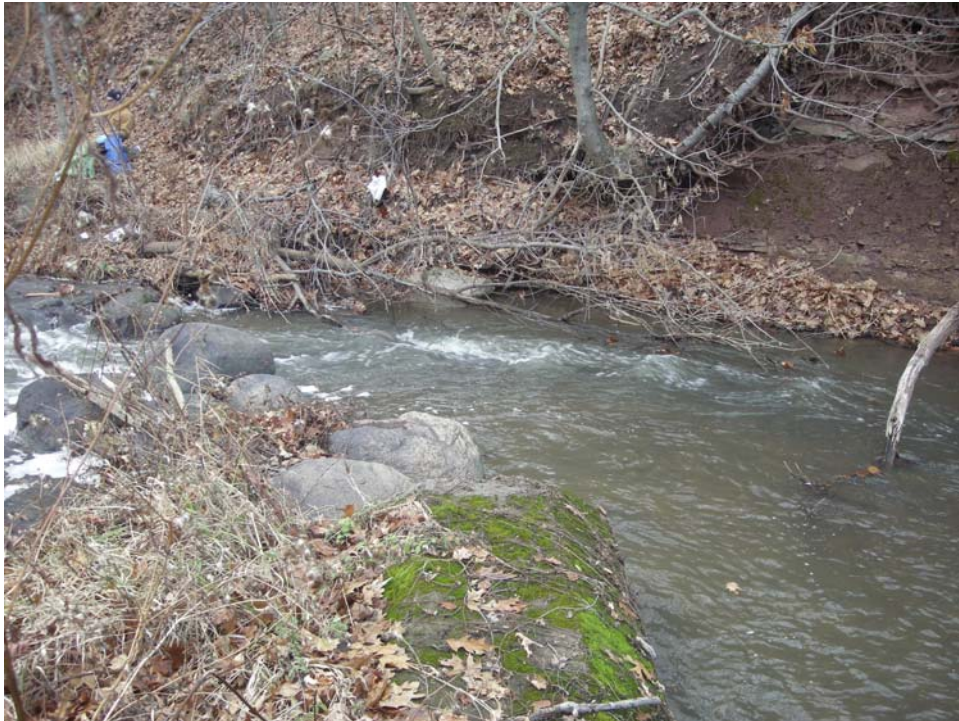
Photo: P51A  
Direction of view: SW  
Description: Impoundment along LDB in creek.

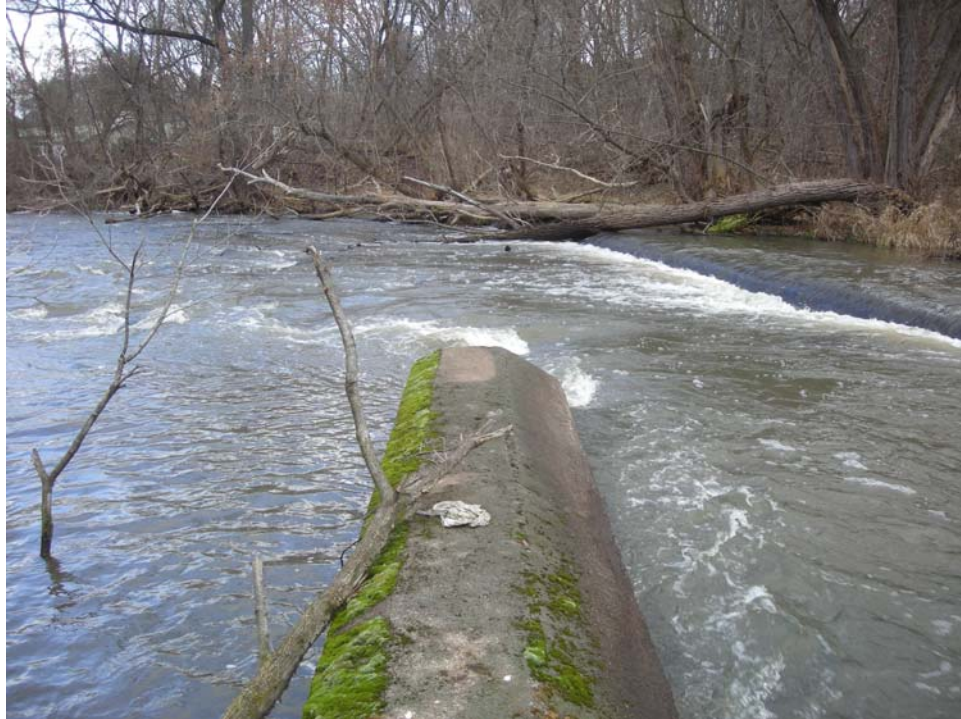
Photo: P52A  
Direction of view: NE  
Description: Impoundment mid-channel of RDB.

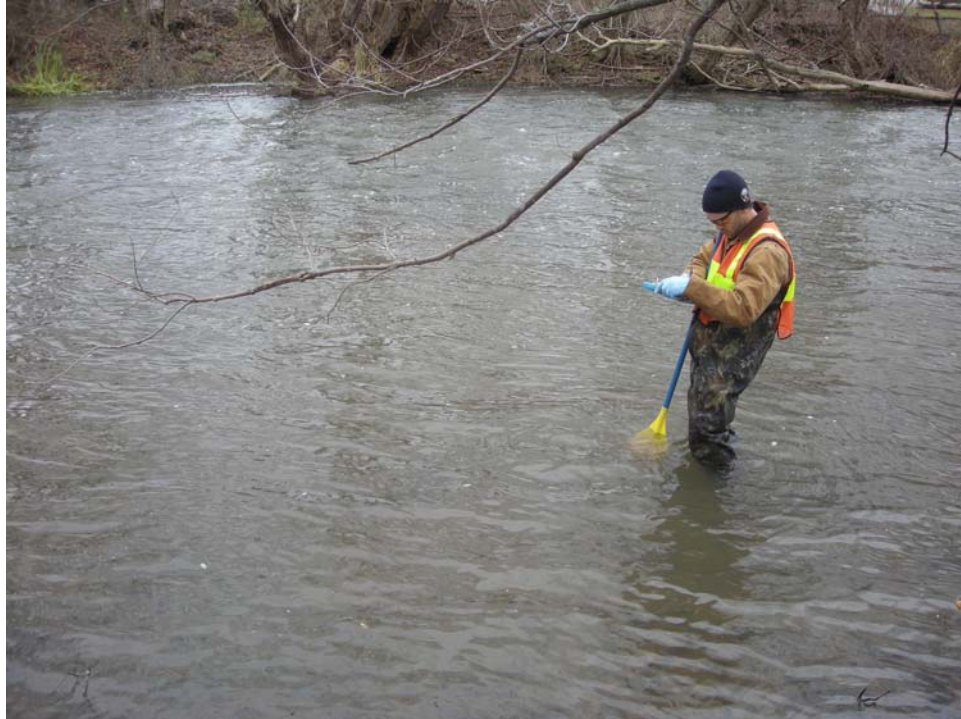
Photo: P58A

Description: At SED 11, view from LDB to RDB across channel.

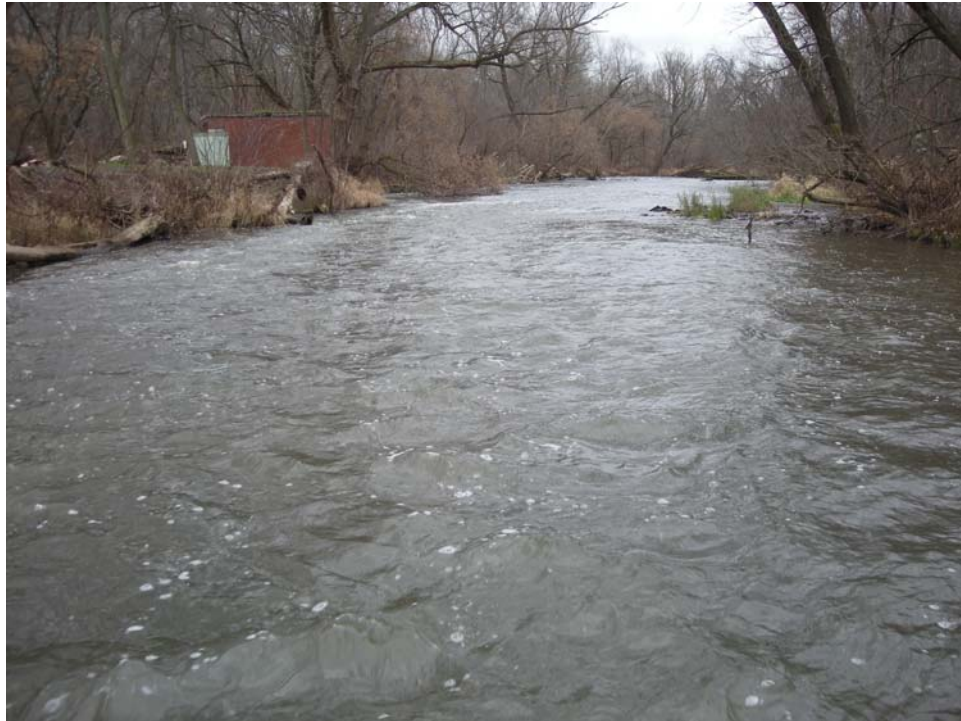
Photo: P59A

Description: At SED 11, upstream view.

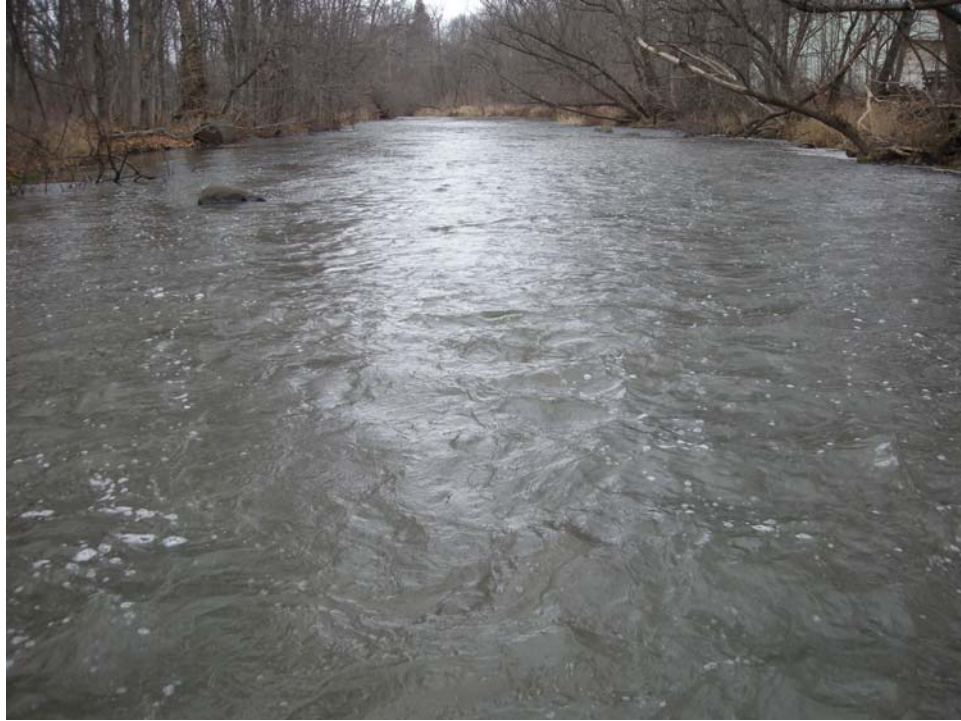
Photo: P60A  
 Direction of view: N  
 Description: At SED 11, downstream view.

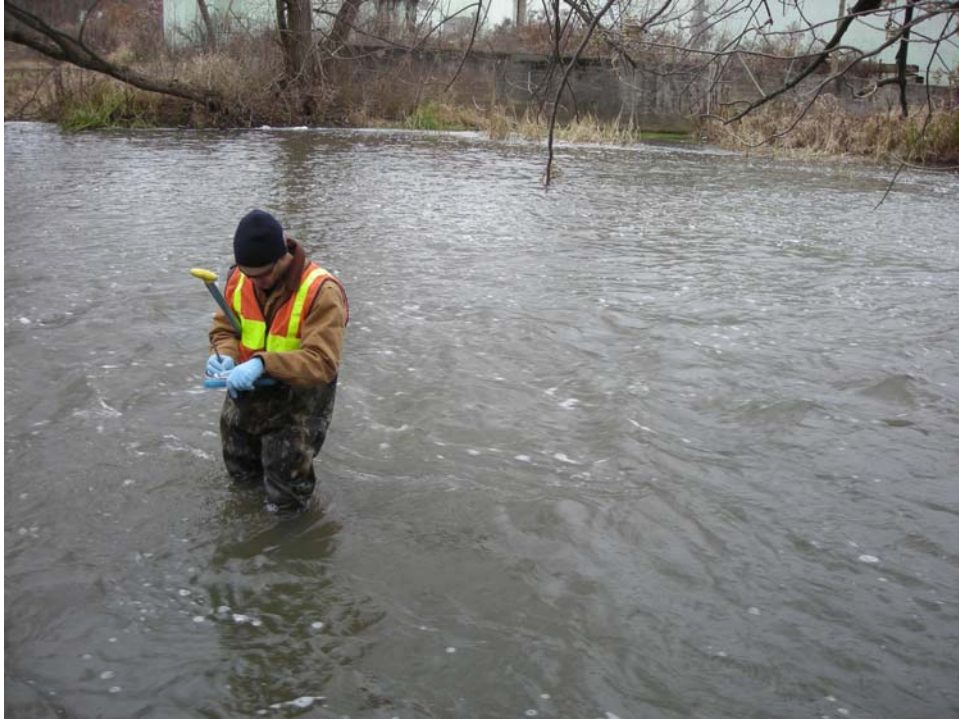
Photo: P64A

Description: At SED 13, view from LDB to RDB across creek.

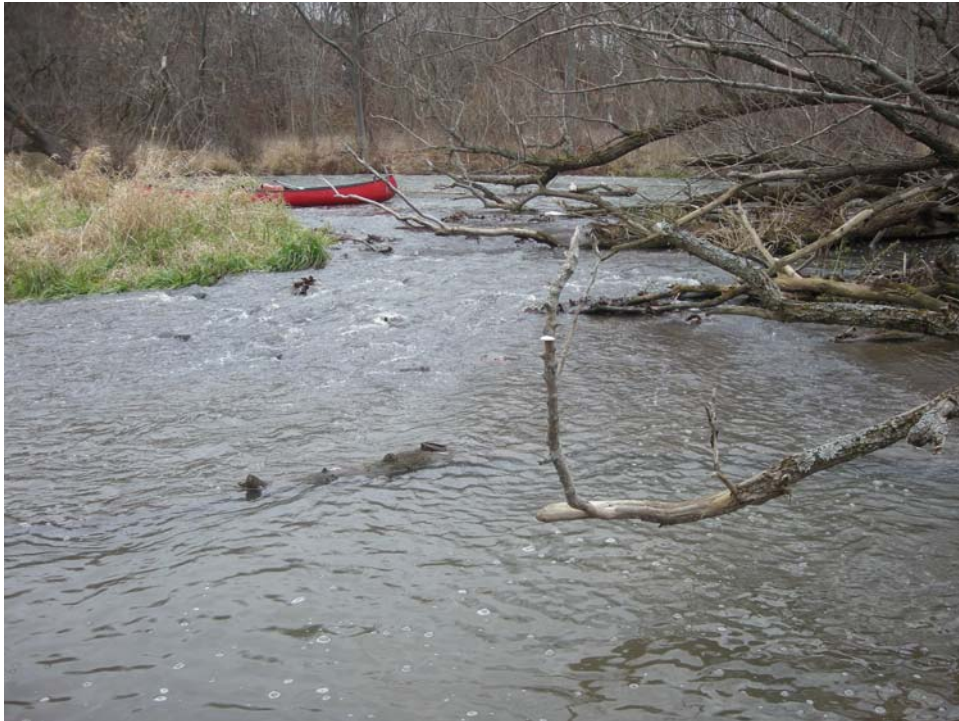
Photo: P65A

Description: At SED 14, view from LDB to RDB across creek.

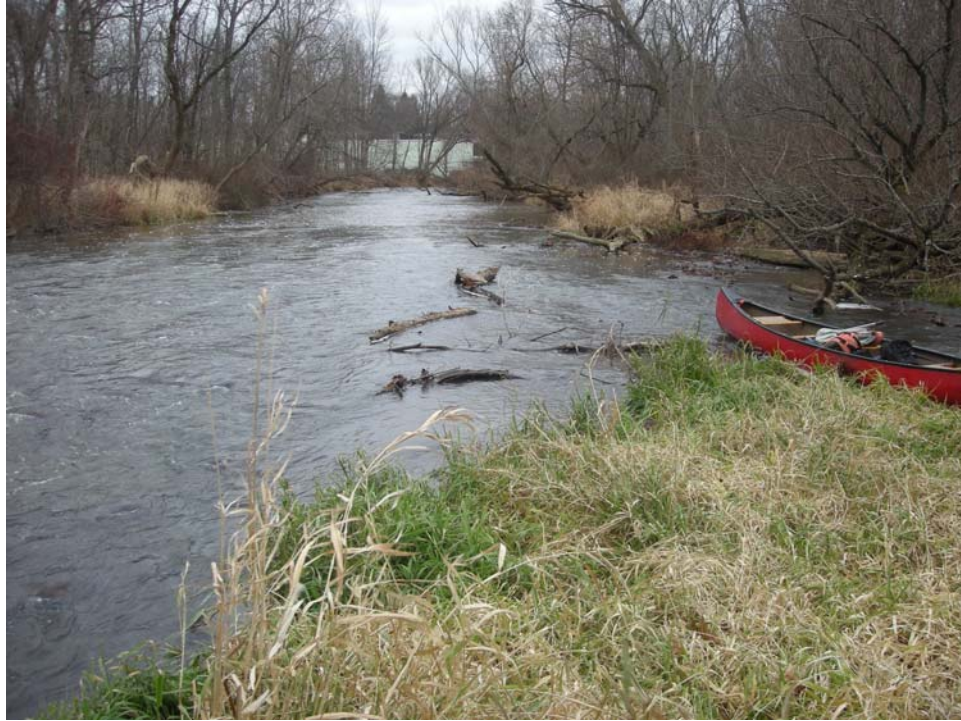
Photo: P66A

Description: At SED 15, upstream view.

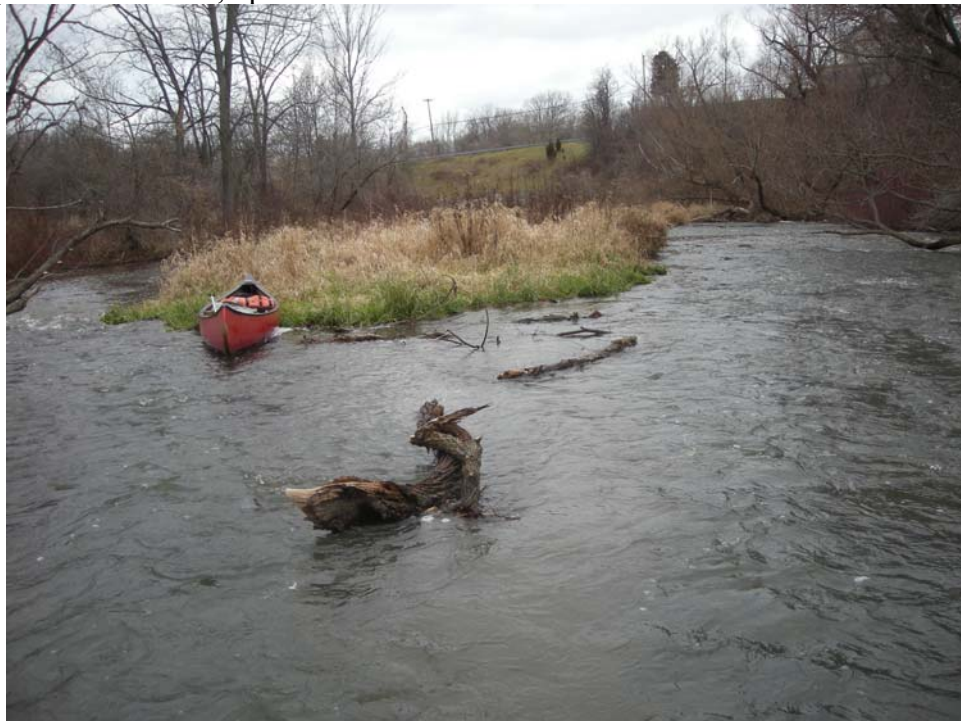
Photo: P67A

Description: At SED 14, downstream view.

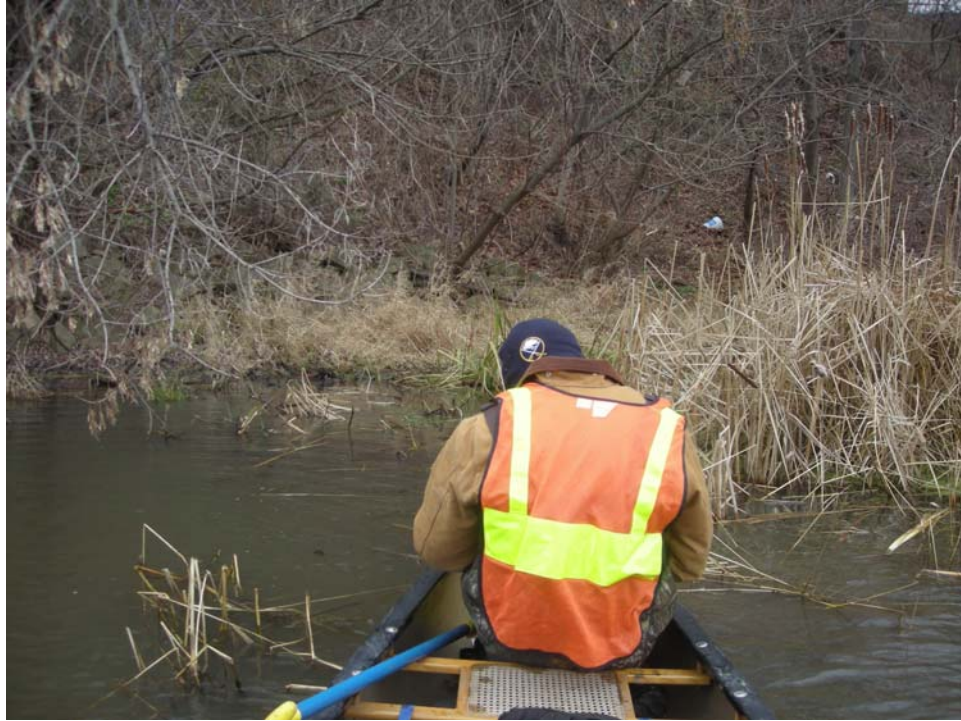
Photo: P68A  
 Direction of view: E  
 Description: At SED 15, wetland along RDB.

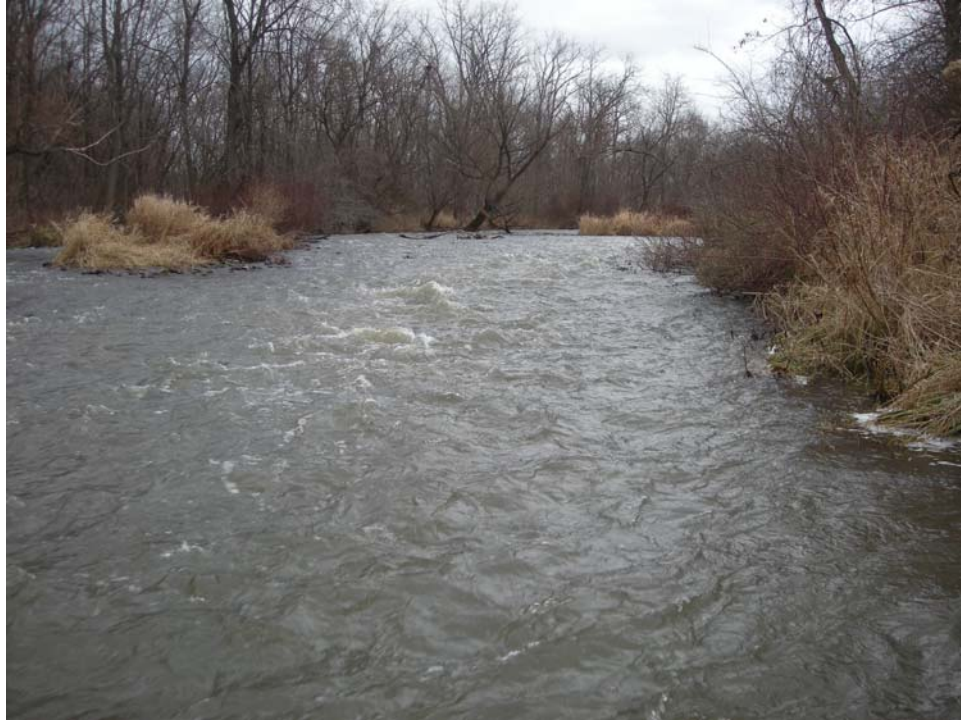
Photo: P70A

Description: At SED 15, upstream view.

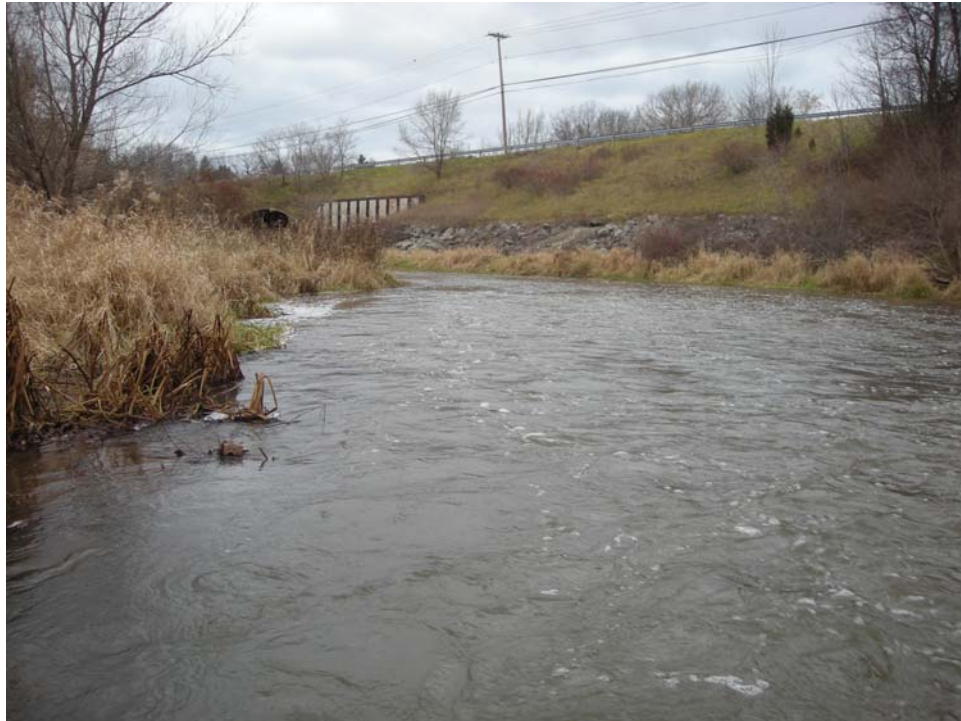
Photo: P71A

Description: At SED 15, downstream view.

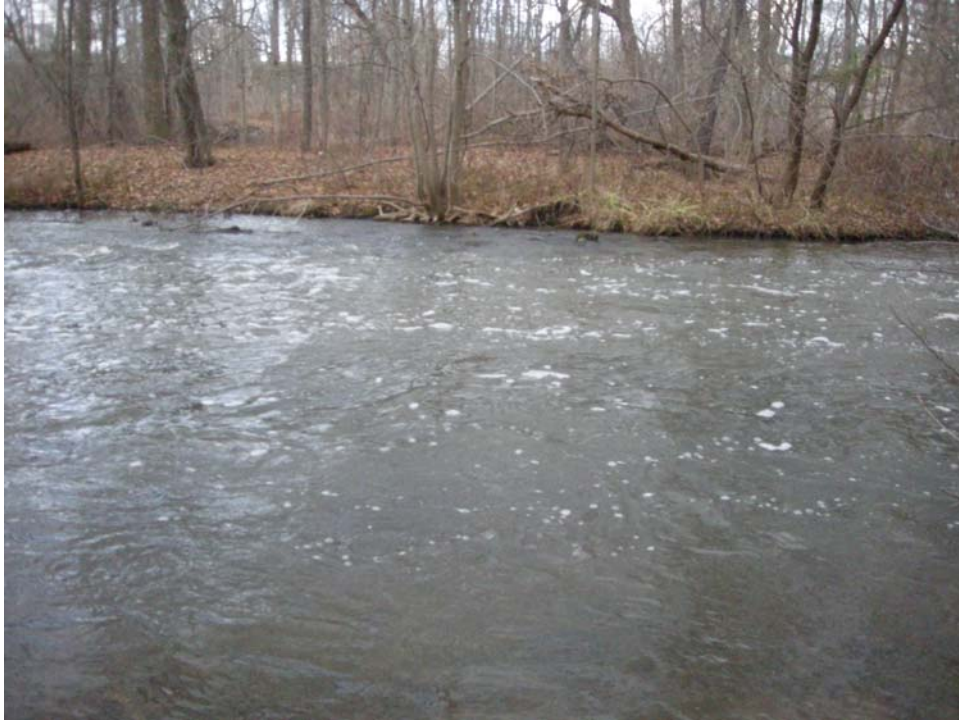
Photo: P76A

Description: View from LDB to RDB across left channel.

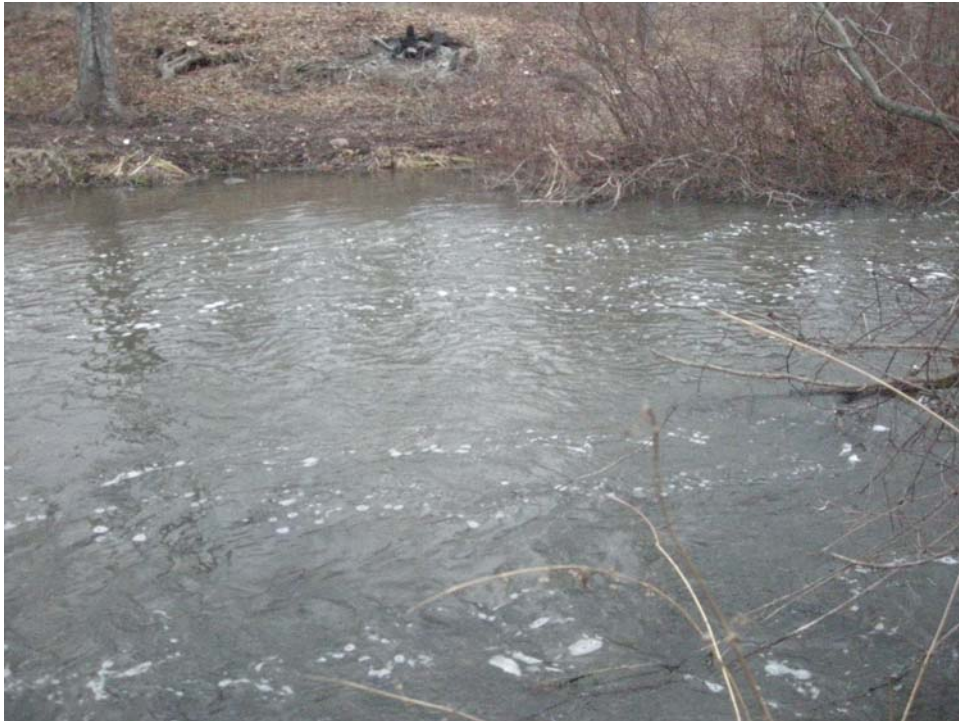
Photo: P77A

Description: View from LDB to RDB across right channel.
