# A

## Survey Figures

# B Survey Data Tables

**Table B-1 Sediment Thickness Points, Eighteenmile Creek, Niagara County, New York**

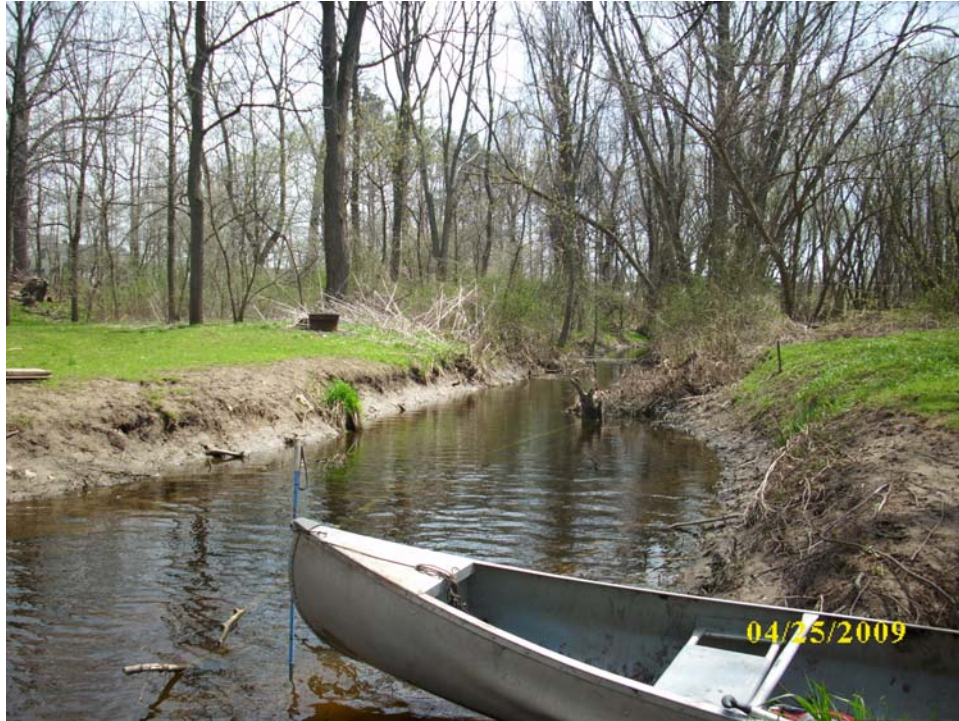
Photo: P115

Description: Tributary along RDB, wide at confluence (TRB-025).

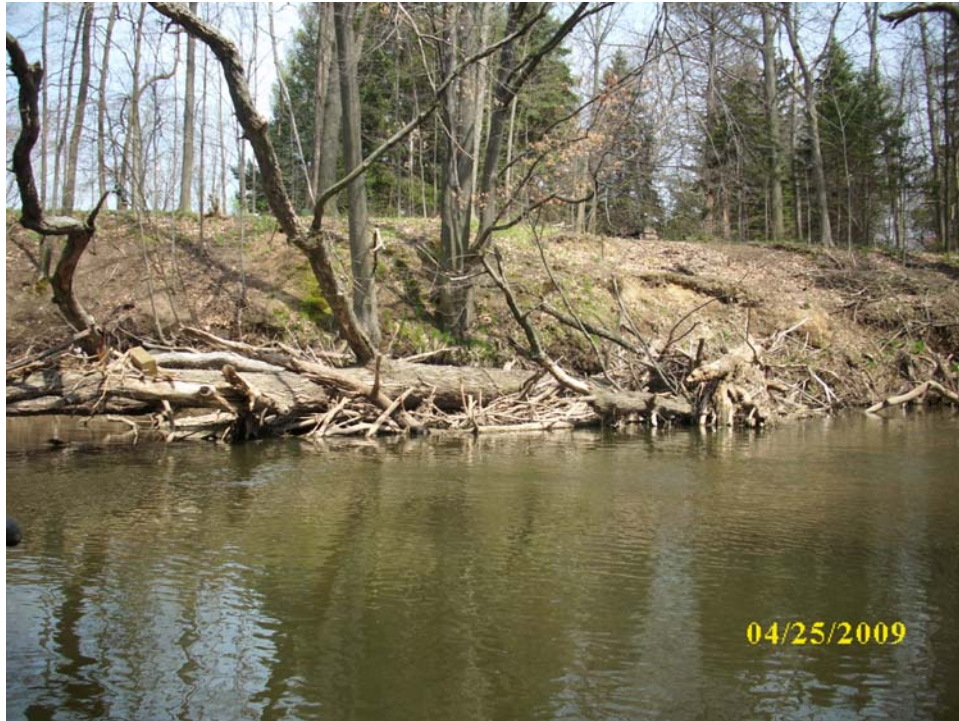
Photo: P116

Description: LWD obstruction that extends across half the creek (OBS-040).

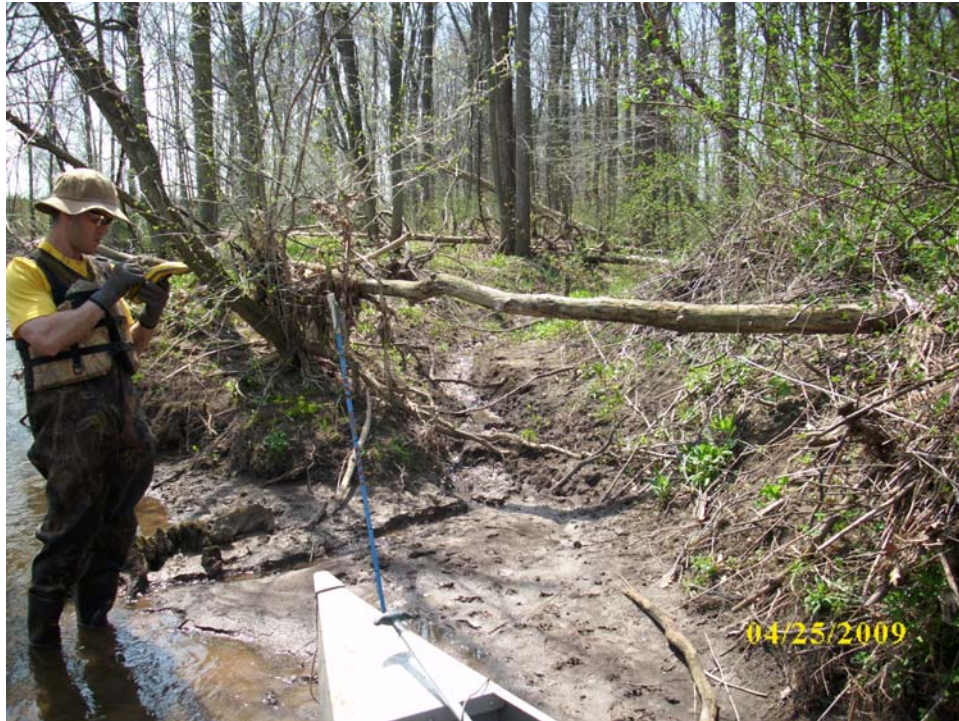
Photo: P118  
 Direction of view: SW  
 Description: Overland drainage with flow along LDB (DRN-043).

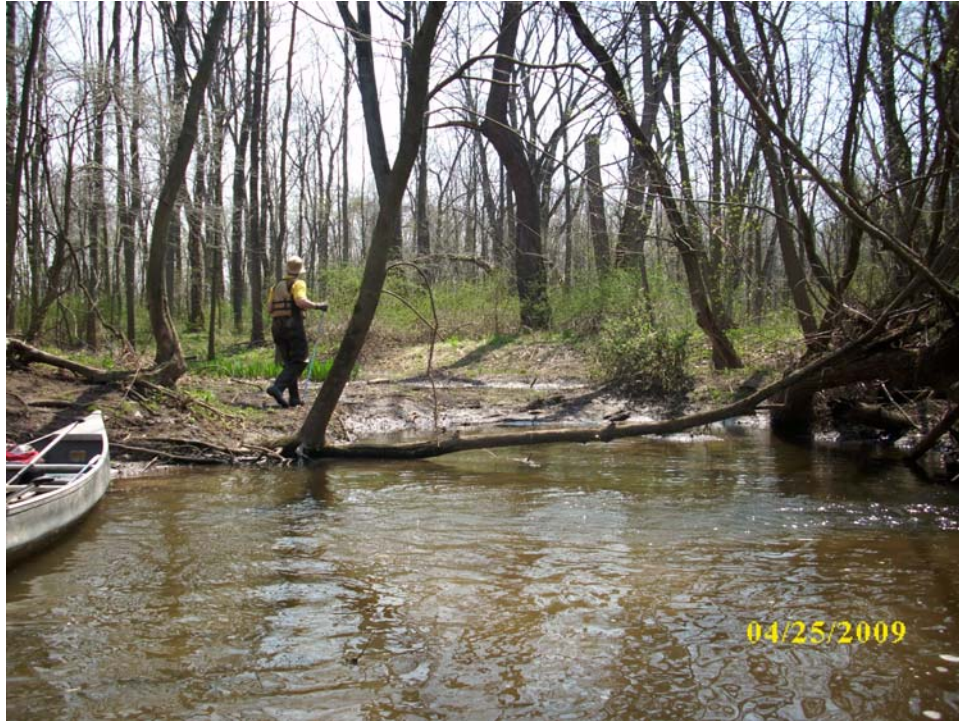
Photo: P119

Description: Wetland along RDB with drainage to the creek (WET-026).

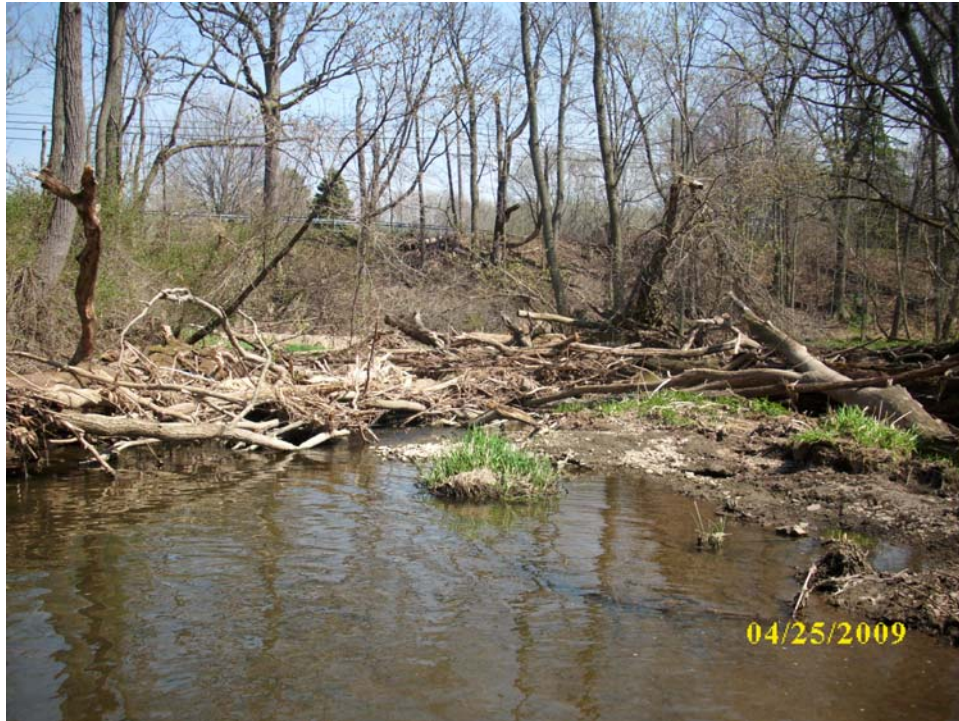
Photo: P66

Description: Where creek splits, forming secondary channel along Route 78 (OTH-037).

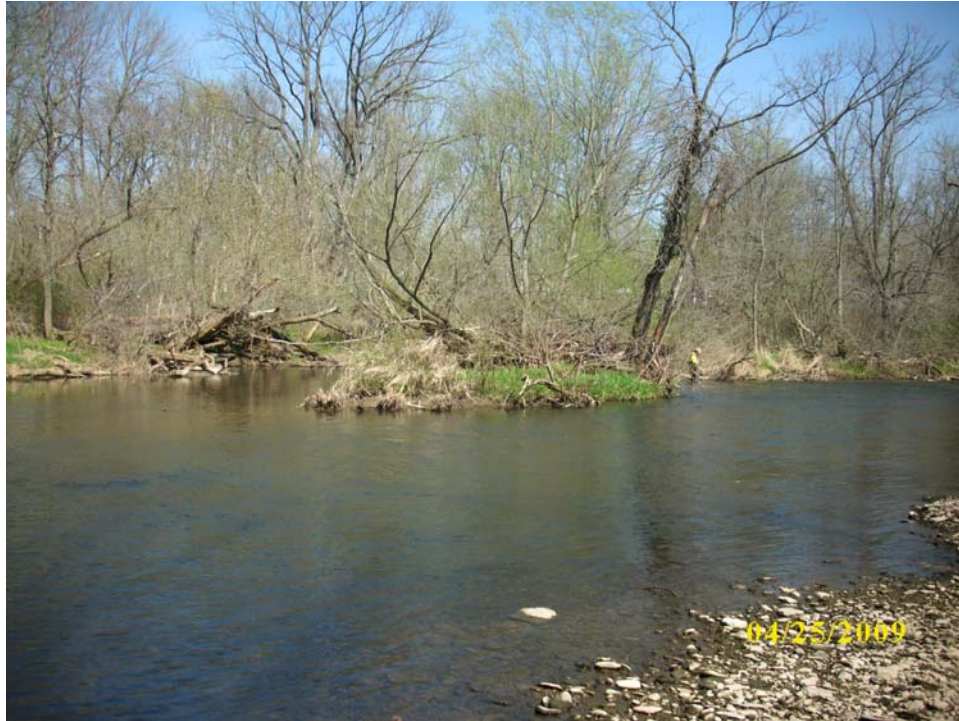
Photo: P120

Description: At downstream end of split where creek rejoins itself (OTH-040).

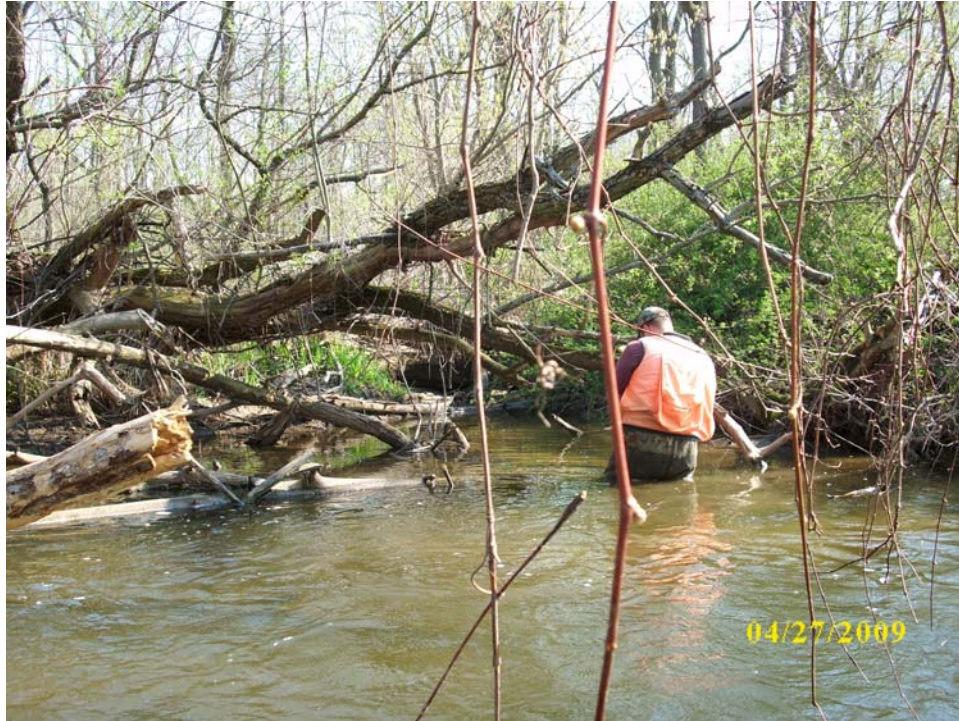
Photo: P121

Description: Small ponded area along RDB with drainage to creek (DRN-045).

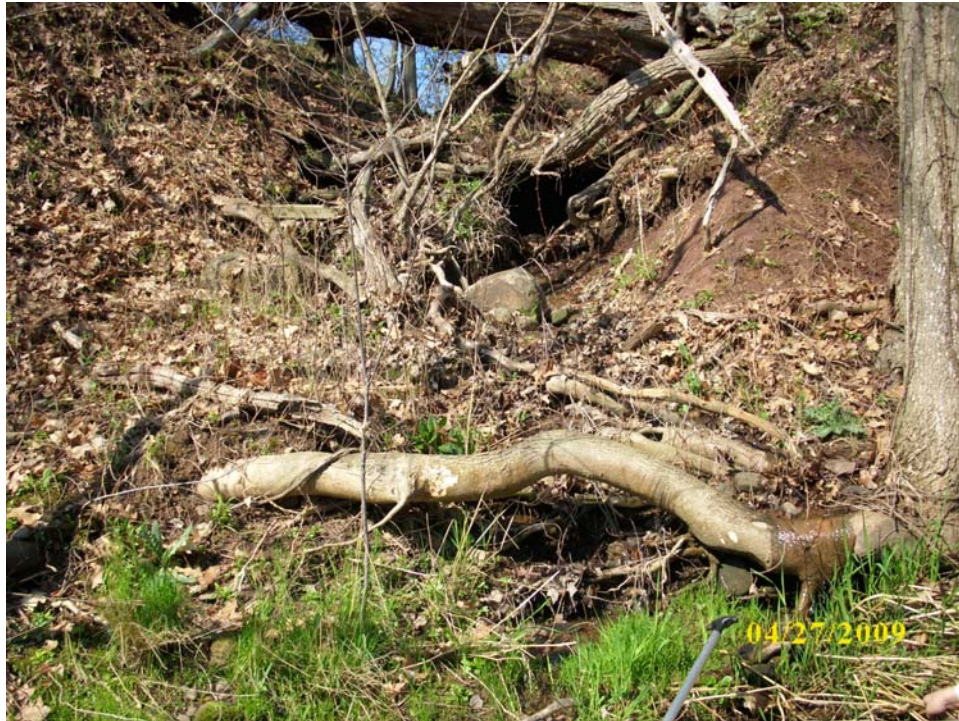
Photo: P122

Description: Run-off along LDB with flow (DRN-046).

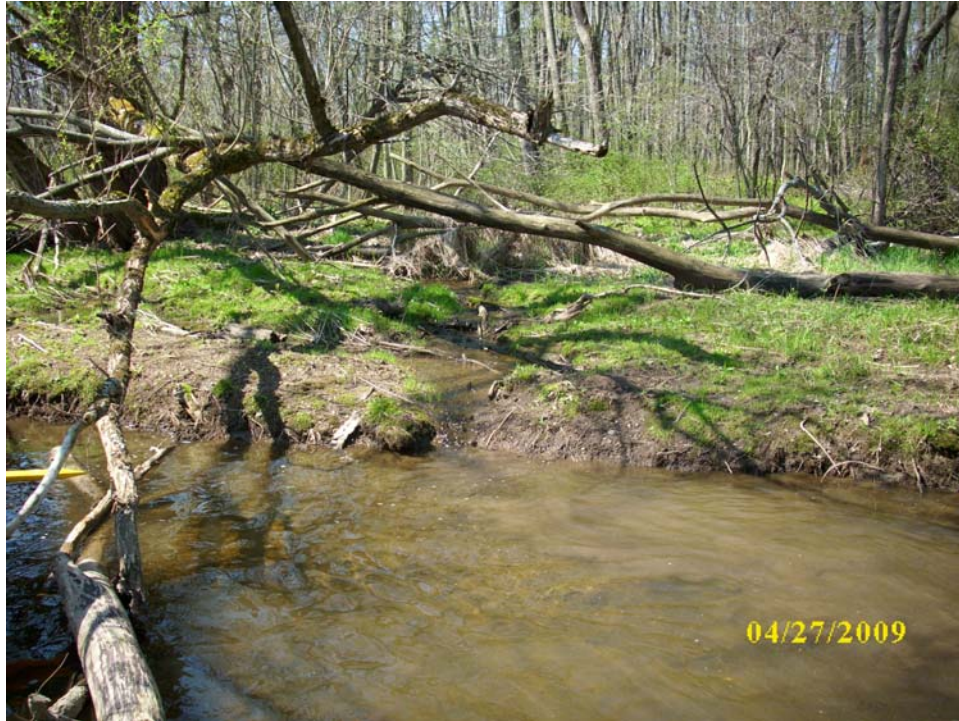
Photo: P126

Description: Floodplain with drainage to creek (DRN-048).

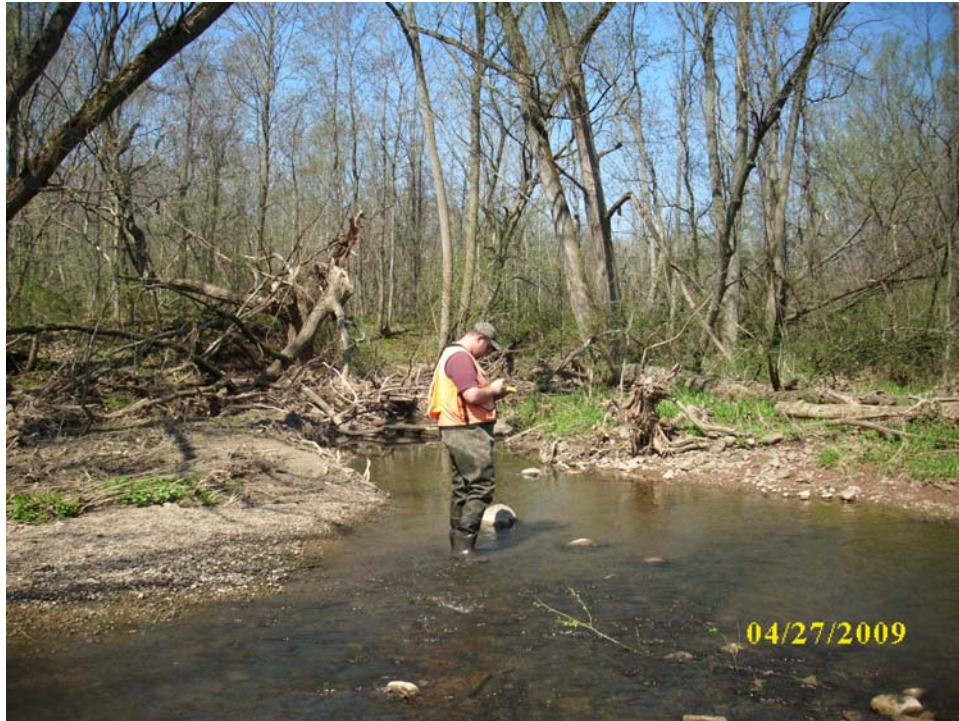
Photo: P127

Description: Start of side channel along LDB (OTH-042).

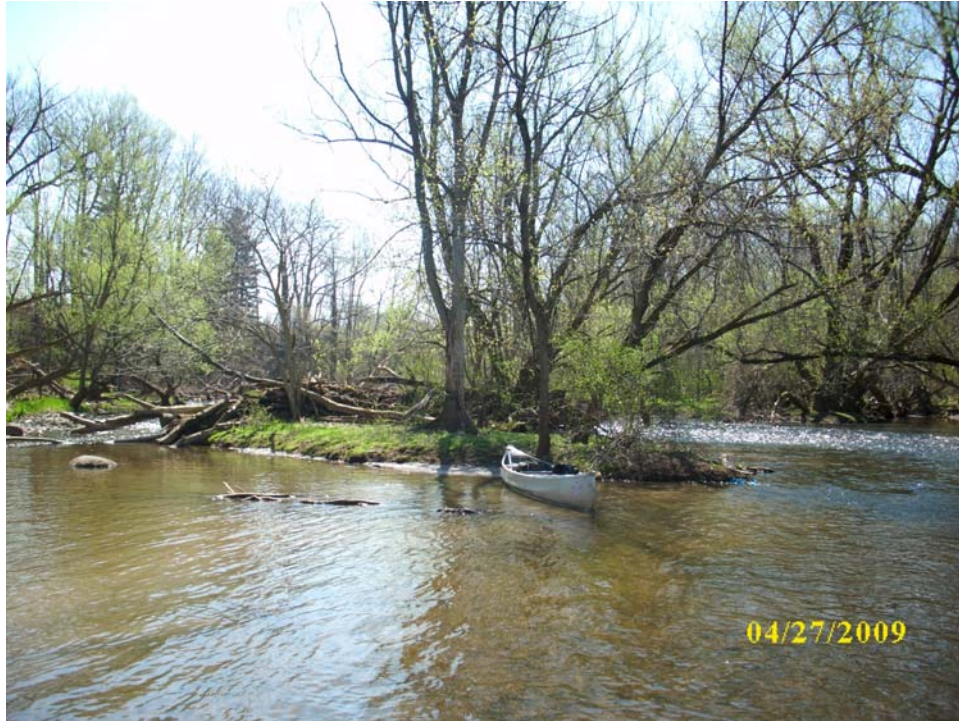
Photo: P70

Description: Standing at SED113, view of upstream at channel split.

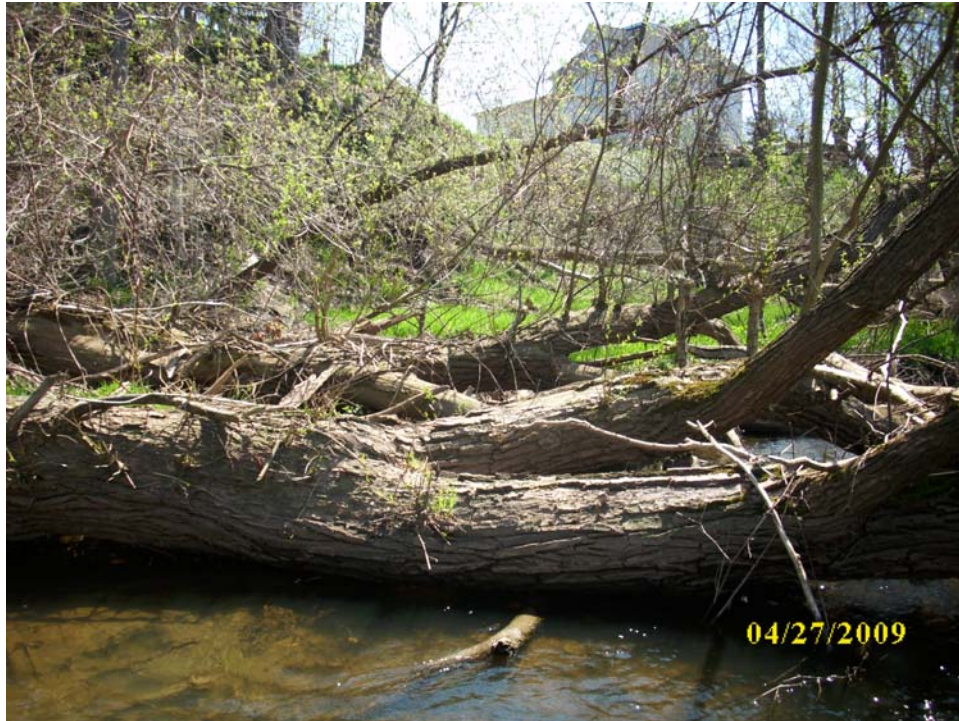
Photo: P71

Description: Wetland area behind fallen trees with possible drainage to creek.

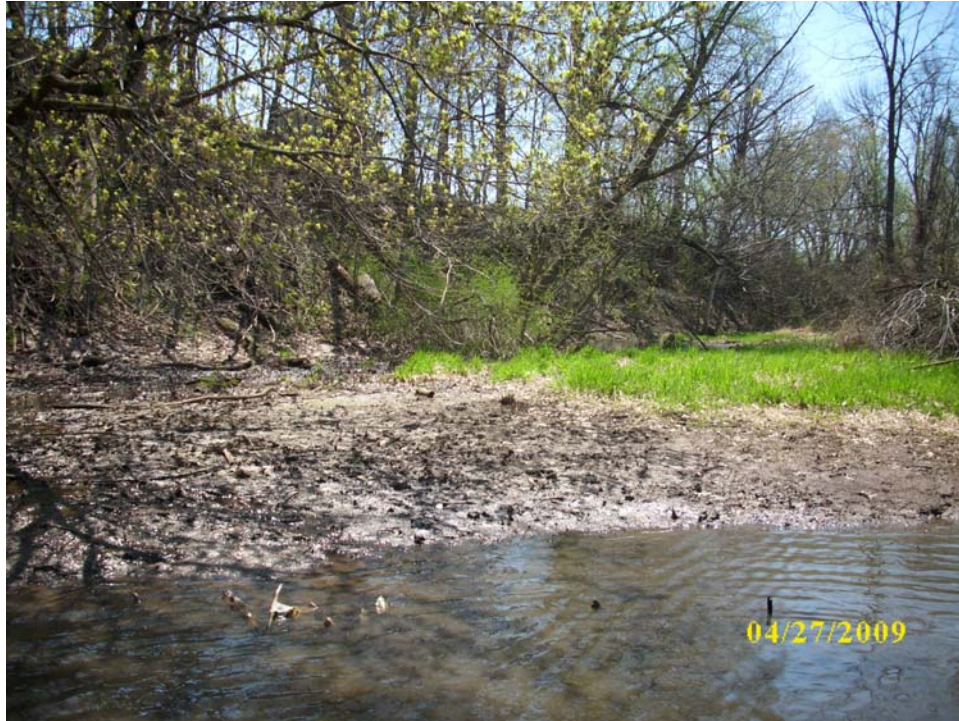
Photo: P74

Description: At SED 117, exposed mudflat and wetland with drainage to creek (DRN-049).

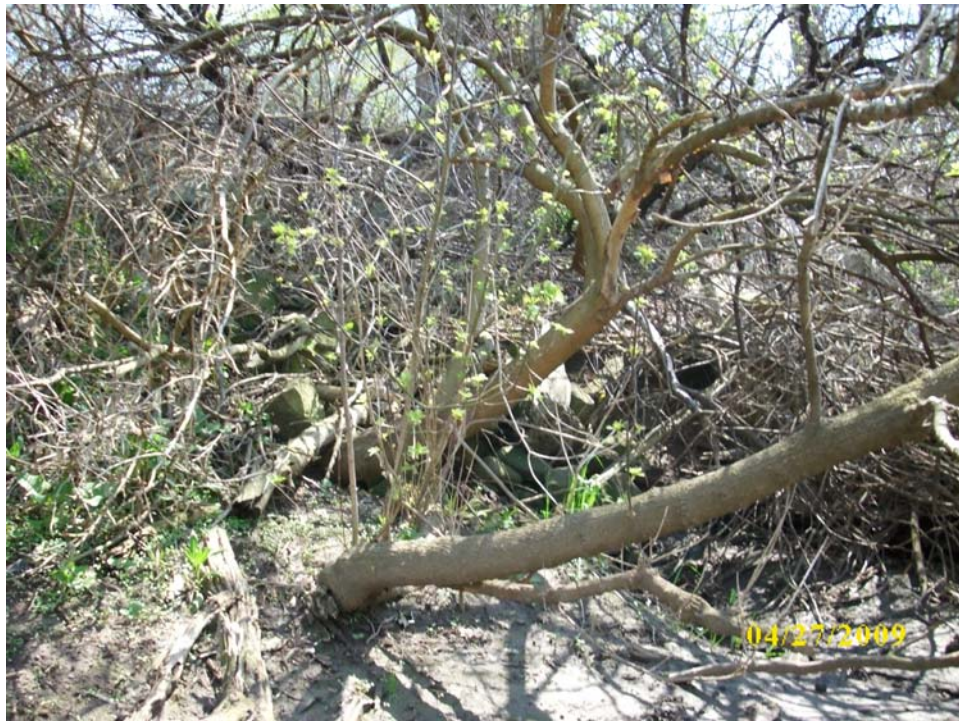
Photo: P128

Description: Rocky swale along RDB (DRN-050).

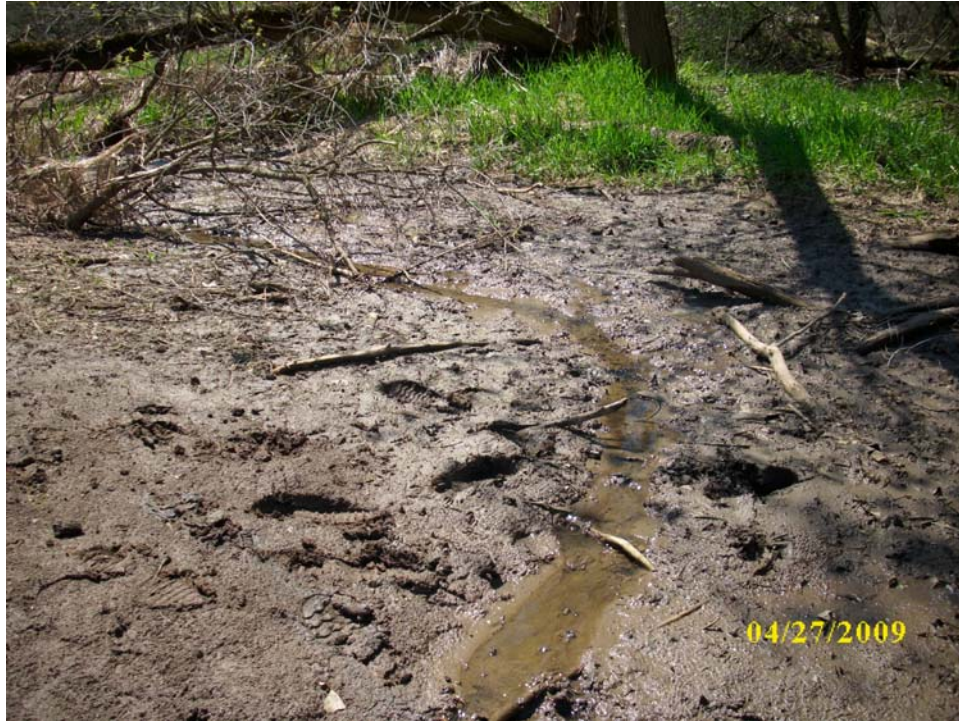
Photo: P75

Description: Wetland with drainage along LDB (DRN-051).

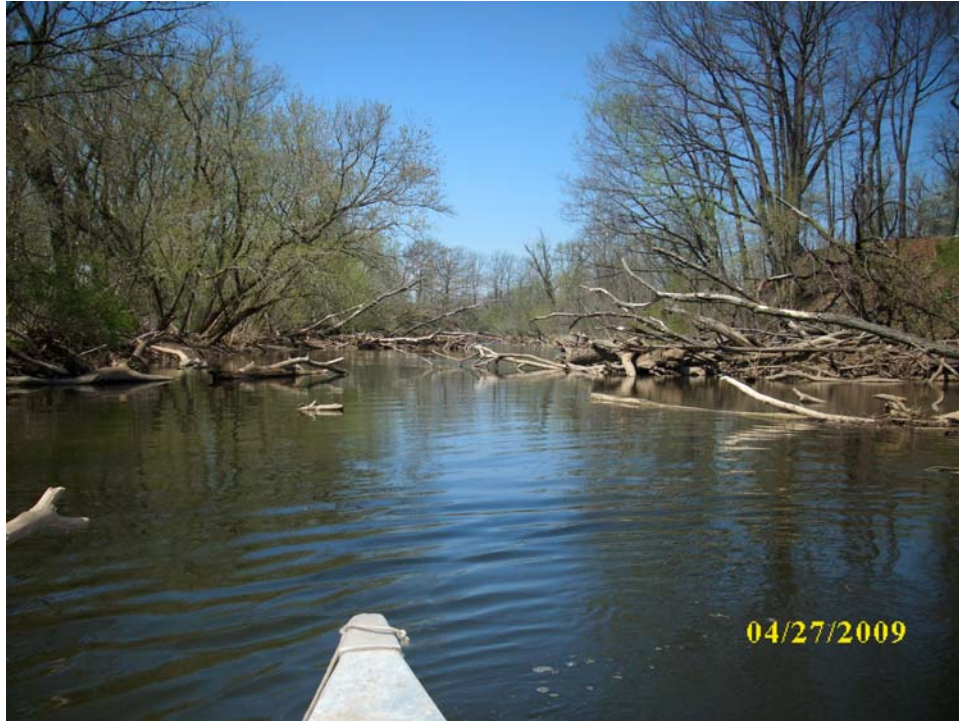
Photo: P77

Direction of view: NE

Description: Downstream view of LWD obstructions across creek (OBS-042).

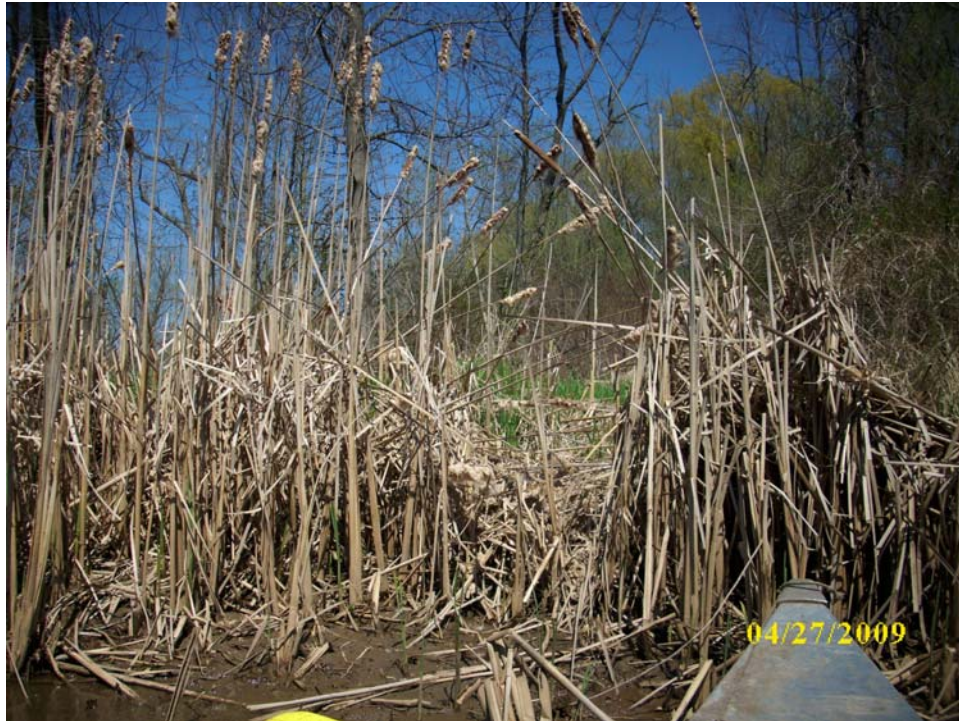
Photo: P129

Direction of view: NE

Description: Cattails along RDB.

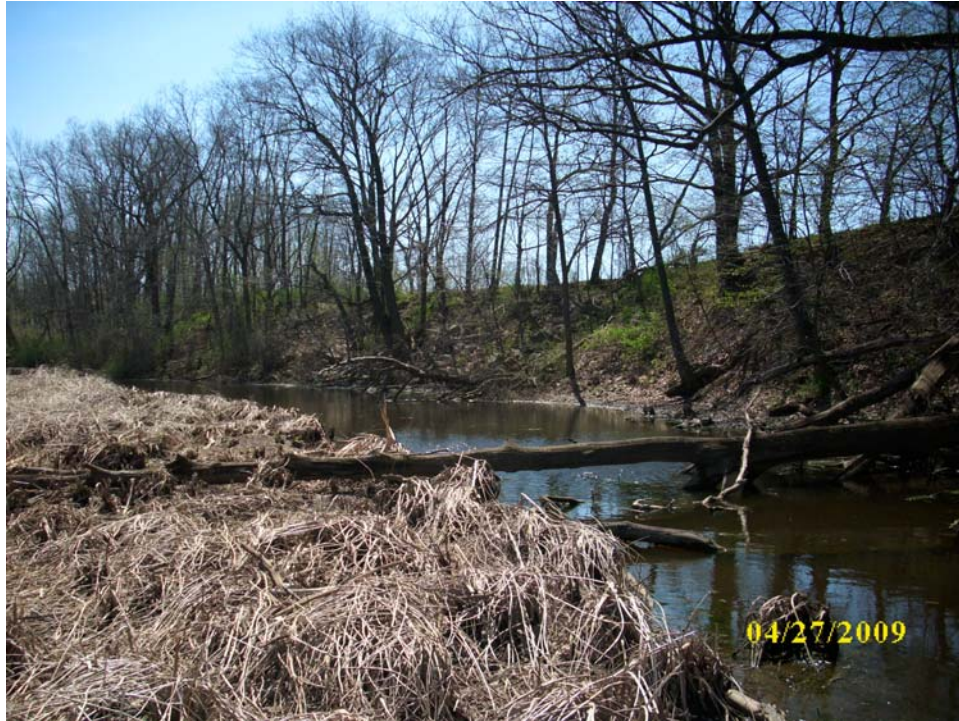
Photo: P78  
 Direction of view: SW  
 Description: Mapped tributary (OTH-043).

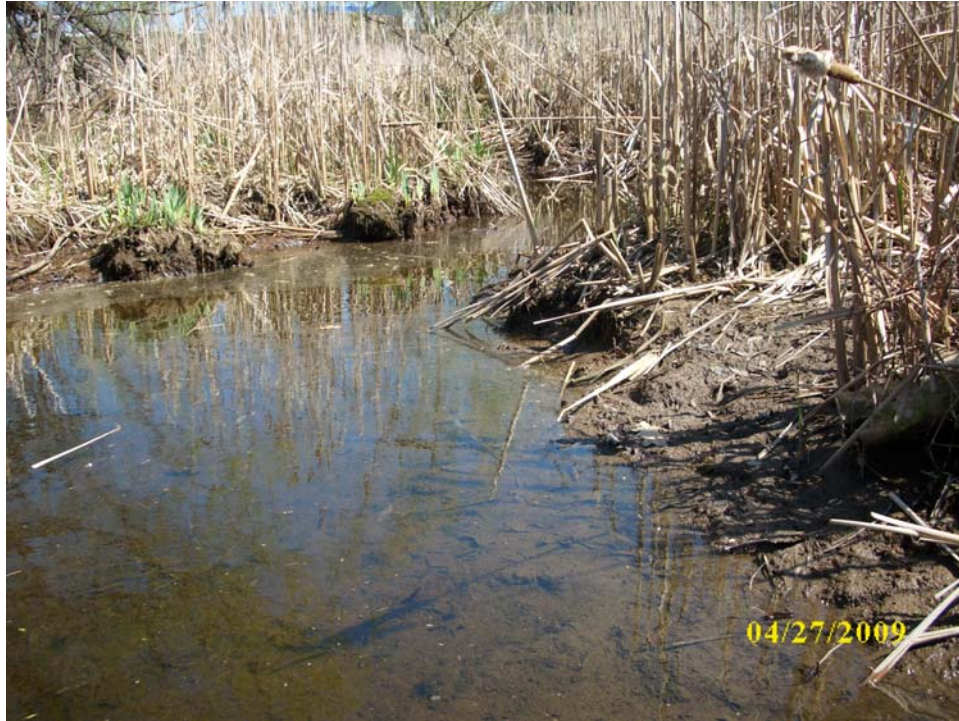
Photo: P131

Direction of view: SE

Description: Tributary in cattails along RDB, possible roadside drainage also (TRB-026).

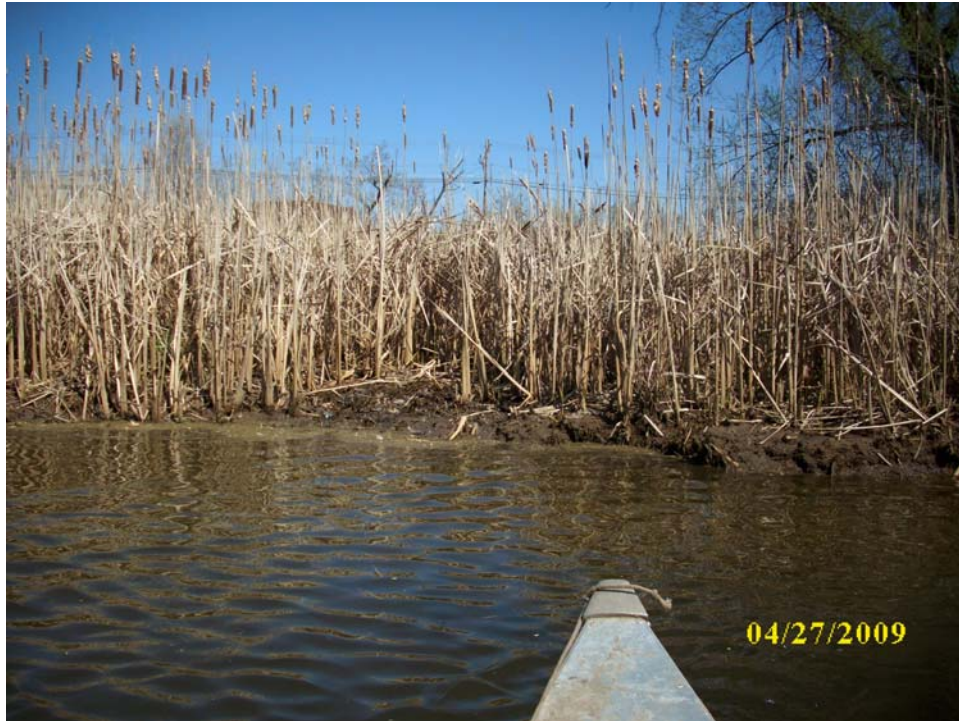
Photo: P79

Direction of view: SE

Description: Overland drainage from cattail marsh along RDB.

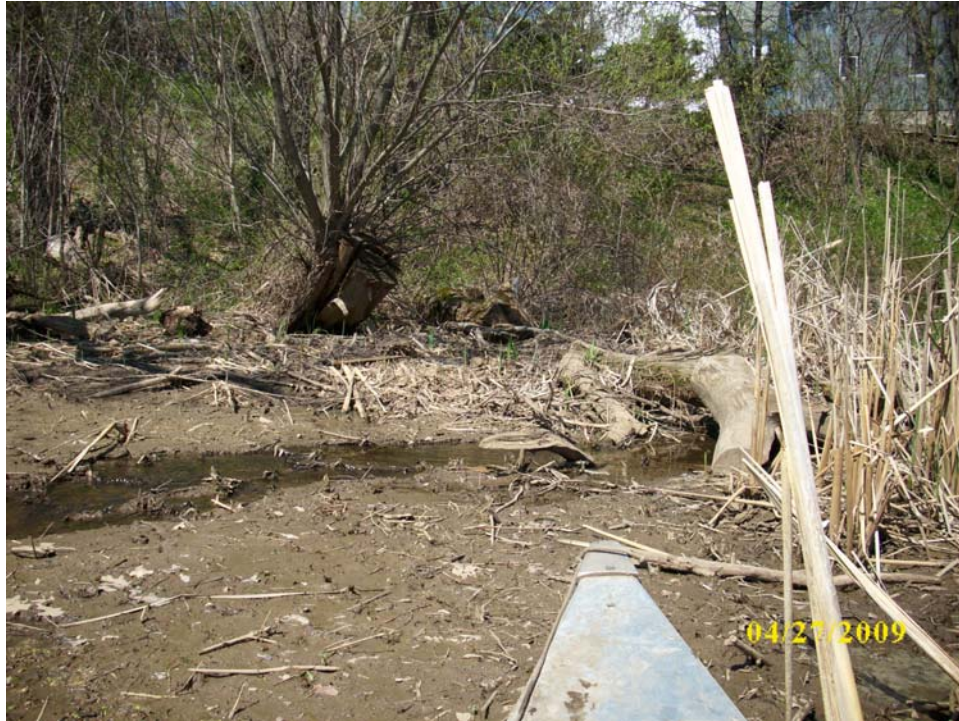
Photo: P132

Direction of view: NE

Description: End of cattail marsh with flow into creek along RDB.

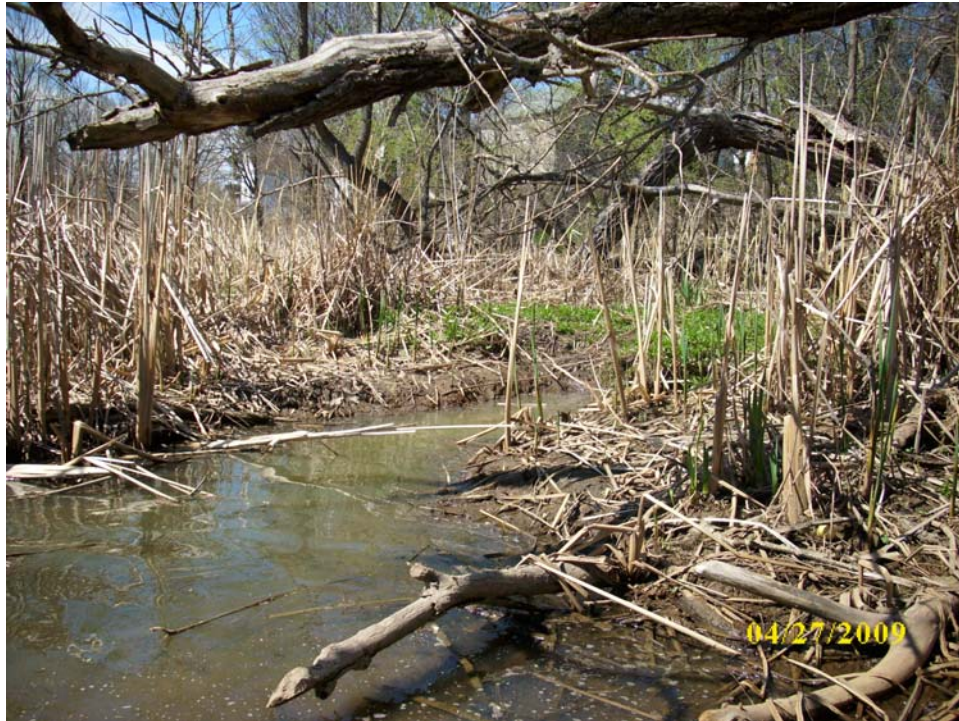
Photo: P133

Direction of view: N

Description: Start point of cattail marsh, small inlet area.

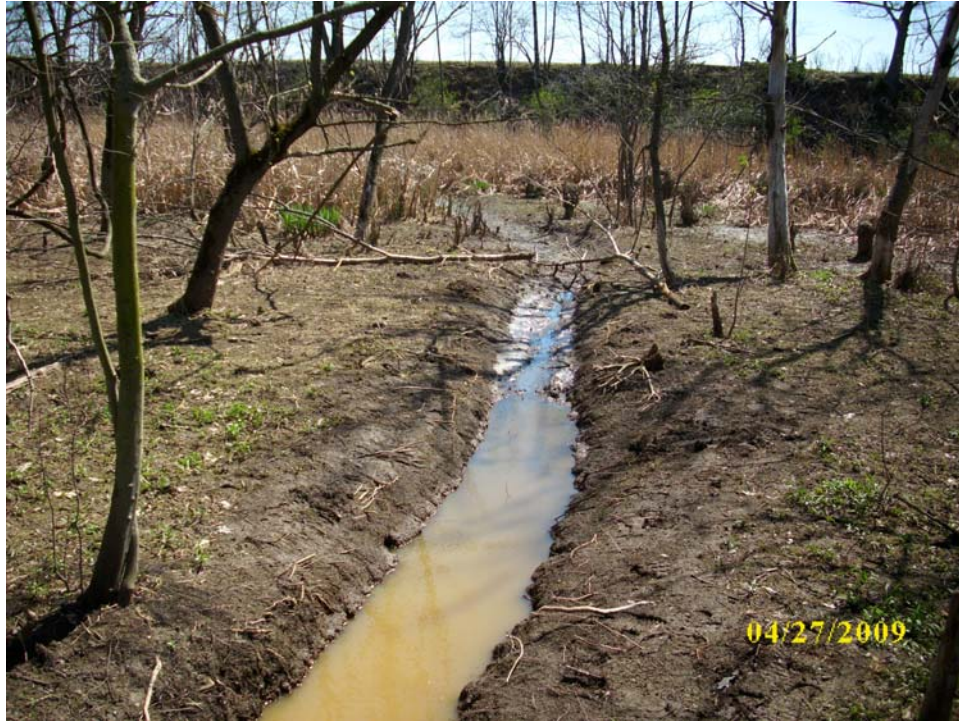
Photo: P134

Direction of view: SW

Description: Maintained drainage to creek along LDB (DRN-052).

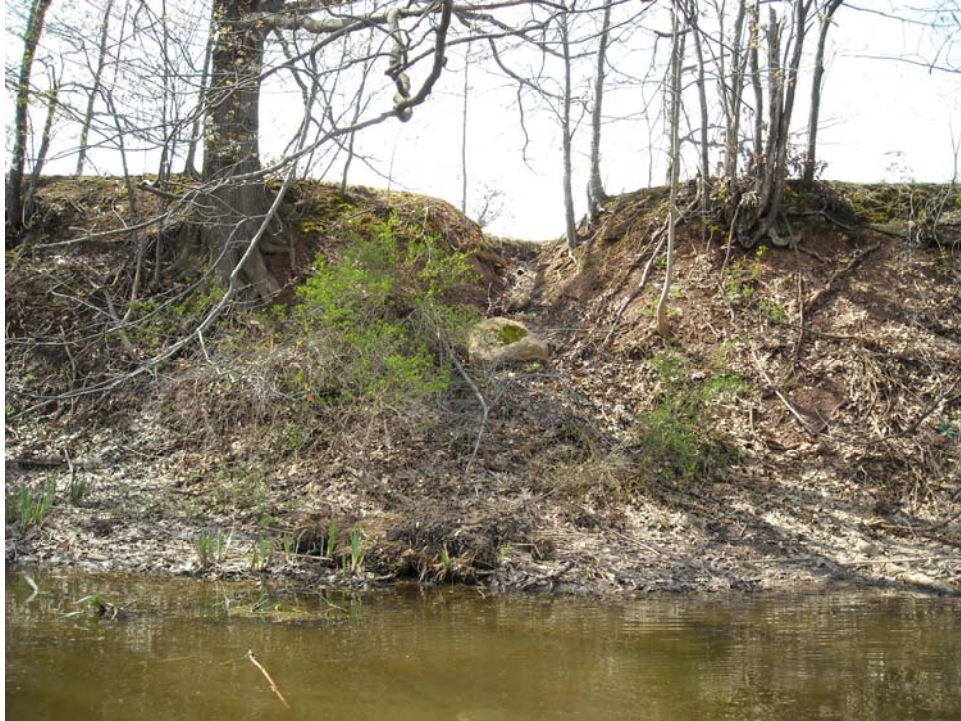
Photo: P81

Direction of view: SW

Description: Incised drainage from up-gradient area (DRN-053).

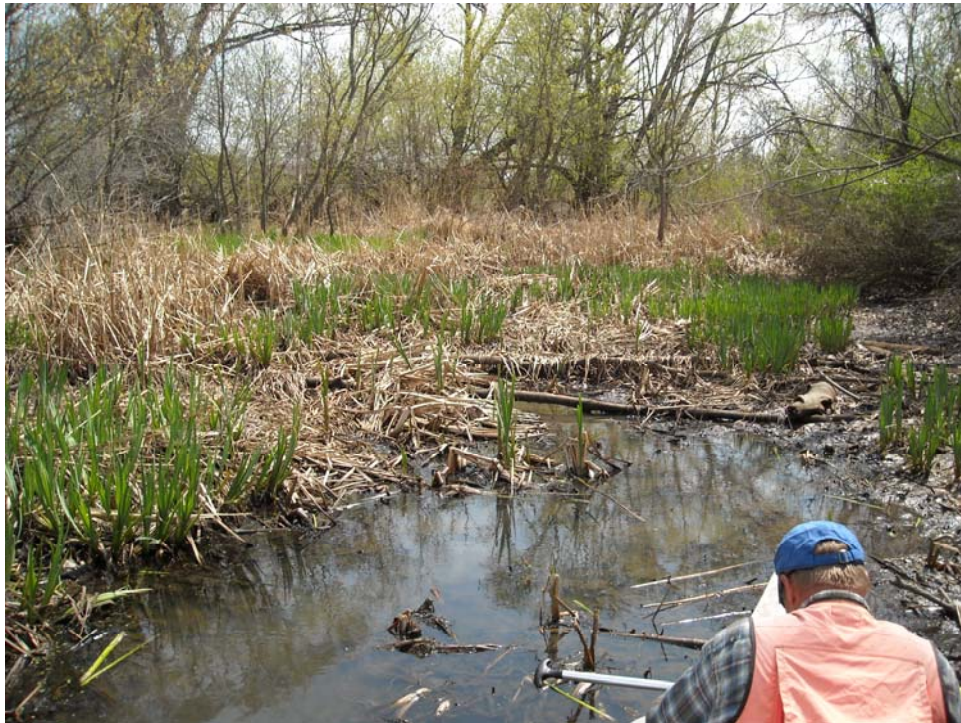
Photo: P82

Direction of view: SE

Description: Terminus of tributary to main channel.

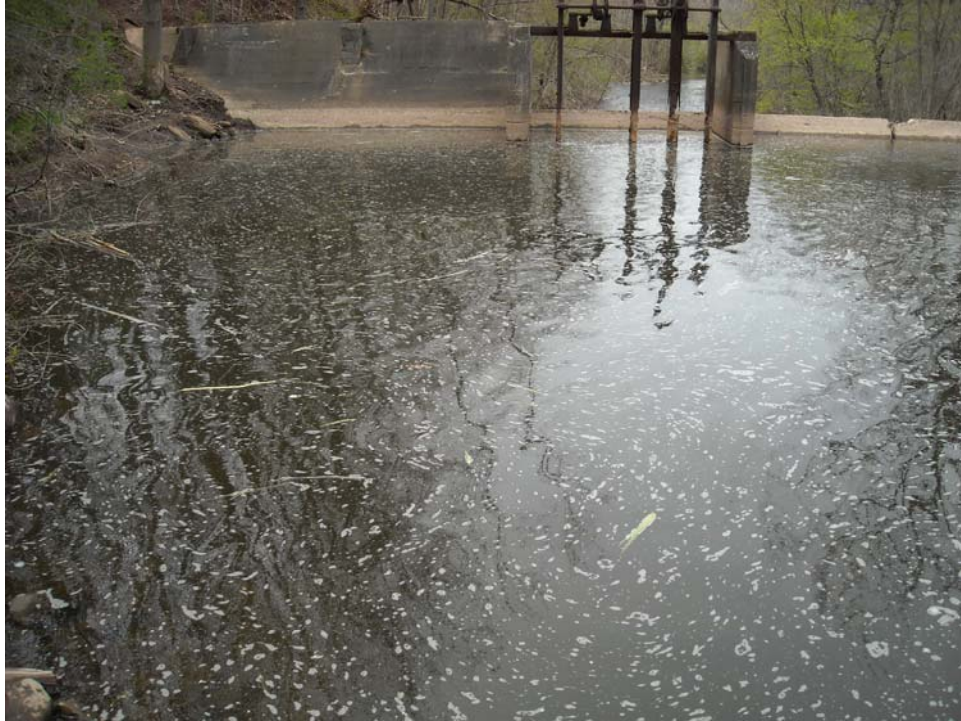
Photo: P83

Direction of view: W

Description: Wooden breaker structure at upstream end of Newfane Dam.

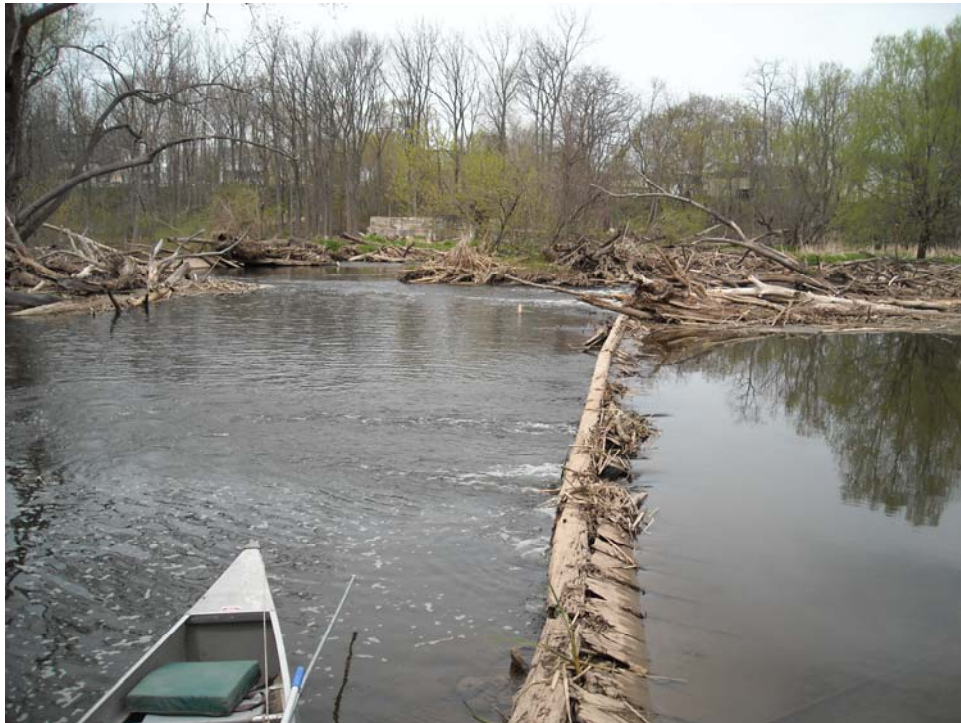
Photo: P84

Direction of view: N

Description: Wooden breaker structure immediately upstream of Newfane Dam.

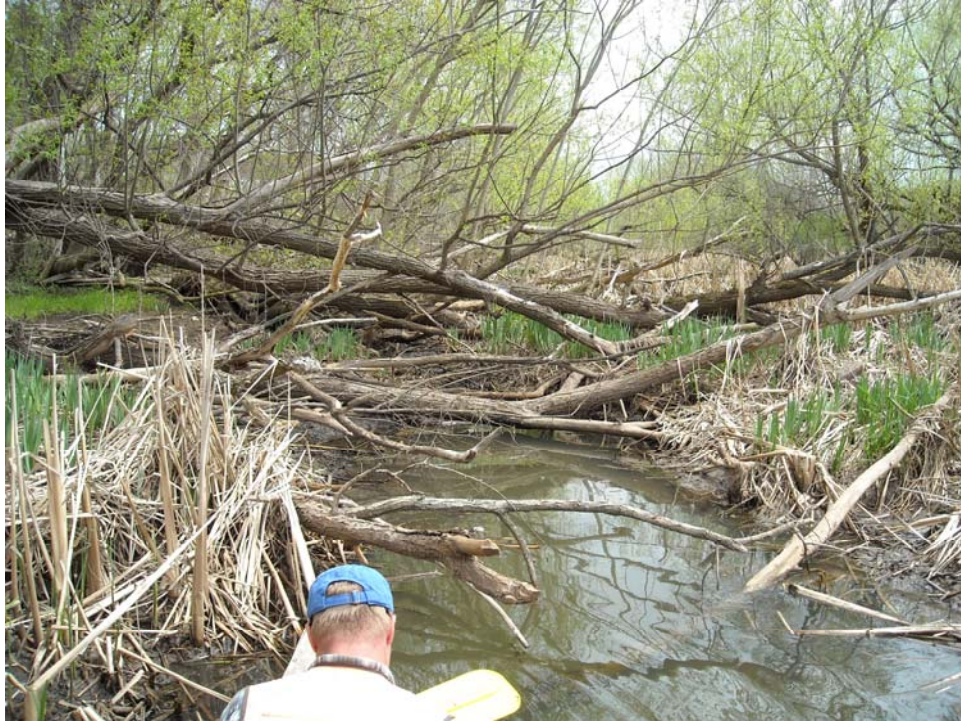
Photo: P85

Direction of view: SE

Description: Terminus of tributary.

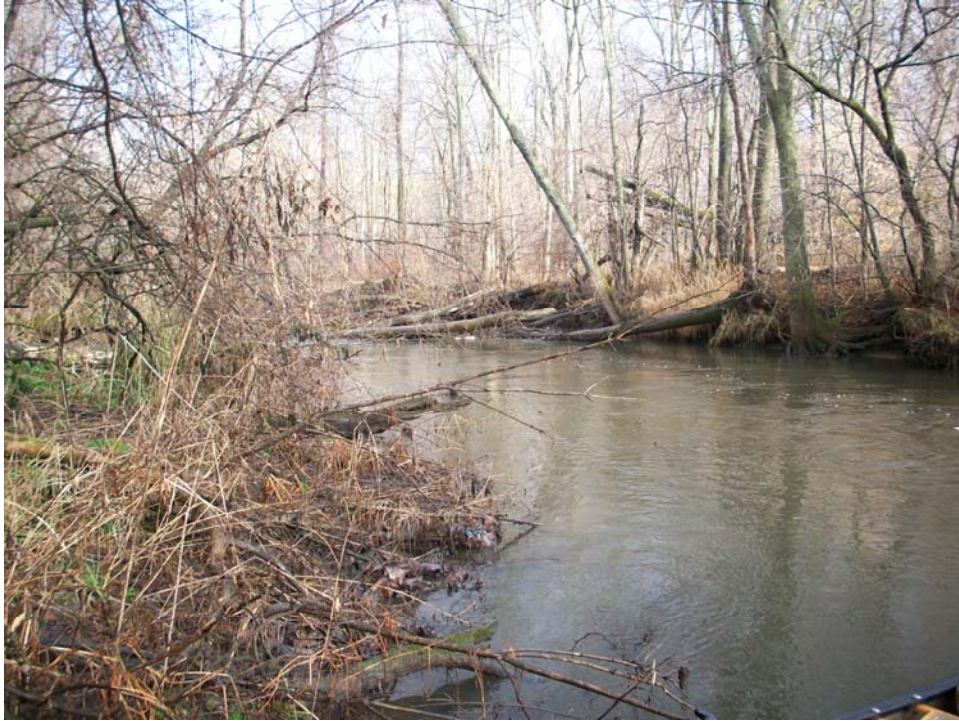
Photo: P01

Description: View of downstream, general creek view.

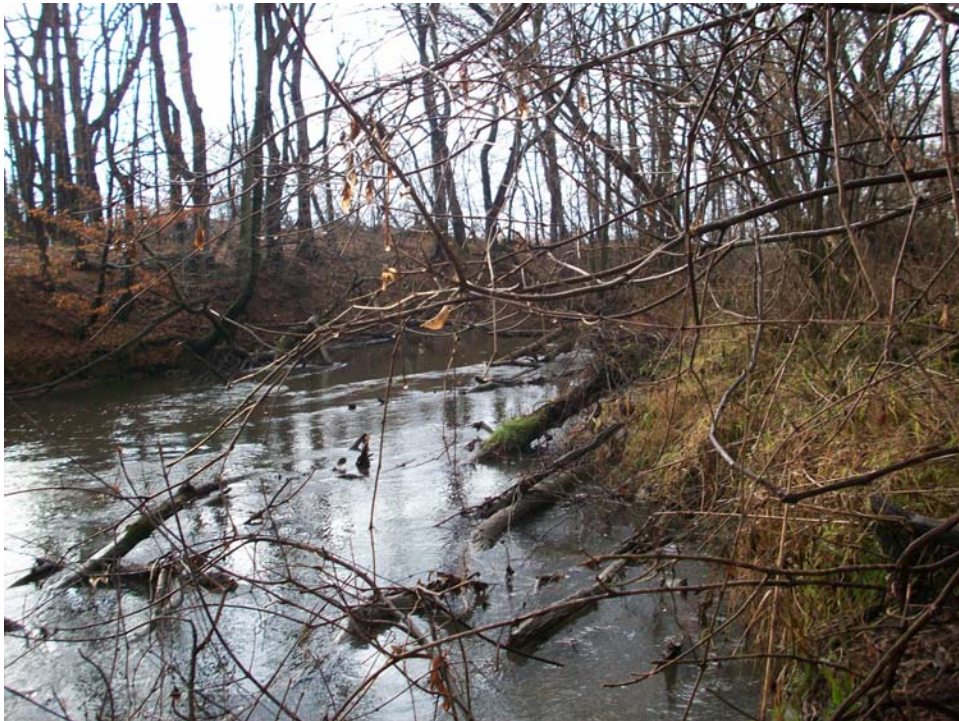
Photo: P02

Description: Few fallen trees along RDB.

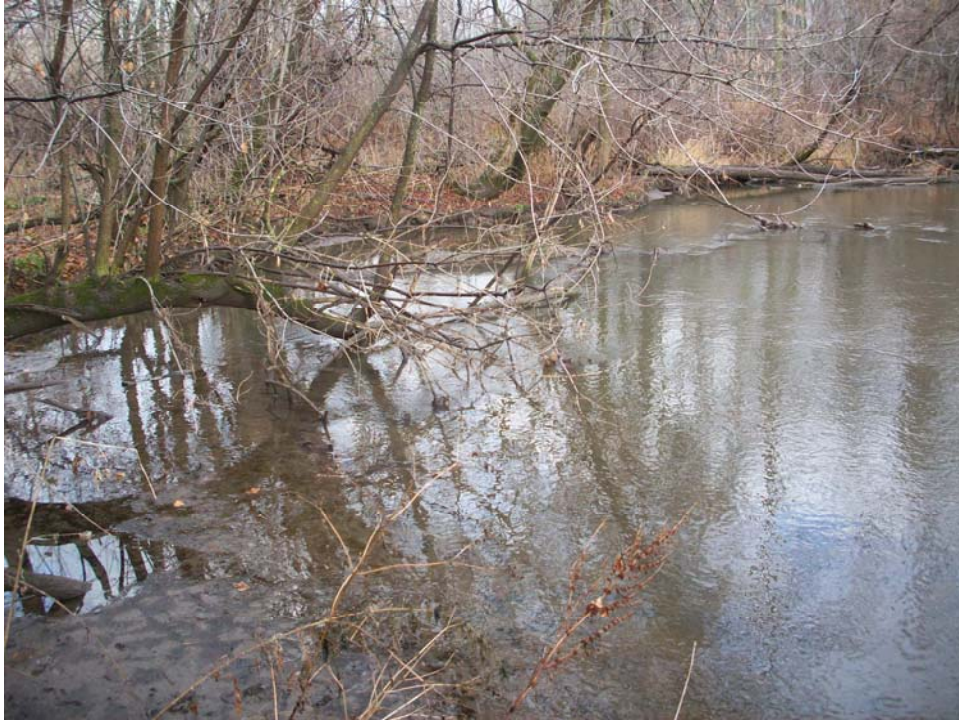
Photo: P03

Description: Gooseneck.

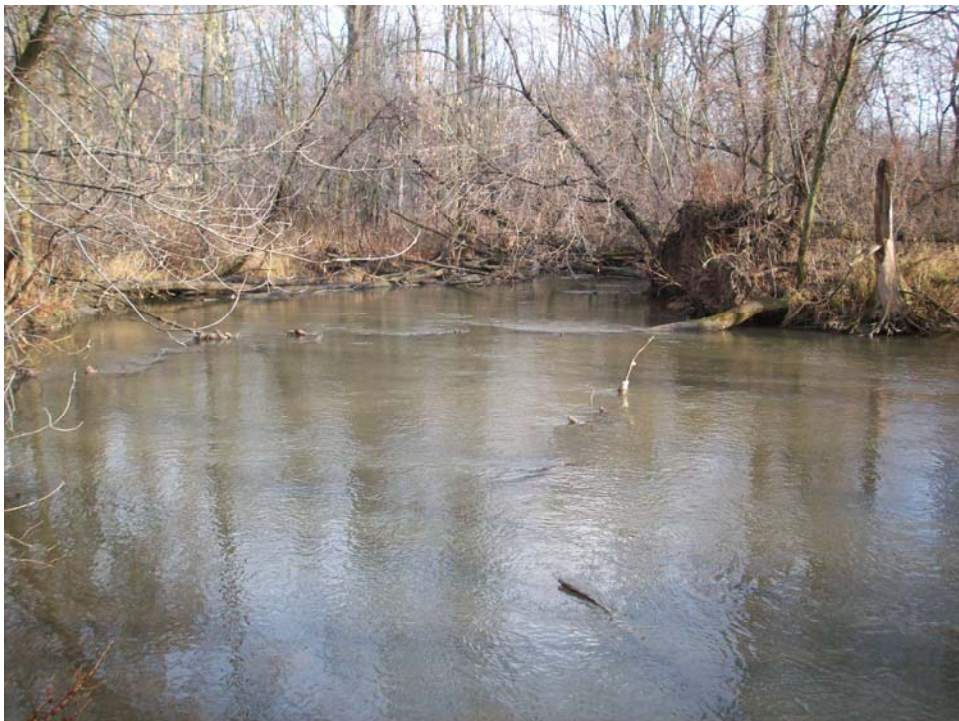
Photo: P04

Description: Gooseneck.
