# A

## Survey Figures

# B Survey Data Tables

**Table B-1 Sediment Thickness Points, Eighteenmile Creek, Niagara County, New York**

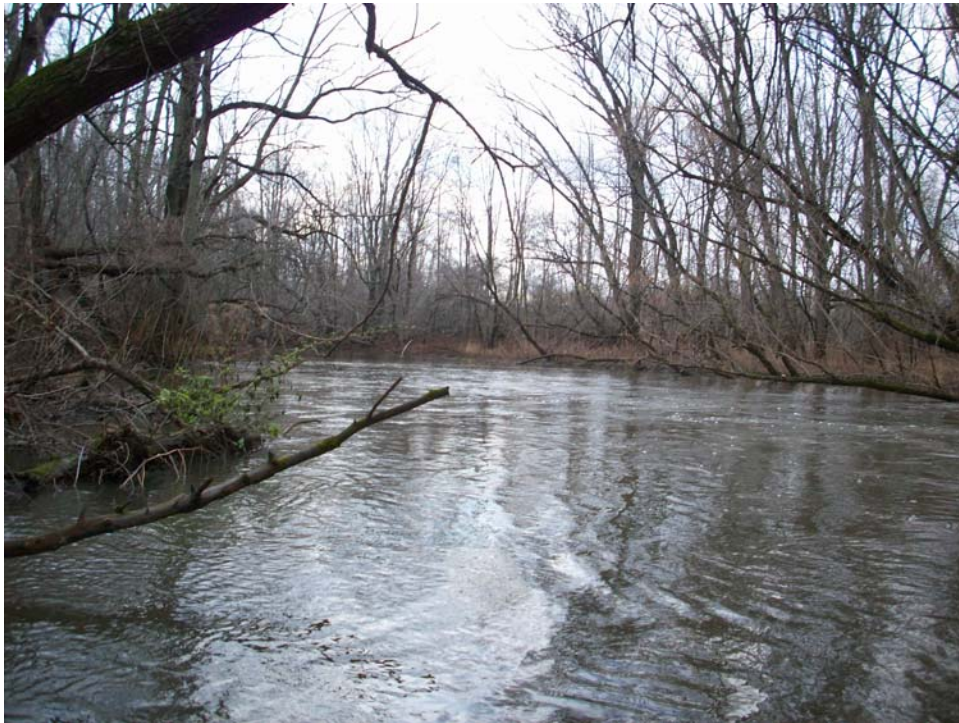
Photo: P07

Description: Farther downstream from farm bridge.

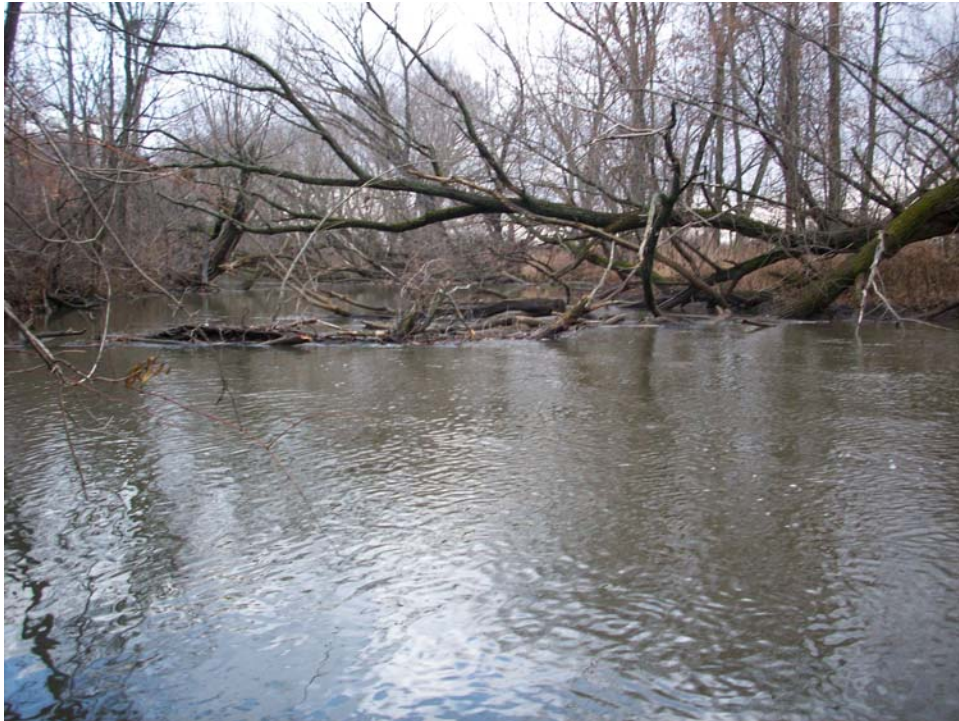
Photo: P08

Description: LWD obstruction across creek.

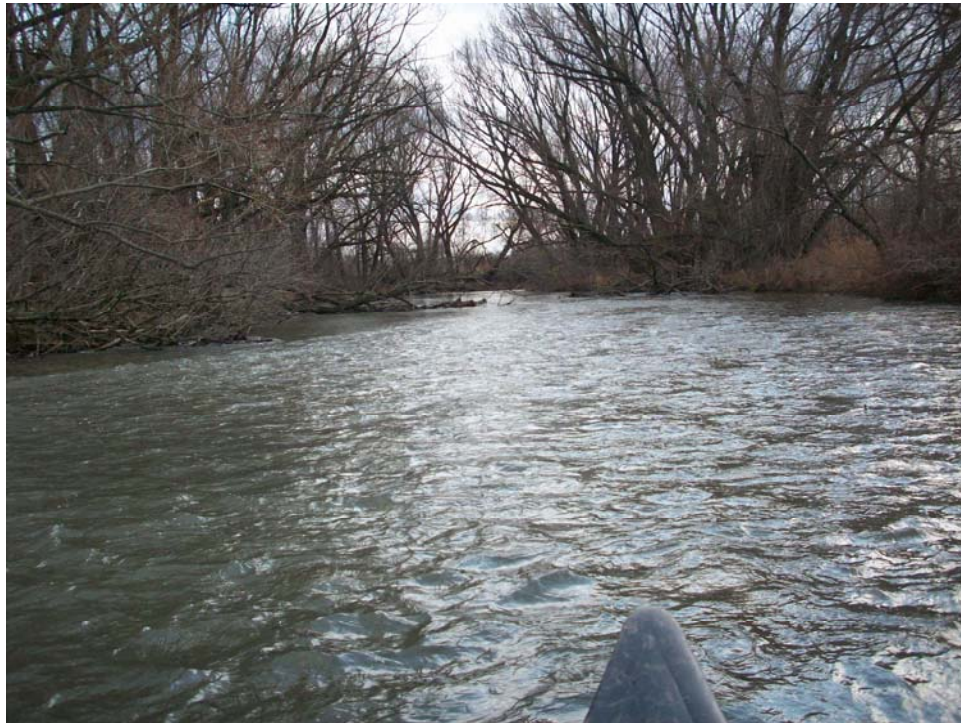
Photo: P09

Description: LWD obstruction across creek.

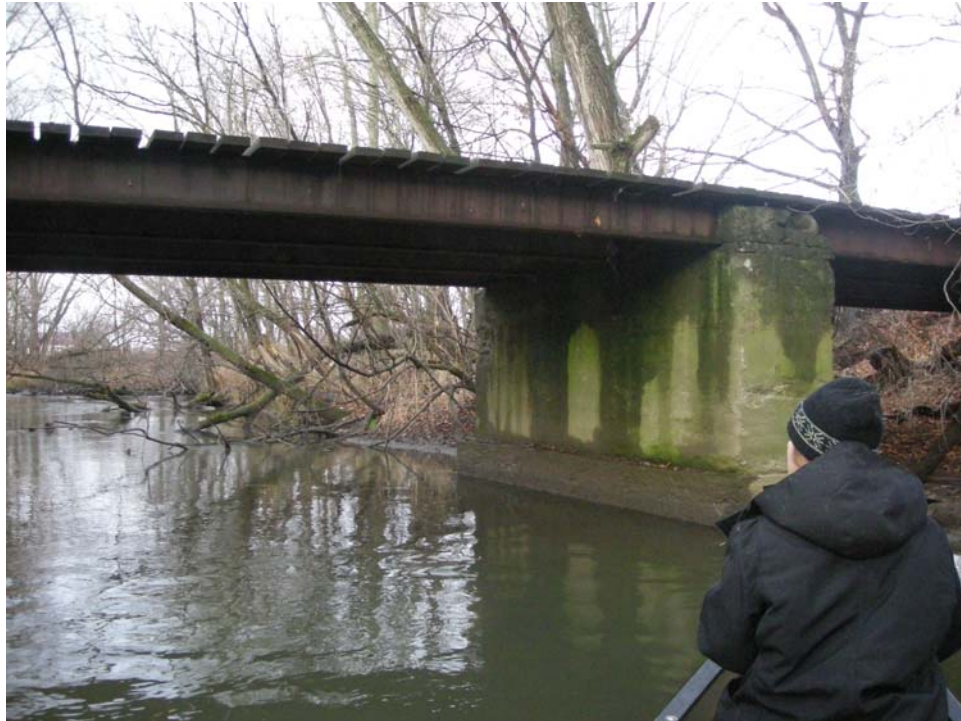
Photo: P21A

Direction of view: SW

Description: Farm bridge #1 from LDB.

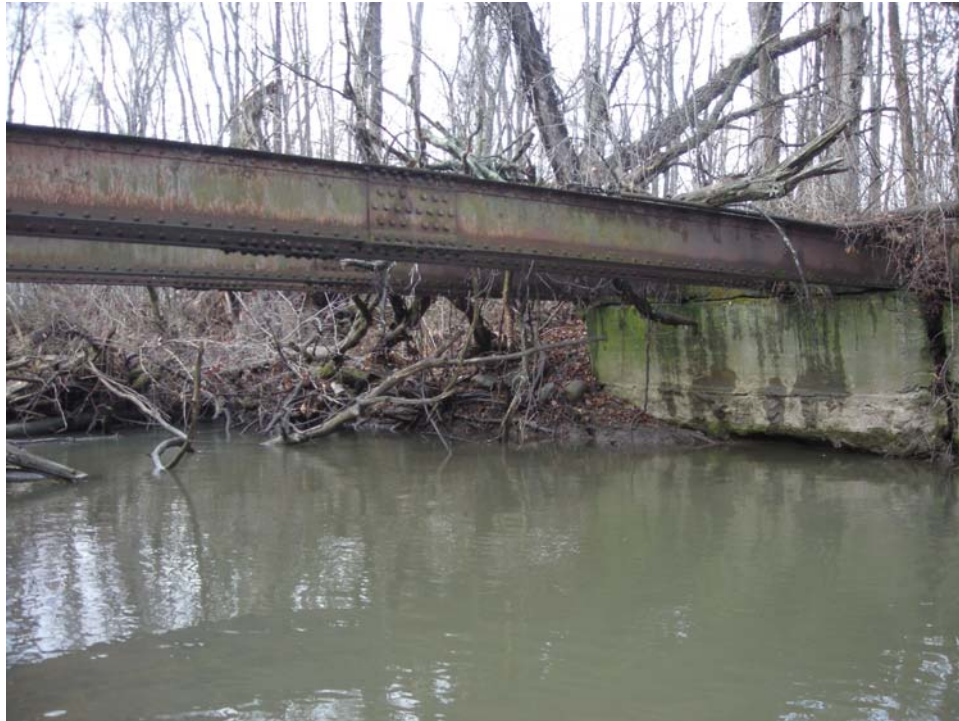
Photo: P25A  
 Direction of view: SW  
 Description: Farm bridge #2 from LDB.

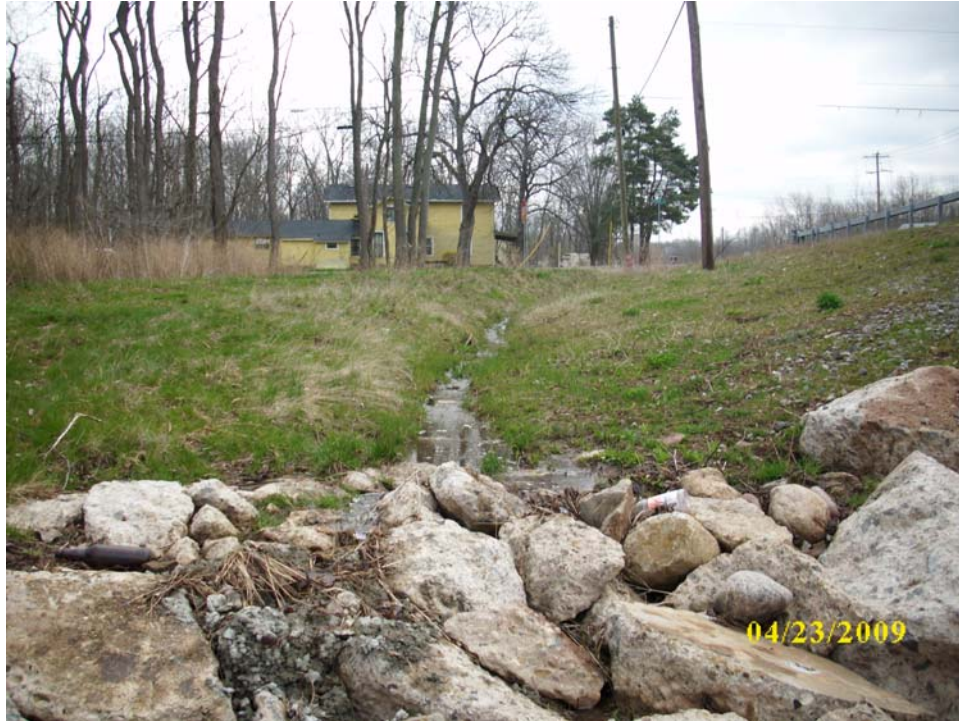
Photo: P20

Direction of view: E

Description: Roadside drainage along RDB (DRN-020).

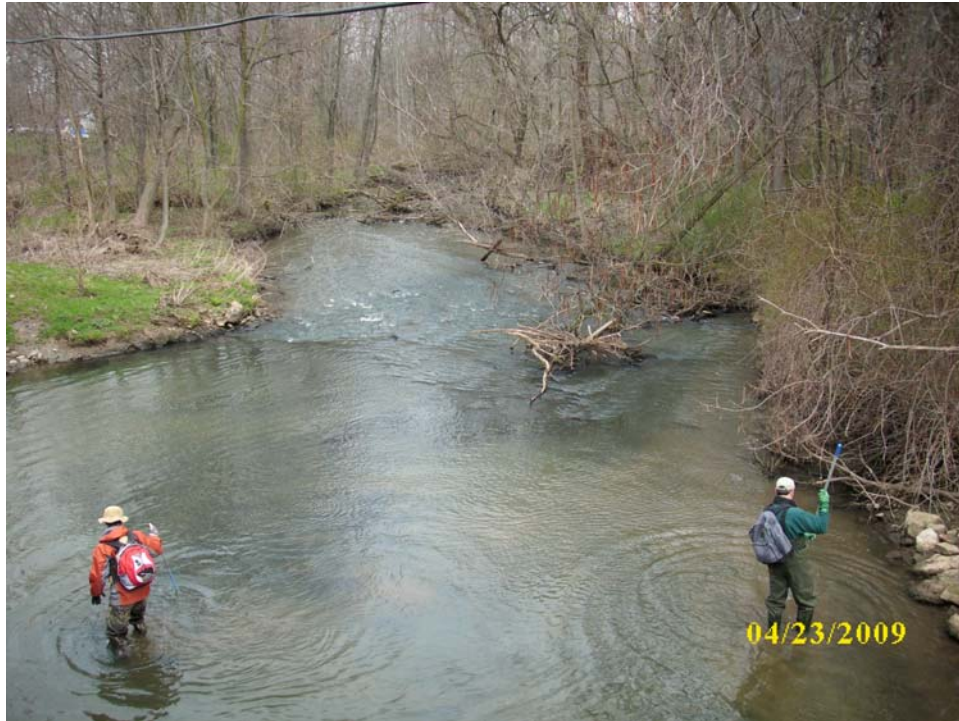
Photo: P21

Direction of view: NW

Description: Downstream view from Stone Road Bridge.

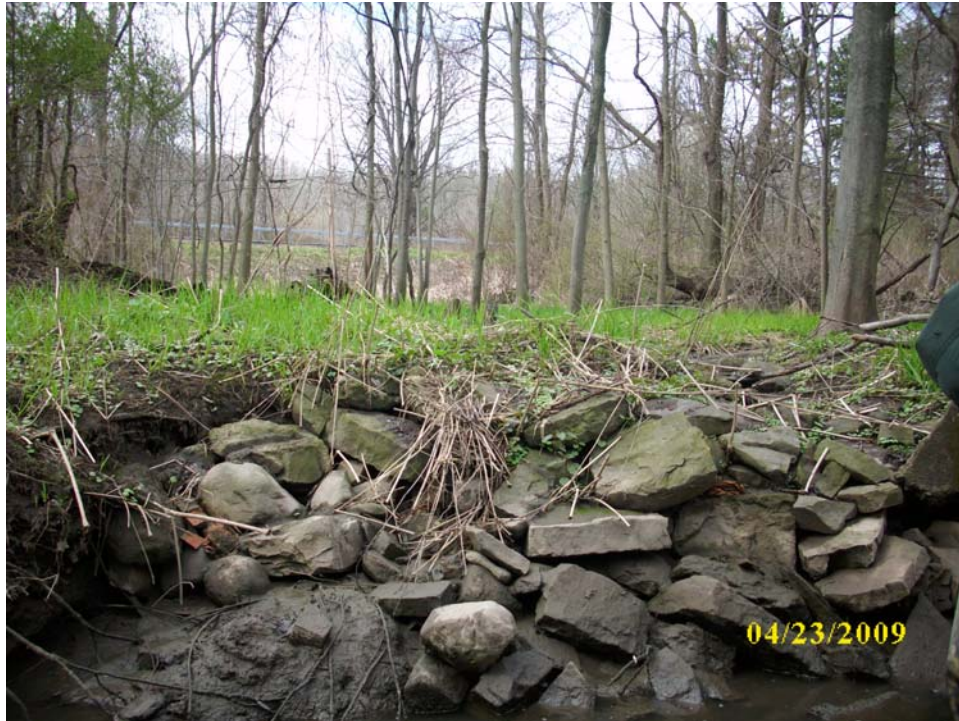
Photo: P27  
 Direction of view: SW  
 Description: Wetland along RDB with drainage to creek (DRN-022).

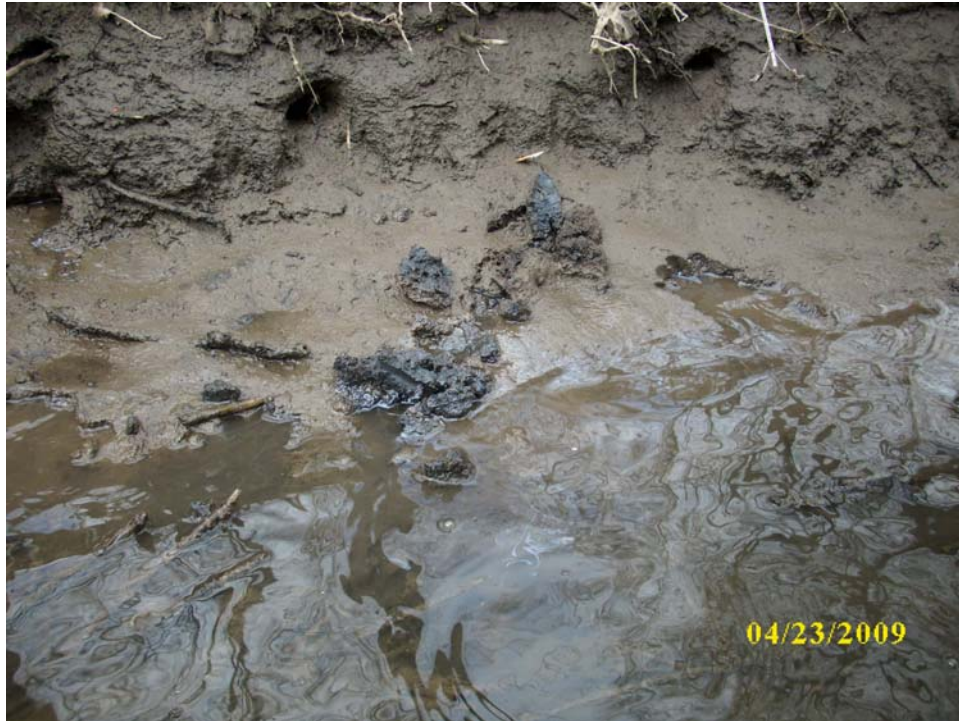
Photo: P29  
Direction of View: N/A  
Description: Sheen seen on sediment along LDB (SED-026).

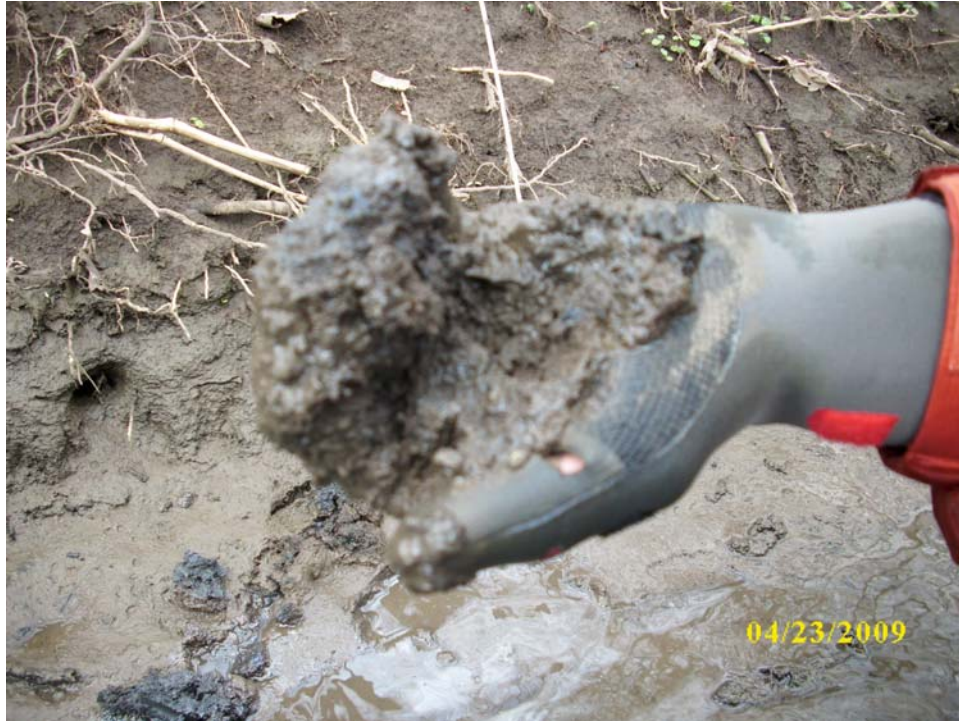
Photo: P30

Direction of view: N/A

Description: Sheen seen on sediment along LDB (SED-026).

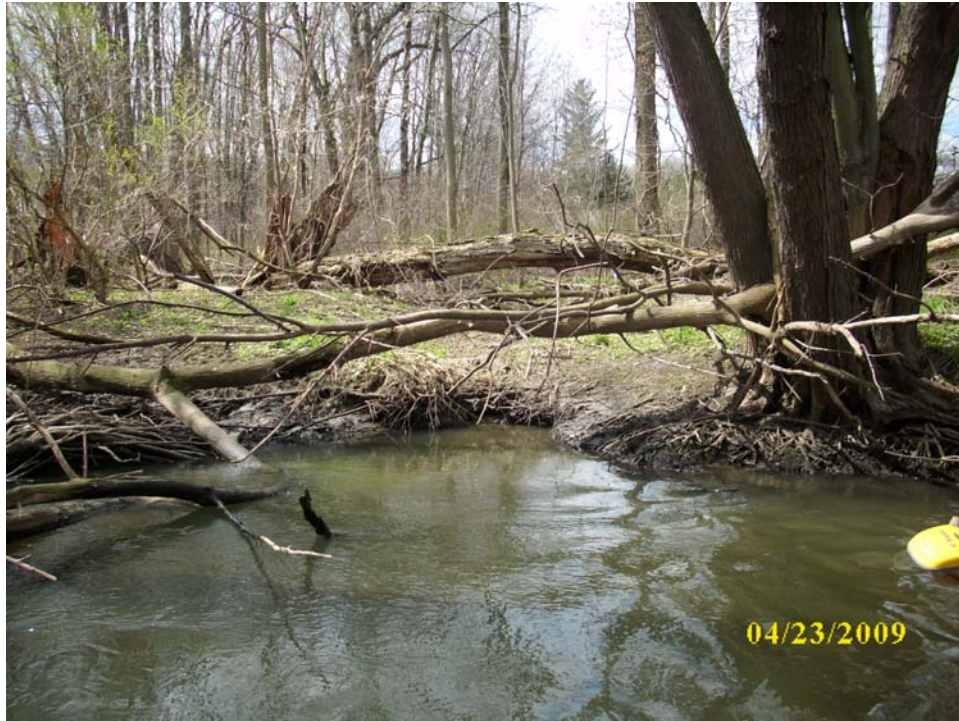
Photo: P31

Direction of view: SW

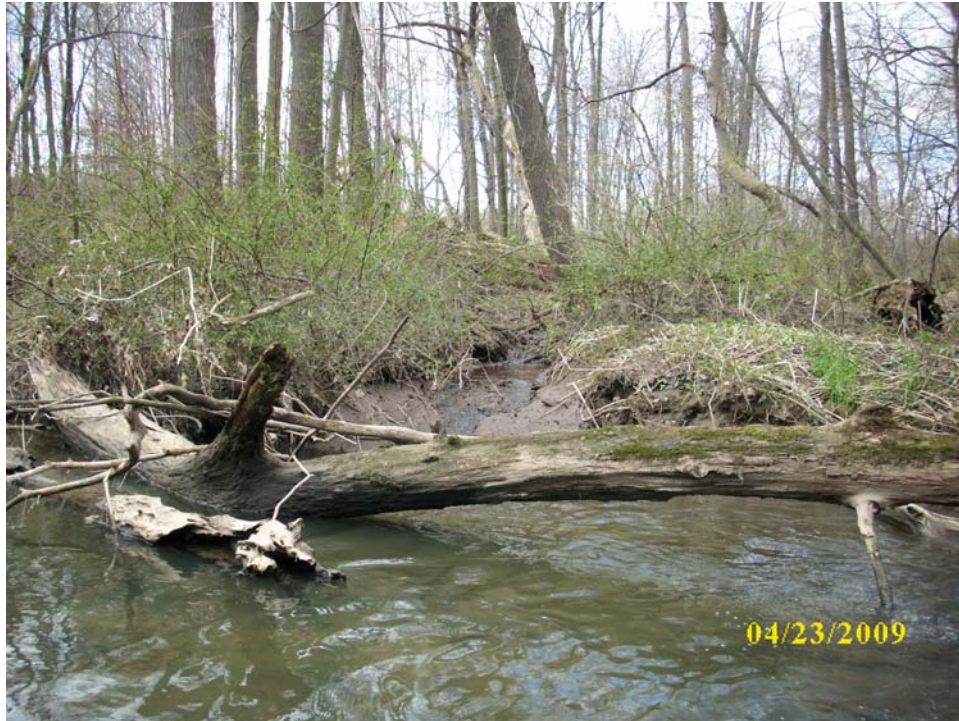
Photo: P33  
 Direction of view: W  
 Description: Tributary along LDB (TRB-020).

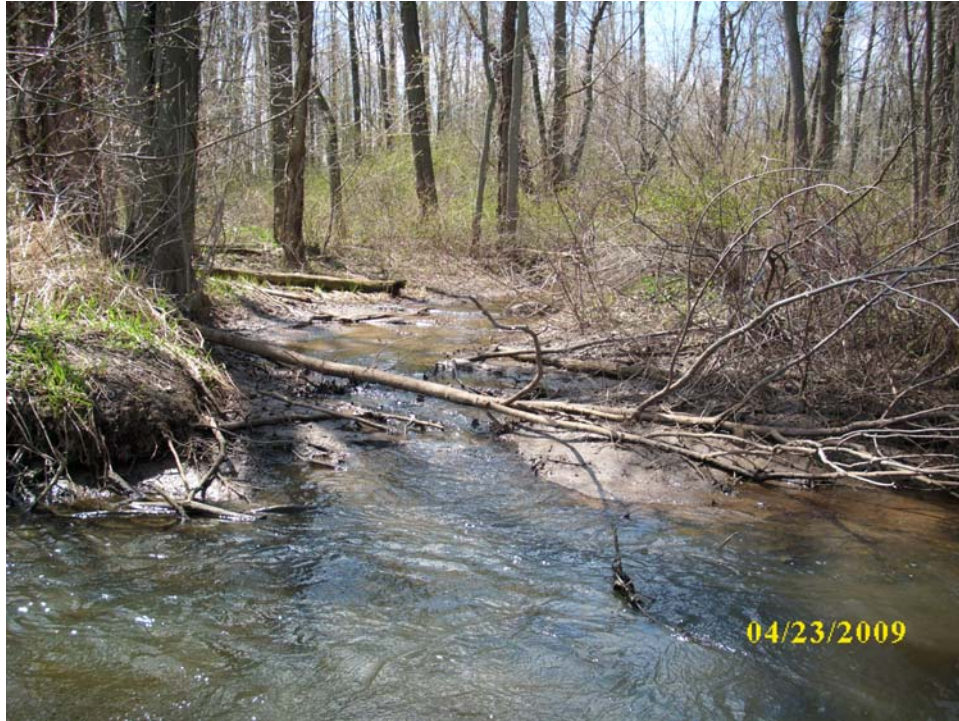
Photo: P38  
Direction of view: SW  
Description: Tributary along LDB (TRB-021).

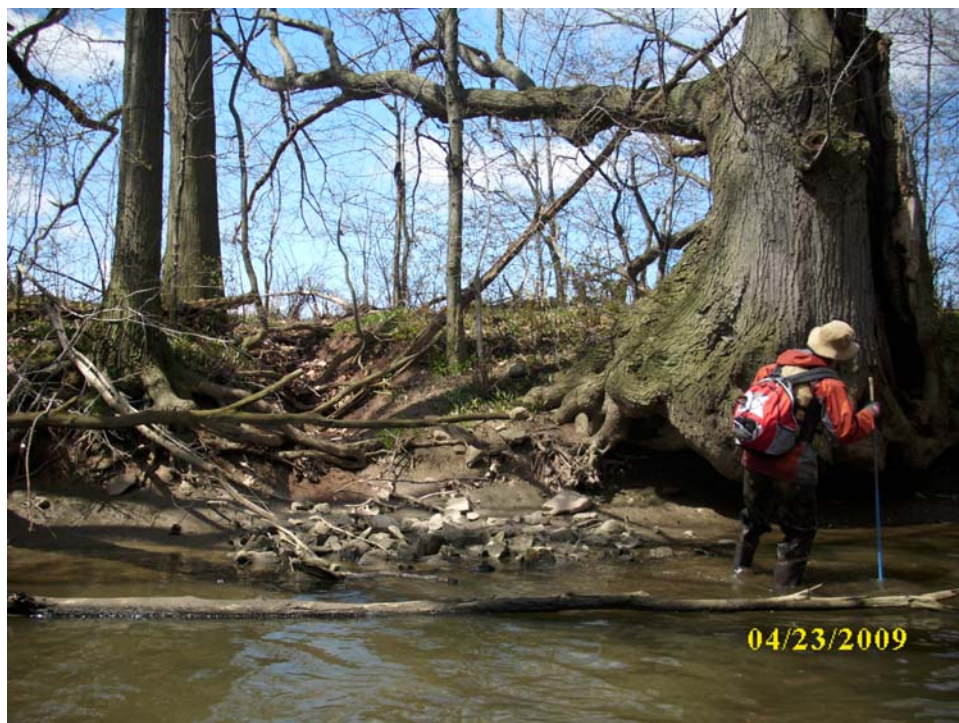
Photo: P40

Description: Agricultural drainage along LDB (DRN-025).

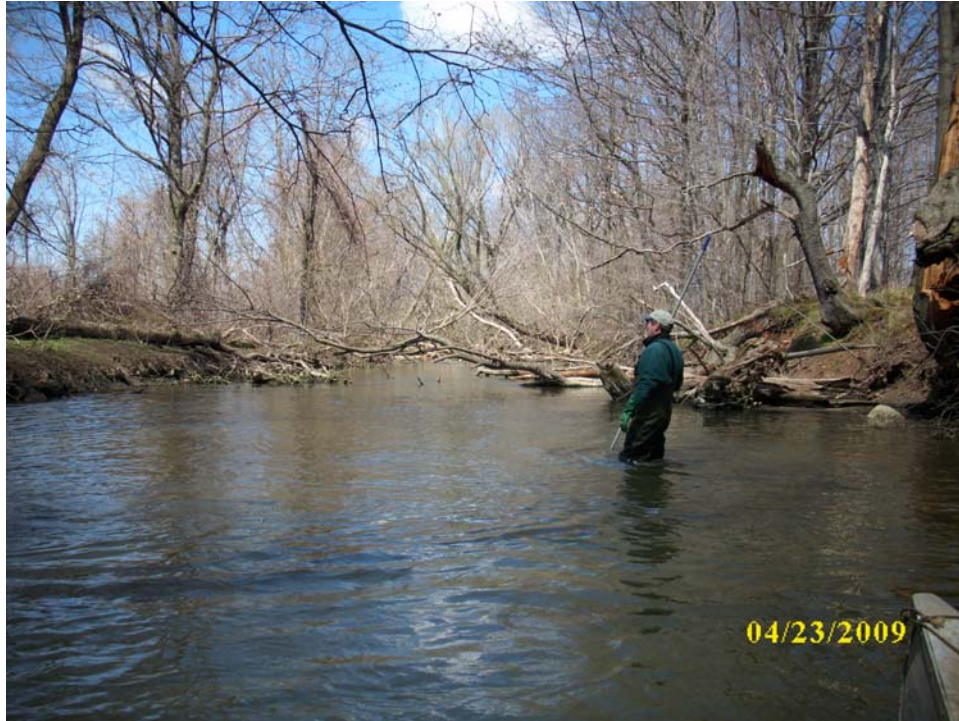
Photo: P44

Description: LWD obstruction across creek (OBS-028).

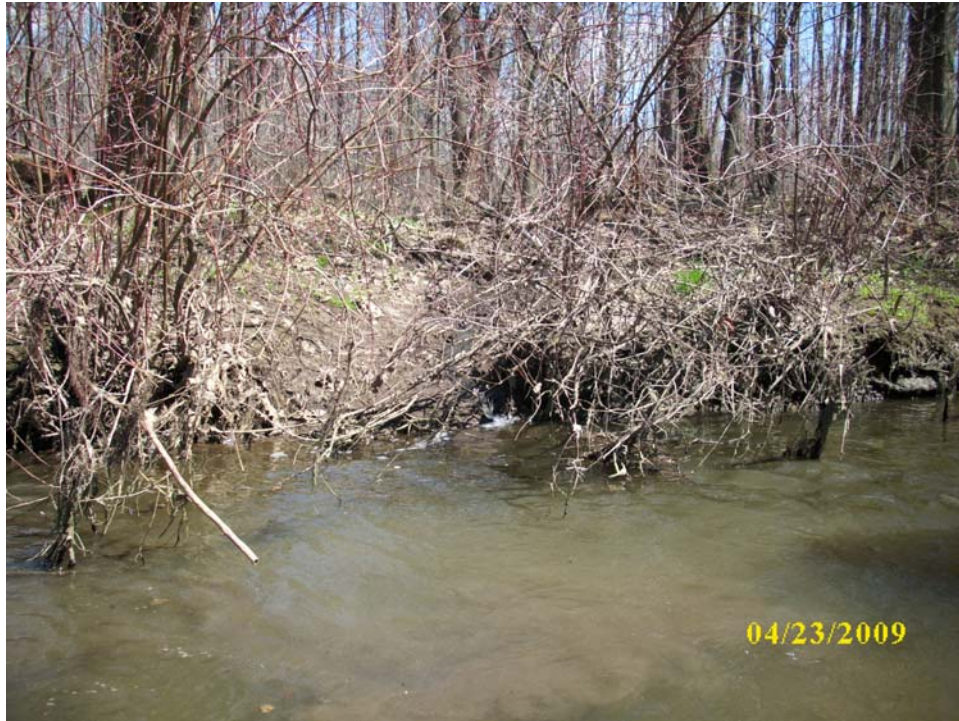
Photo: P45

Description: Tributary along RDB (TRB-022).

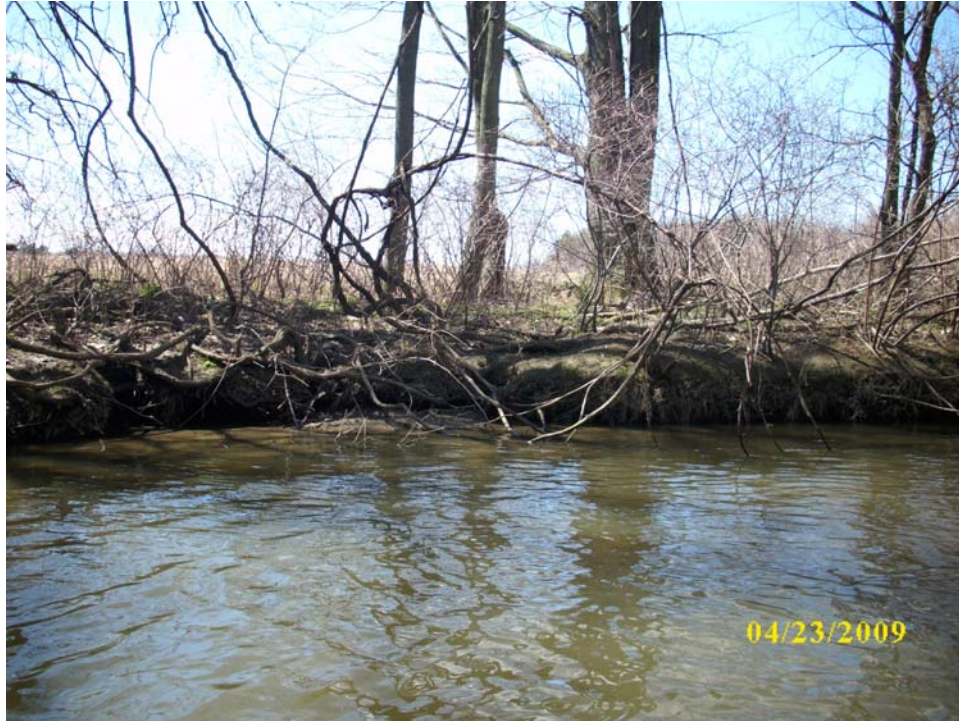
Photo: P46

Description: Agricultural run-off from LDB and depositional area (DRN-026).

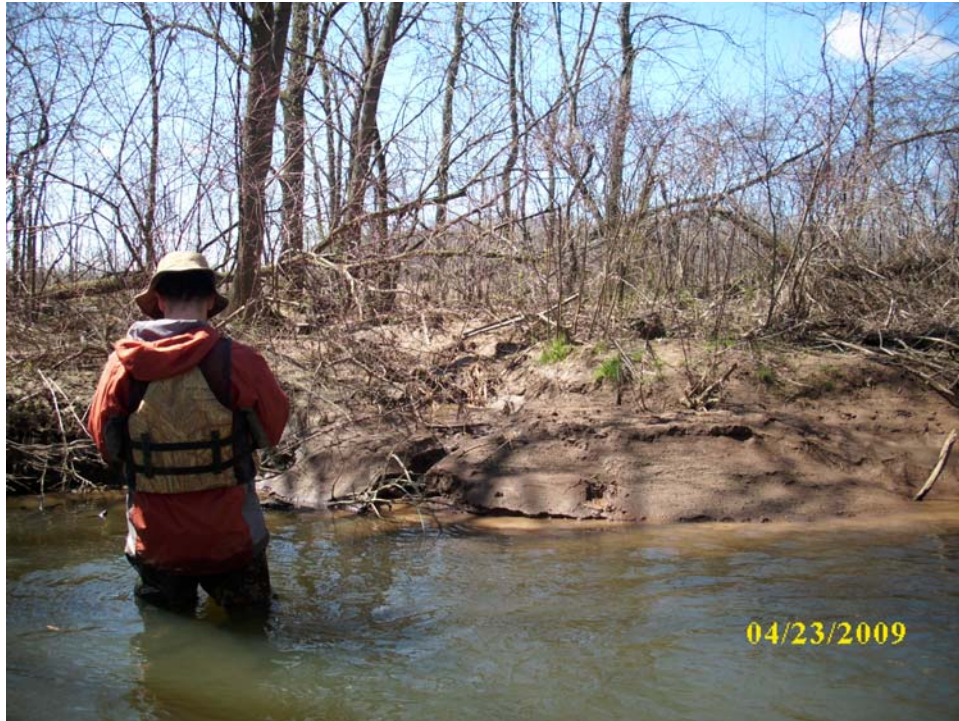
Photo: P47

Description: Agricultural run-off along LDB and depositional area (DRN-027).

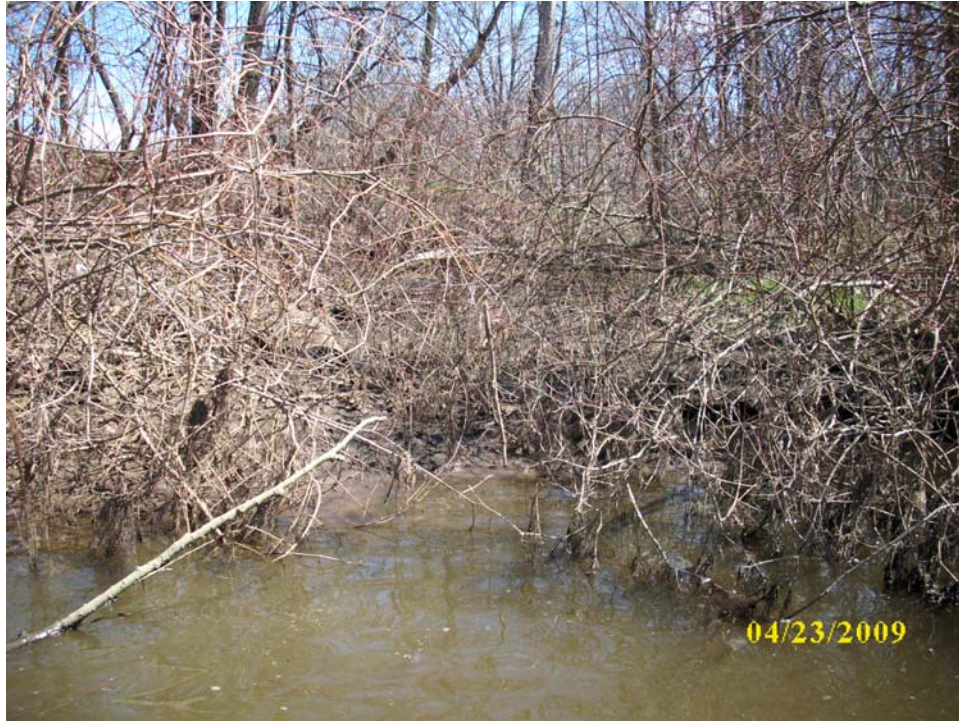
Photo: P48

Description: Tributary along RDB, runs through culvert at road (TRB-023).

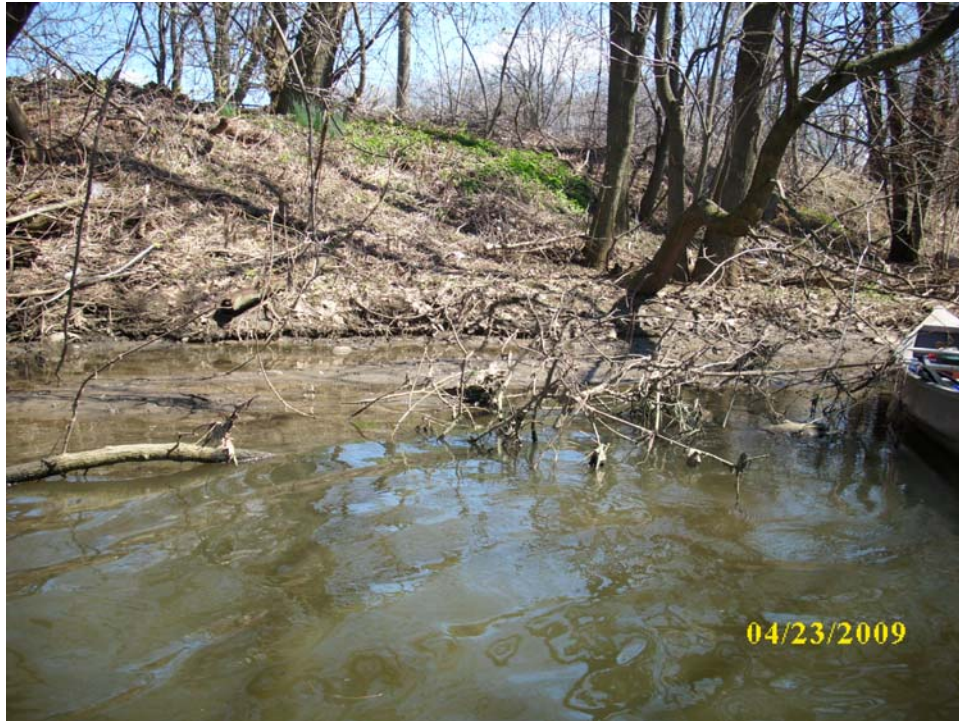
Photo: P49

Description: Exposed area of sediment bar along RDB.

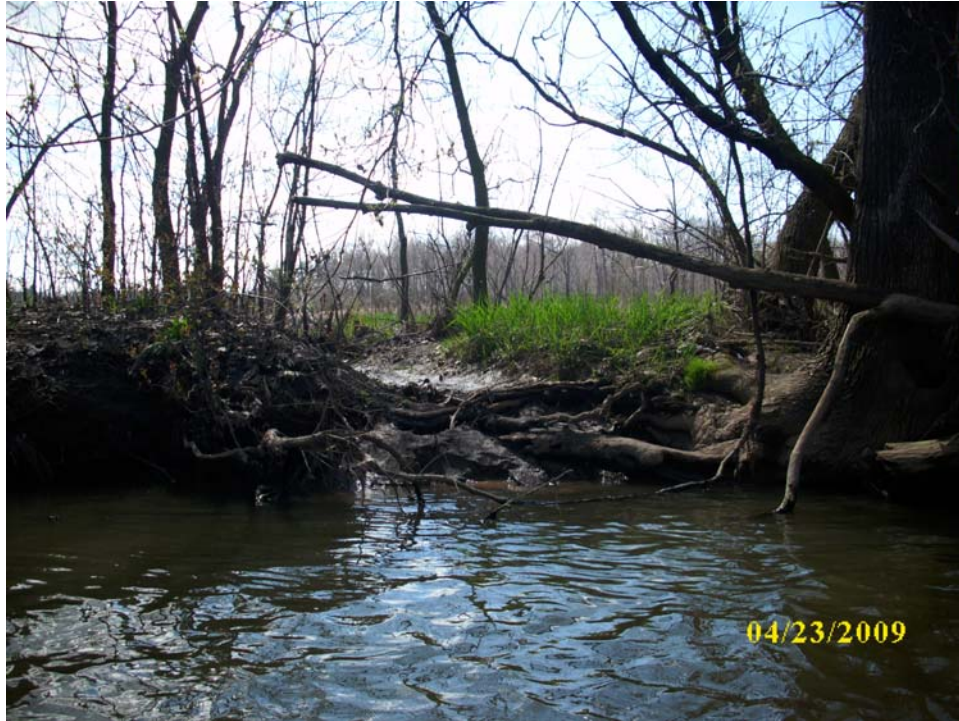
Photo: P50

Description: Agricultural run-off along LDB (DRN-028).

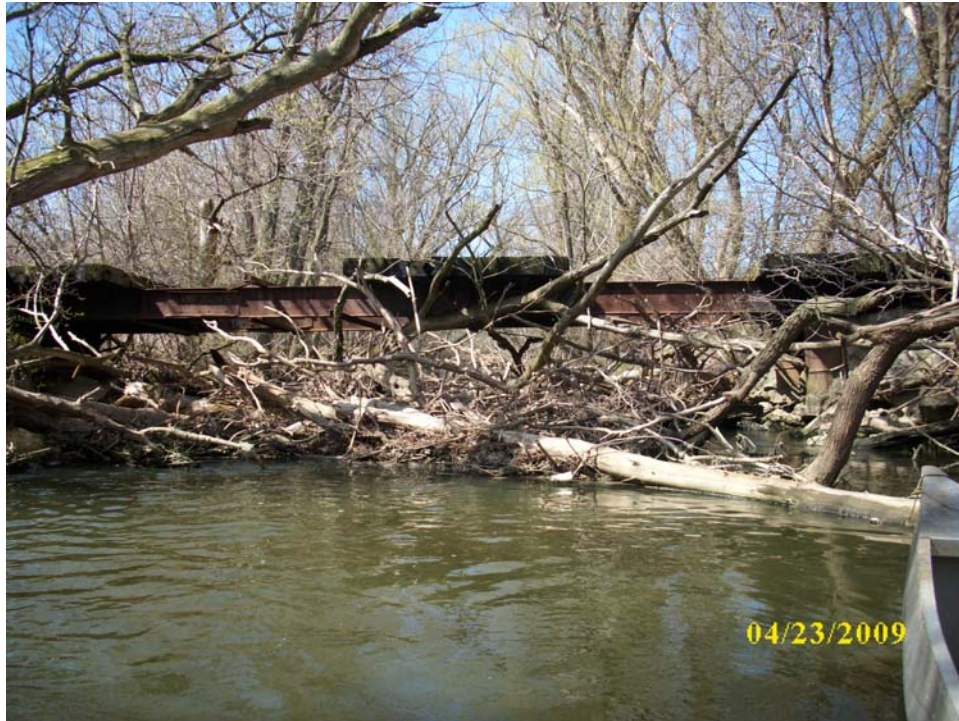
Photo: P51

Description: LWD obstruction and bridge across creek (OBS-029).

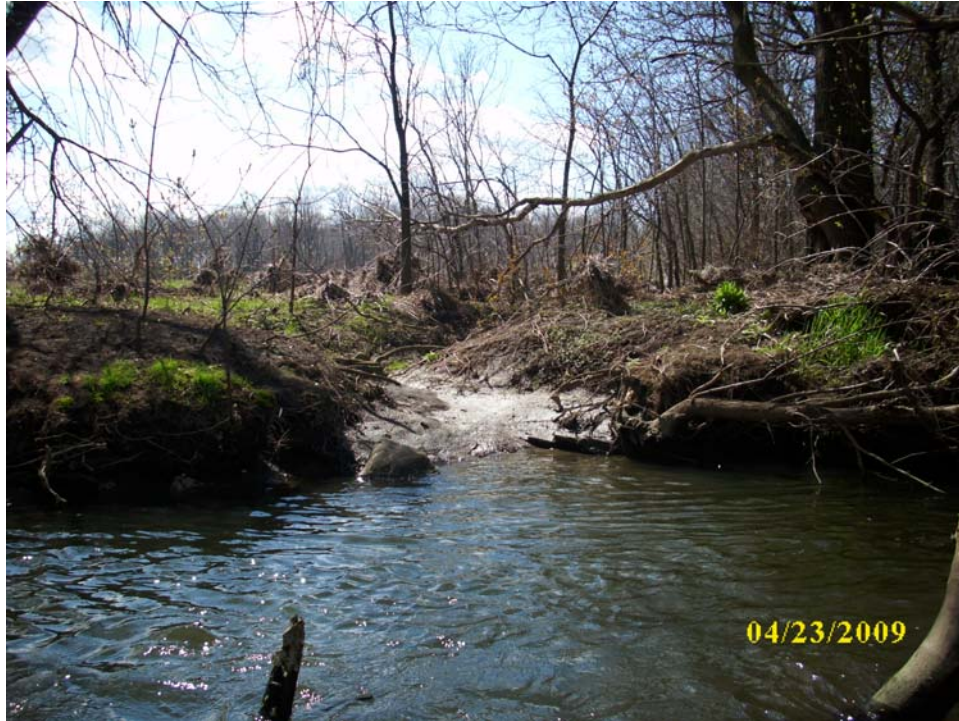
Photo: P52

Description: Surface drainage from agricultural fields along LDB (DRN-029).

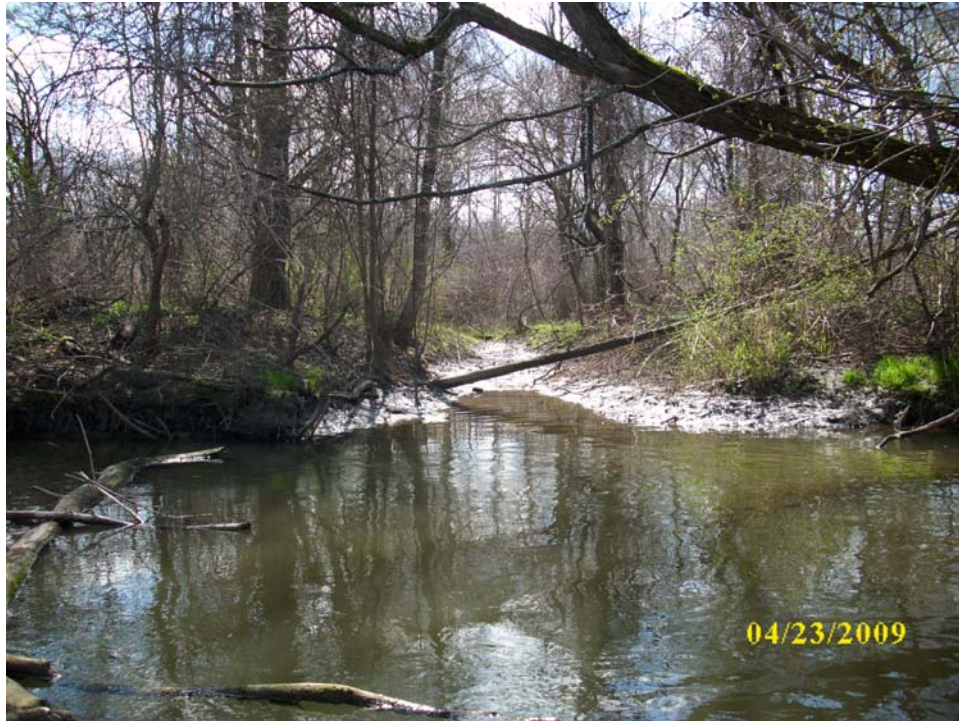
Photo: P53

Description: Tributary along LDB (DRN-030).

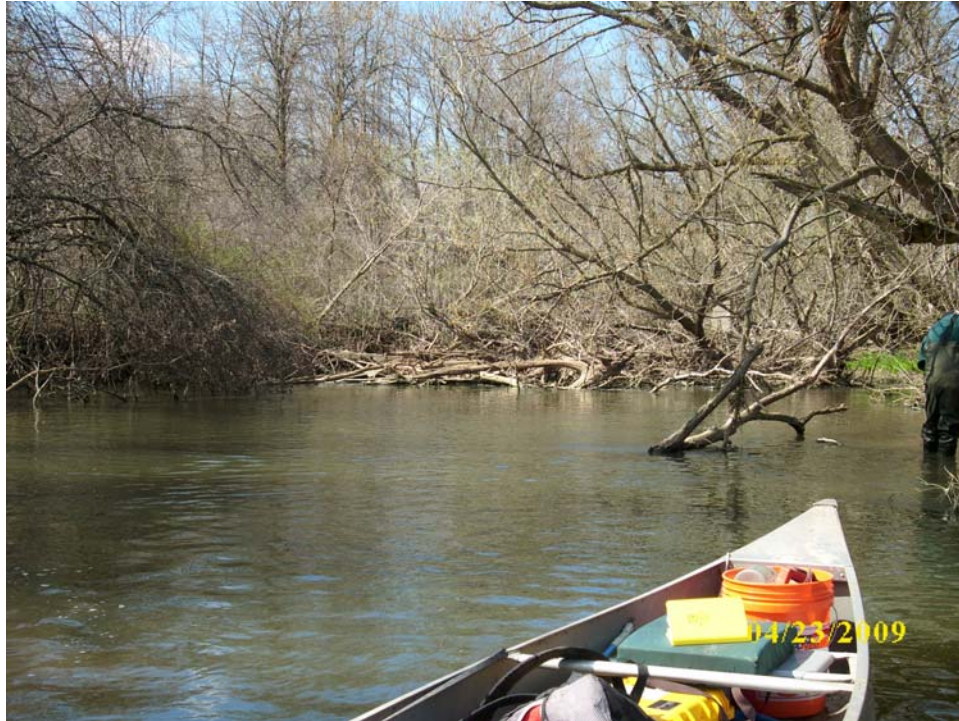
Photo: P54

Description: LWD obstruction across creek, downstream of SED 61 (OBS-034).

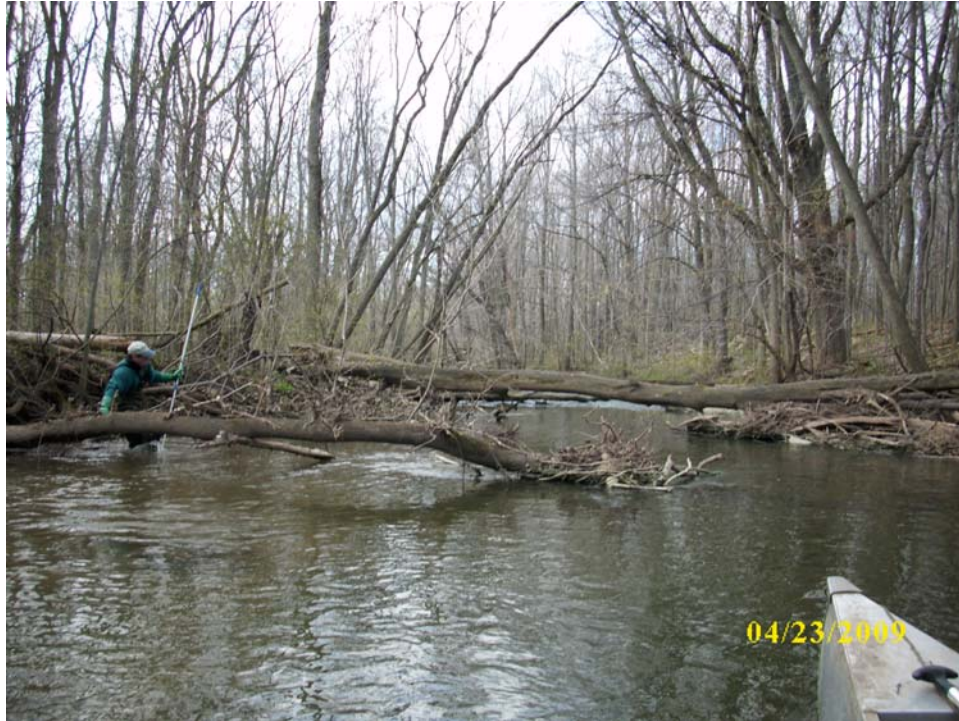
Photo: P58

Description: LWD obstruction across creek.

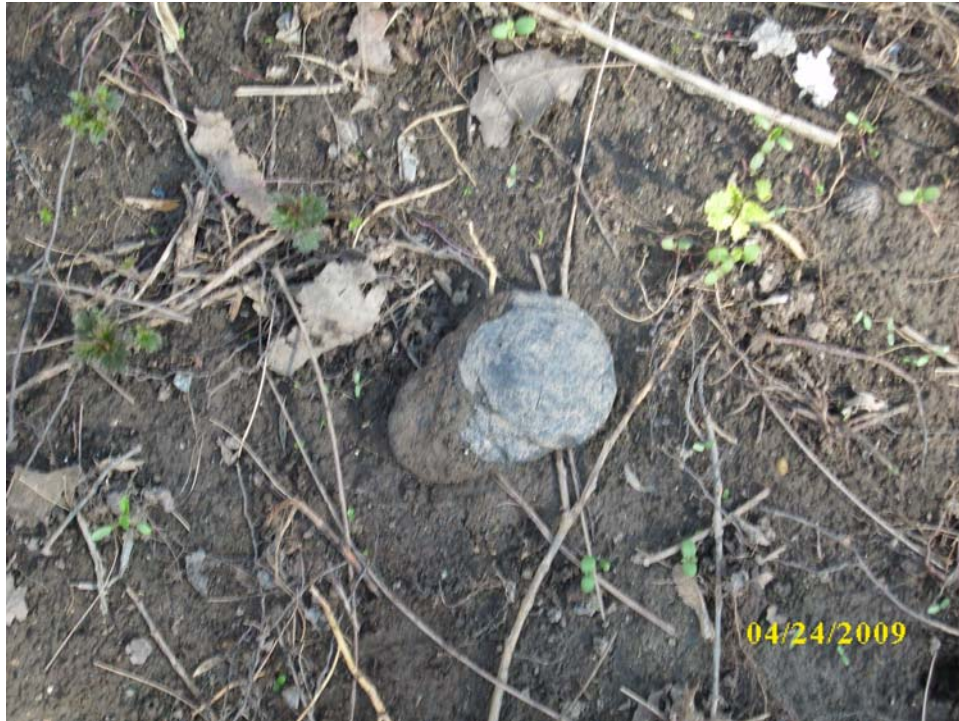
Photo: P59

Description: Tar-like material found on LDB.

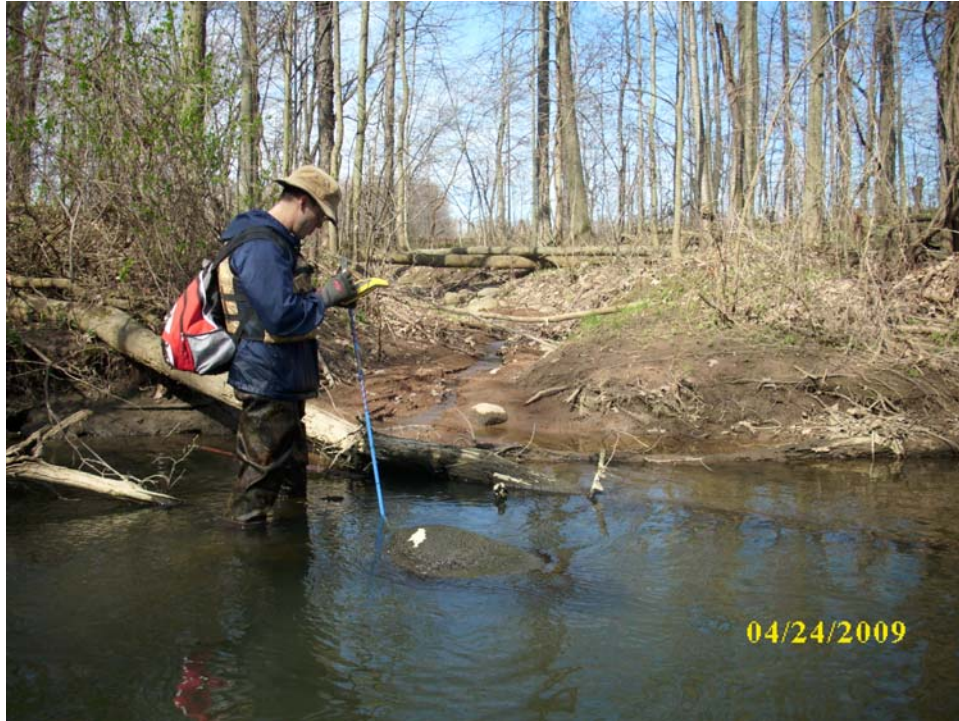
Photo: P62

Description: Overland drainage along LDB (DRN-032).

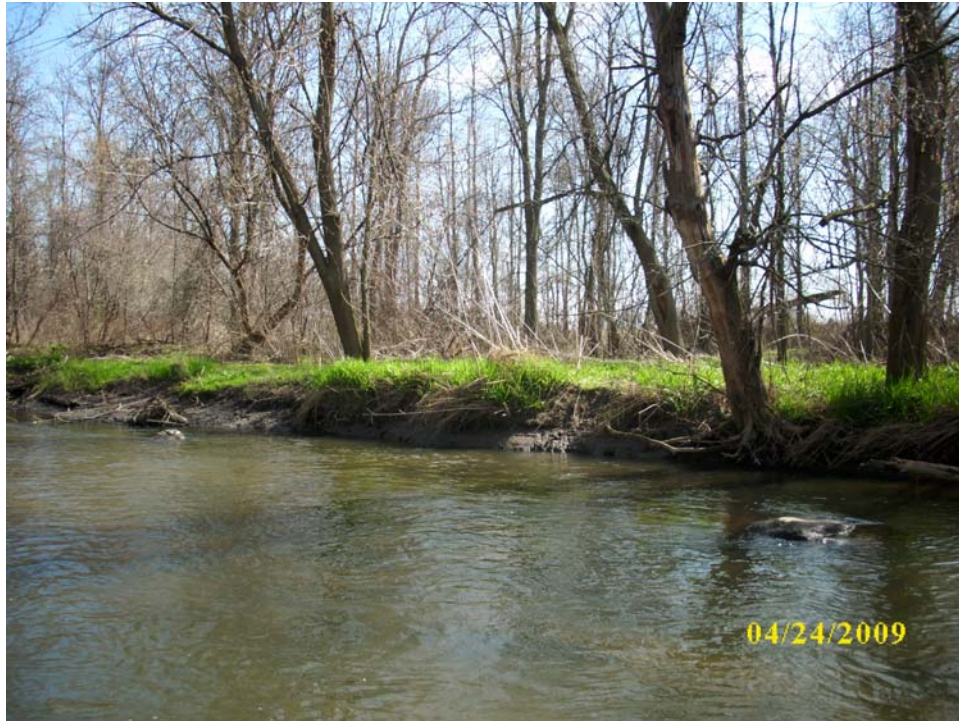
Photo: P63

Description: Extensive wetland along RDB.

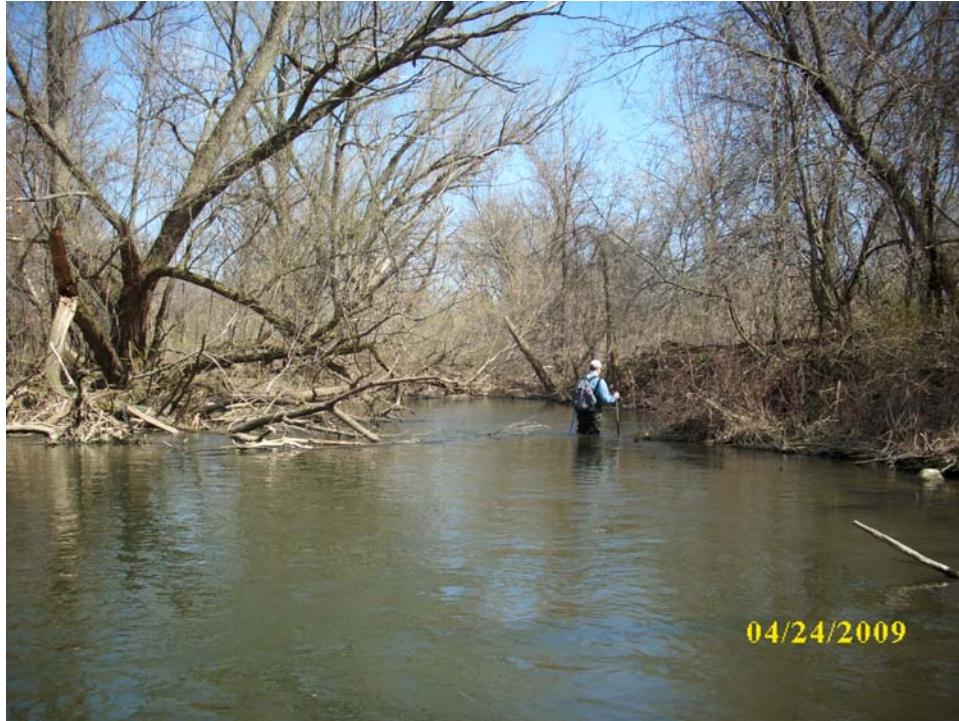
Photo: P64

Description: LWD obstruction across creek (OBS-034).

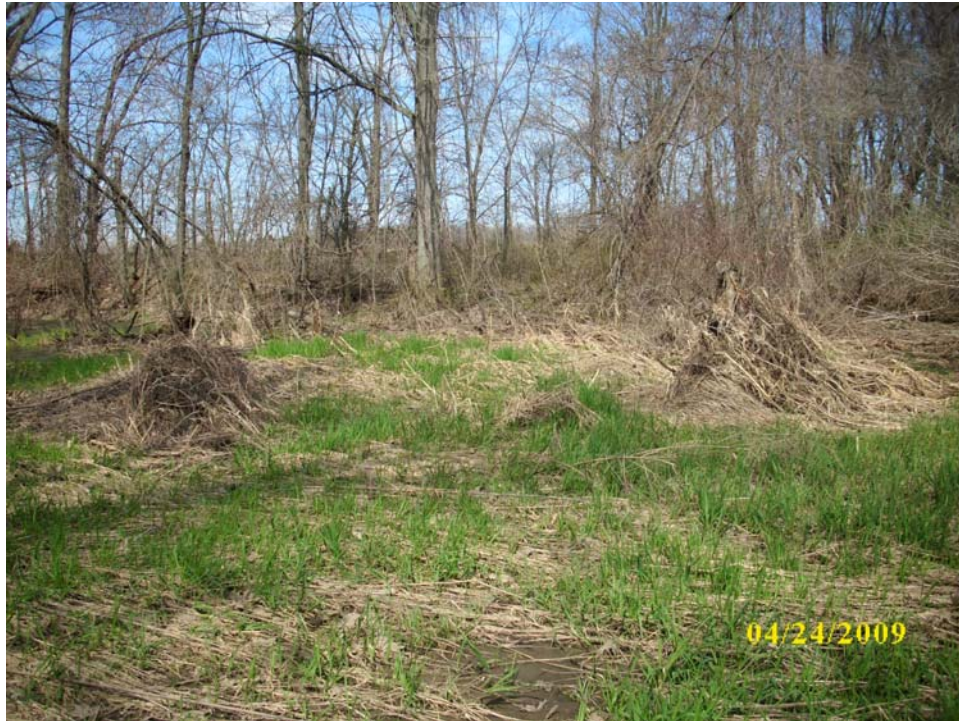
Photo: P65

Description: Large forested wetland within floodplain along LDB.

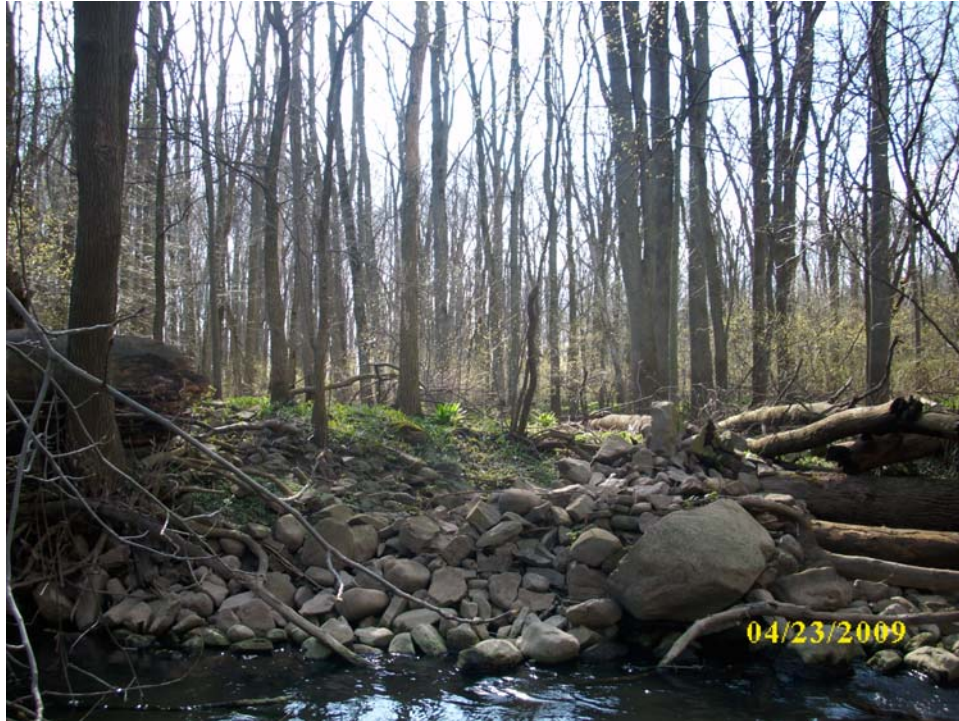
Photo: P96  
 Direction of view: W  
 Description: Large forested wetland along LDB.
