# A

## Survey Figures

# B Survey Data Tables

**Table B-1 Sediment Thickness Points, Eighteenmile Creek, Niagara County, New York**

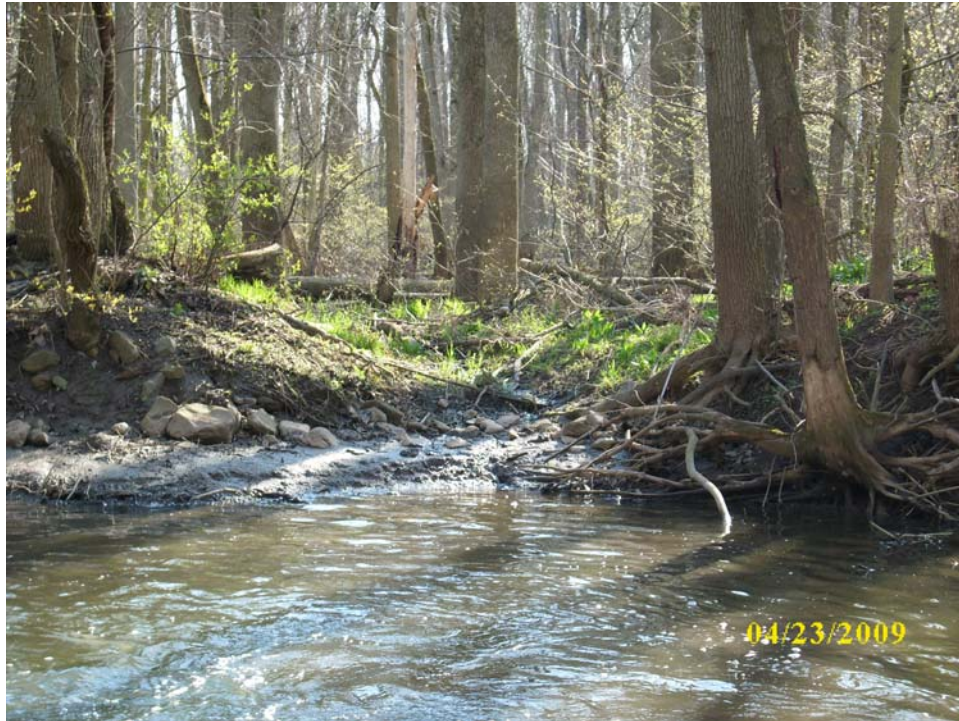
Photo: P97  
 Direction of view: SW  
 Description: Discharge from large forested wetland (WET-021)

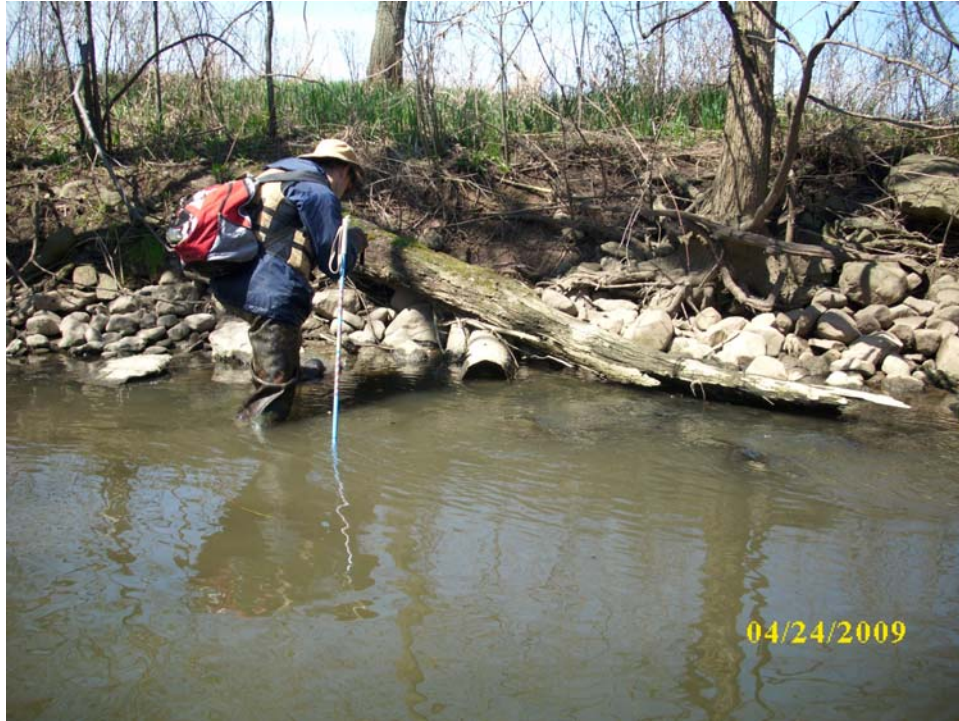
Photo: P102

Description: Pipe outfall along LDB with flow.

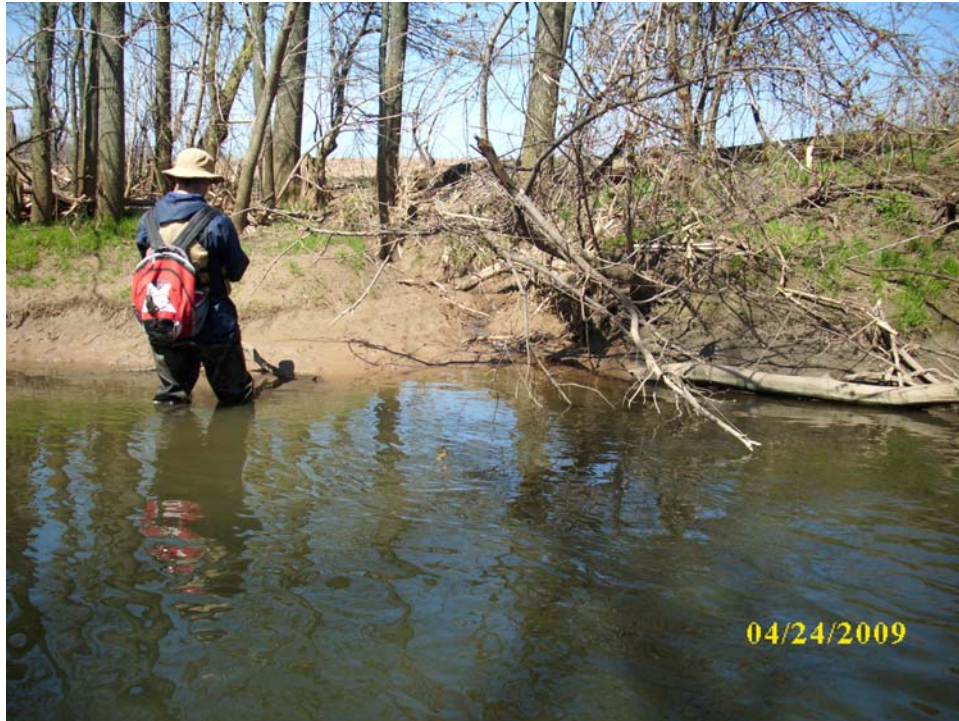
Photo: P103

Description: Surface run-off from agricultural fields along LDB (DRN-034).

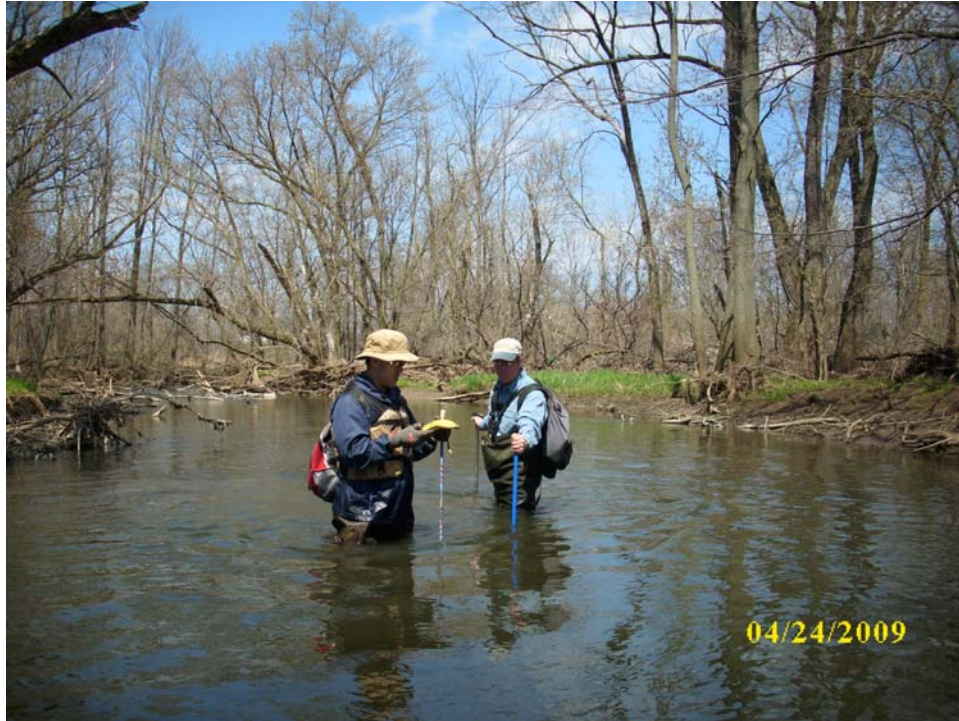
Photo: P104

Description: Taking a mid-channel water depth (WD-043).

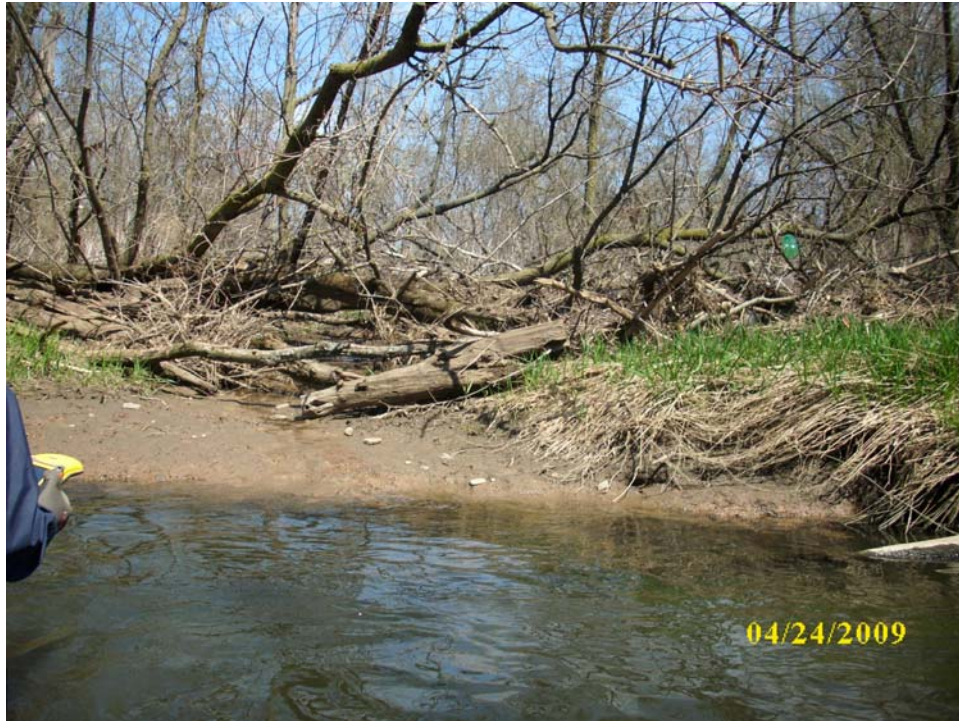
Photo: P105

Description: Wetland drainage along RDB (DRN-035).

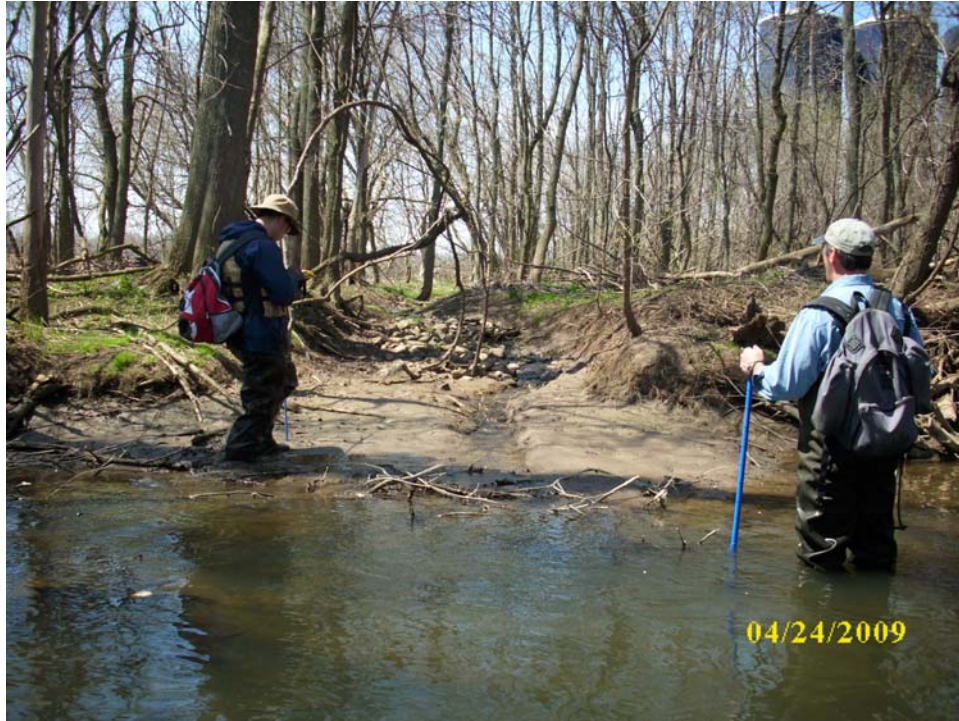
Photo: P106

Description: Surface drainage from wetland and agricultural fields along LDB (DRN-036).

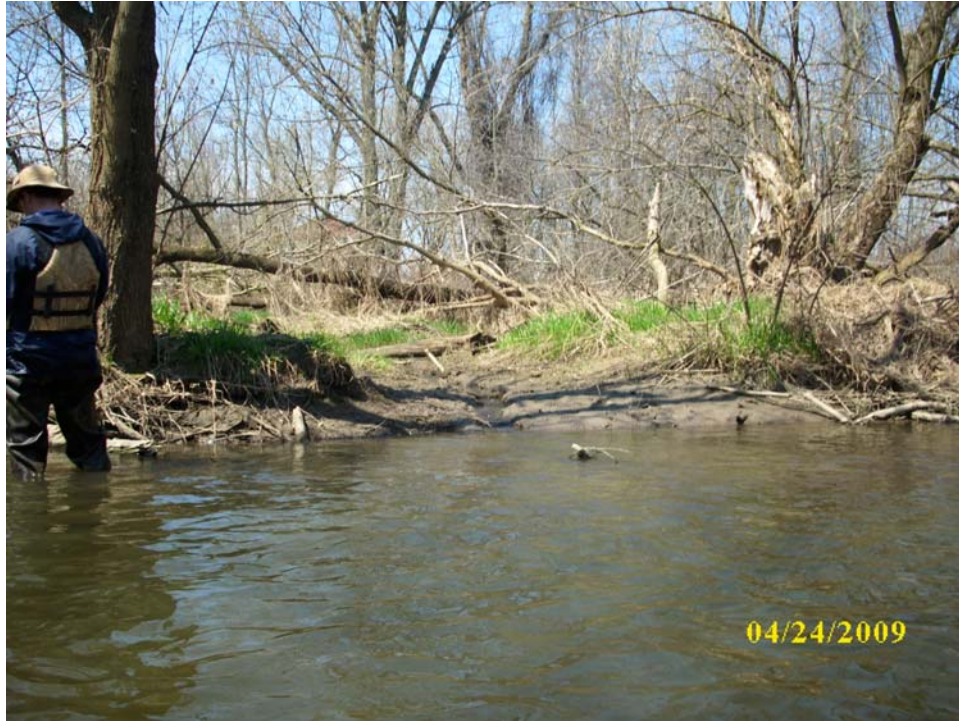
Photo: P108

Description: Wetland from P107 second discharge point (DRN-038).

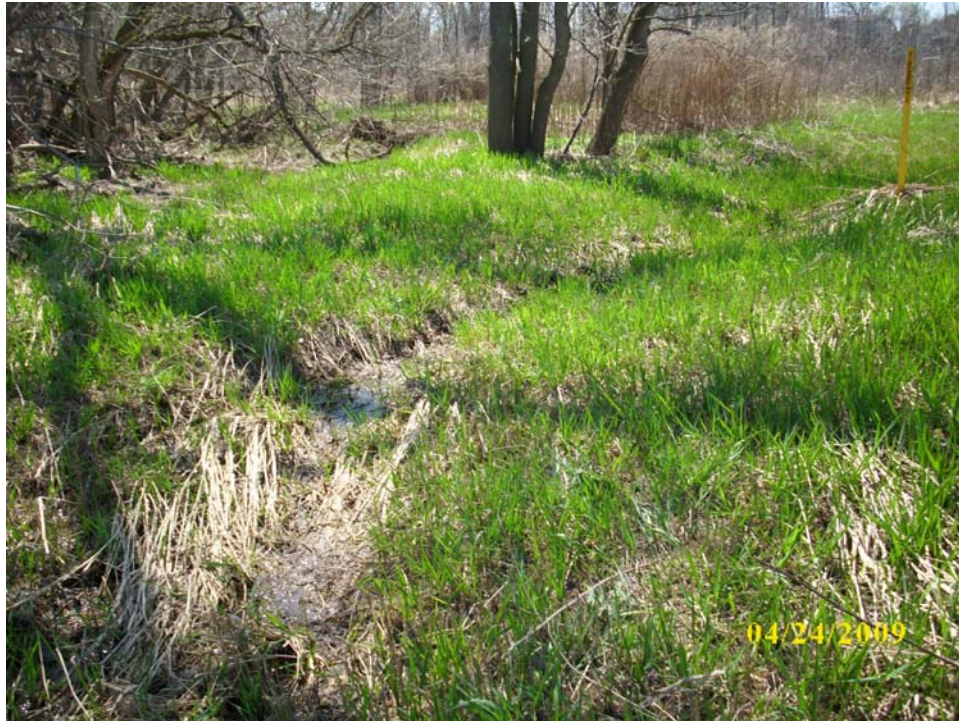
Photo: P109

Description: Wetland with drainage along LDB, upstream of Ridge Road (DRN-039).

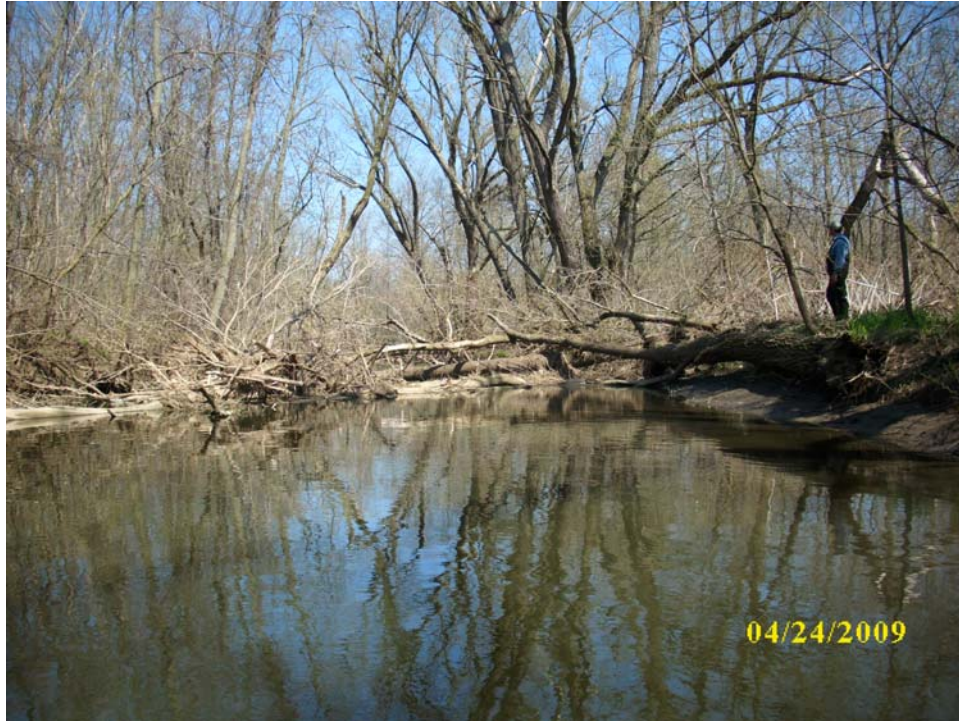
Photo: P110

Description: LWD obstruction across creek downstream of Ridge Road (OBS-036).

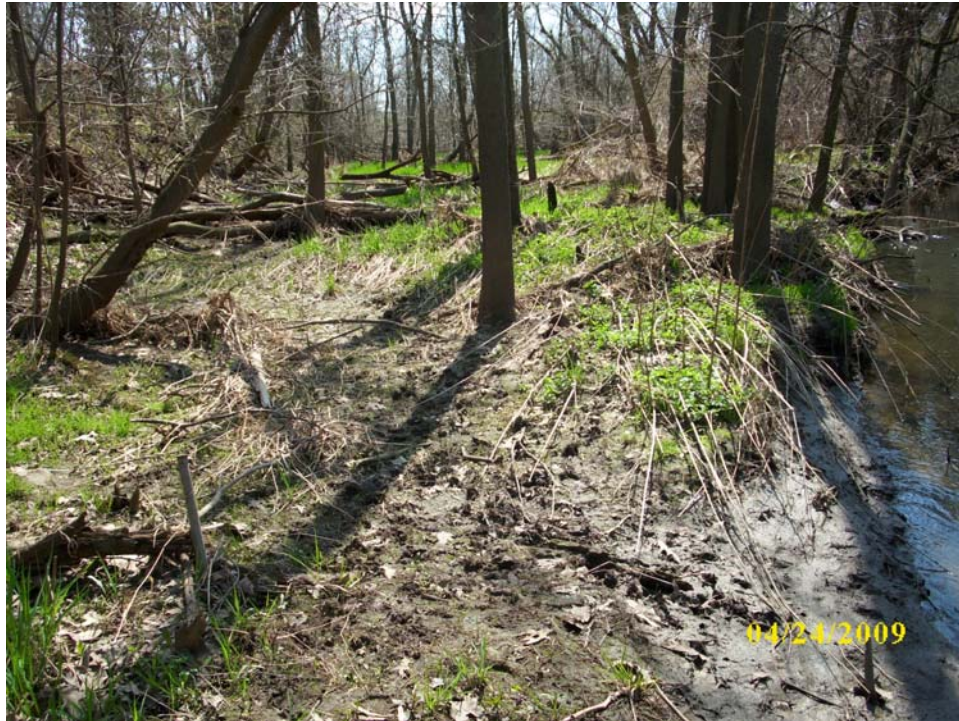
Photo: P111

Description: Wetland discharge along RDB (DRN-040).

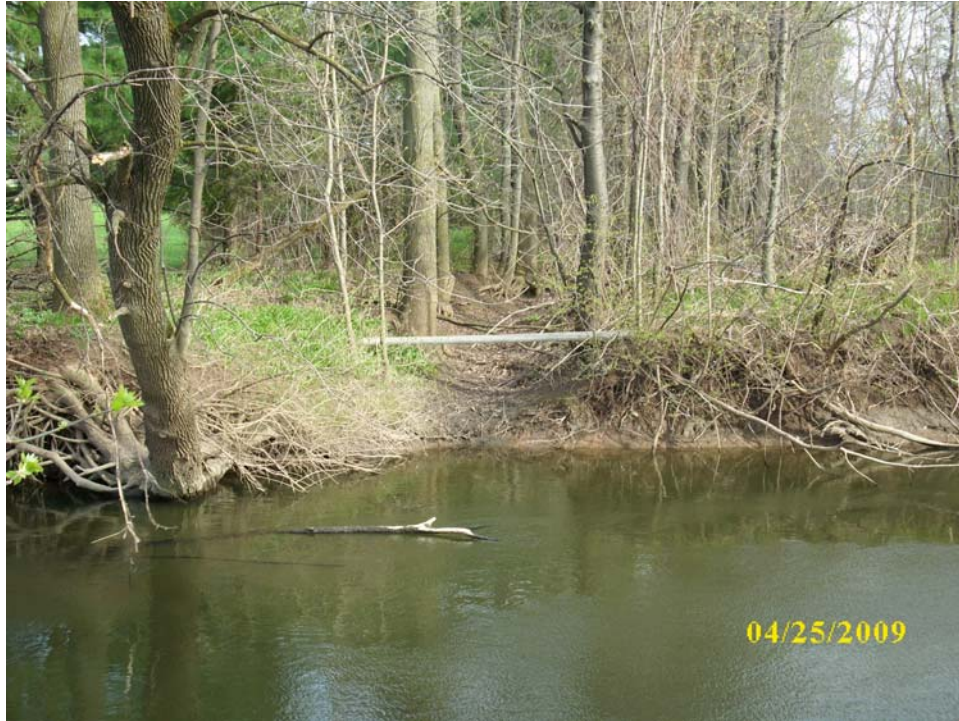
Photo: P112

Description: Tributary (drainage) along LDB just downstream of Ridge Rd (DRN-041).

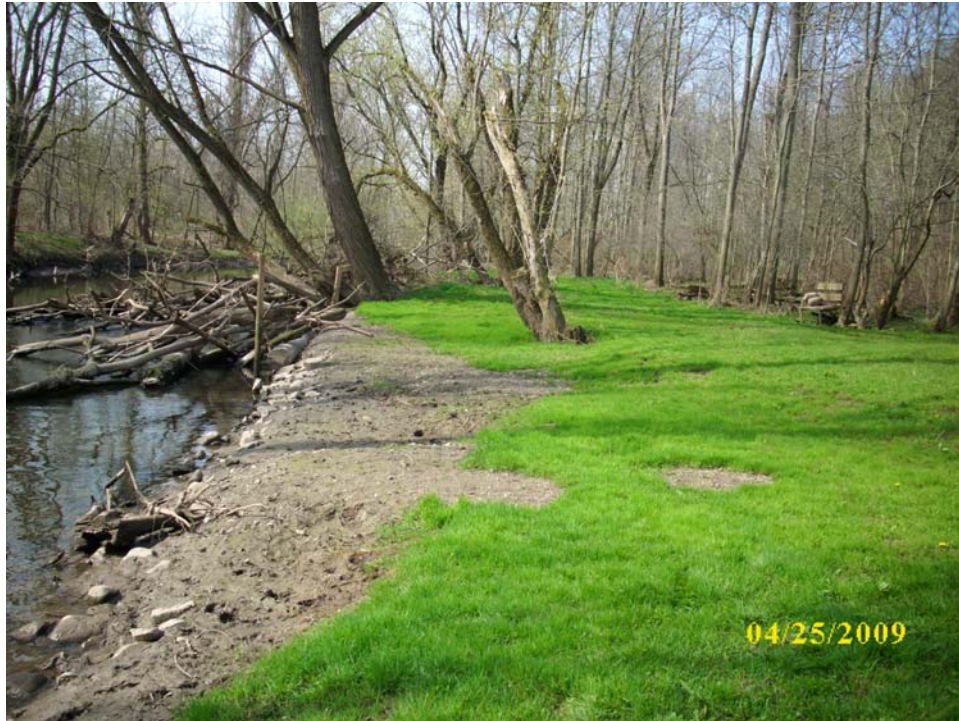
Photo: P113

Description: Open floodplain along LDB with bank stabilization in place (SED-097).
