Project	340 Myrtle Ave Site	Report No.	10
BCP Site	BCP Site No. C224340	Date	6/3/2024
Location	340 Myrtle Avenue, Brooklyn, NY	File No.	0210873
Client	340 Myrtle Development LLC	Temperature	L: 65 H:84
Contractor	Haley & Aldrich, Bruklyn Builders,	Wind Direction	WSW to ENE, 4 mph
	Blanco Drilling (Blanco), Raptor		
	Construction (Raptor)		
Weather	Mostly Cloudy	Personnel on Site	Z. Richards
Humidity	80%	Time on Site	6:50 am to 4:30 pm

H & A of New York Engineering and Geology, LLP (Haley & Aldrich) was present to document the implementation of the April 2024 NYSDEC-approved Remedial Action Work Plan (RAWP) prepared by Tenen Environmental, LLC (Tenen) for the 340 Myrtle Ave BCP Site (C224340), located at 340 Myrtle Avenue, Brooklyn, NY. Site Observations are summarized below.

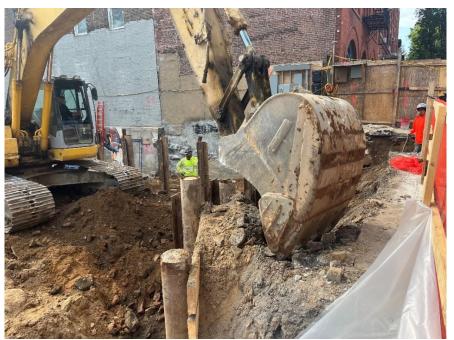
Photo 2: View of contractor breaking down concrete, facing northeast.

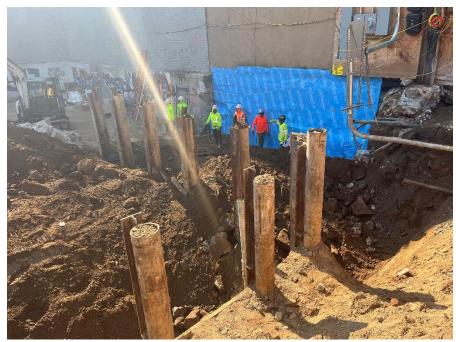
Photo 2: View of contractor excavating in the northwest portion of site, facing north.

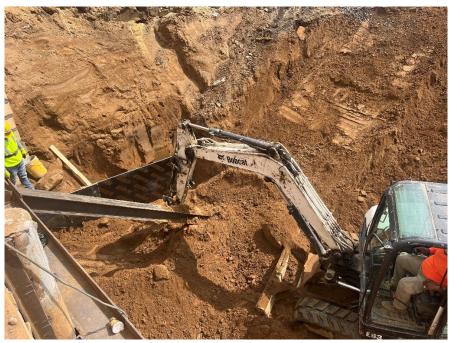
Photo 3: View of SOE work, facing north.

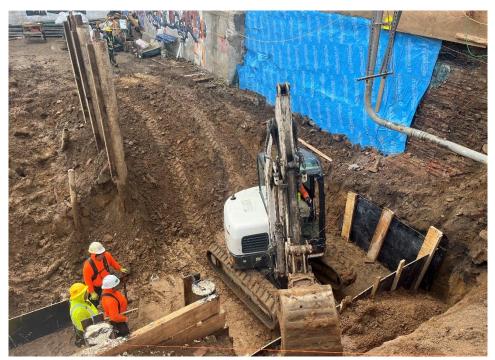
Photo 1: View of contractor preparing footing, facing south.

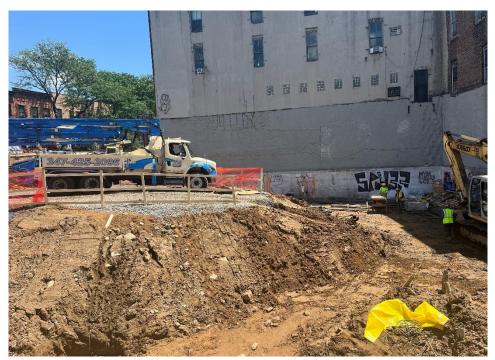
Photo 1: View of contractor creating trucking pad surface, facing east.

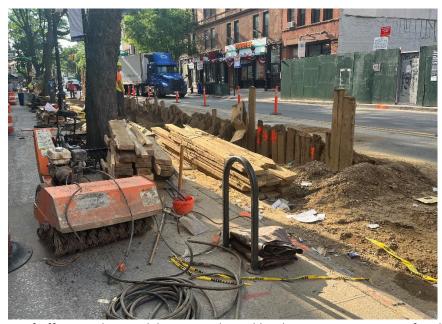
Photo 4: View of off-Site utility work being conducted by the NYC Department of Buildings along Myrtle Avenue, facing southeast.

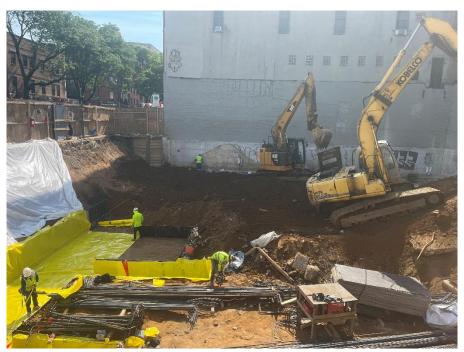
Photo 2: View of contractor excavating soil along northern portion of Site, facing east.

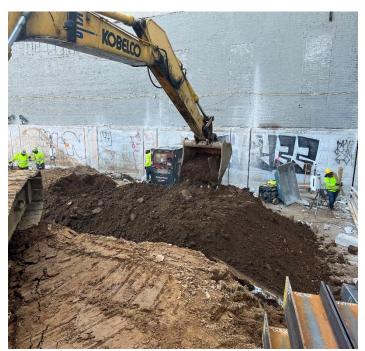
Photo 2: View of contractor stockpiling soil and CAMP Stations 1 and 2, facing east.

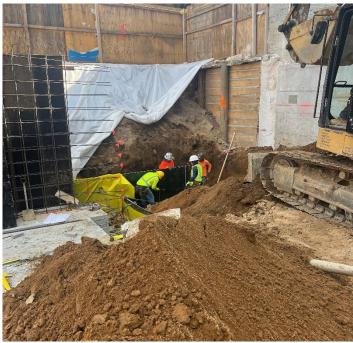
Photo 2: View of contractor preparing for SOE installation in northeastern portion of Site, facing north.

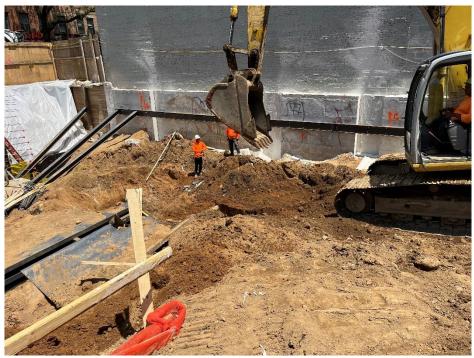
Photo 2: View of contractor preparing for SOE installation in northeastern portion of Site, facing northeast.

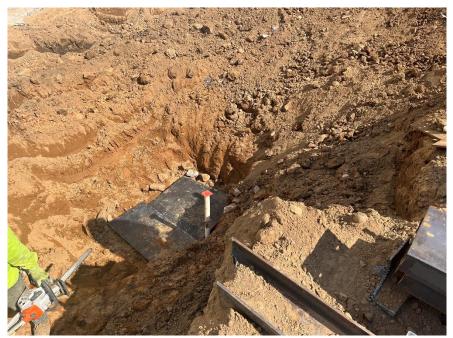
Photo 3: View of MW-06, facing southeast.

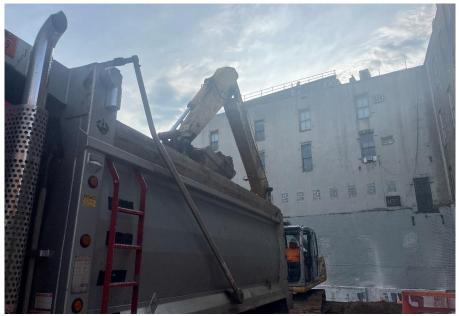
Photo 1: View of contractor loading tri-axle truck, facing east.

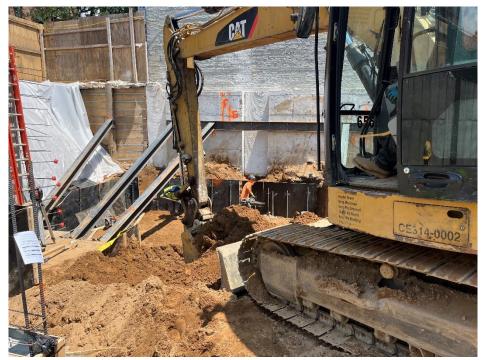
Photo 2: View of contractor preparing for SOE installation in eastern portion of Site, facing east.

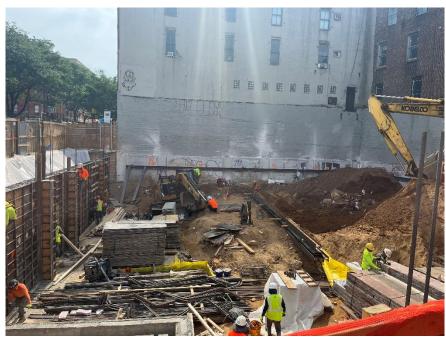
Photo 3: View of contractor installing SOE in northeastern portion of Site, facing east.

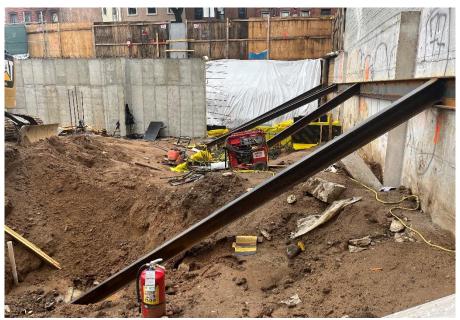
Photo 1: View of SOE installation, facing north.

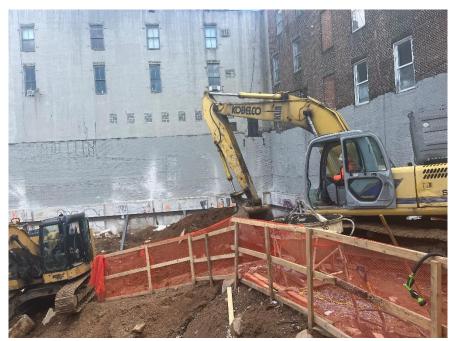
Photo 3: View of contractor stockpiling soils, facing east.

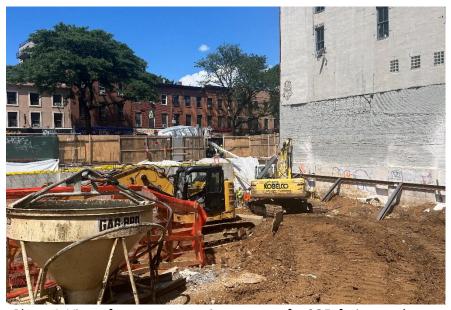
Photo 4: View of contractor pouring concrete for SOE, facing northeast.

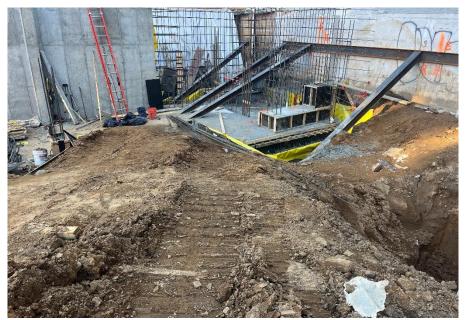
Photo 1: View of SOE installation in northeastern portion of Site, facing northeast.

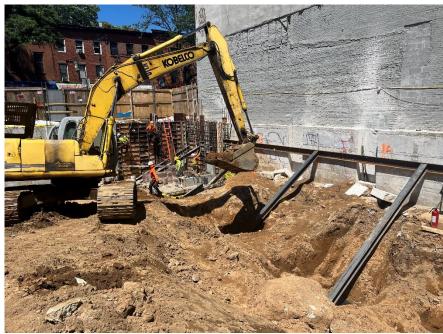
Photo 3: View of contractor installing SOE in northeastern portion of Site, facing northeast.
