Appendix H

Photograph Log

**West 34th Street
New York, New York
BCP Site #C231049**

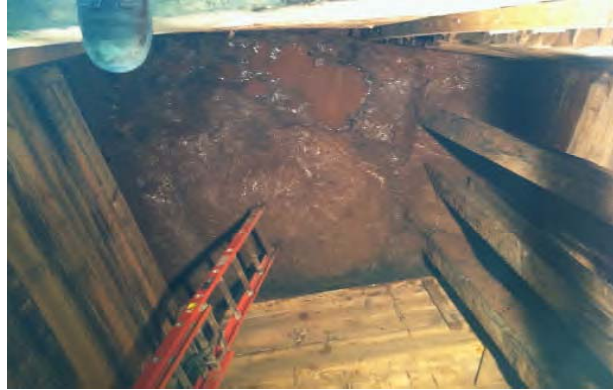
1. Section A of Phase 3 at clean bedrock

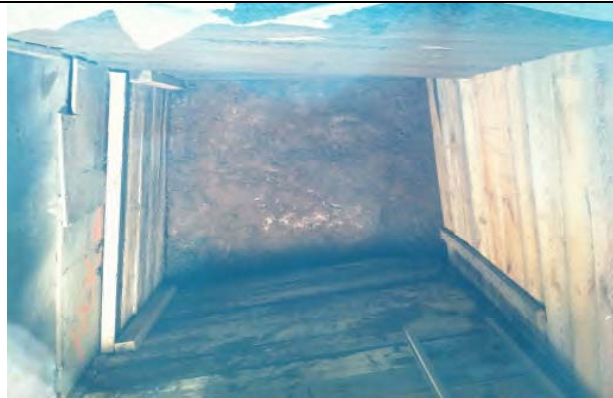
2. Section C of Phase 3 at clean bedrock

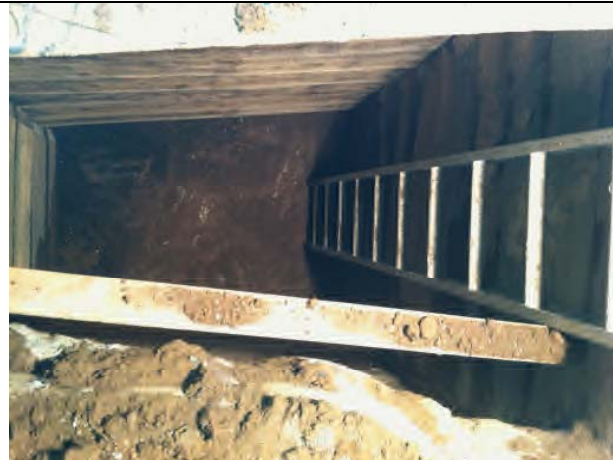
3. Section E of Phase 3 at clean bedrock

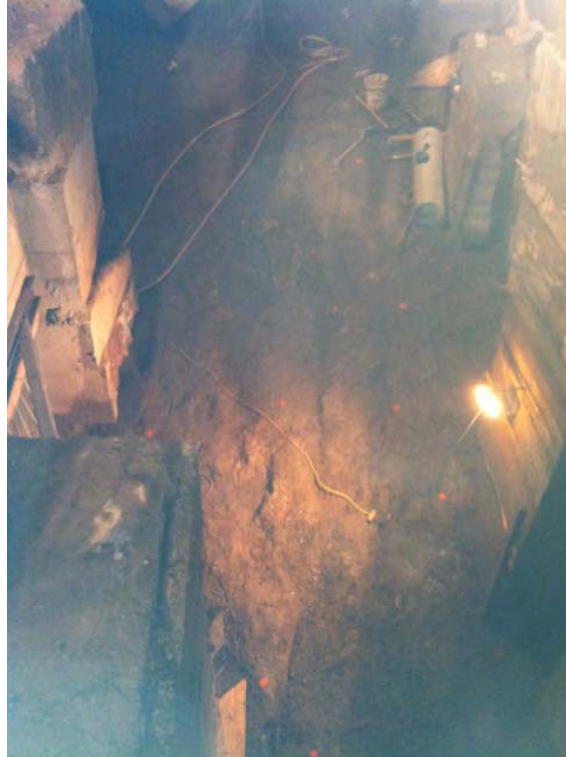
1. Phase II area excavated and cleaned to bedrock.

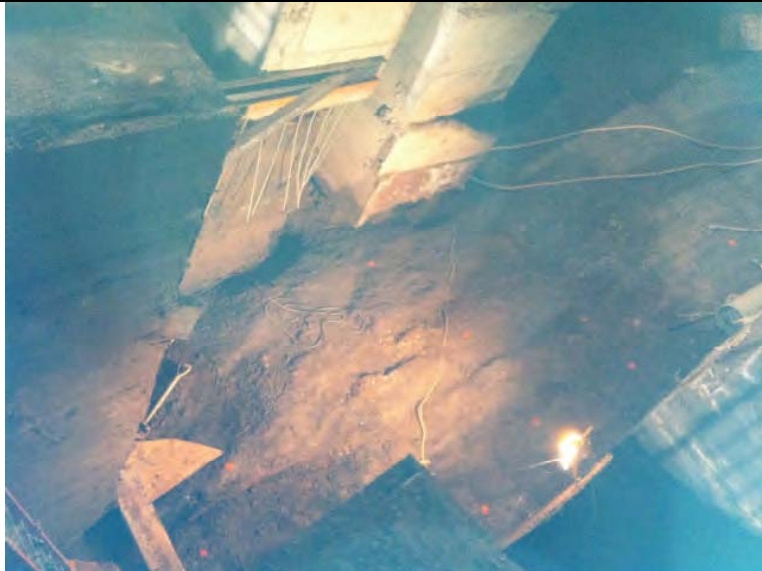
2. Phase II area excavated and cleaned to bedrock.

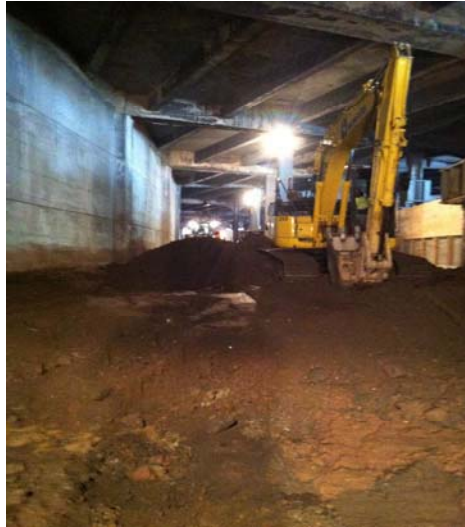
1. Excavation to slightly reduce the grade.

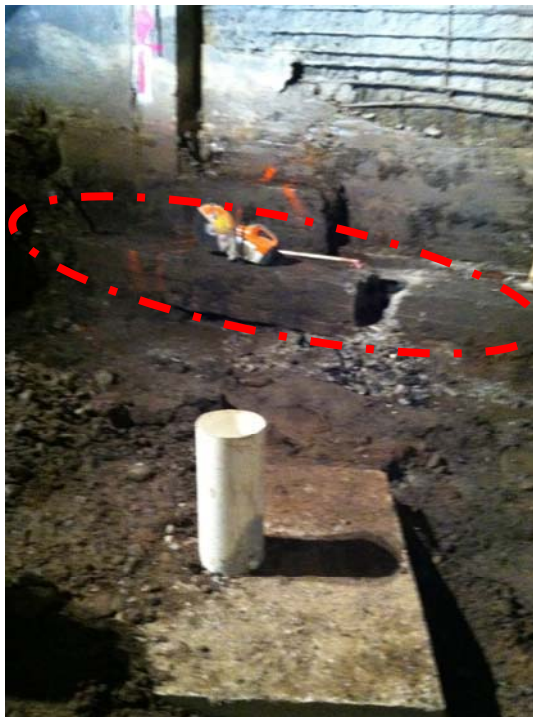
2. Pipe encountered during pier installation.

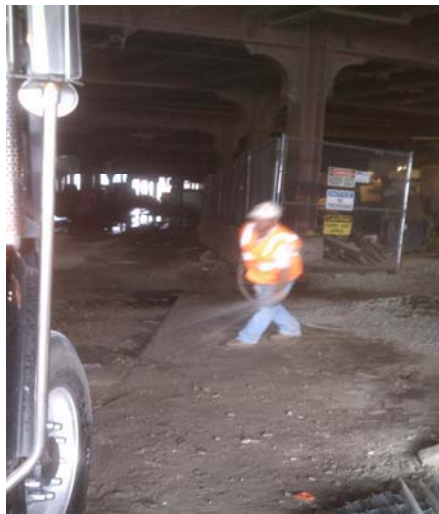
2. Dust suppression measures were implemented during soil load out

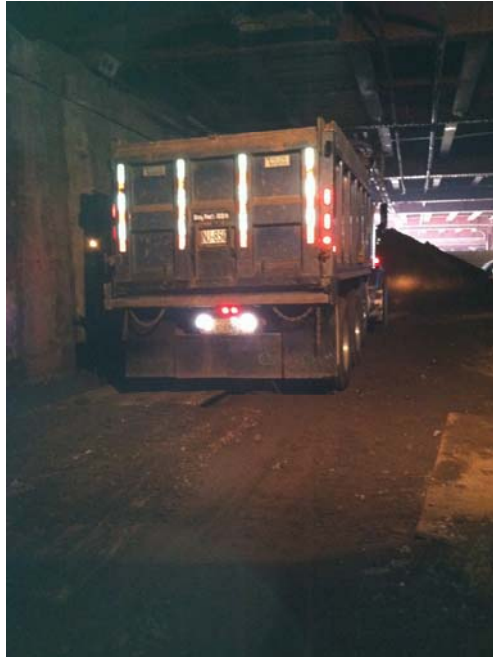
1. 16 truckloads of soil were exported to Lincoln Park West Landfill Facility in New Jersey

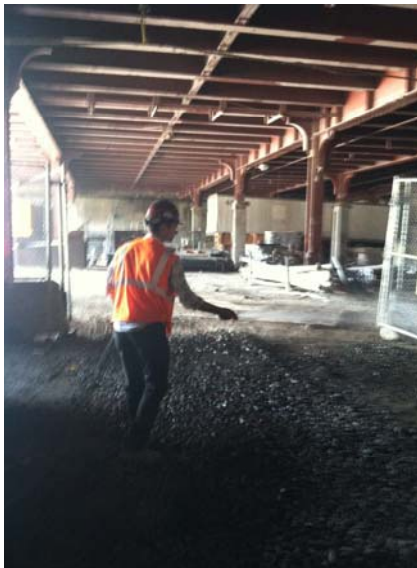
2. Dust suppression measures were implemented during soil load out

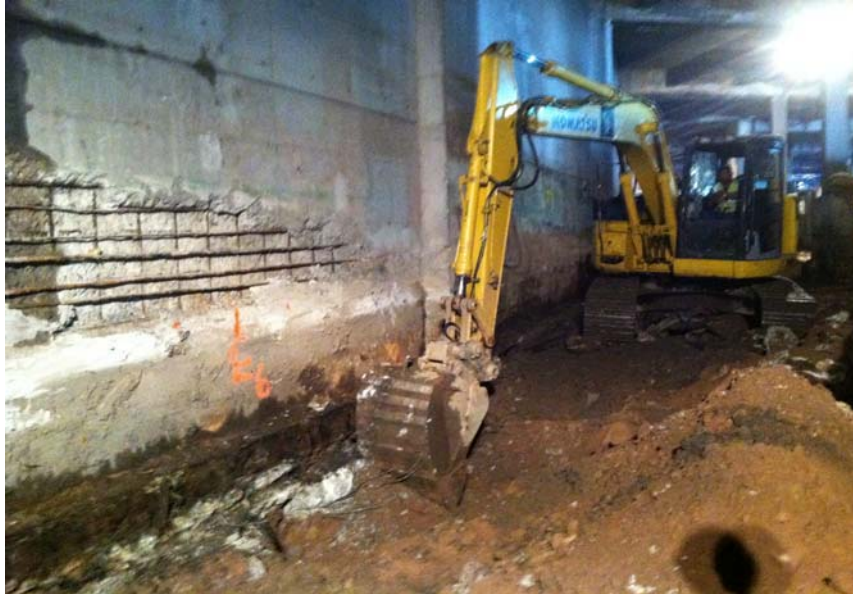
1. Minor excavation was done in preparation for Pier #6.

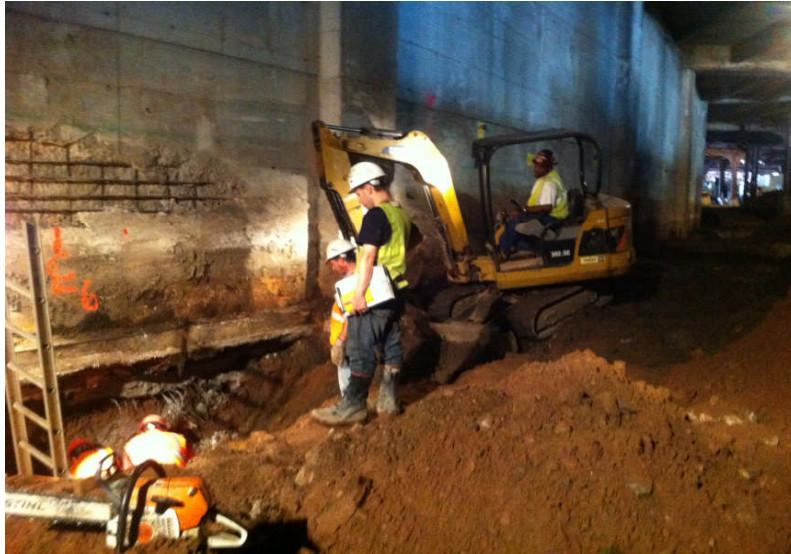
1. Excavation activities being performed via mini excavator.

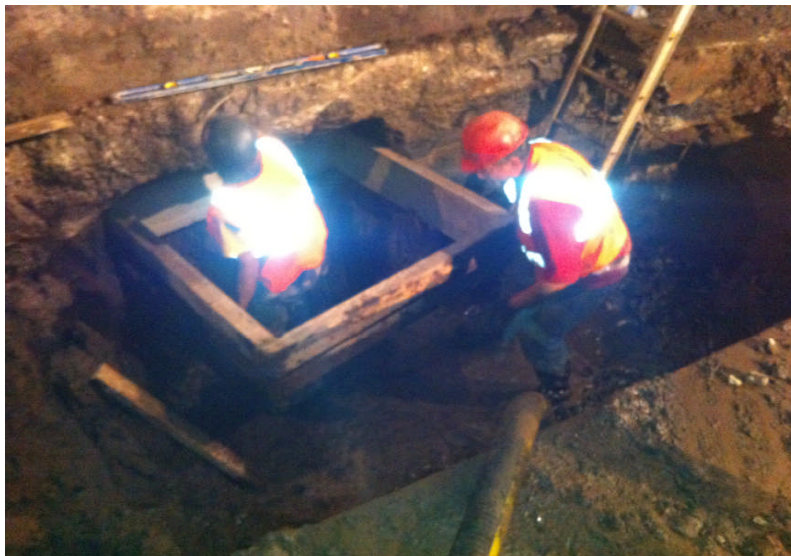
2. Framing activities at Pier #8.

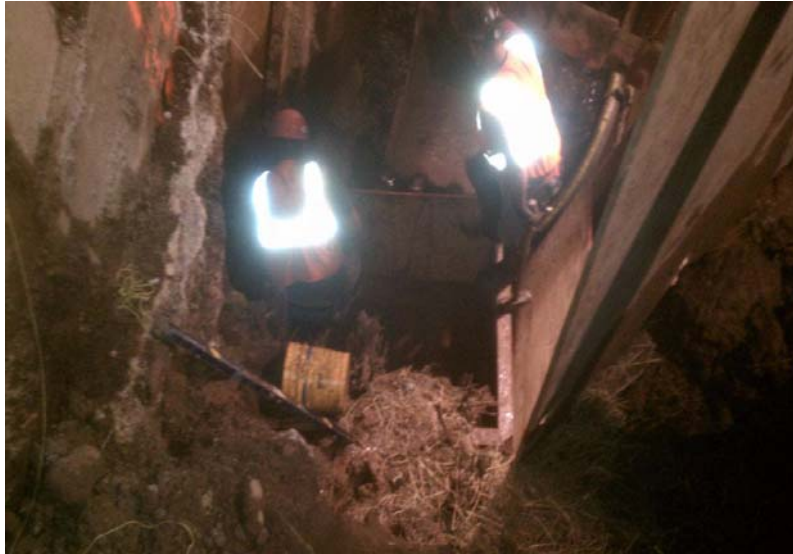
1. Framing activities taking place at Pier #4.

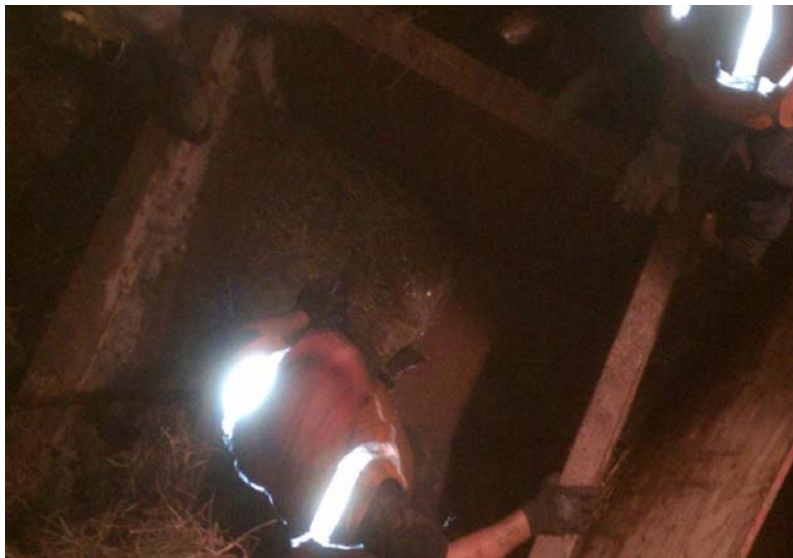
2. Bedrock encountered at Pier #4.

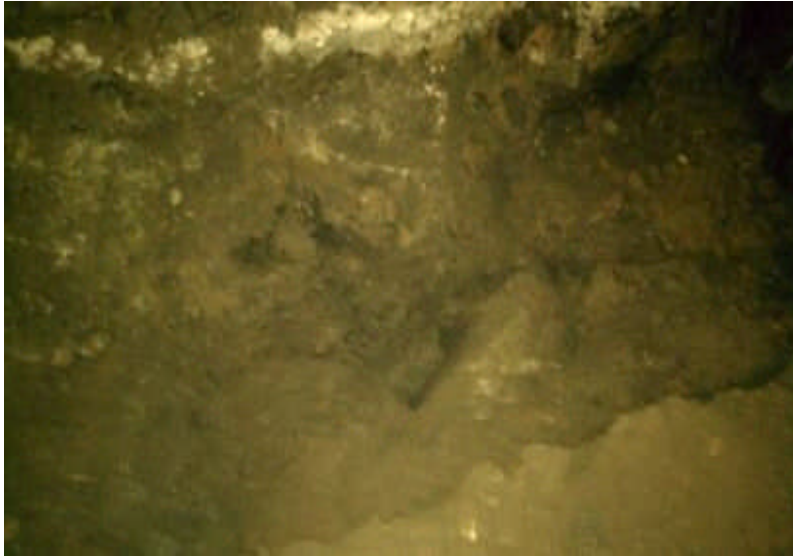
1. Bedrock encountered at Pier #7.

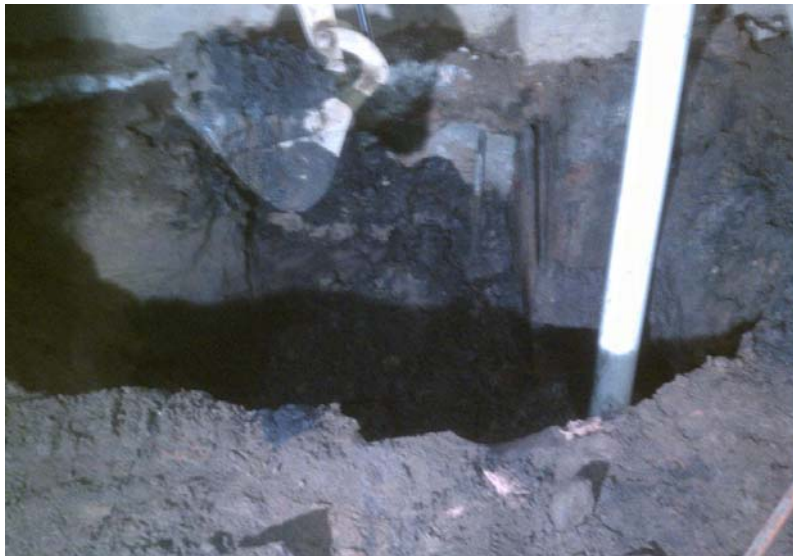
2. Dark soils encountered at Pier #9.

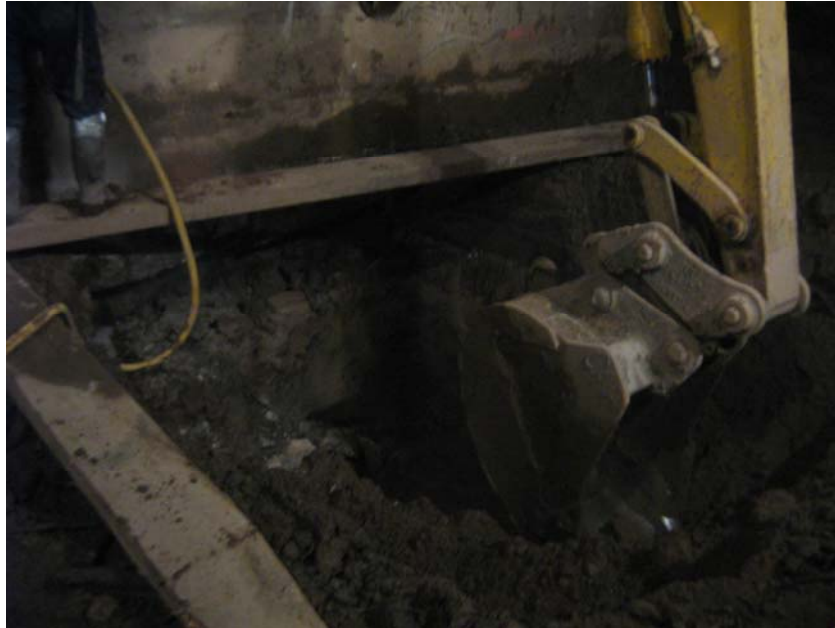
1. Pier # 11 Excavation

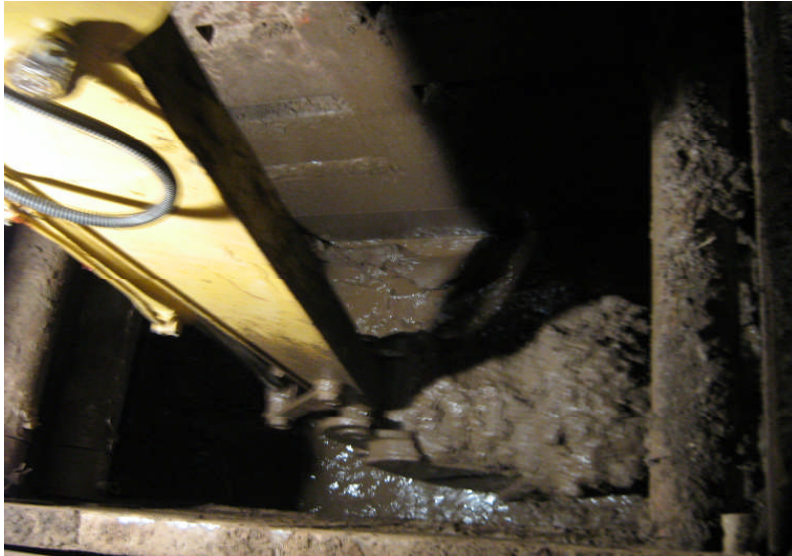
1. Excavation activities taking place at Pier #11.

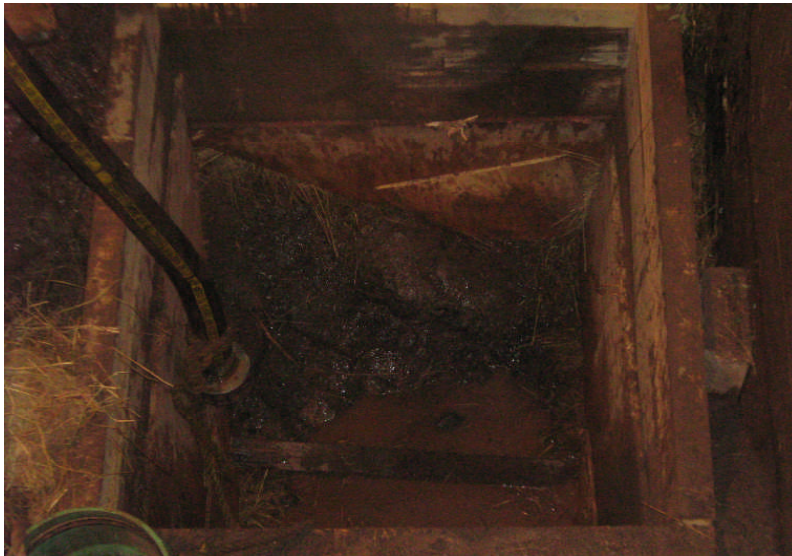
2. Bedrock encountered at Pier #11.

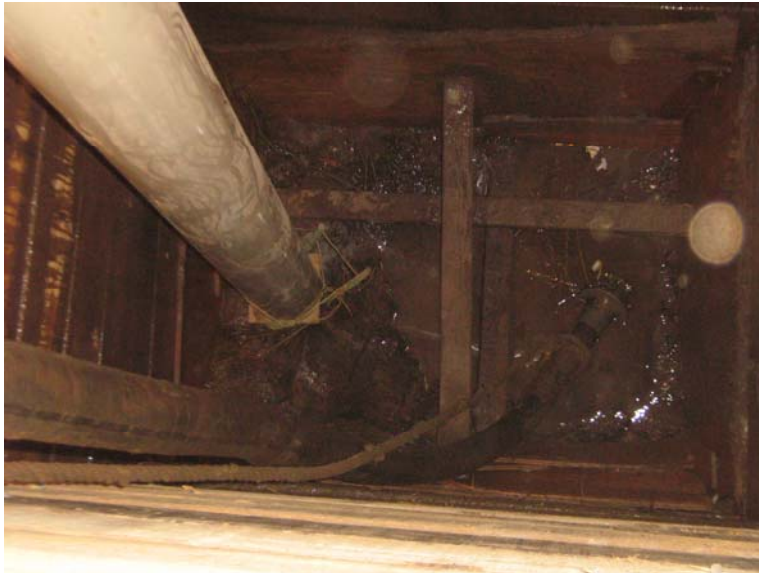
1. Pier # 11 Exposed bedrock, after additional hand cleaning, just prior to concrete installation

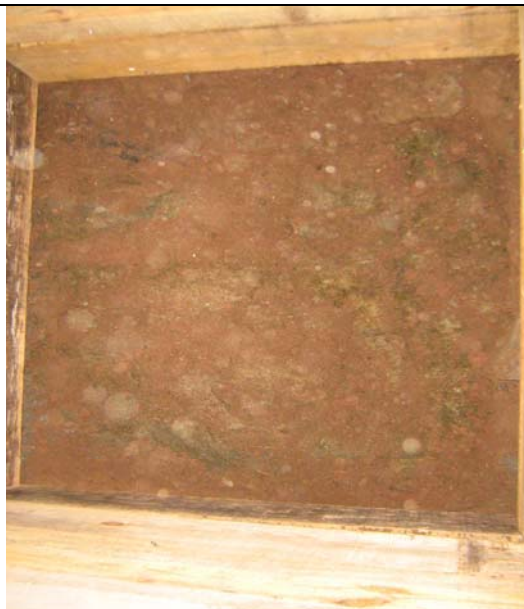
2. Pier #5 Exposed bedrock, prior to concrete installation

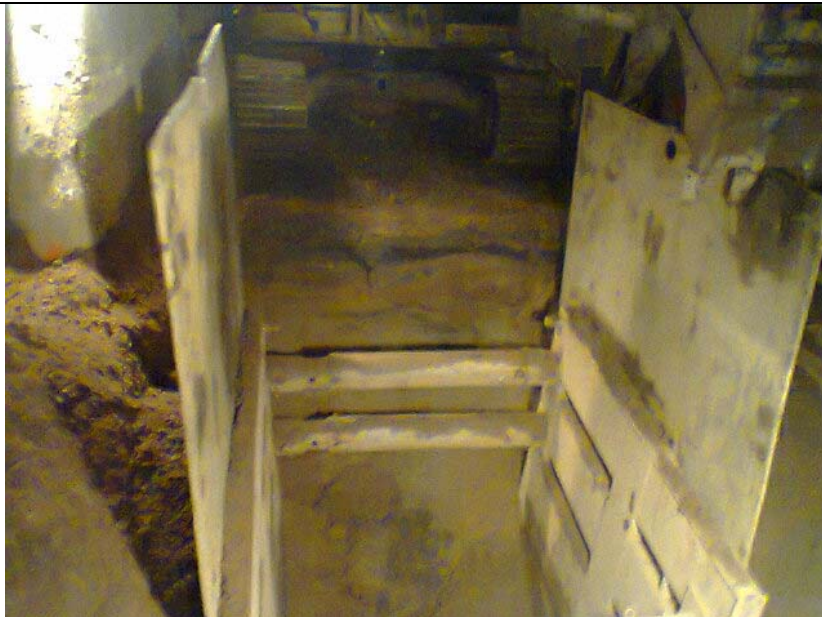
2. Trench boxes and frames were used for the Pier's mold prior to concrete installation.

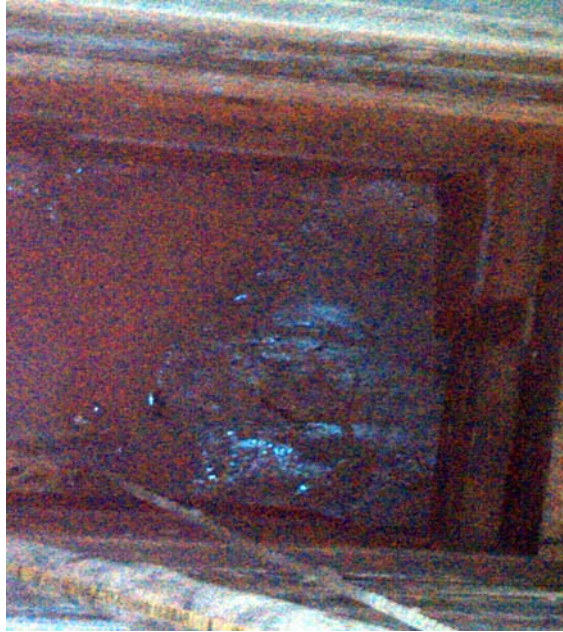
1. Pier # 12 Exposed bedrock, after additional hand cleaning, just prior to concrete installation

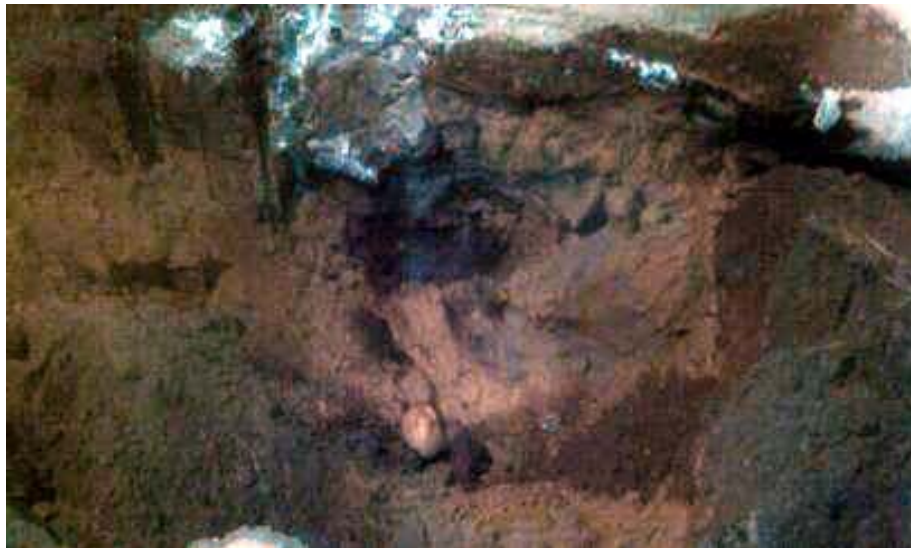
2. Impacted soils at pier # 10 with moderate odors

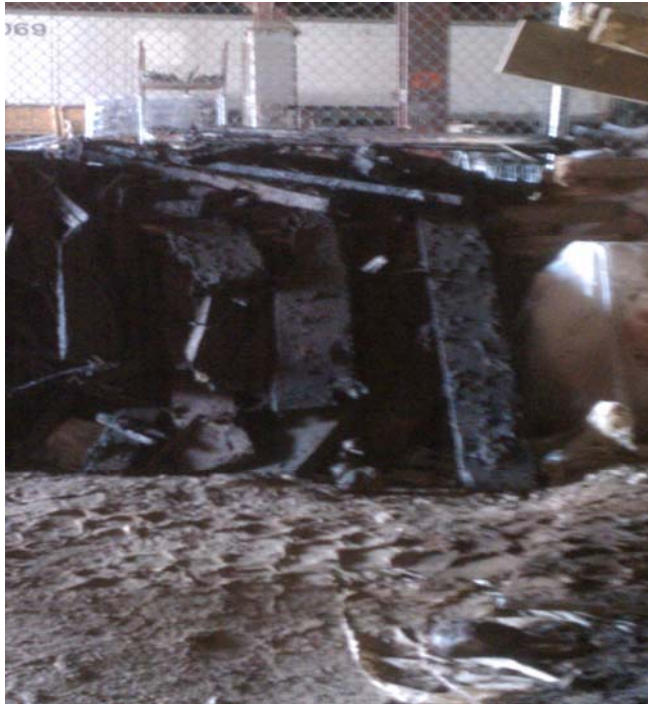
1. Saturated wood sheeting taken during excavation of Pier #13. Slight to moderate odors.

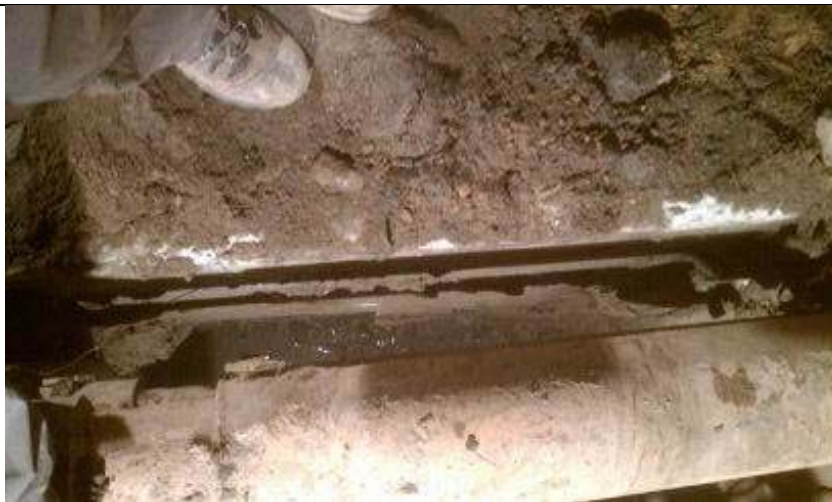
2. Pier # 13. Encountered pre-existing pier along the west wall

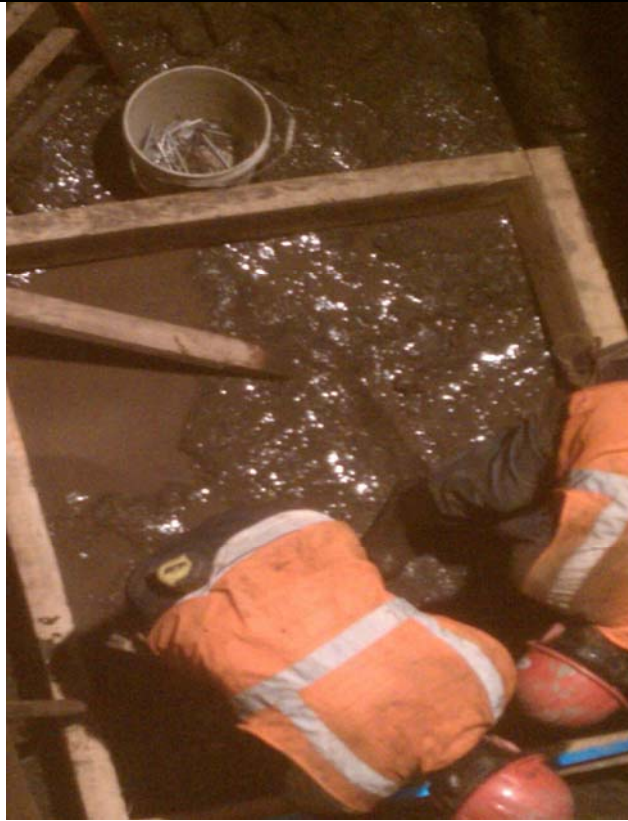
3. Pier #13 excavated down to bedrock.

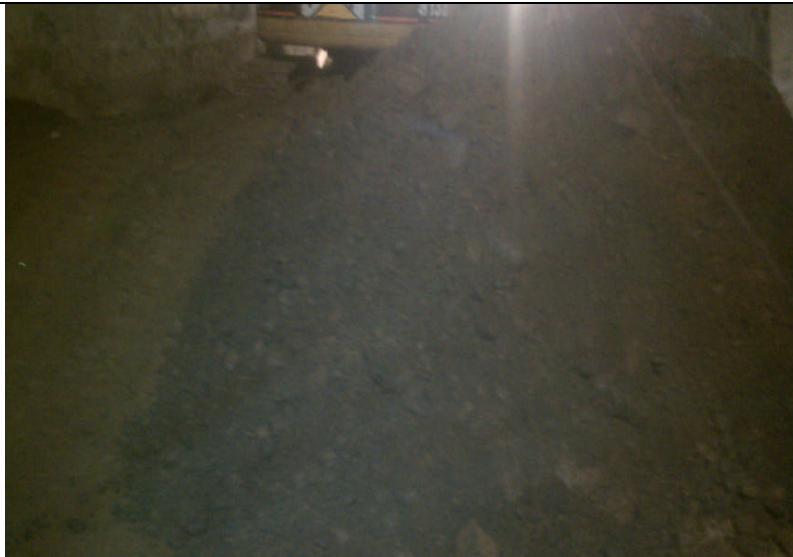
2. Soil excavated from Pier #10. Soil exhibited a petroleum odor.

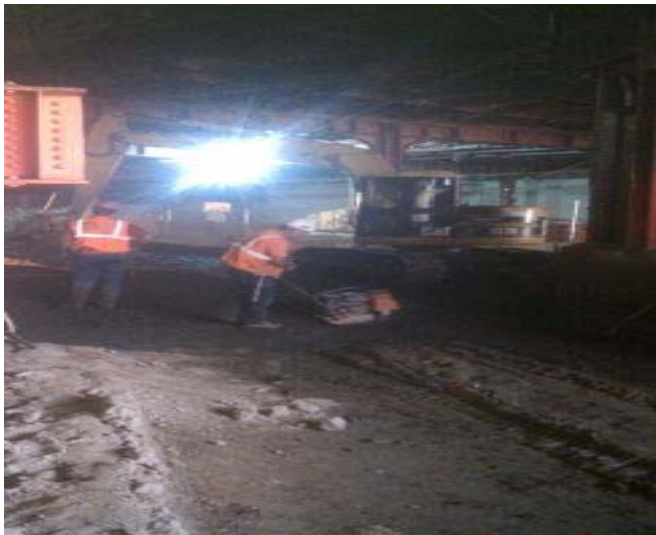
2. Phase 4 backfilled and being compacted at finished grade.

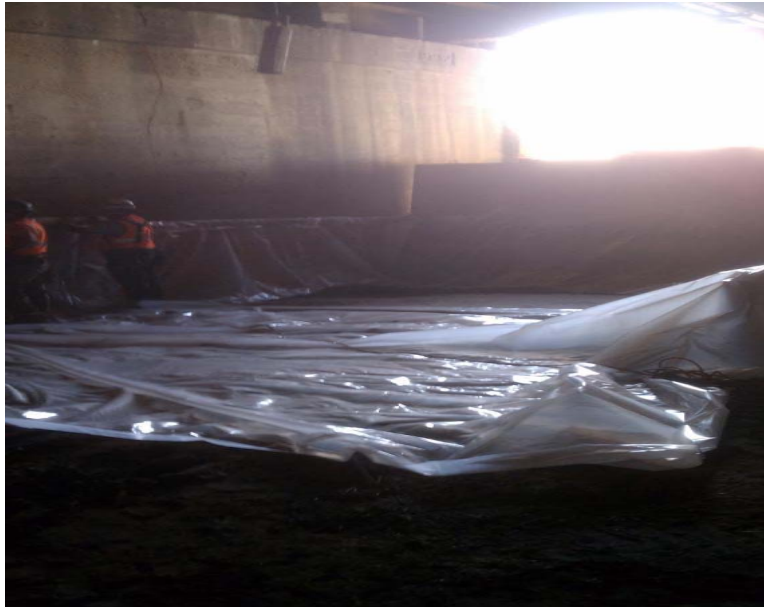
1. Impacted soil staging area set up to segregate more heavily impacted soil from less impacted soils.

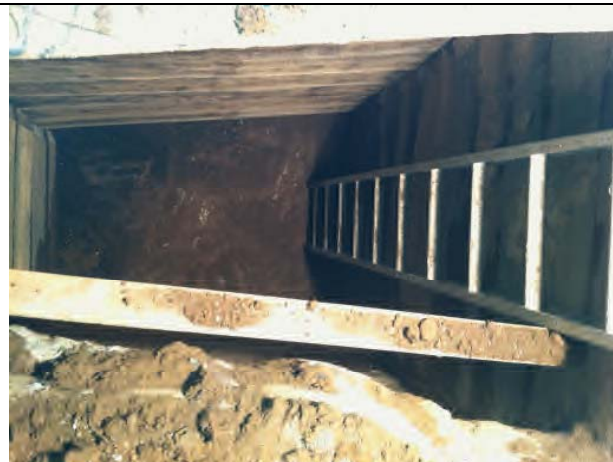
3. Section E of Phase 3 at clean bedrock
