APPENDIX K

Battered Secant Photo Log and
Engineering Sign-off

Lot 22 Secant Pile Log

Job #2139021

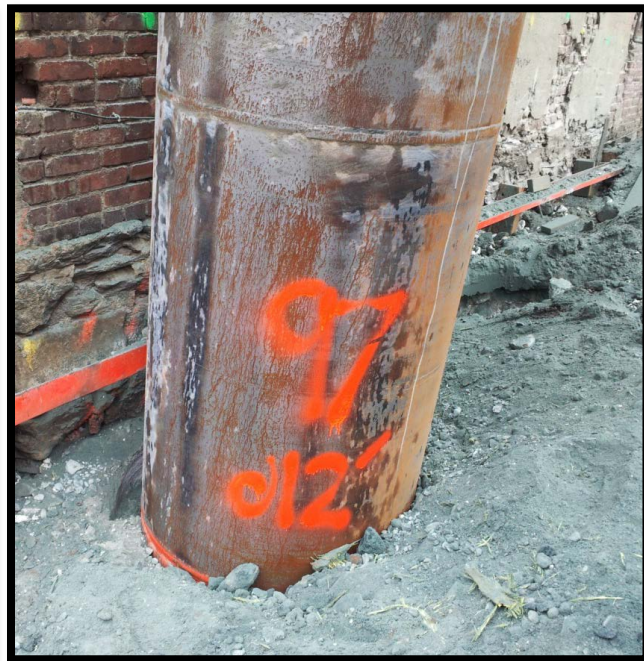
Photo 10A (left) & 10B (right): Battered secant pile #97P; confirming 6 degree tilt at EL +0 using a jig and bubble level.

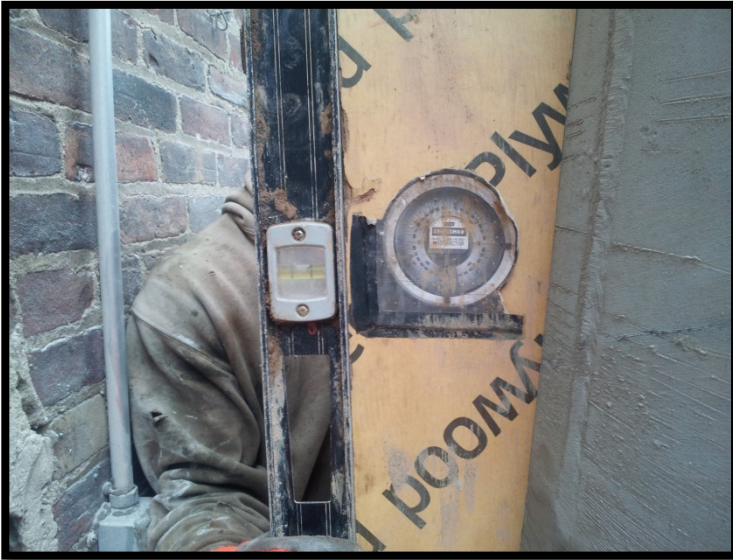
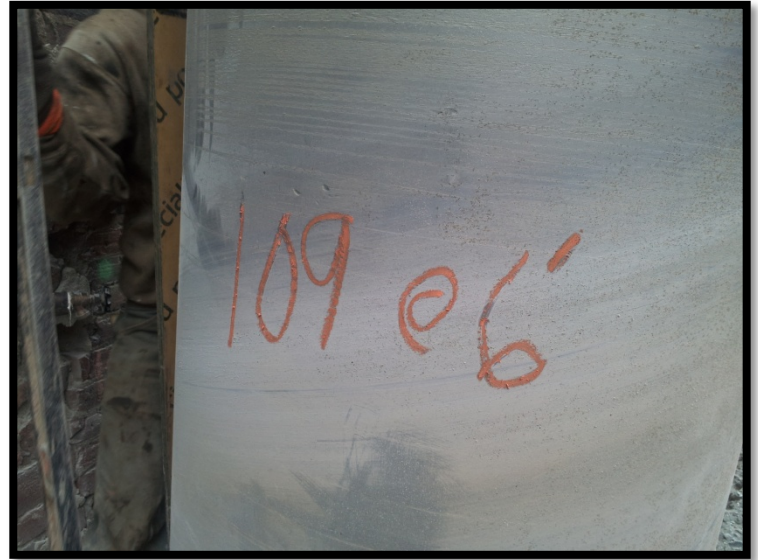
Photo 11A (left) & 11B (right): Battered secant pile #109P; confirming 6 degree tilt at EL +5 using a jig and bubble level.

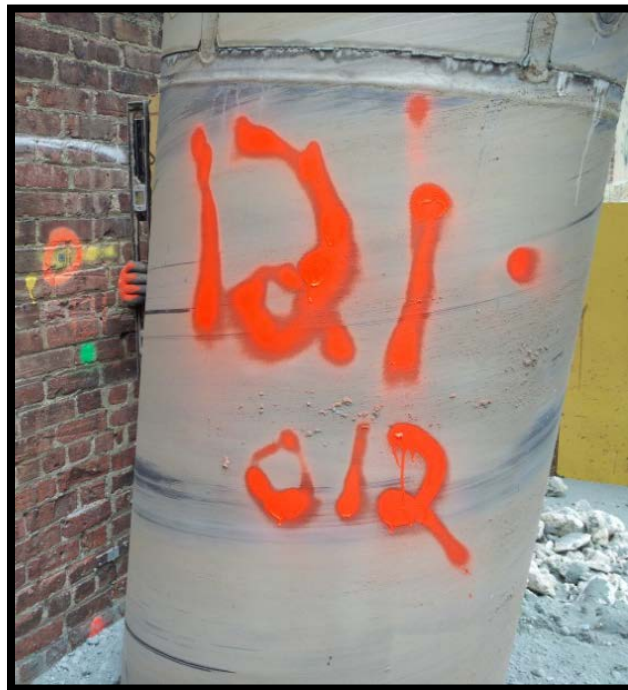
Photo 18: Battered secant pile #121P; confirming 6 degree tilt at EL +0 using a jig and bubble level.

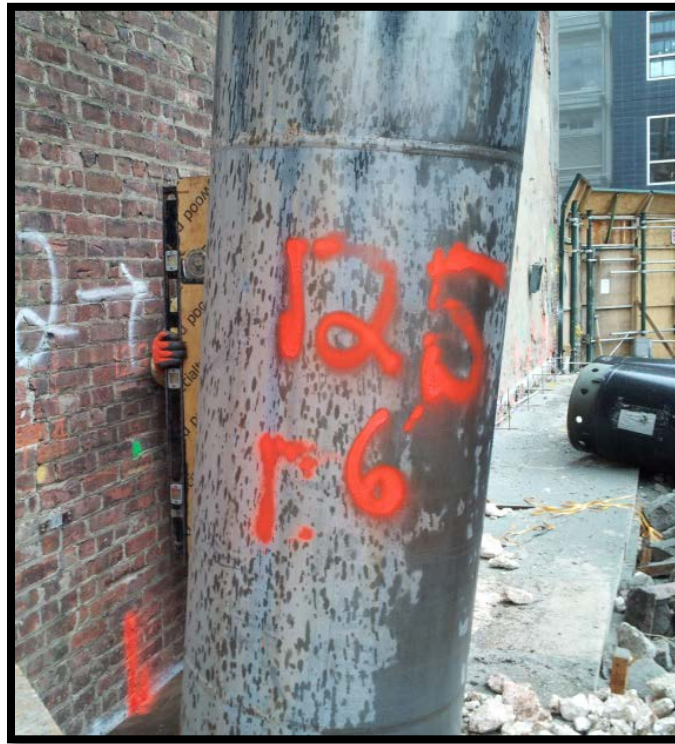
Photo 19: Battered secant pile #125P; confirming 6 degree tilt at EL +5 using a jig and bubble level.

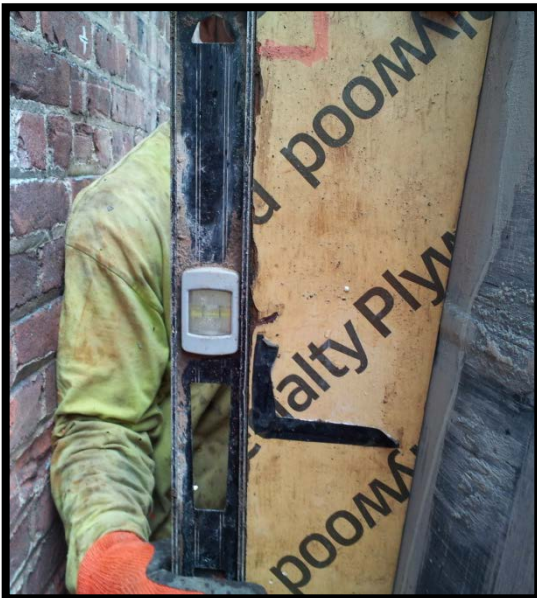
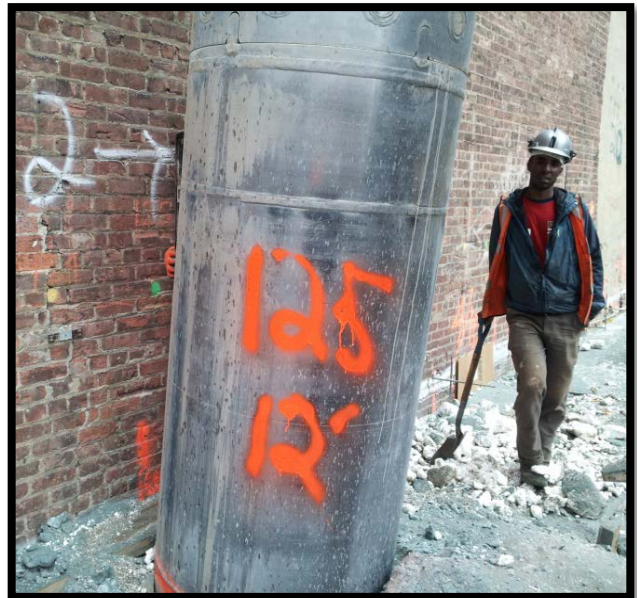
Photo 20A (left) & 20B (right): Battered secant pile #125P; confirming 6 degree tilt at EL +0 using a jig and bubble level.

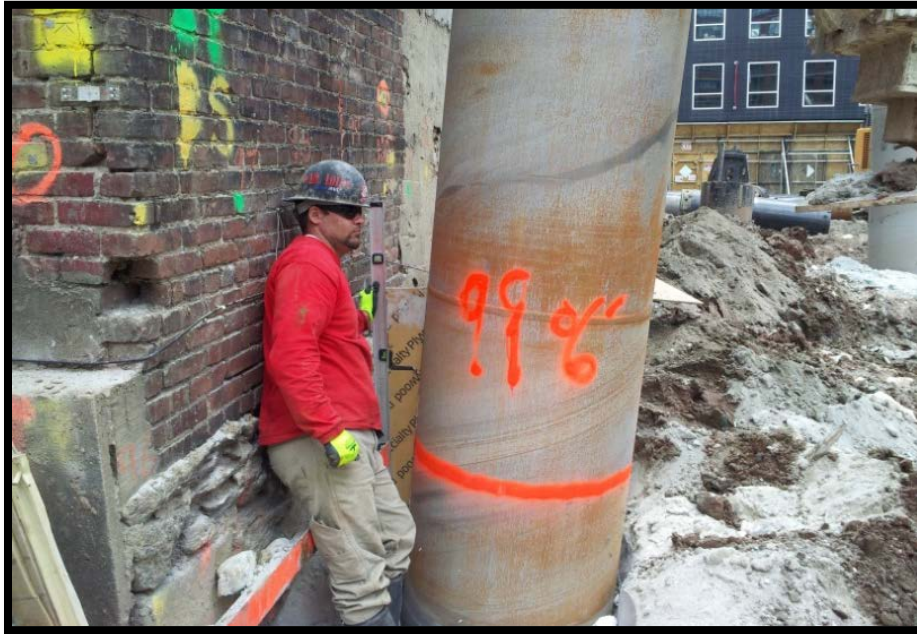
Photo 21: Battered secant pile #99P; confirming 6 degree tilt at EL +5 using a jig and bubble level.

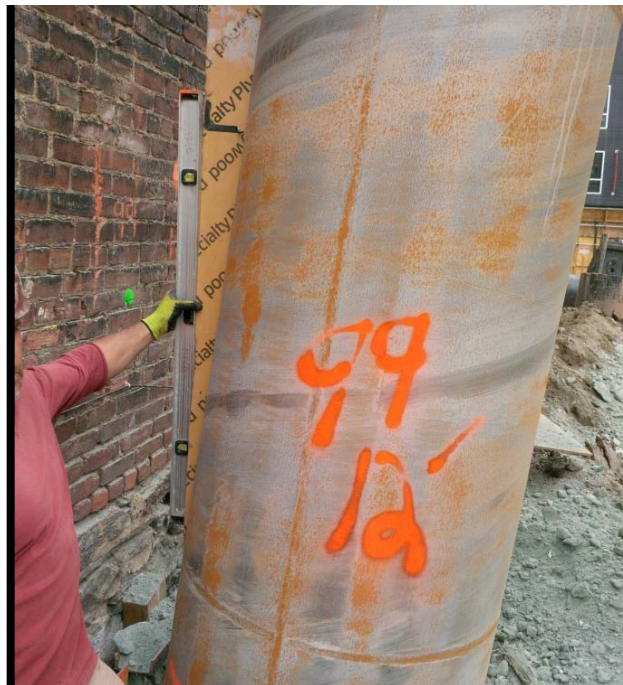
Photo 22: Battered secant pile #99P; confirming 6 degree tilt at EL +0 using a jig and bubble level.

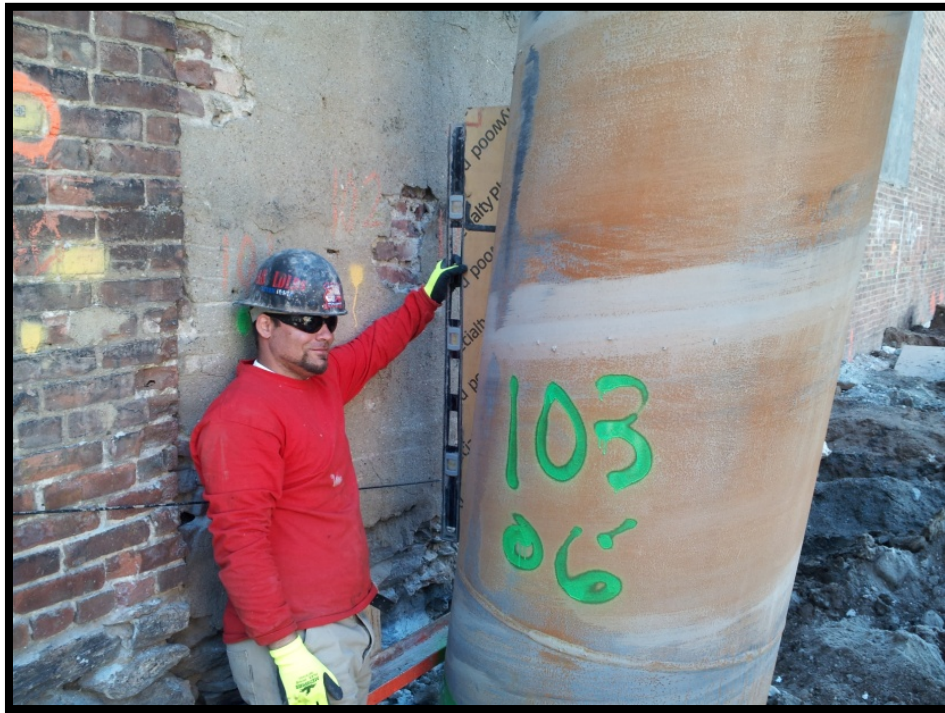
Photo 23: Battered secant pile #103P; confirming 6 degree tilt at EL +5 using a jig and bubble level.

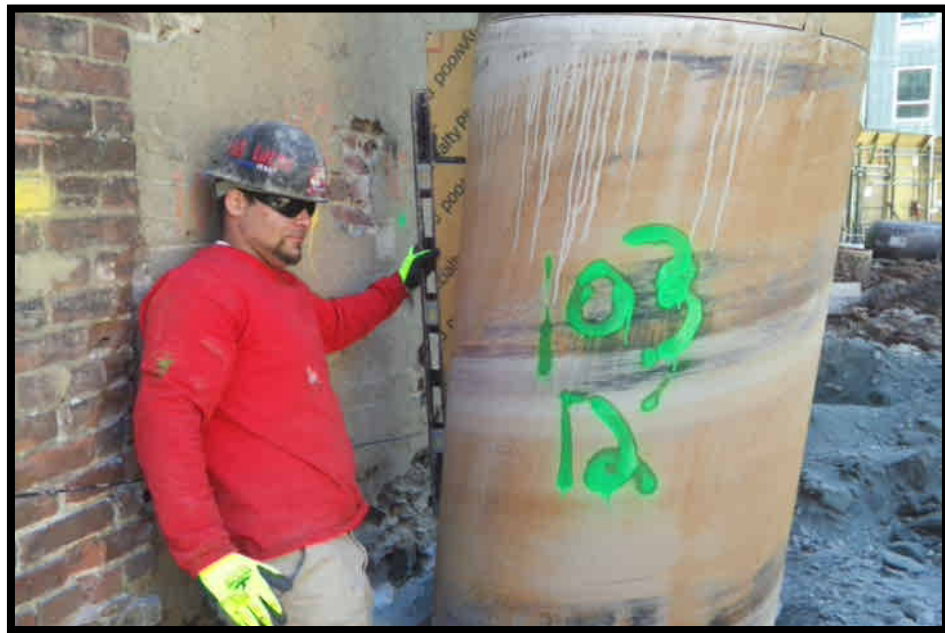
Photo 24: Battered secant pile #103P; confirming 6 degree tilt at EL +0 using a jig and bubble level.

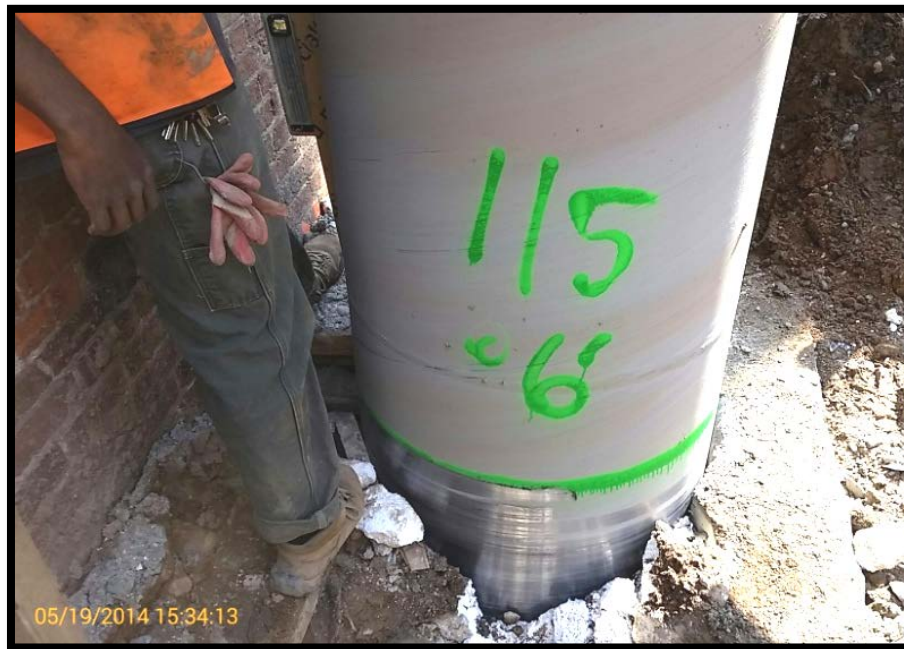
Photo 25: Battered secant pile #115P; confirming 6 degree tilt at EL +5 using a jig and bubble level.

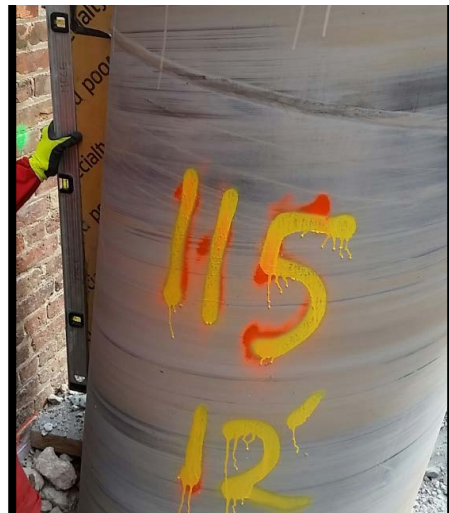
Photo 26: Battered secant pile #115P; confirming 6 degree tilt at EL +0 using a jig and bubble level.

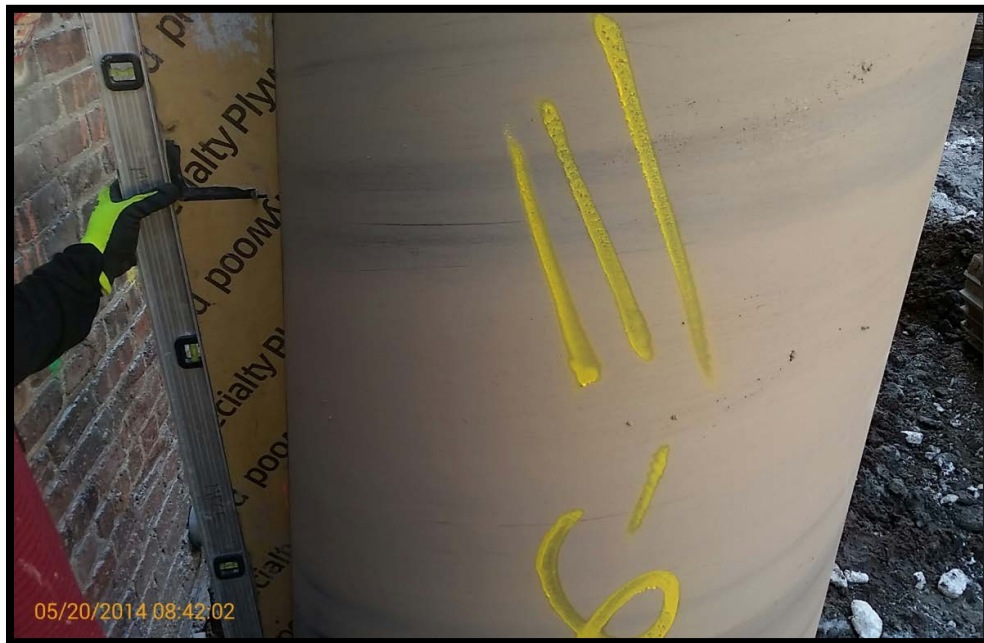
Photo 27: Battered secant pile #111P; confirming 6 degree tilt at EL +5 using a jig and bubble level.

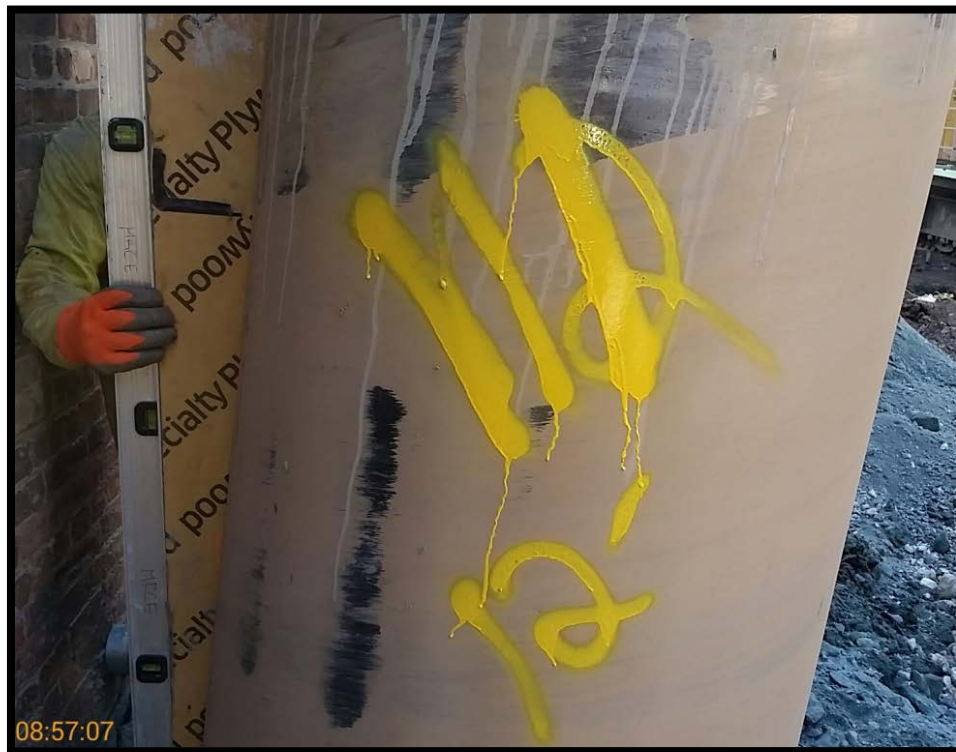
Photo 28: Battered secant pile #111P; confirming 6 degree tilt at EL +0 using a jig and bubble level.

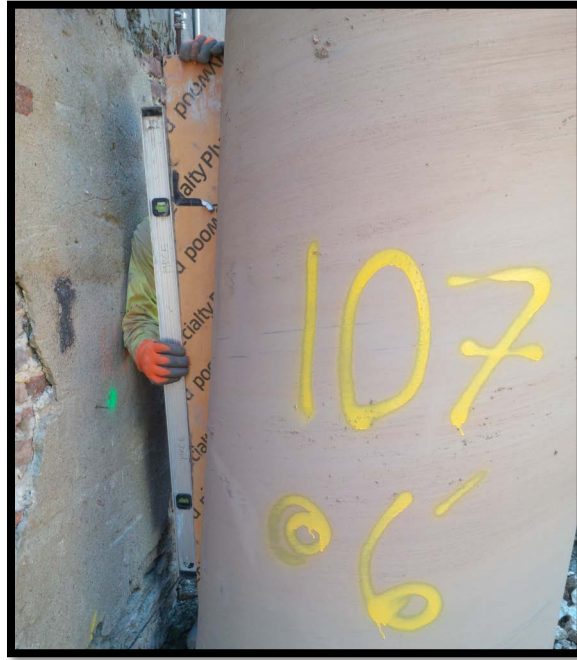
Photo 29: Battered secant pile #107P; confirming 6 degree tilt at EL +5 using a jig and bubble level.

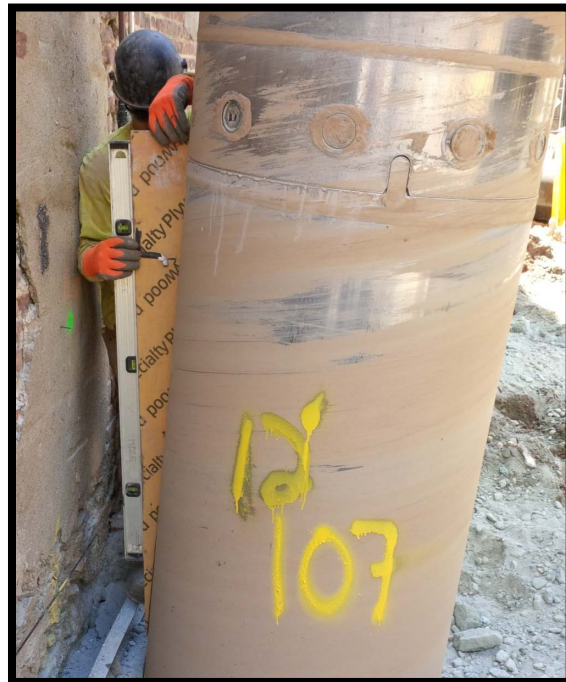
Photo 30: Battered secant pile #107P; confirming 6 degree tilt at EL +0 using a jig and bubble level.

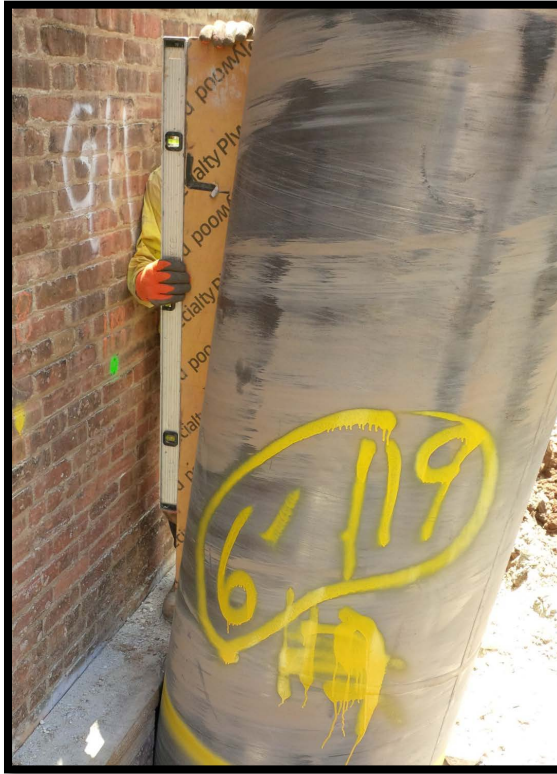
Photo 31: Battered secant pile #119P; confirming 6 degree tilt at EL +5 using a jig and bubble level.

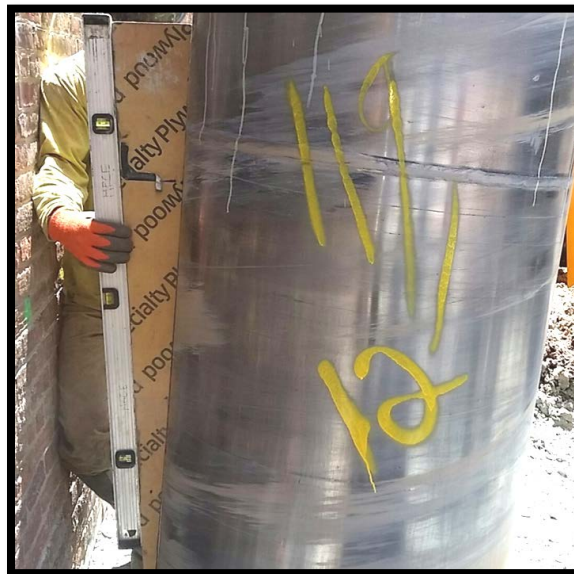
Photo 32: Battered secant pile #119P; confirming 6 degree tilt at EL +0 using a jig and bubble level.

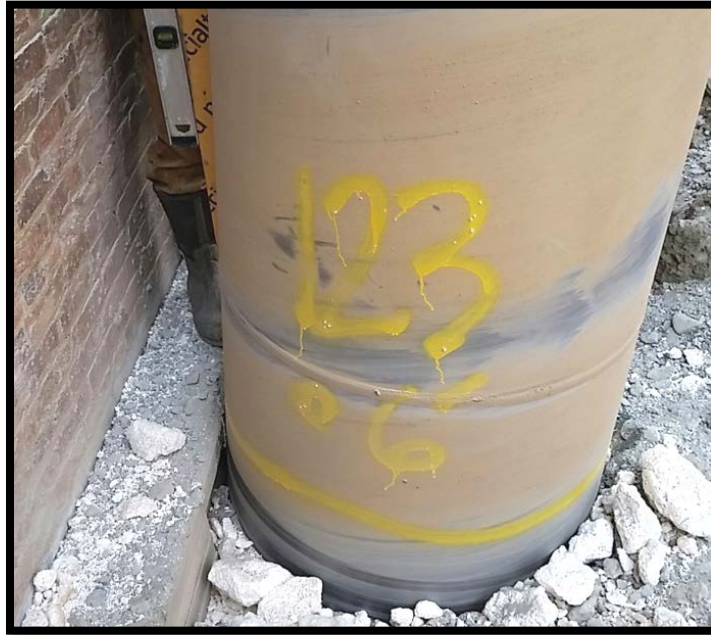
Photo 33: Battered secant pile #123; confirming 6 degree tilt at EL +5 using a jig and bubble level.

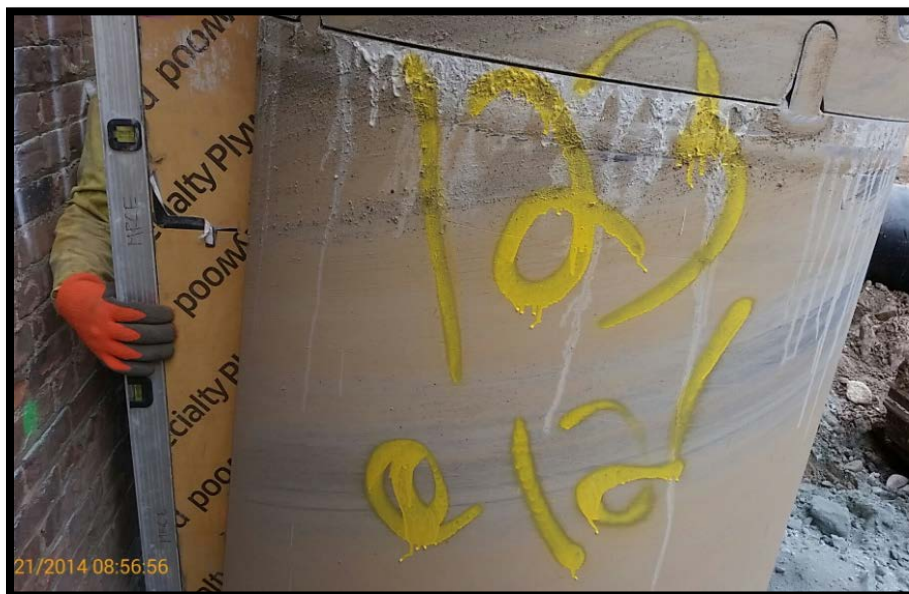
Photo 34: Battered secant pile #123P; confirming 6 degree tilt at EL +0 using a jig and bubble level.

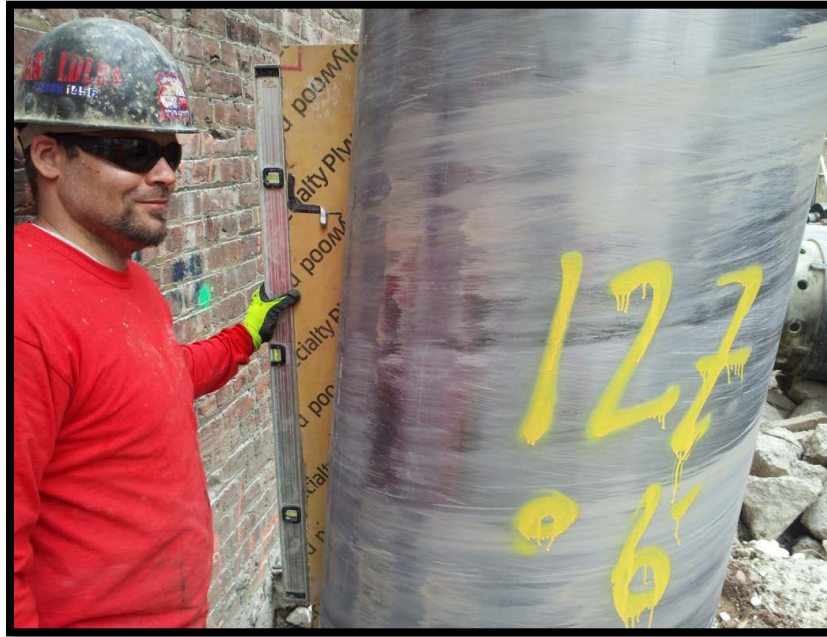
Photo 35: Battered secant pile #127P; confirming 6 degree tilt at EL +5 using a jig and bubble level.

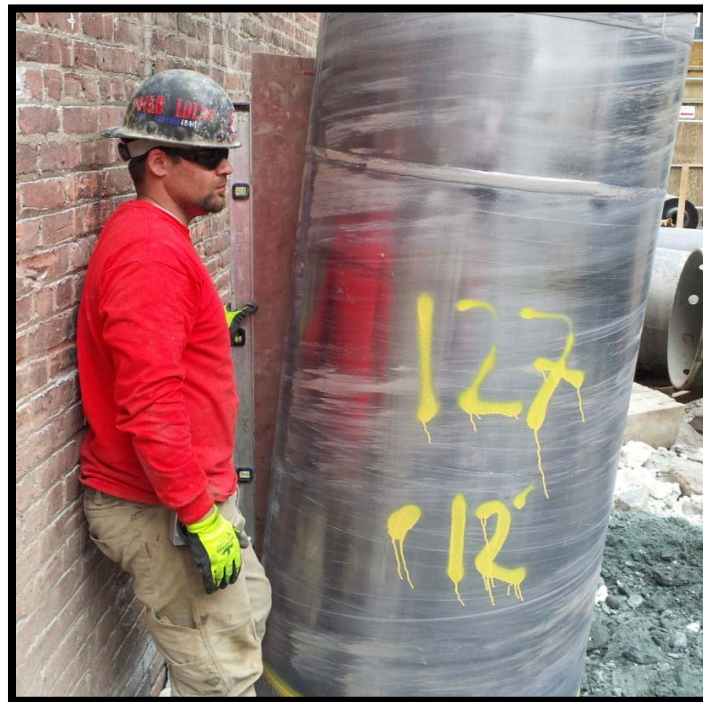
Photo 36: Battered secant pile #127P; confirming 6 degree tilt at EL +0 using a jig and bubble level.

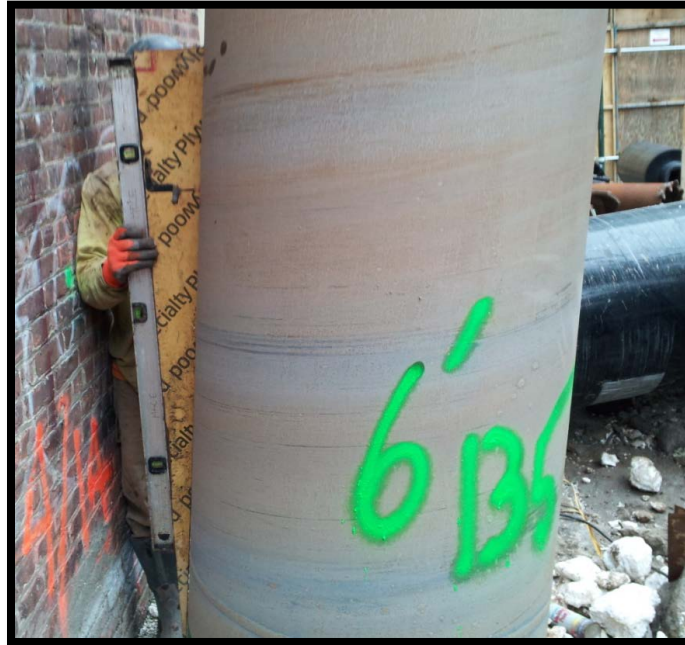
Photo 39: Battered secant piling #135P; confirming 6 degree tilt at EL +5 using a jig and bubble level.

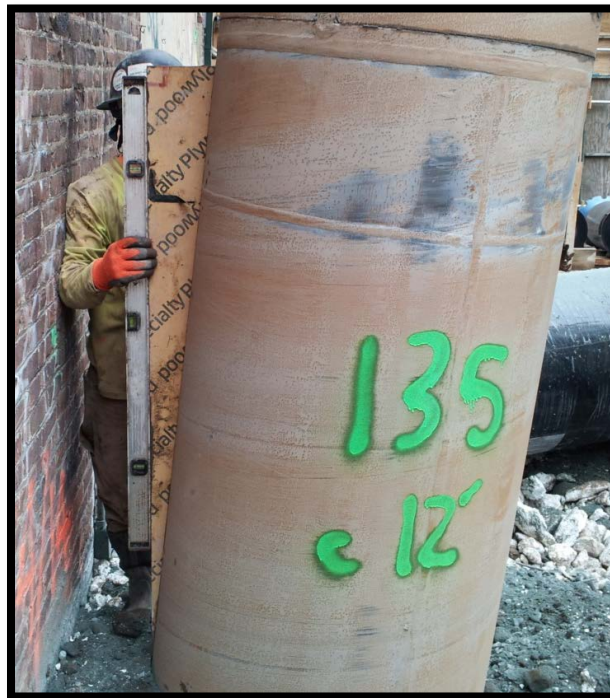
Photo 40: Battered secant pile #135P; confirming 6 degree tilt at EL +0 using a jig and bubble level.

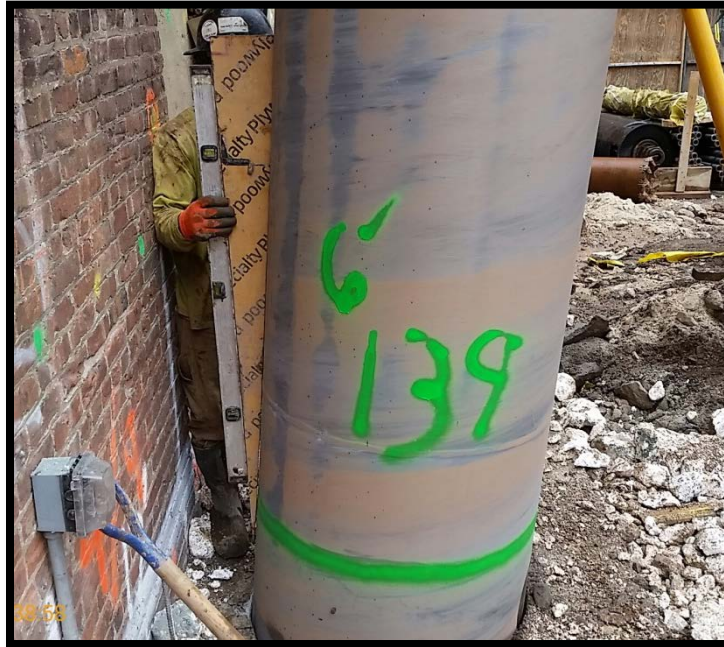
Photo 41: Battered secant pile #139P; confirming 6 degree tilt at EL +5 using a jig and bubble level.

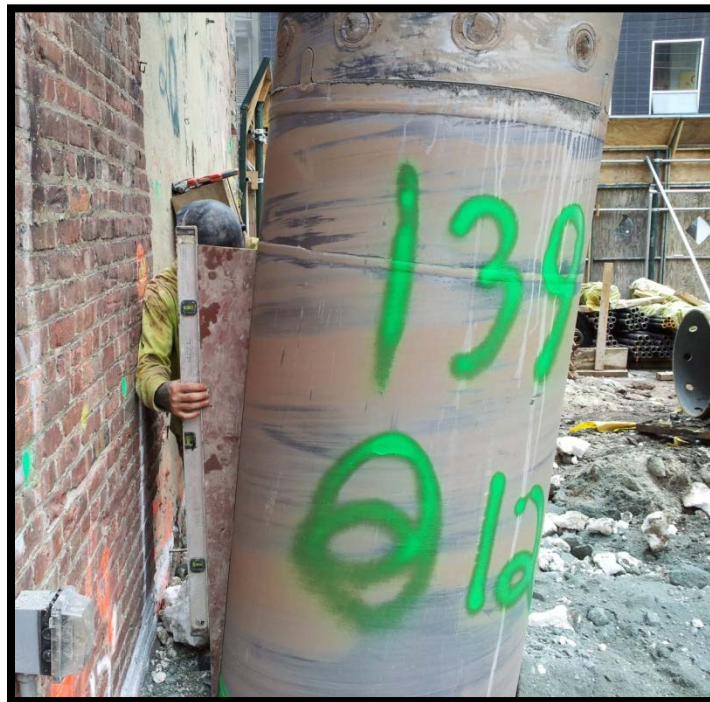
Photo 42: Battered secant pile #139P; confirming 6 degree tilt at EL +0 using a jig and bubble level.

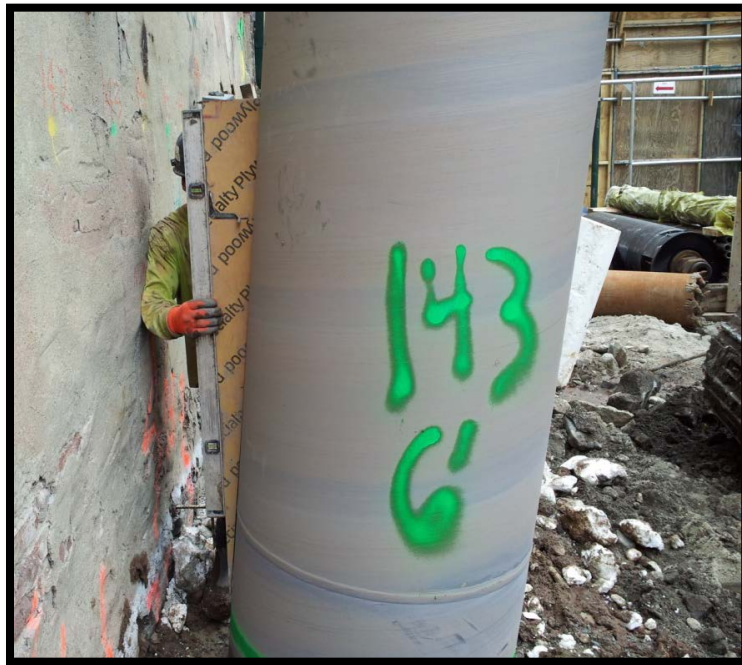
Photo 43: Battered secant pile #143P; confirming 6 degree tilt at EL +5 using a jig and bubble level.

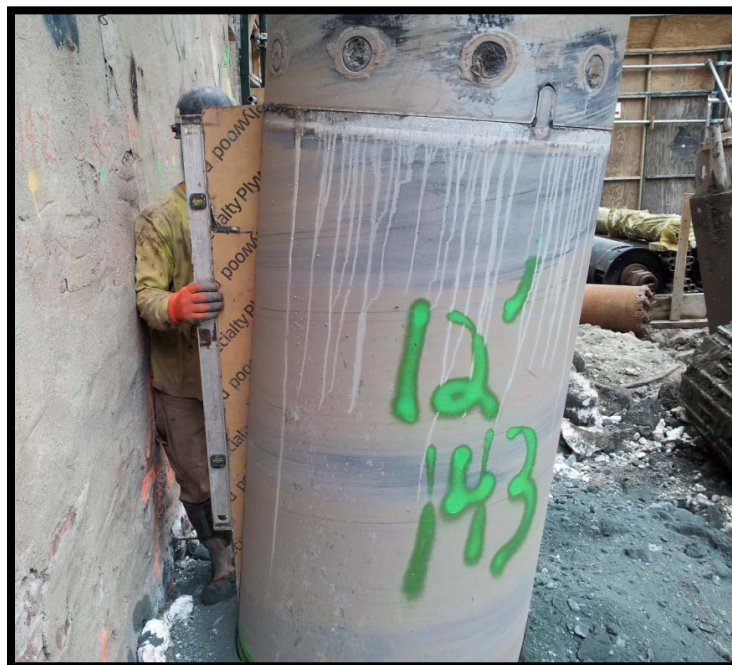
Photo 44: Battered secant pile #143P; confirming 6 degree tilt at EL +0 using a jig and bubble level.

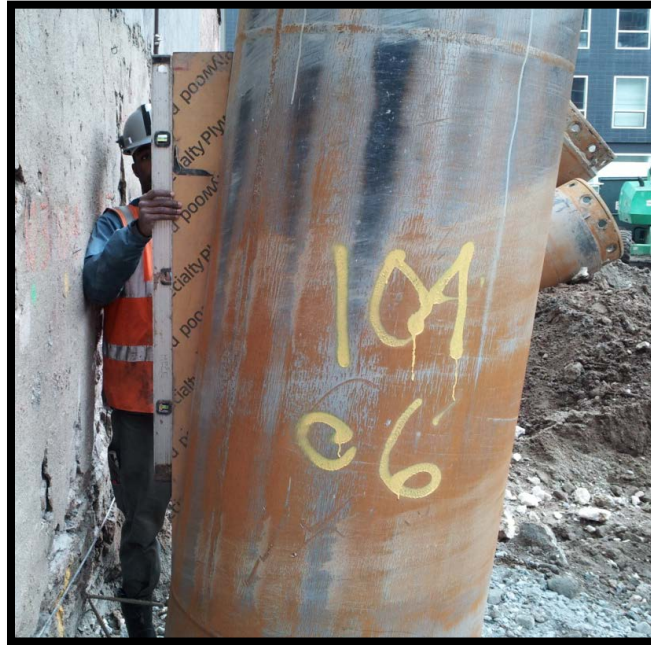
Photo 45: Battered secant pile #104S; confirming 6 degree tilt at EL +5 using a jig and bubble level.

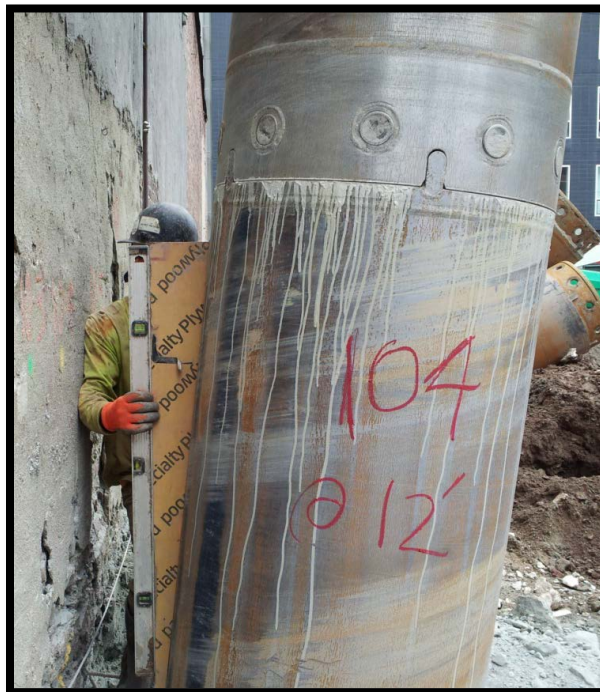
Photo 46: Battered secant pile #104S; confirming 6 degree tilt at EL +0 using a jig and bubble level.

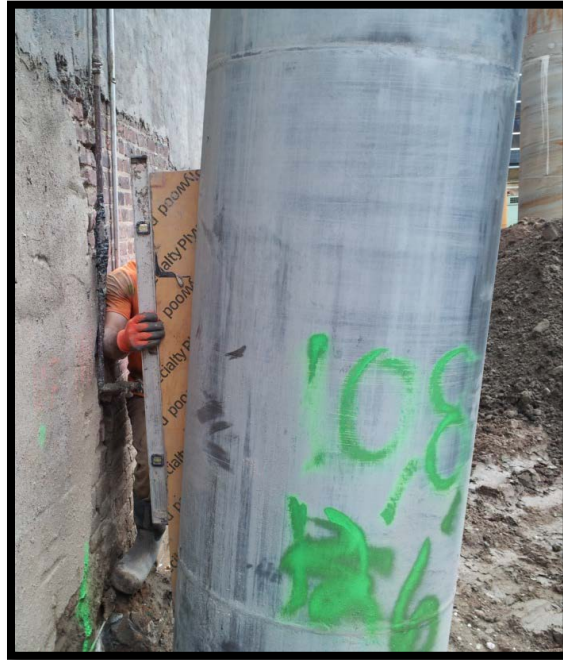
Photo 47: Battered secant pile #108S; confirming 6 degree tilt at EL +5 using a jig and bubble level.

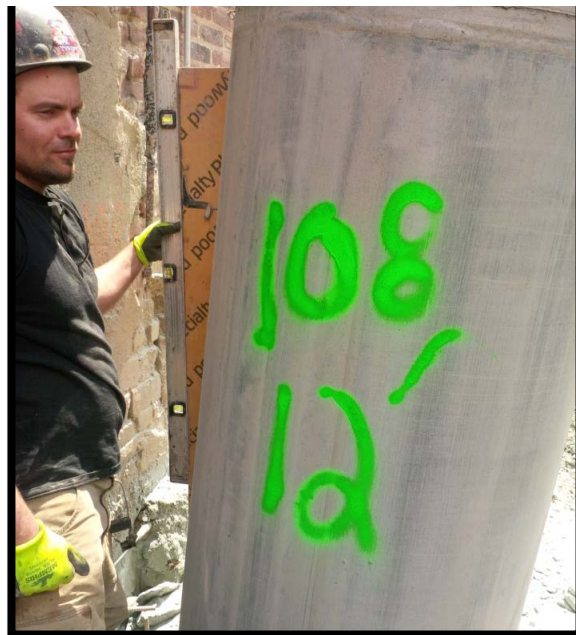
Photo 48: Battered secant pile #108S; confirming 6 degree tilt at EL +0 using a jig and bubble level.

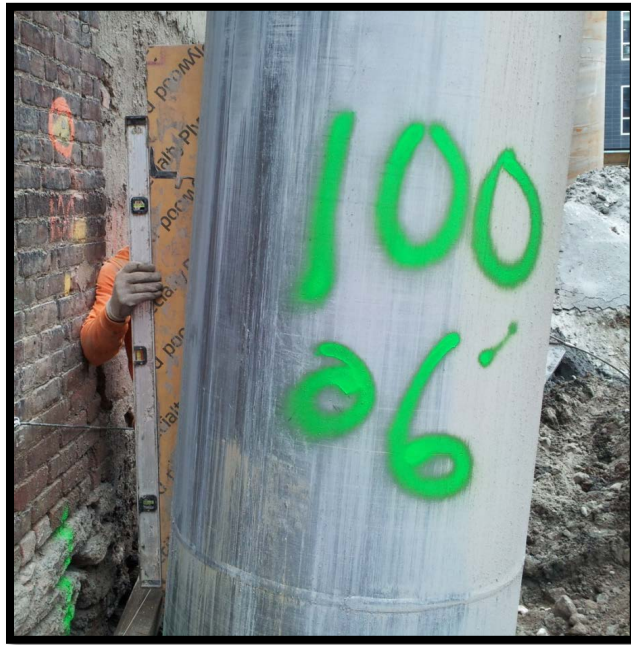
Photo 49: Battered secant pile #100S; confirming 6 degree tilt at EL +5 using a jig and bubble level.

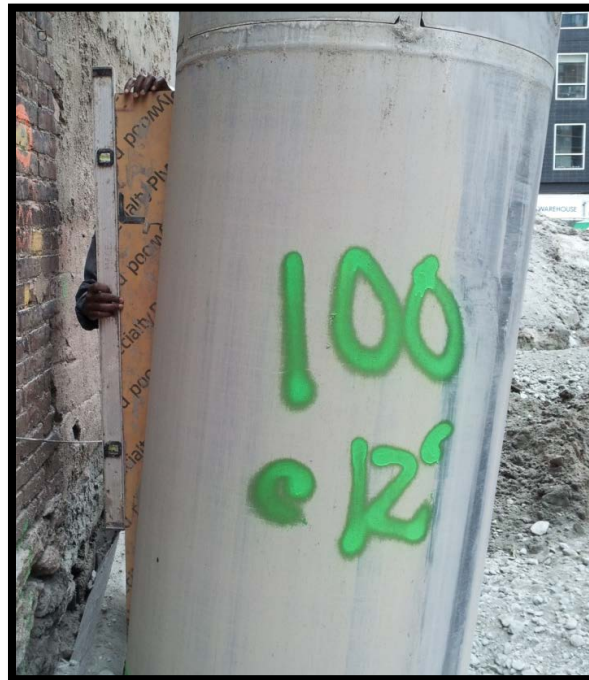
Photo 50: Battered secant pile #100S; confirming 6 degree tilt at EL +0 using a jig and bubble level.

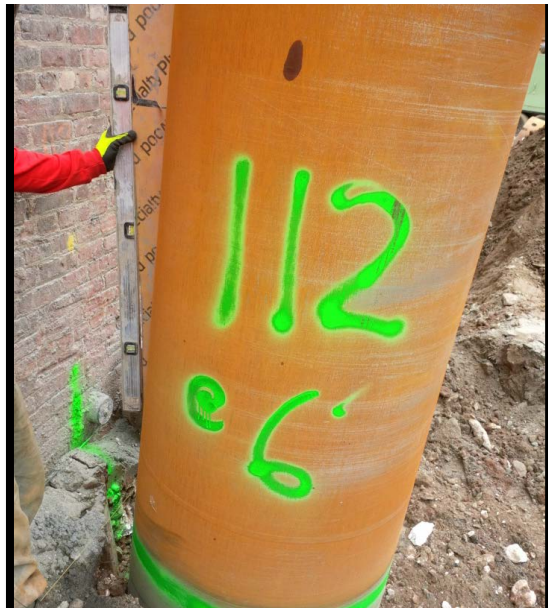
Photo 51: Battered secant pile #112S; confirming 6 degree tilt at EL +5 using a jig and bubble level.

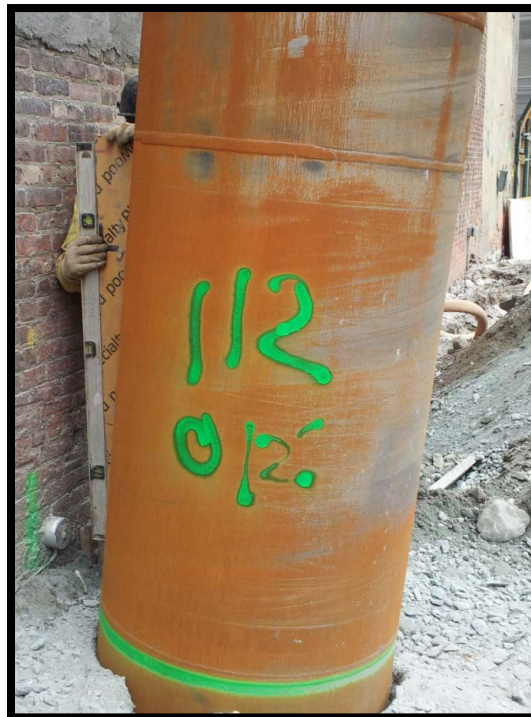
Photo 52: Battered secant pile #112S; confirming 6 degree tilt at EL +0 using a jig and bubble level.

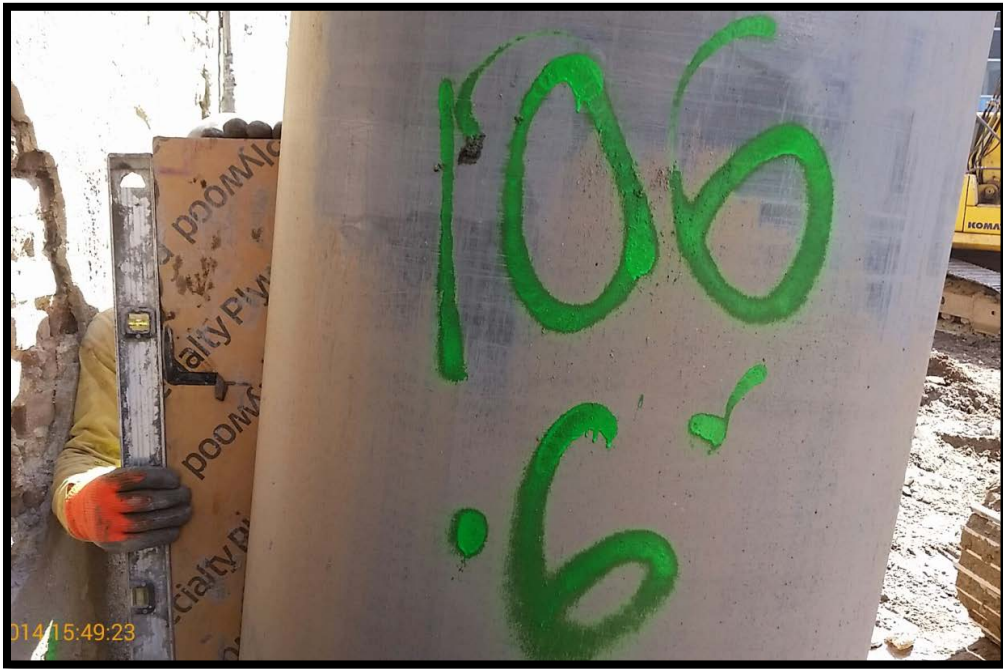
Photo 53: Battered secant pile #106S; confirming 6 degree tilt at EL +5 using a jig and bubble level.

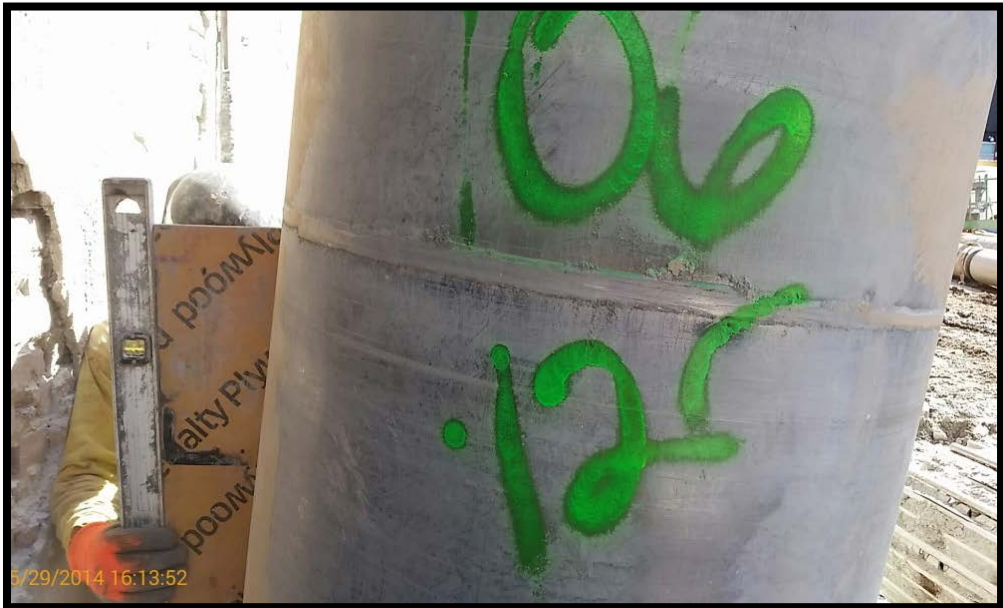
Photo 54: Battered secant pile #106S; confirming 6 degree tilt at EL +0 using a jig and bubble level.

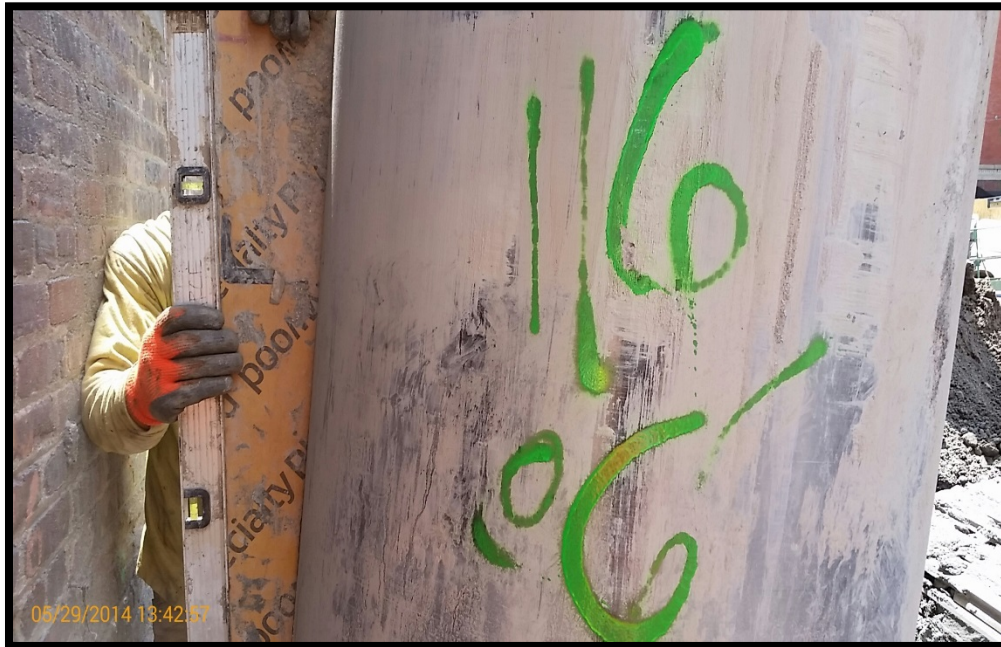
Photo 55: Battered secant pile #116S; confirming 6 degree tilt at EL +5 using a jig and bubble level.

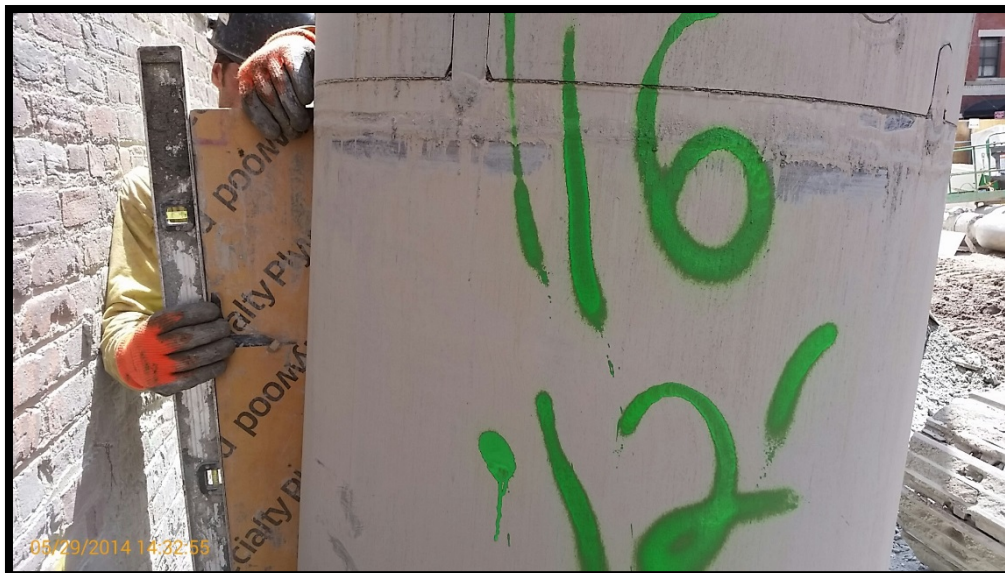
Photo 56: Battered secant pile #116S; confirming 6 degree tilt at EL +0 using a jig and bubble level.

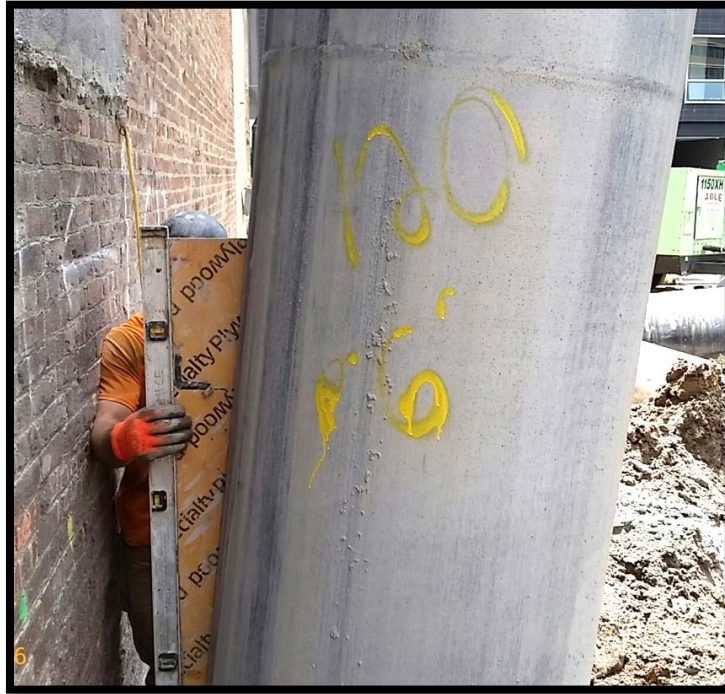
Photo 57: Battered secant pile #120S; confirming 6 degree tilt at EL +5 using a jig and bubble level.

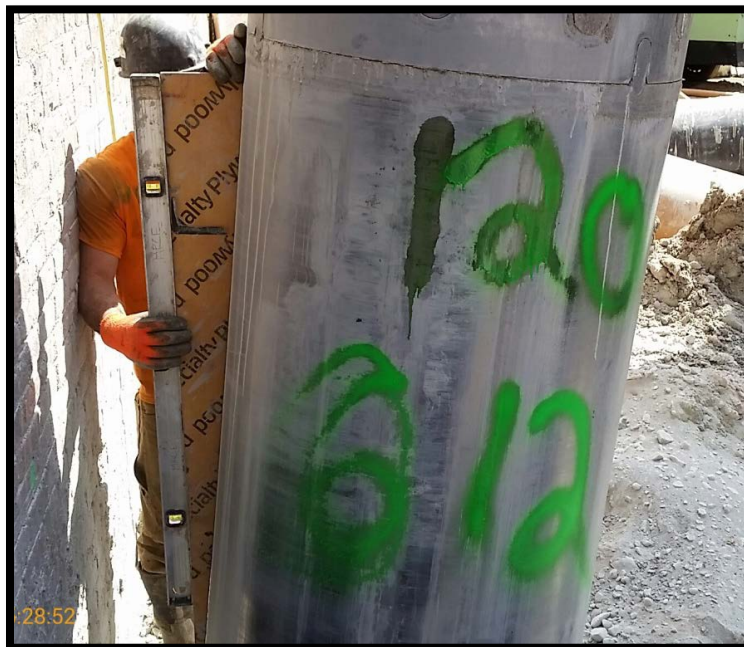
Photo 58: Battered secant pile #120S; confirming 6 degree tilt at EL +0 using a jig and bubble level.

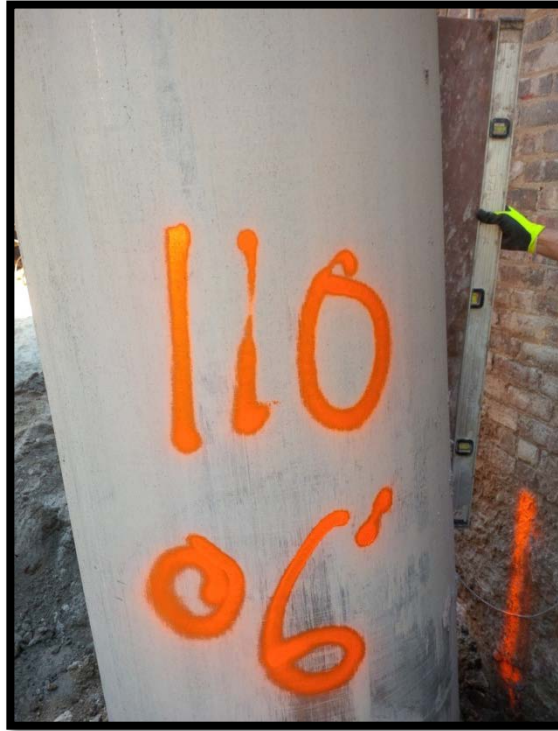
Photo 59: Battered secant pile #110S; confirming 6 degree tilt at EL +5 using a jig and bubble level.

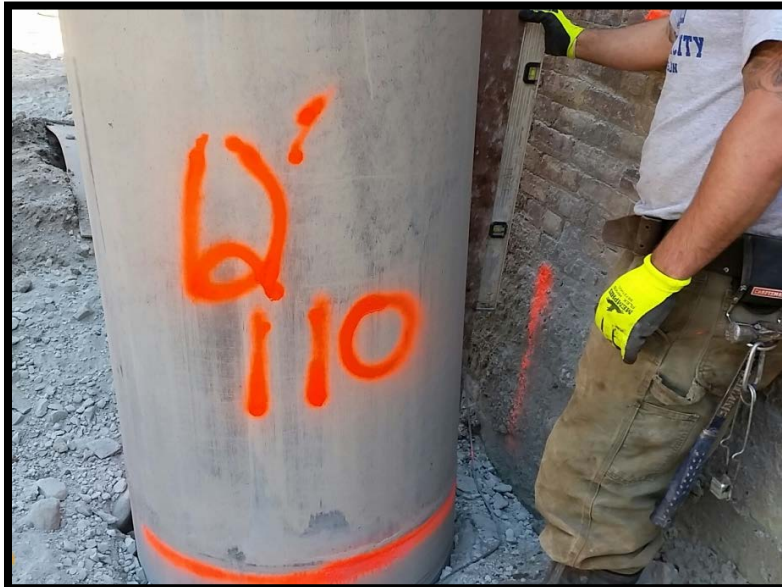
Photo 60: Battered secant pile #110S; confirming 6 degree tilt at EL +0 using a jig and bubble level.

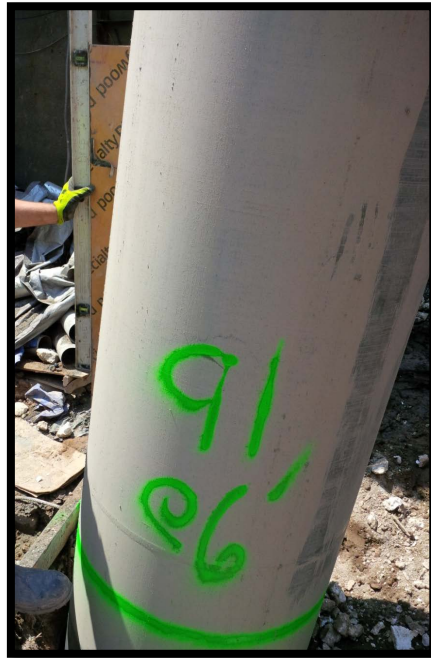
Photo 61: Battered secant pile #91P; confirming 6 degree tilt at EL +5 using a jig and bubble level.

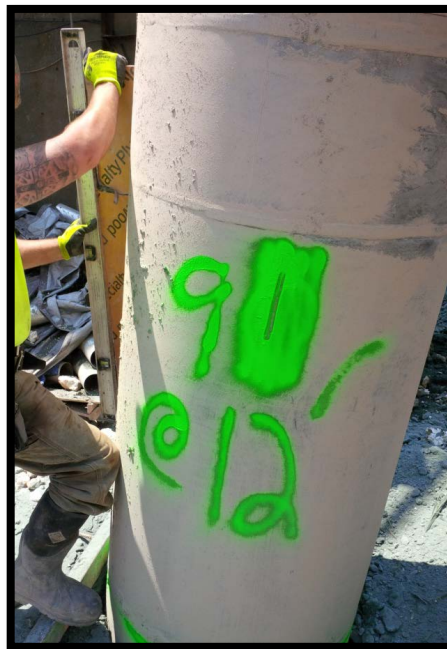
Photo 62: Battered secant pile #91P; confirming 6 degree tilt at EL +0 using a jig and bubble level.
