APPENDIX K

Battered Secant Photo Log and
Engineering Sign-off

Lot 22 Secant Pile Log

Job #2139021

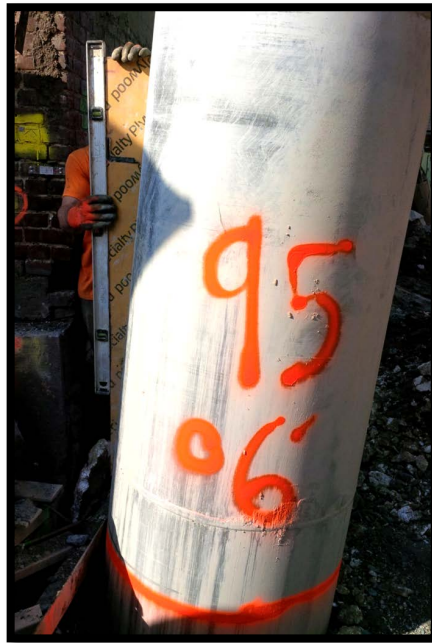
Photo 63: Battered secant pile #95P; confirming 6 degree tilt at EL +5 using a jig and bubble level.

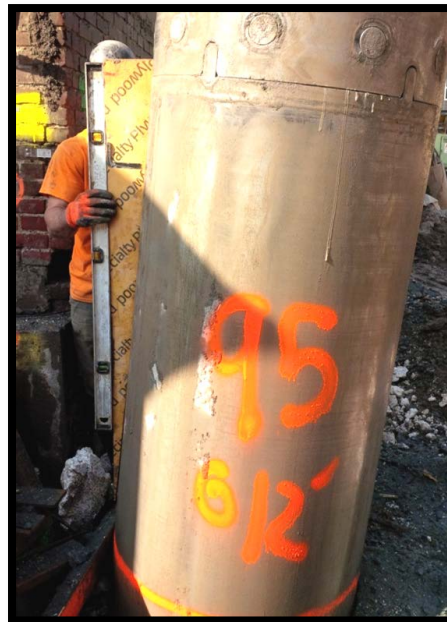
Photo 64: Battered secant pile #95P; confirming 6 degree tilt at EL +0 using a jig and bubble level.

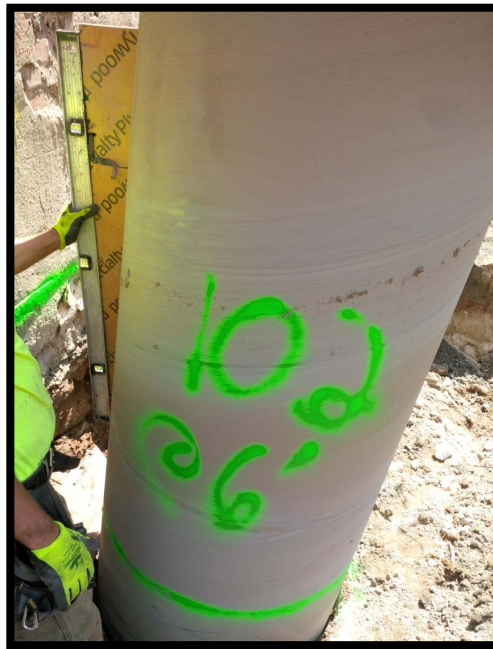
Photo 65: battered secant pile #102S; confirming 6 degree tilt at 6 EL +5 using a jig and bubble level.

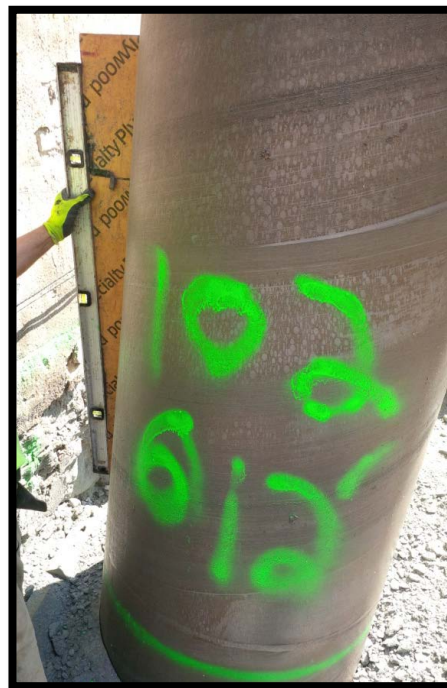
Photo 66: Battered secant pile #102S; confirming 6 degree tilt at EL +0 using a jig and bubble level.

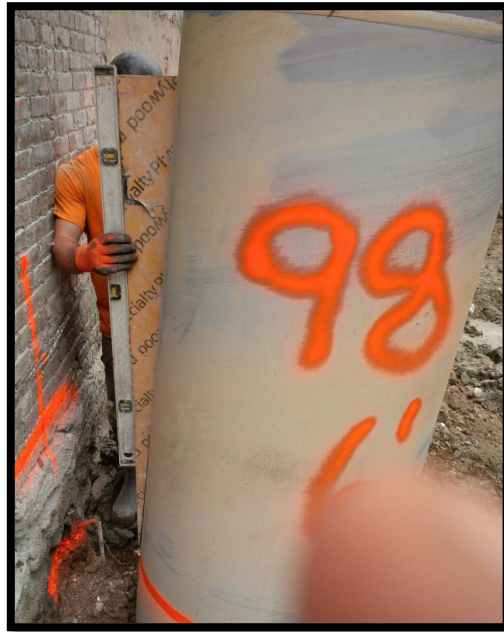
Photo 67: Battered secant pile #98S; confirming 6 degree tilt at EL +5 using a jig and bubble level.

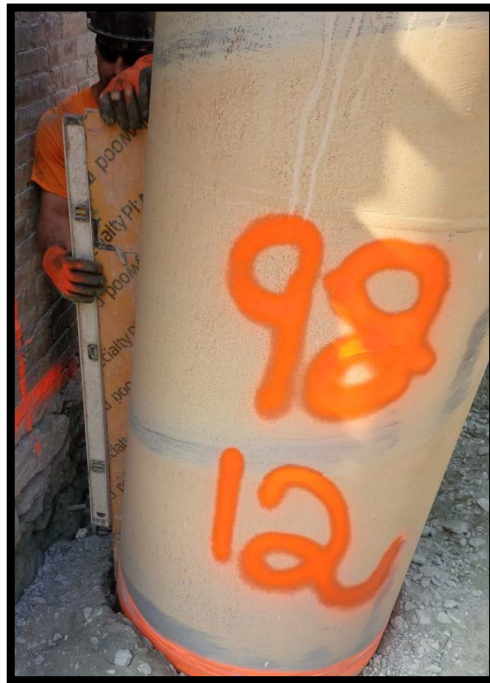
Photo 68: Battered secant pile #98S; confirming 6 degree tilt at EL +0 using a jig and bubble level.

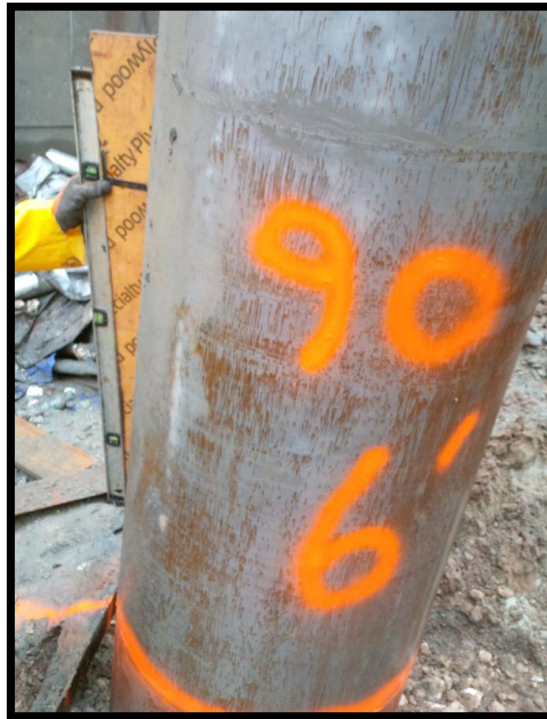
Photo 69: Battered secant pile #90S; confirming 6 degree tilt at EL +5 using a jig and bubble level.

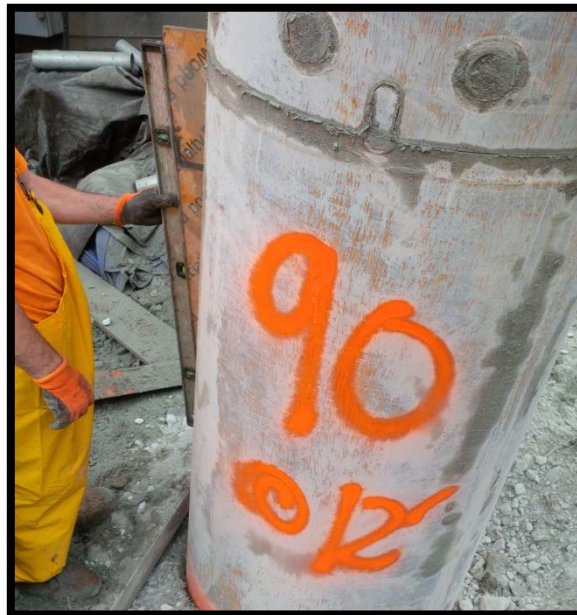
Photo 70: Battered secant pile #90S; confirming 6 degree tilt at EL +0 using a jig and bubble level.

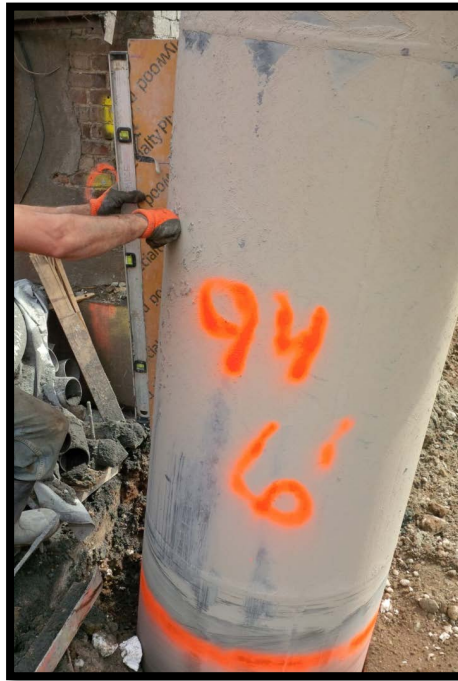
Photo 71: Battered secant pile #94S; confirming 6 degree tilt at EL +5 using a jig and bubble level.

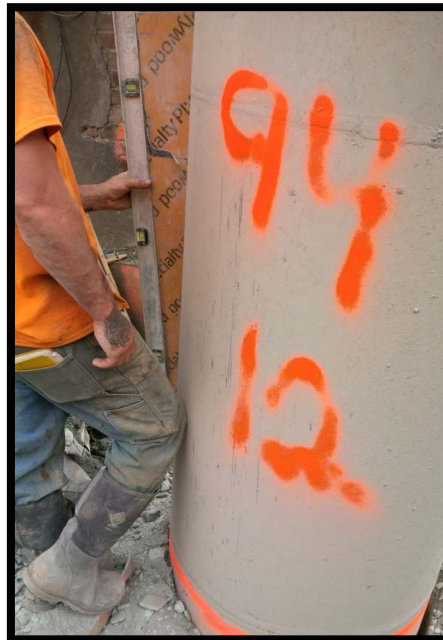
Photo 72: Battered secant pile #94S; confirming 6 degree tilt at EL +0 using a jig and bubble level.

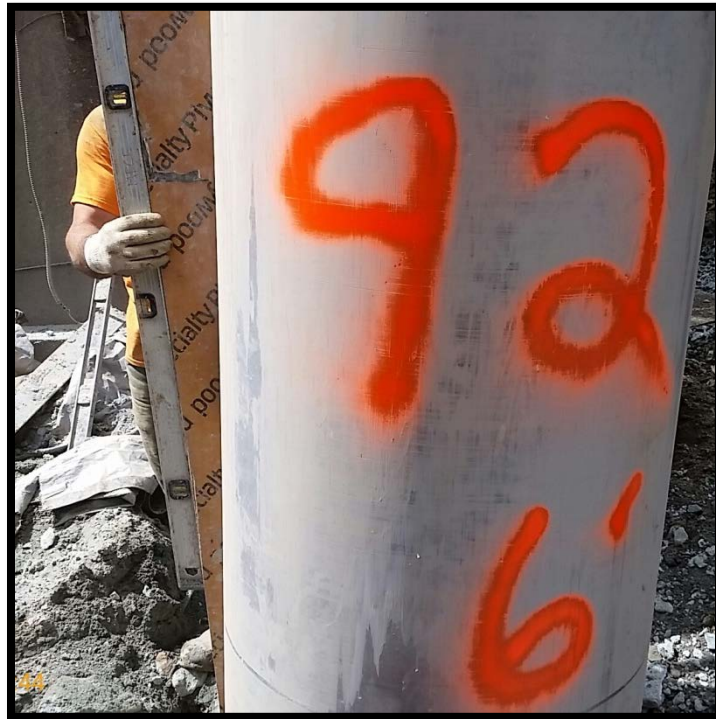
Photo 73: Battered secant pile #92S; confirming 6 degree tilt at EL +5 using a jig and bubble level.

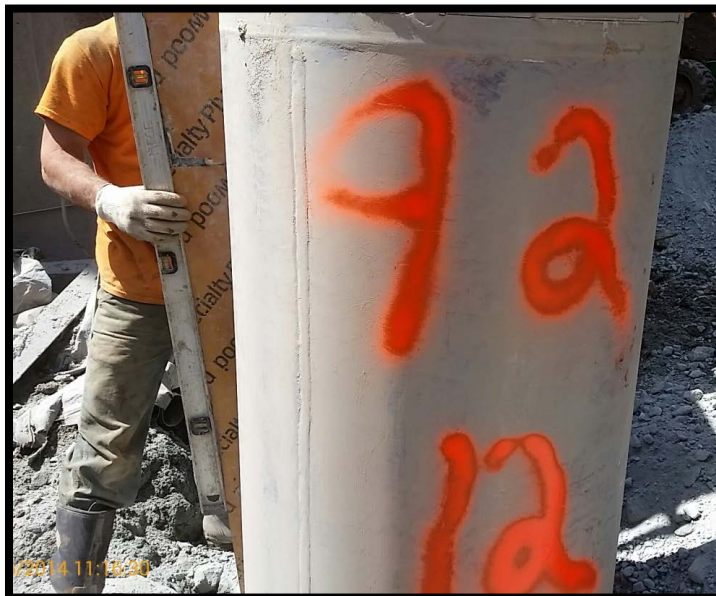
Photo 74: Battered secant pile #92S; confirming 6 degree tilt at EL +0 using a jig and bubble level.

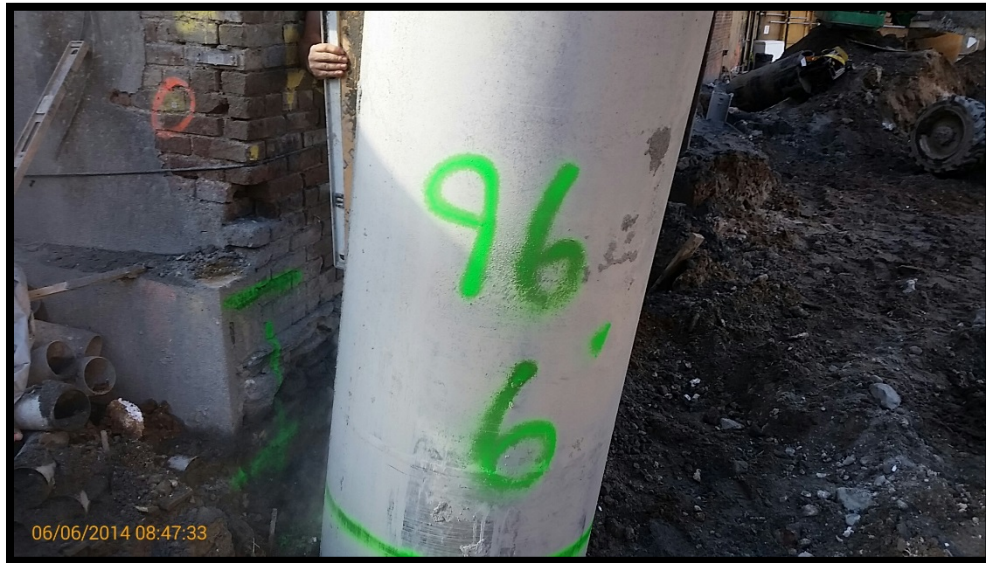
Photo 75: Battered secant pile #96S; confirming 6 degree tilt at EL +5 using a jig and bubble level.

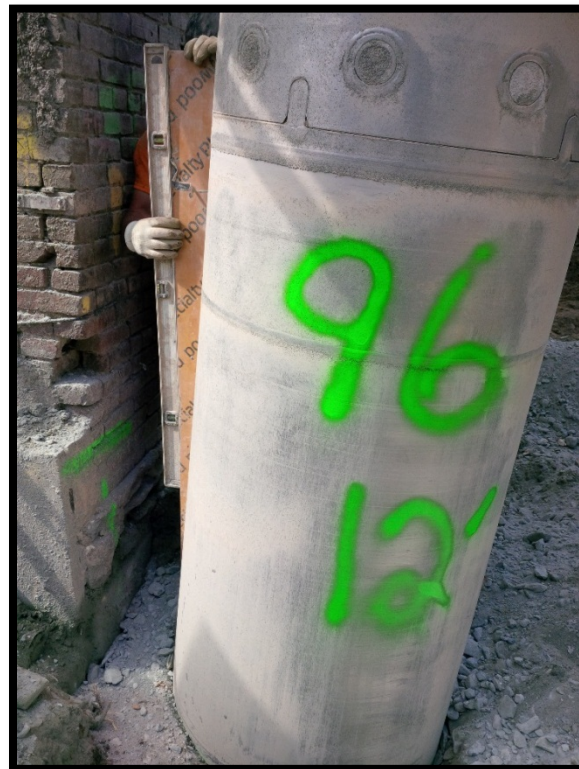
Photo 76: Battered secant pile #96S; confirming 6 degree tilt at EL +0 using a jig and bubble level.

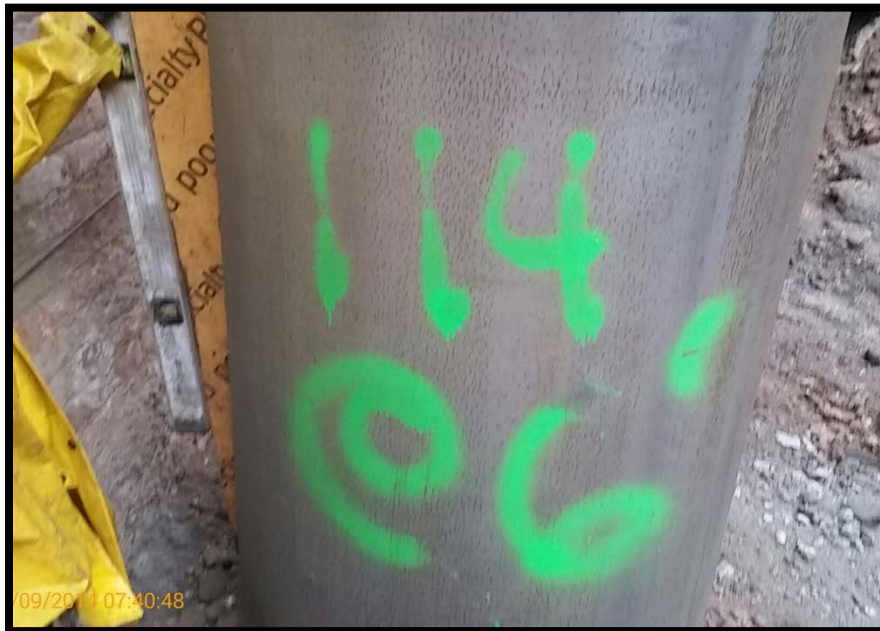
Photo 77: Battered secant pile #114S; confirming 6 degree tilt at EL +5 using a jig and bubble level.

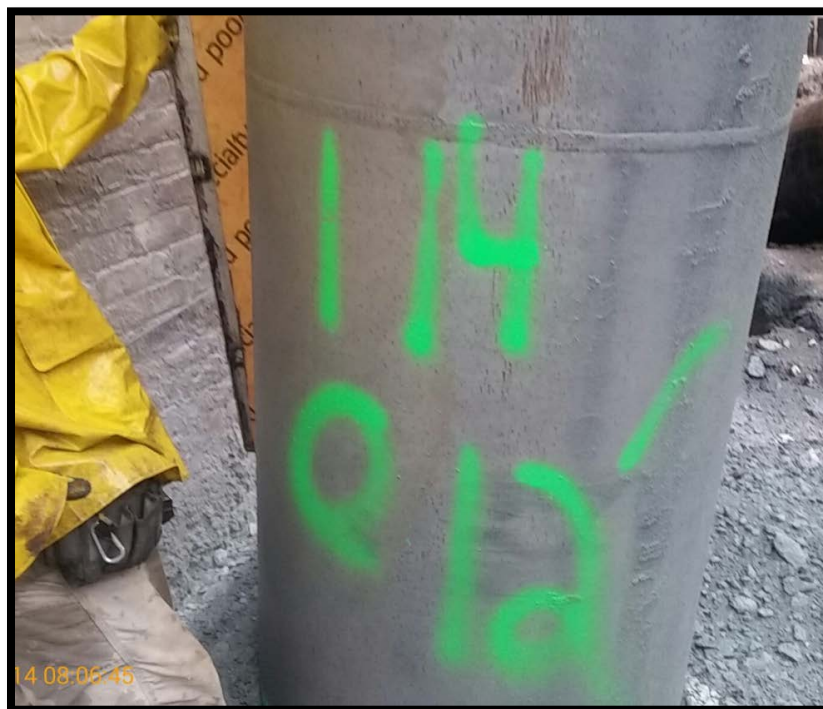
Photo 78: Battered secant pile #114S; confirming 6 degree tilt at EL +0 using a jig and bubble level.

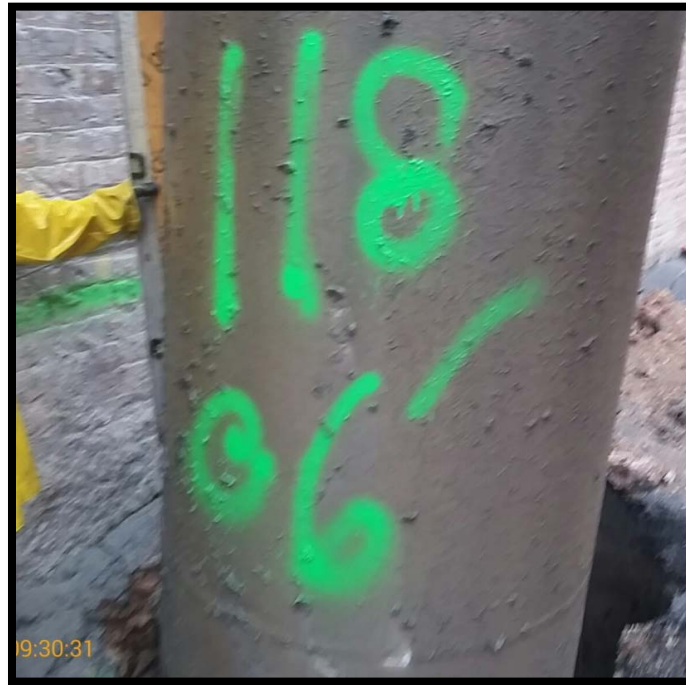
Photo 79: Battered secant pile #118S; confirming 6 degree tilt at EL +5 using a jig and bubble level.

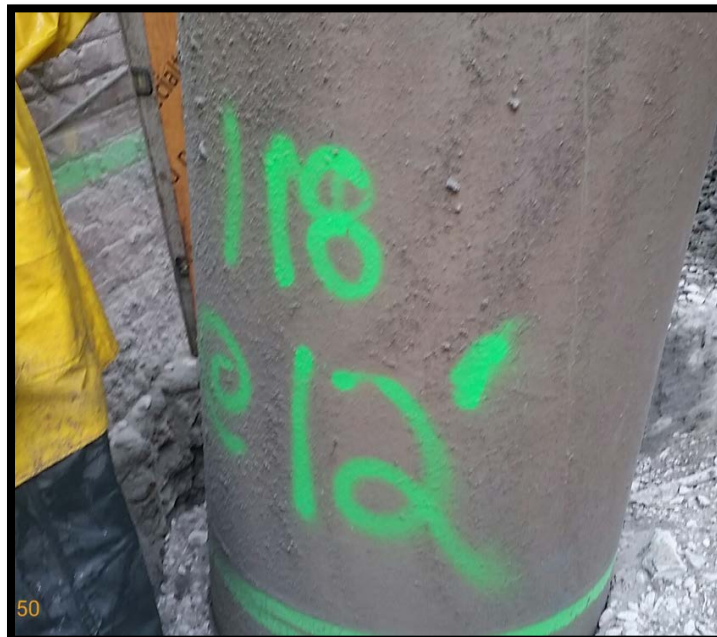
Photo 80: Battered secant pile #118S; confirming 6 degree tilt at EL +0 using a jig and bubble level.

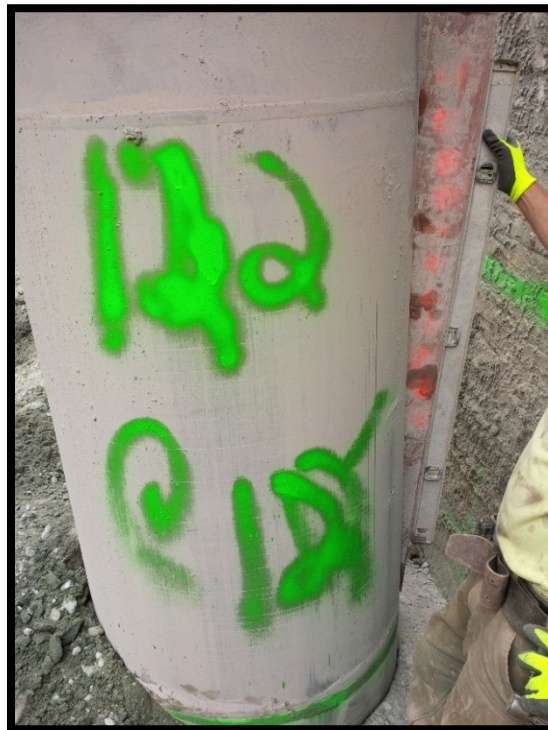
Photo 81: Battered secant pile #122S; confirming 6 degree tilt at EL +0 using a jig and bubble level.

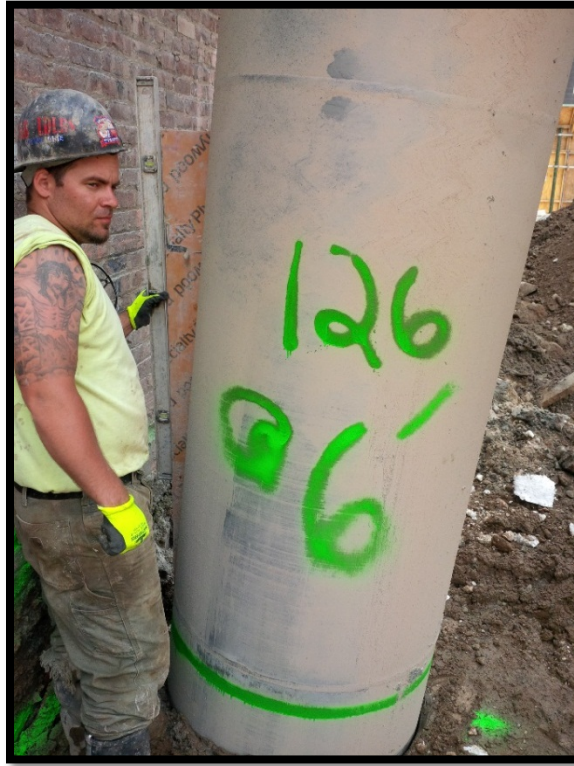
Photo 83: Battered secant pile #126S; confirming 6 degree tilt at EL +5 using a jig and bubble level.

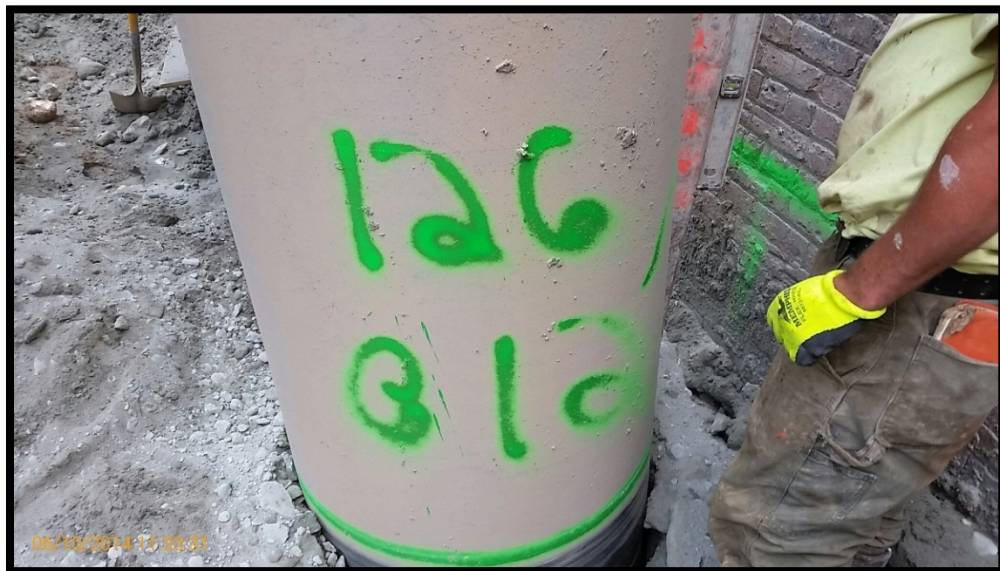
Photo 84: Battered secant pile #126S; confirming 6 degree tilt at EL +0 using a jig and bubble level.

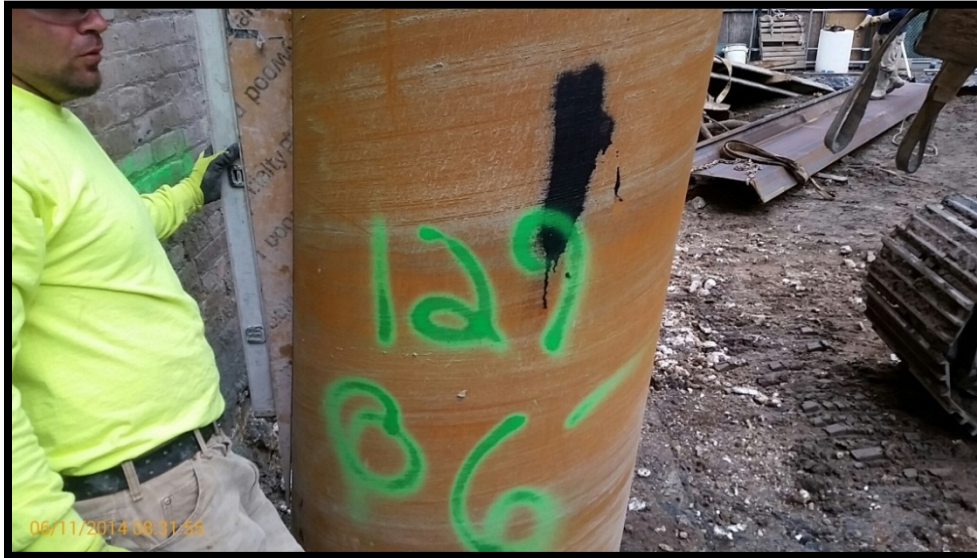
Photo 85: Battered secant pile #129P; confirming 6 degree tilt at EL +5 using a jig and bubble level.

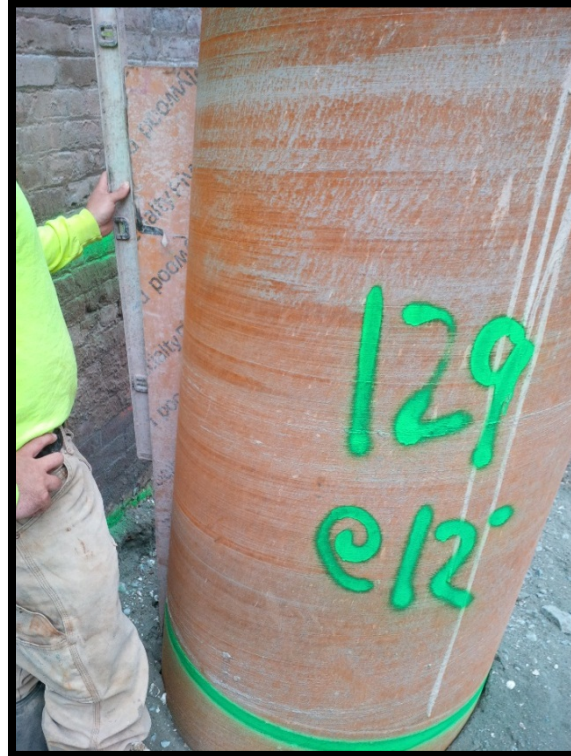
Photo 86: Battered secant pile #129P; confirming 6 degree tilt at EL +0 using a jig and bubble level.

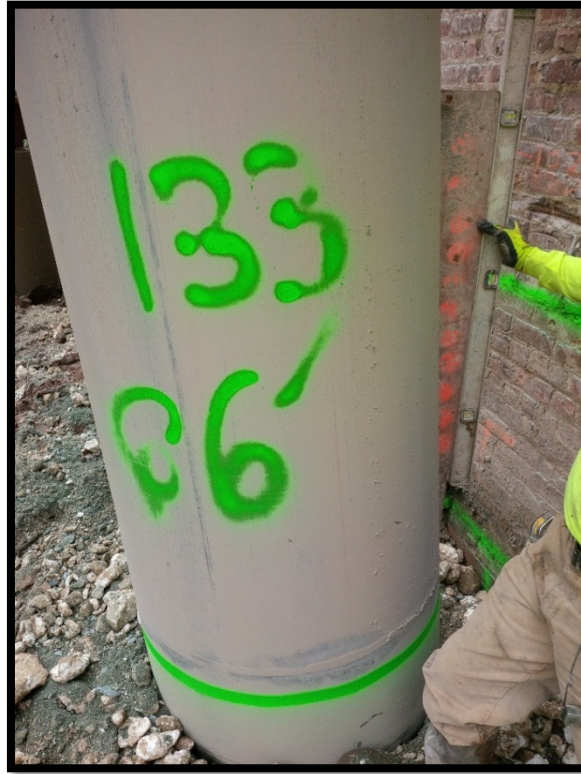
Photo 87: Battered secant pile #133P; confirming 6 degree tilt at EL +5 using a jig and bubble level.

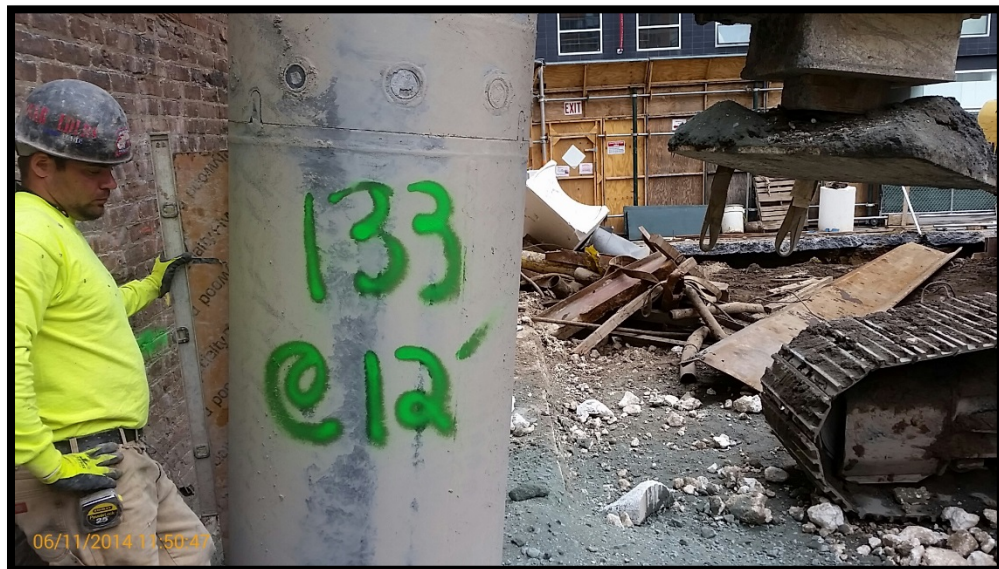
Photo 88: Battered secant pile #133P; confirming 6 degree tilt at EL +0 using a jig and bubble level.

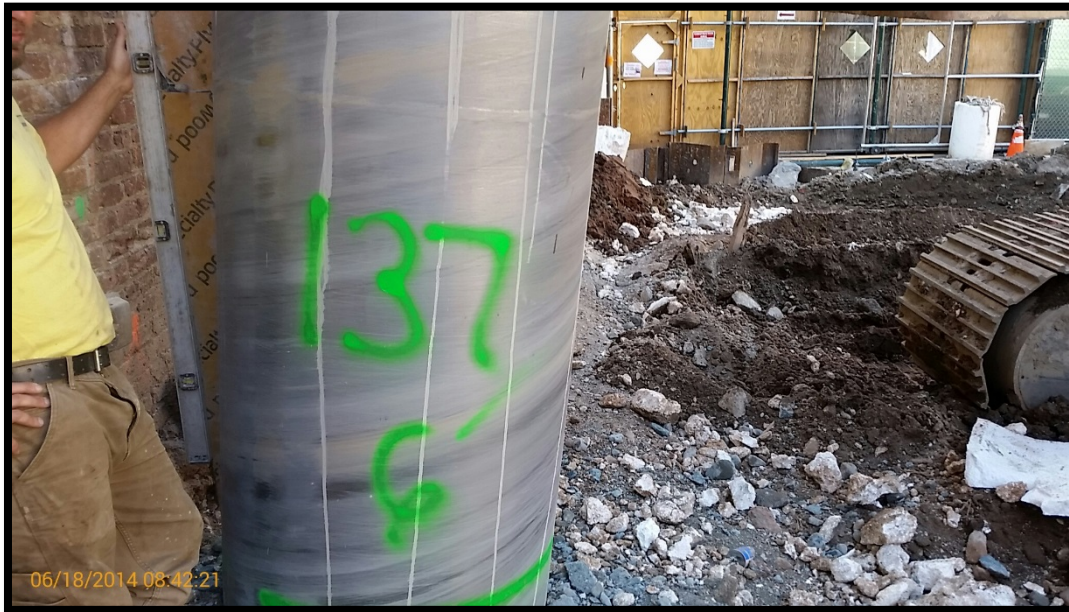
Photo 89: Battered secant pile #137P; confirming 6 degree tilt at EL +5 using a jig and bubble level.

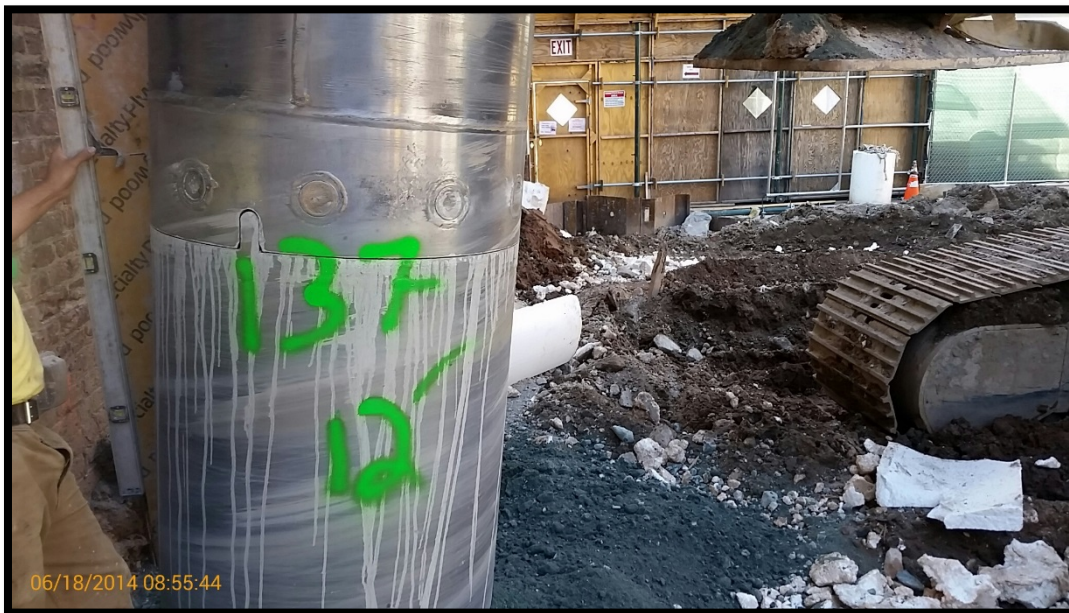
Photo 90: Battered secant pile #137P; confirming 6 degree tilt at EL +0 using a jig and bubble level.

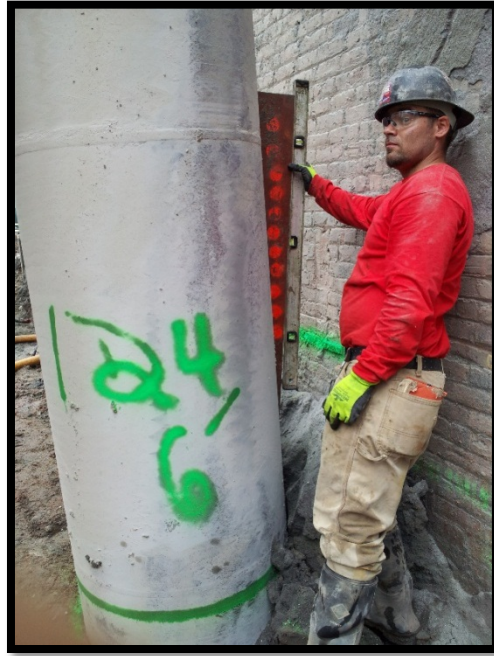
Photo 91: Battered secant pile #124S; confirming 6 degree tilt at EL +5 using a jig and bubble level.

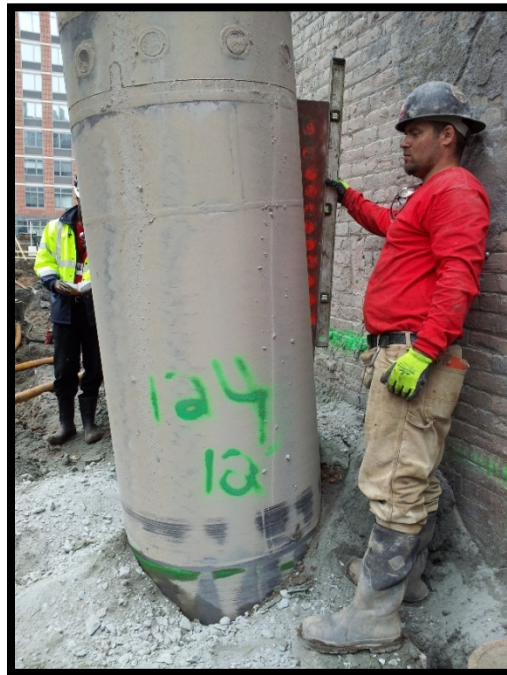
Photo 92: Battered secant pile #124S; confirming 6 degree tilt at EL +0 using a jig and bubble level.

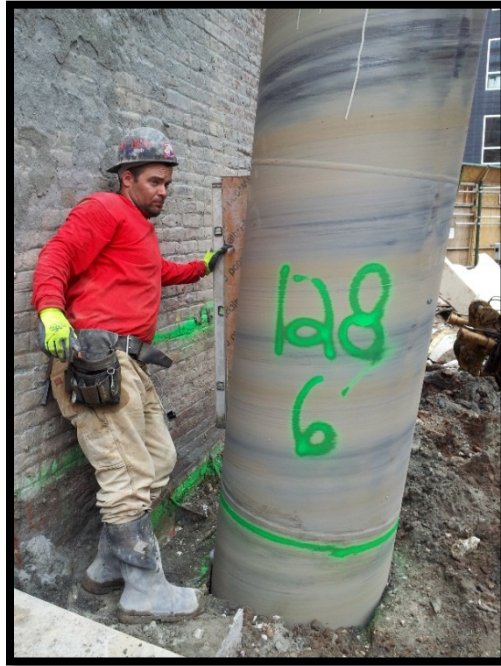
Photo 93: Battered secant pile #128S; confirming 6 degree tilt at EL +5 using a jig and bubble level.

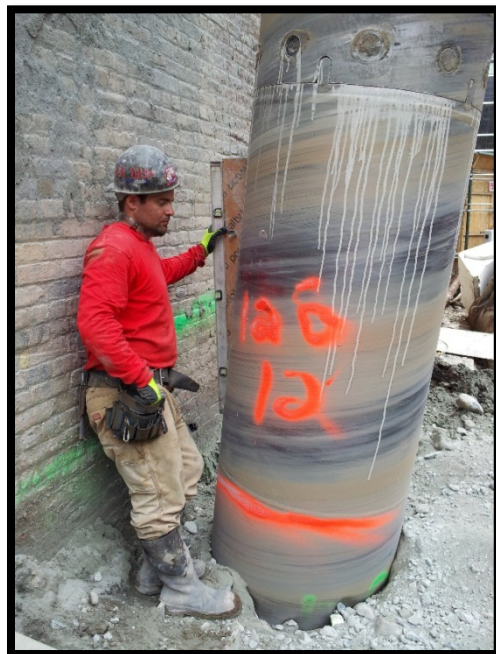
Photo 94: Battered secant pile #128S; confirming 6 degree tilt at EL +0 using a jig and bubble level.

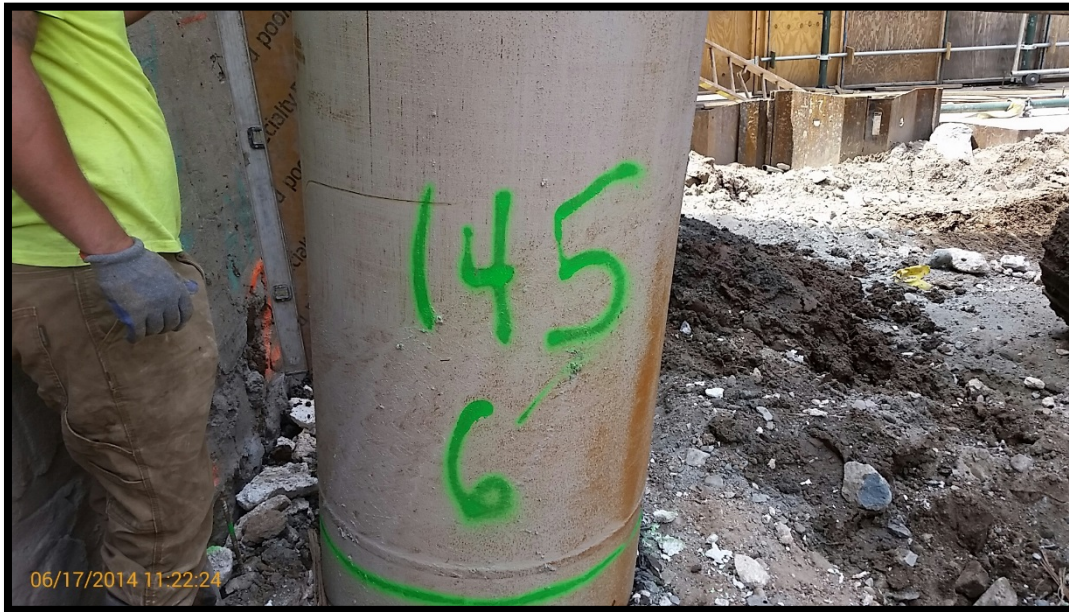
Photo 95: Battered secant pile #145P; confirming 6 degree tilt at EL +5 using a jig and bubble level.

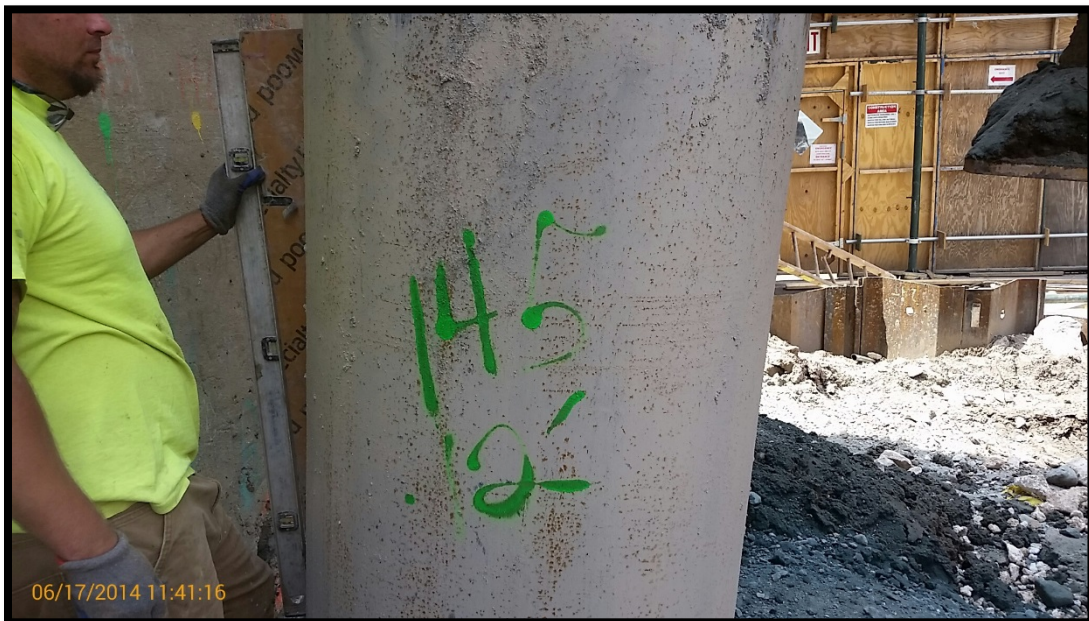
Photo 96: Battered secant pile #145P; confirming 6 degree tilt at EL +0 using a jig and bubble level.

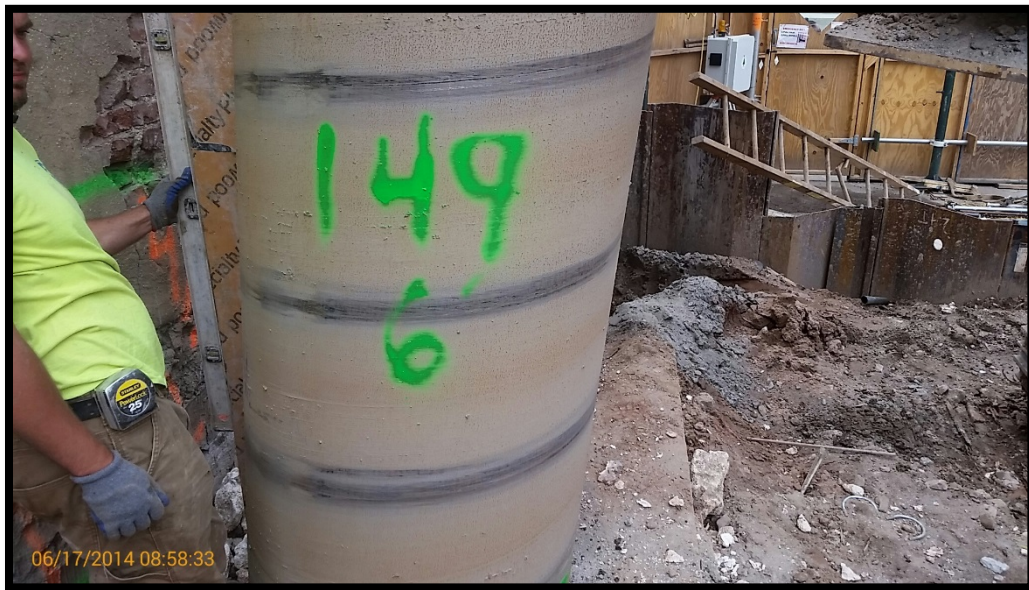
Photo 97: Battered secant pile #149P; confirming 6 degree tilt at EL +5 using a jig and bubble level.

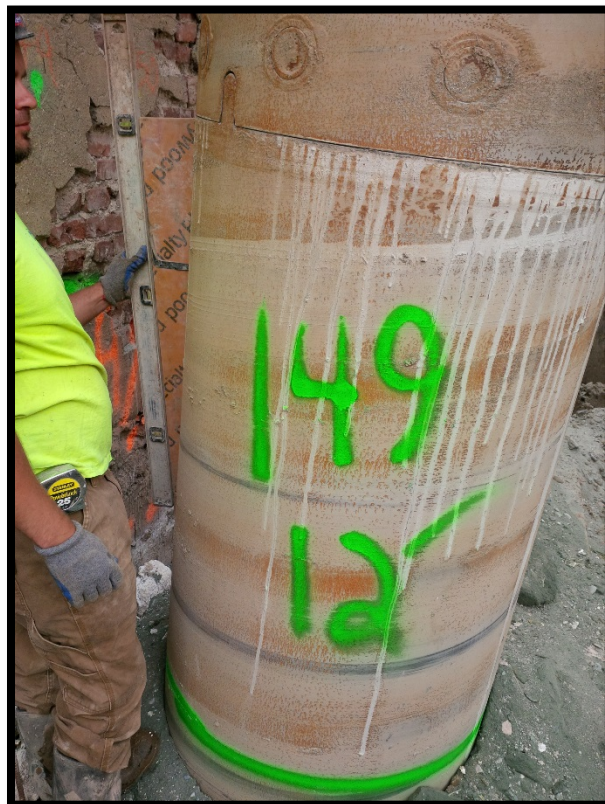
Photo 98: Battered secant pile #149P; confirming 6 degree tilt at EL +0 using a jig and bubble level.

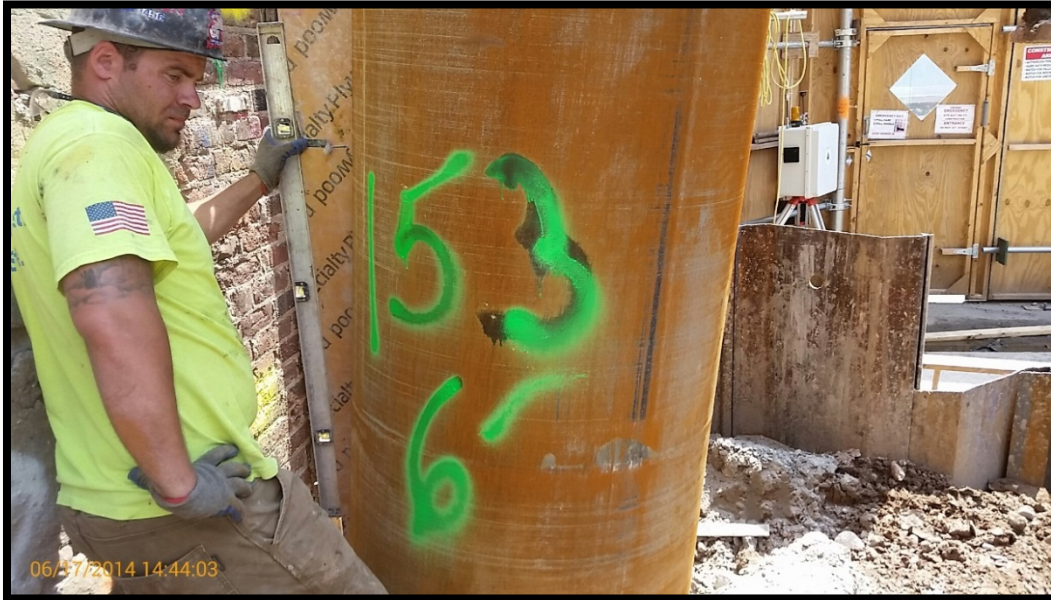
Photo 99: Battered secant pile #153P; confirming 6 degree tilt at EL +5 using a jig and bubble level.

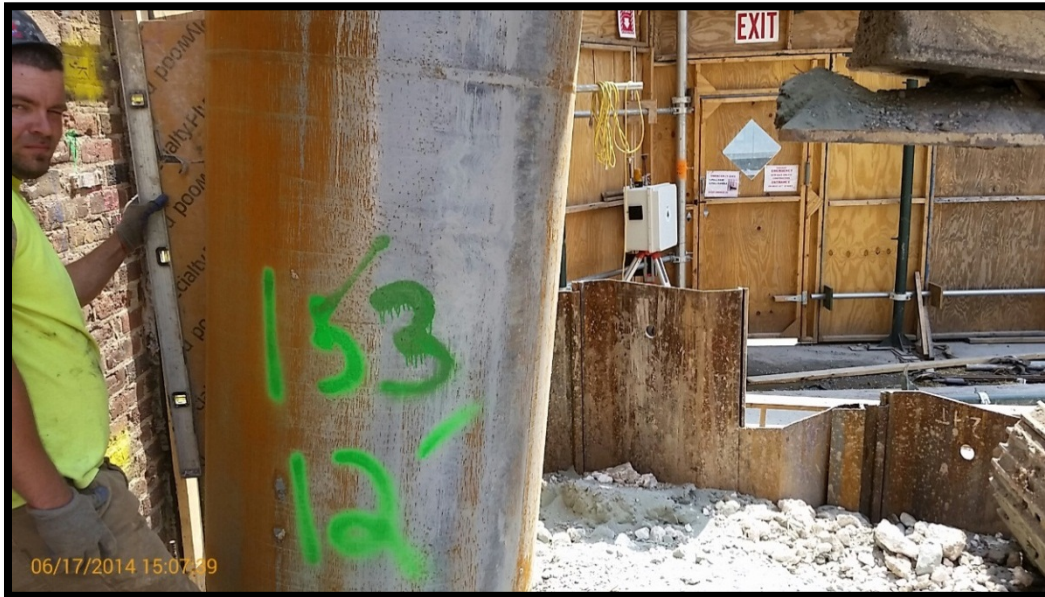
Photo 100: Battered secant pile #153P; confirming 6 degree tilt at EL +0 using a jig and bubble level.

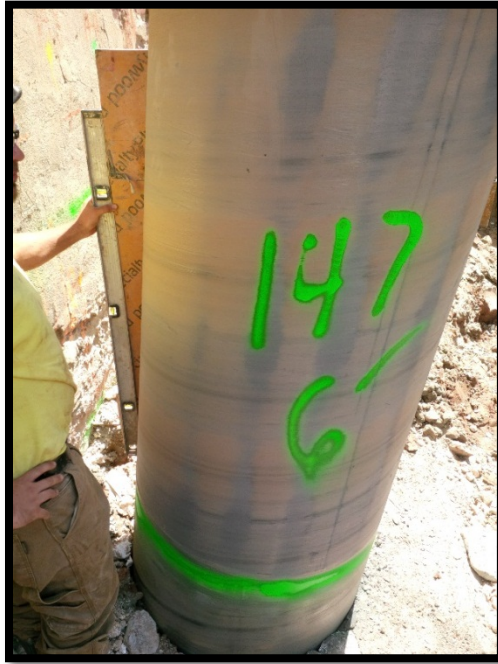
Photo 101: Battered secant pile #147P; confirming 6 degree tilt at EL +5 using a jig and bubble level.

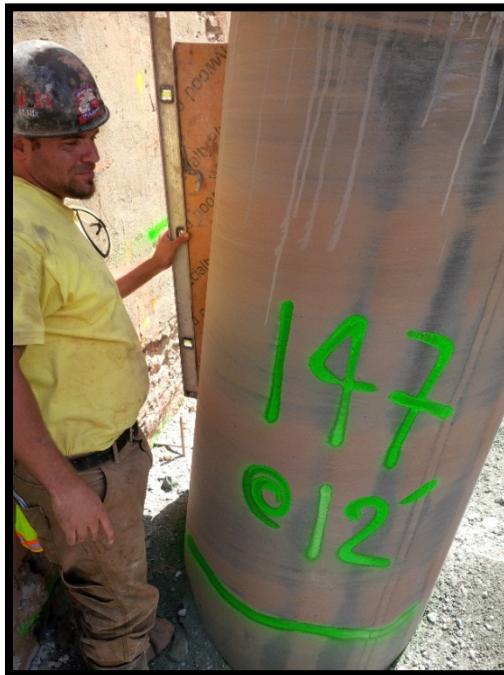
Photo 102: Battered secant pile #147P; confirming 6 degree tilt at EL +0 using a jig and bubble level.

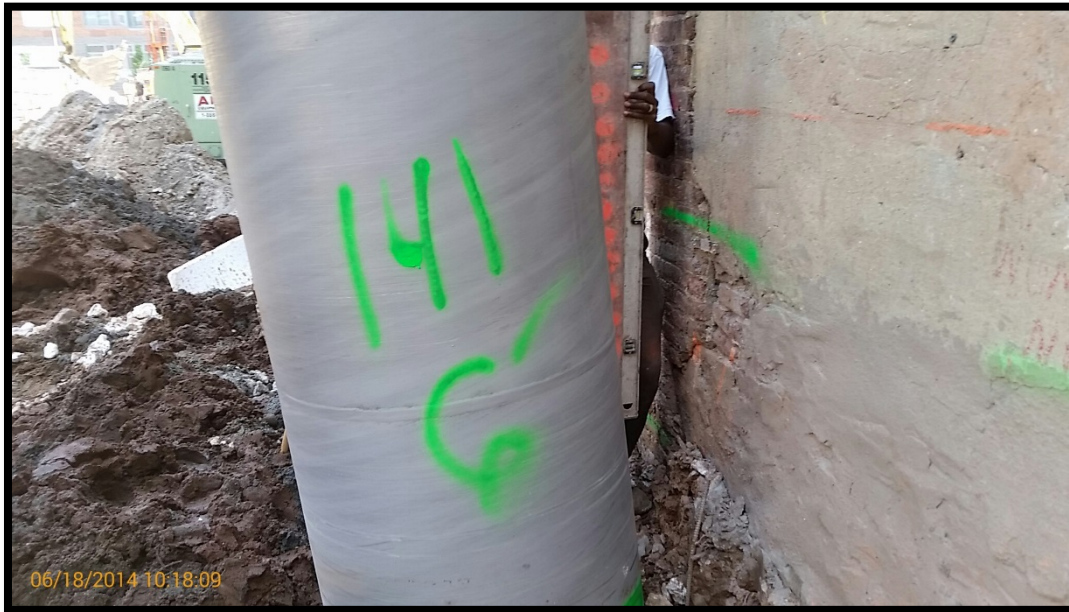
Photo 103: Battered secant pile #141P; confirming 6 degree tilt at EL +5 using a jig and bubble level.

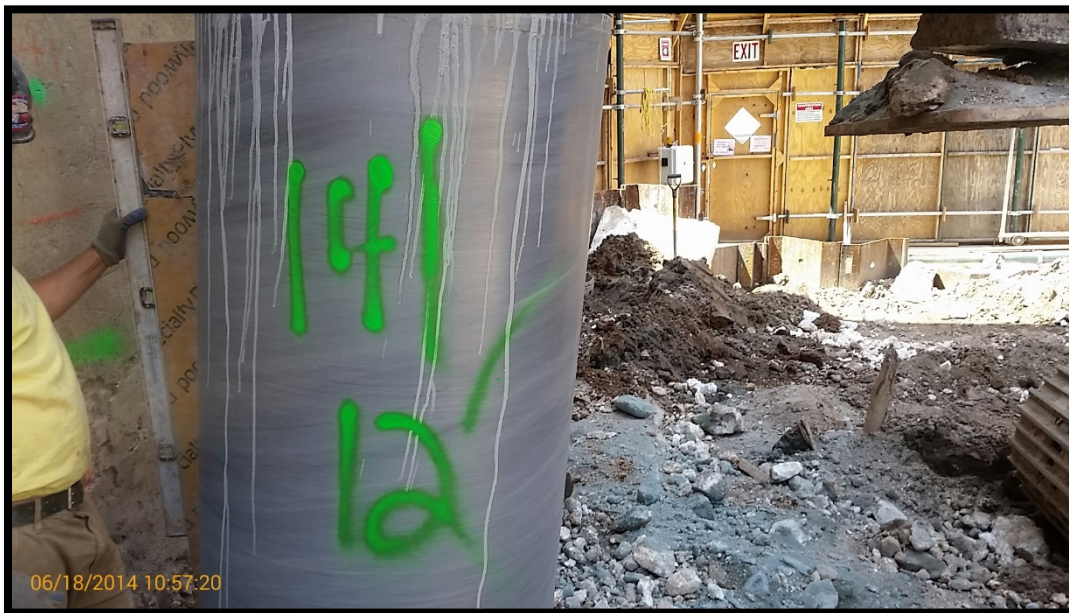
Photo 104: Battered secant pile #141P; confirming 6 degree tilt at EL +0 using a jig and bubble level.

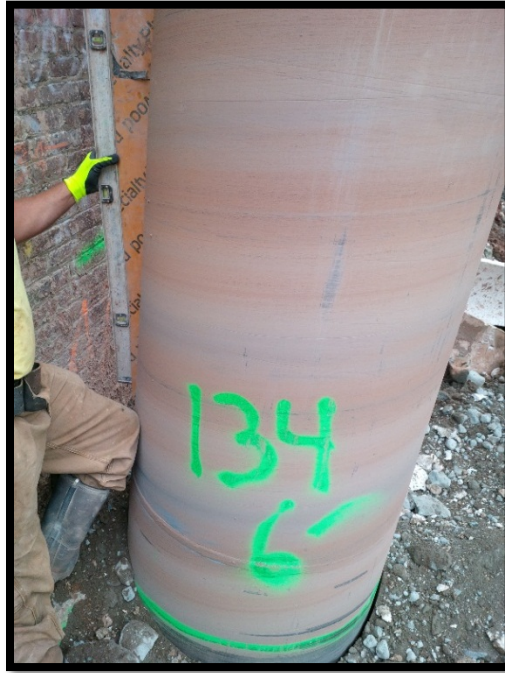
Photo 105: Battered secant pile #134S; confirming 6 degree tilt at EL +5 using a jig and bubble level.

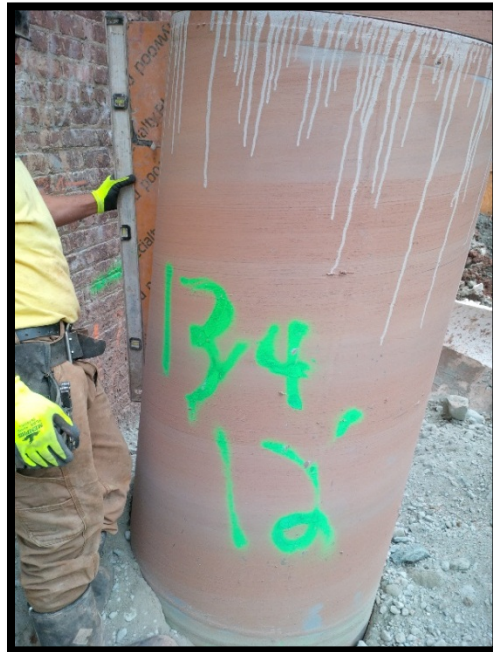
Photo 106: Battered secant pile #134S; confirming 6 degree tilt at EL +0 using a jig and bubble level.

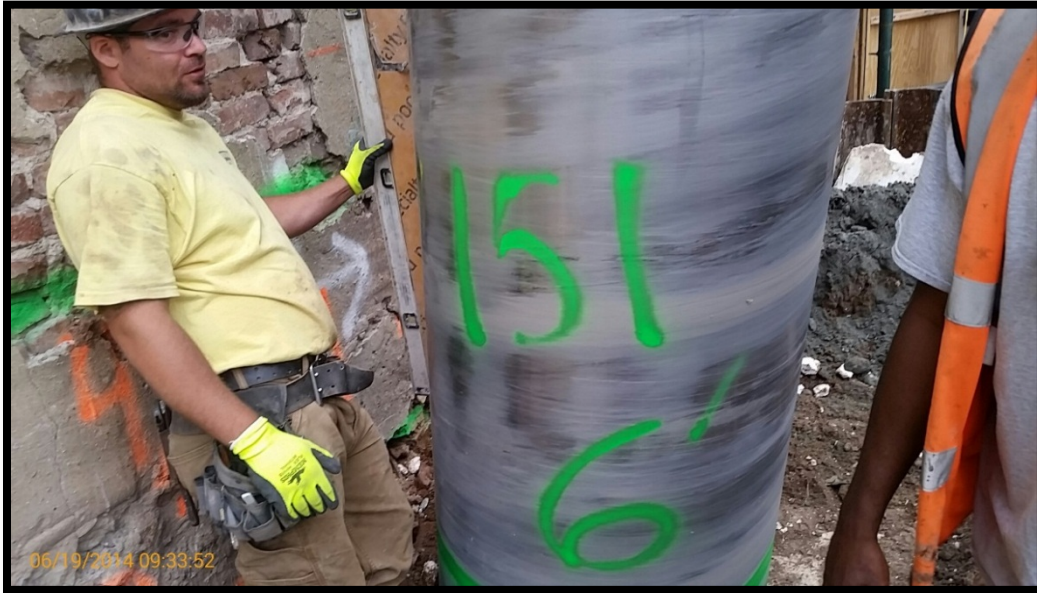
Photo 107: Battered secant pile #151P; confirming 6 degree tilt at EL +5 using a jig and bubble level.

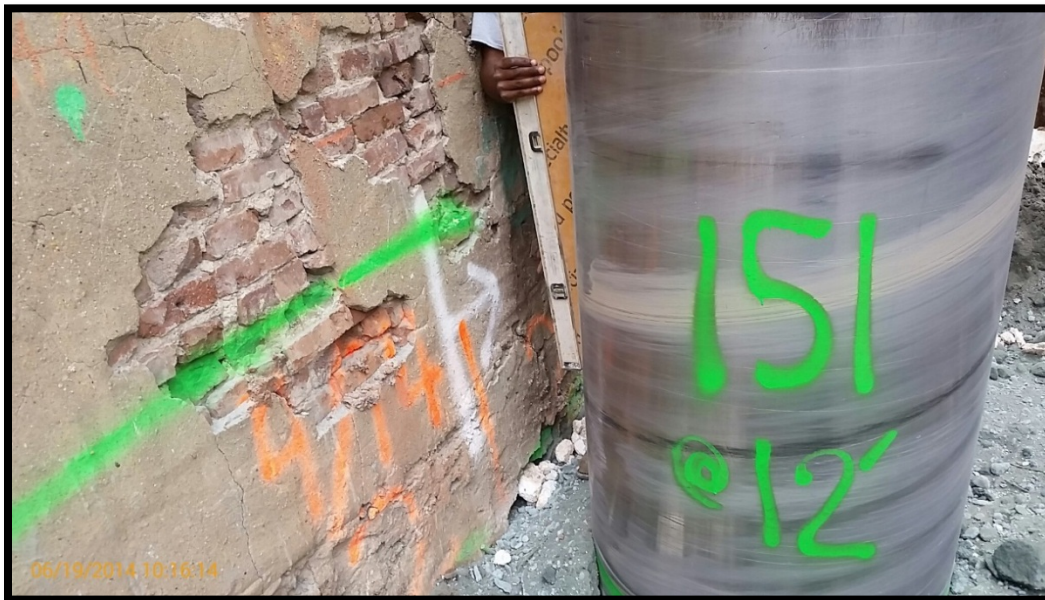
Photo 108: Battered secant pile #151P; confirming 6 degree tilt at EL +0 using a jig and bubble level.

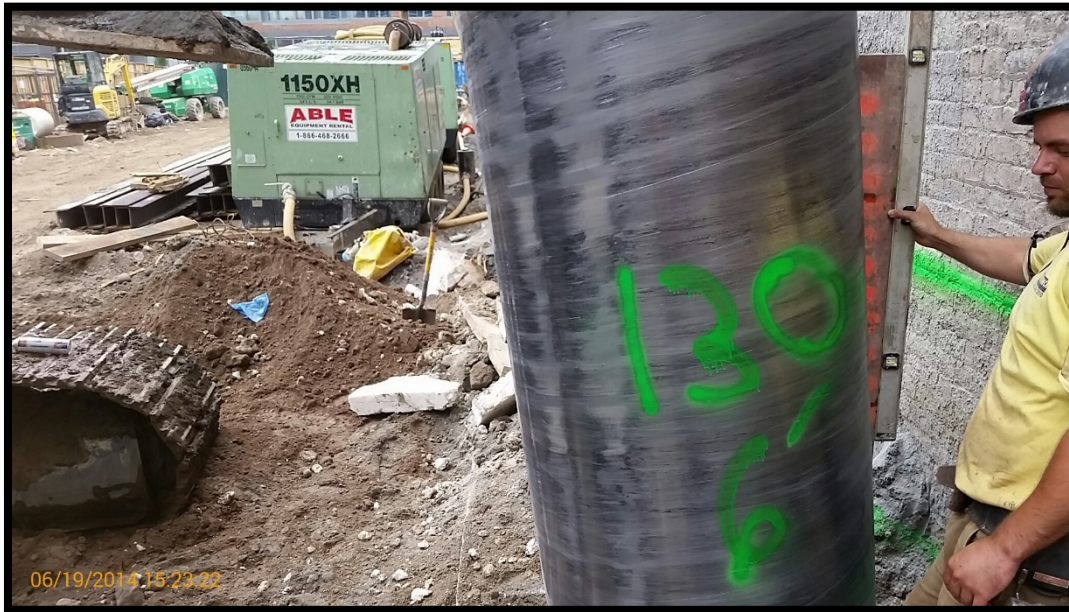
Photo 109: Battered secant pile #130S; confirming 6 degree tilt at EL +5 using a jig and bubble level.
