APPENDIX K

Battered Secant Photo Log and
Engineering Sign-off

Lot 22 Secant Pile Log

Job #2139021

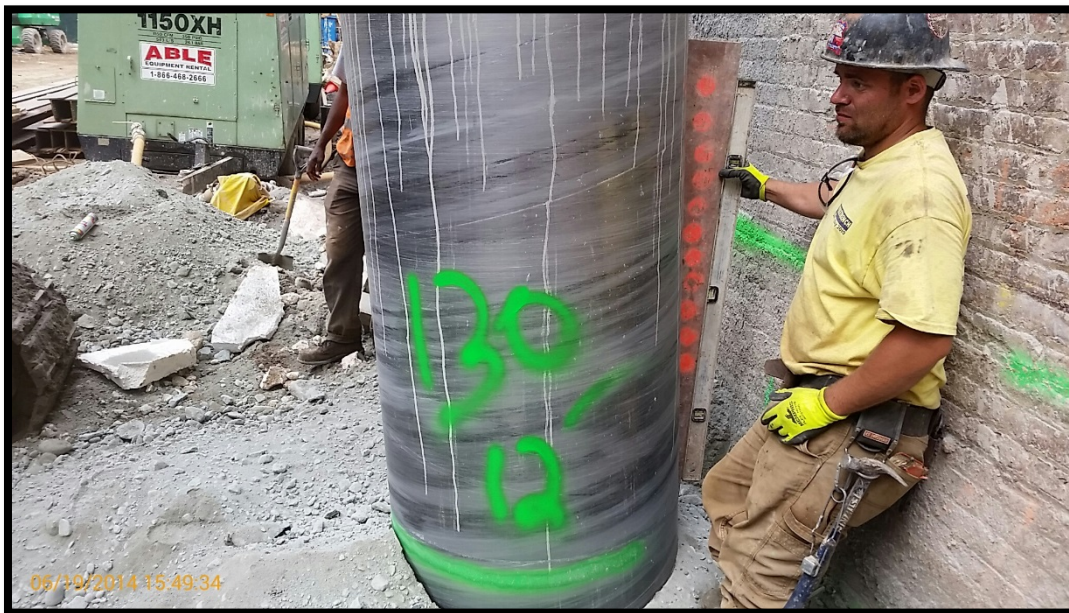
Photo 110: Battered secant pile #130S; confirming 6 degree tilt at EL +0 using a jig and bubble level.

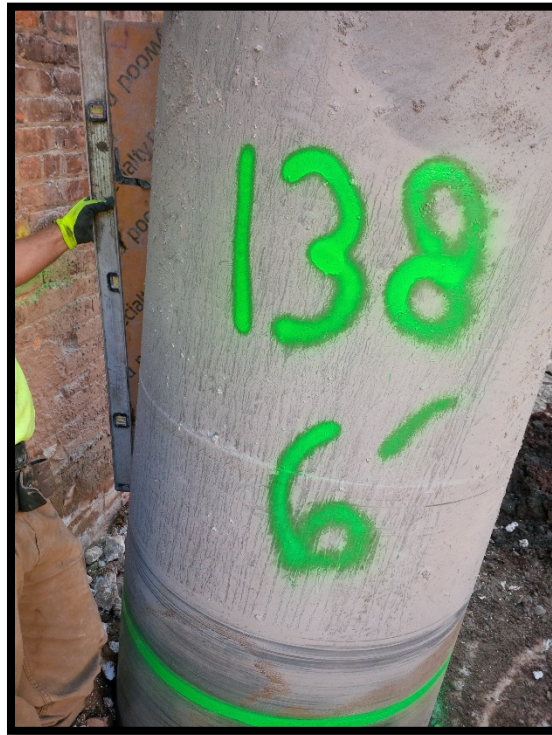
Photo 111: Battered secant pile #138S; confirming 6 degree tilt at EL +5 using a jig and bubble level.

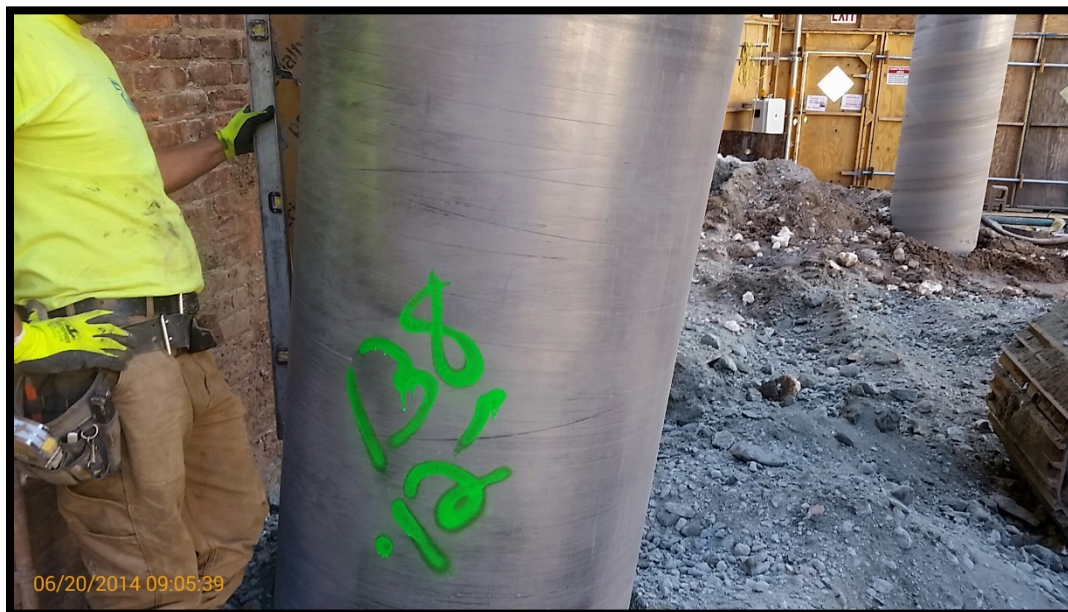
Photo 112: Battered secant pile #138S; confirming 6 degree tilt at EL +0 using a jig and bubble level.

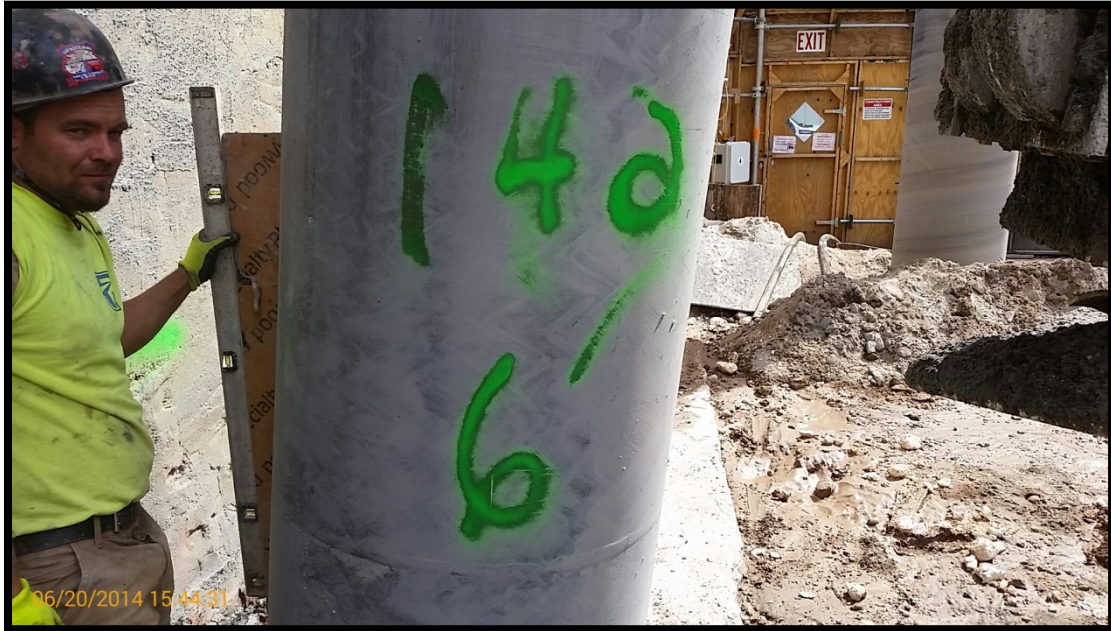
Photo 113: Battered secant pile #142S; confirming 6 degree tilt at EL +5 using a jig and bubble level.

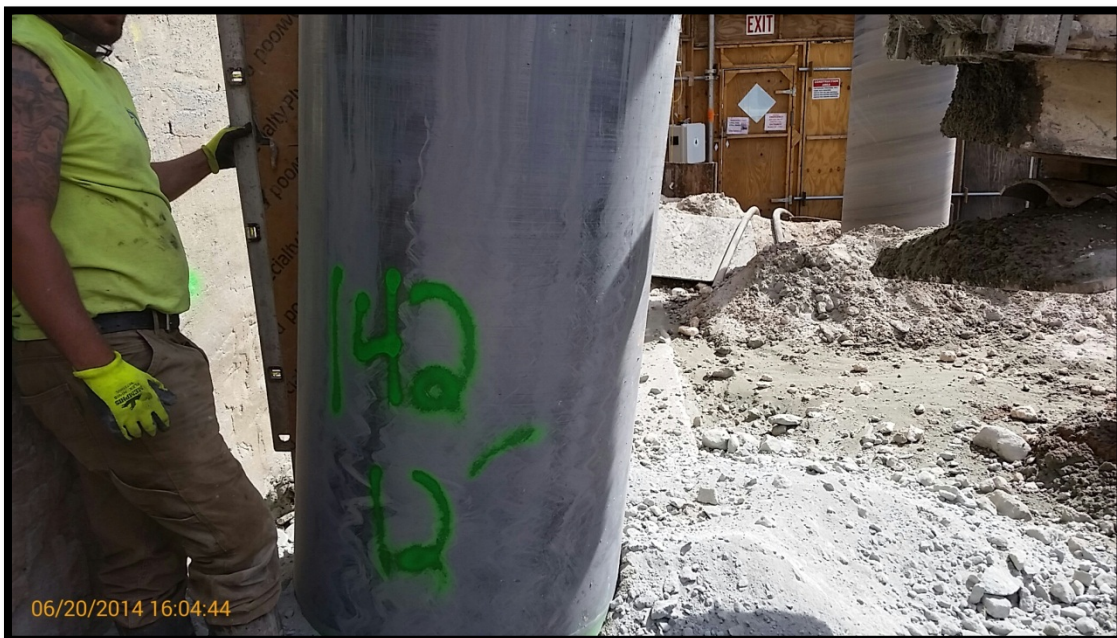
Photo 114: Battered secant pile #142S; confirming 6 degree tilt at EL +0 using a jig and bubble level.

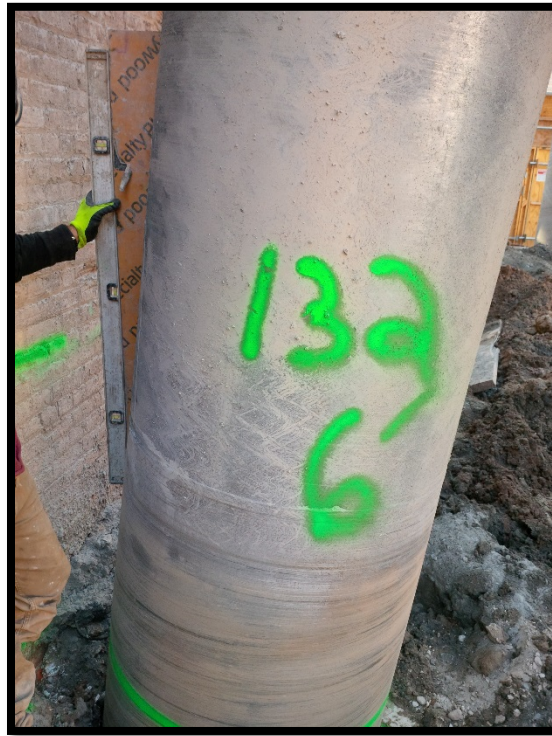
Photo 115: Battered secant pile #132S; confirming 6 degree tilt at EL +5 using a jig and bubble level.

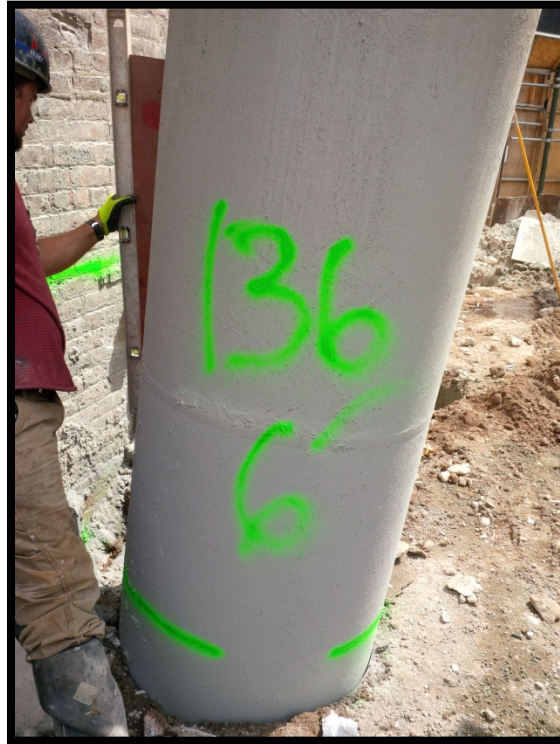
Photo 117: Battered secant pile #136S; confirming 6 degree tilt at EL +5 using a jig and bubble level.

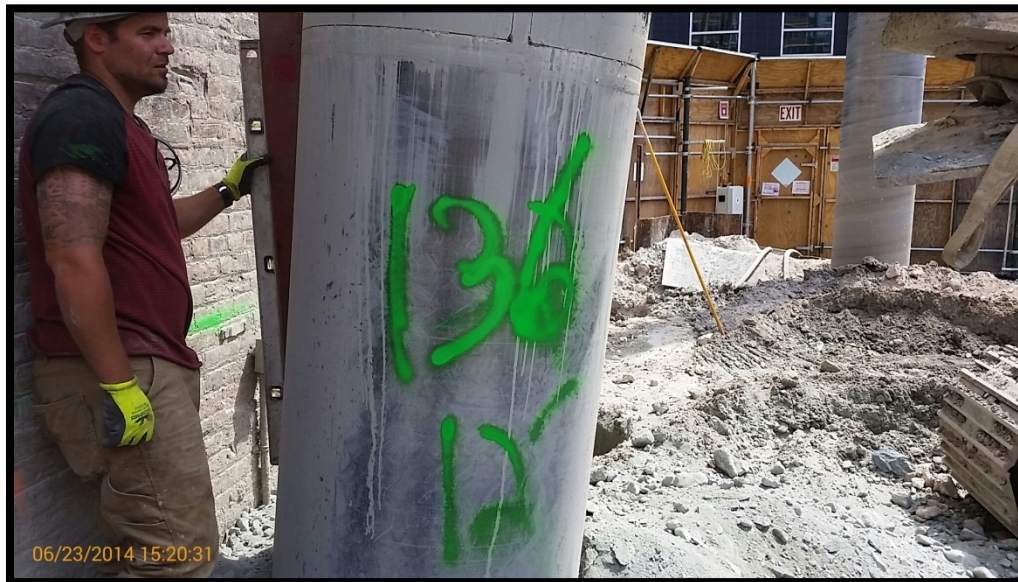
Photo 118: Battered secant pile #136S; confirming 6 degree tilt at EL +0 using a jig and bubble level.

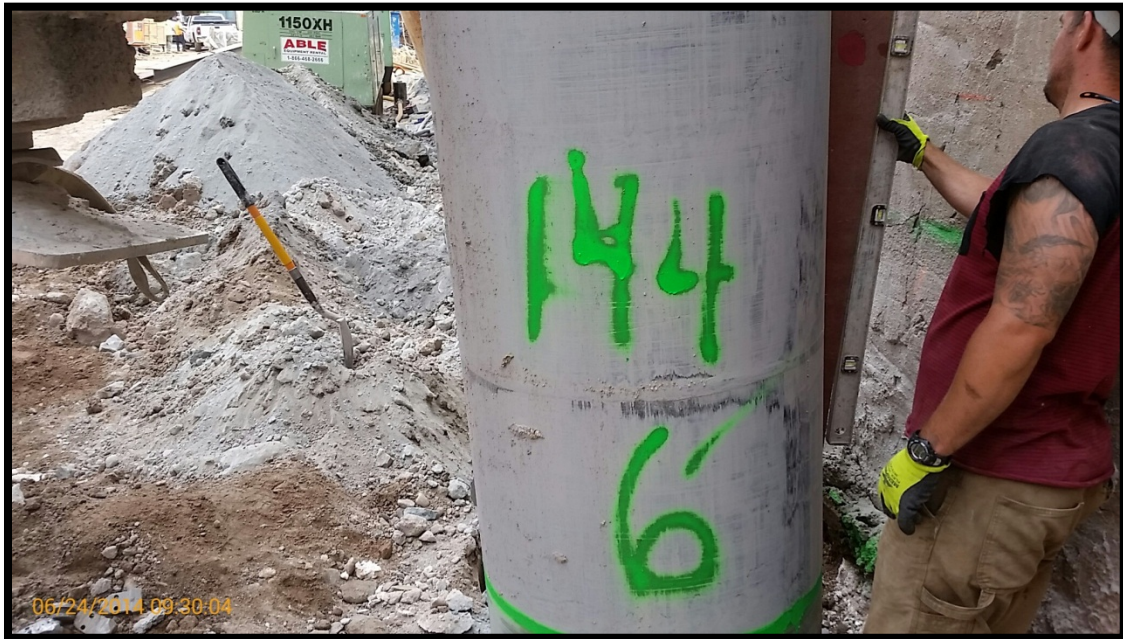
Photo 119: Battered secant pile #144S; confirming 6 degree tilt at EL +5 using a jig and bubble level.

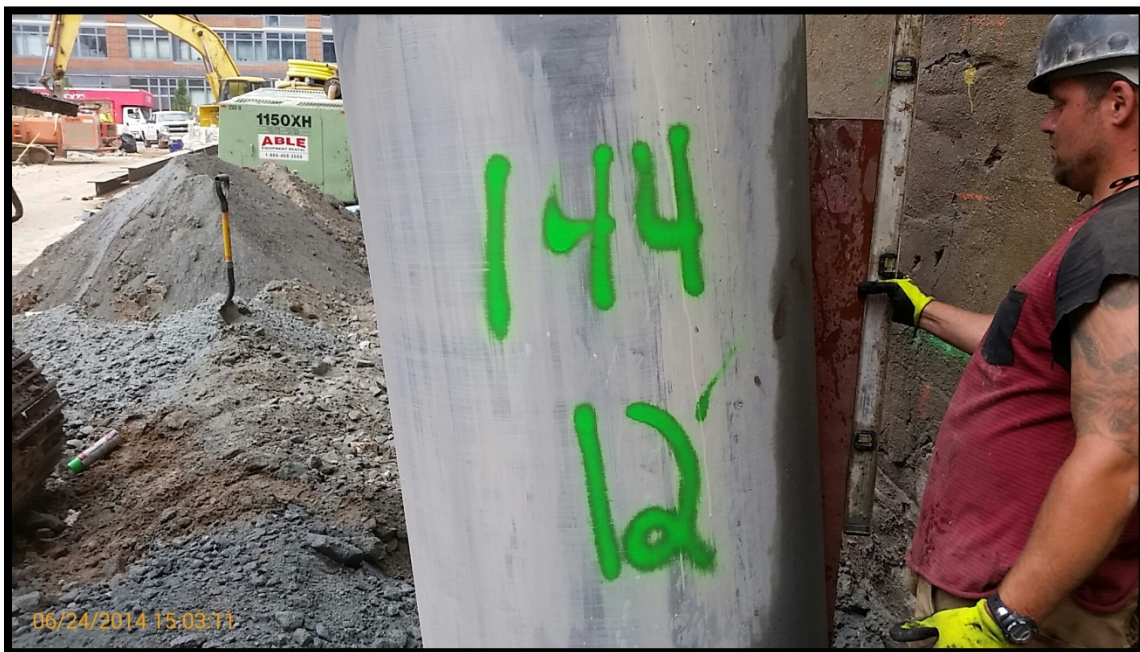
Photo 120: Battered secant pile #144S; confirming 6 degree tilt at EL +0 using a jig and bubble level.

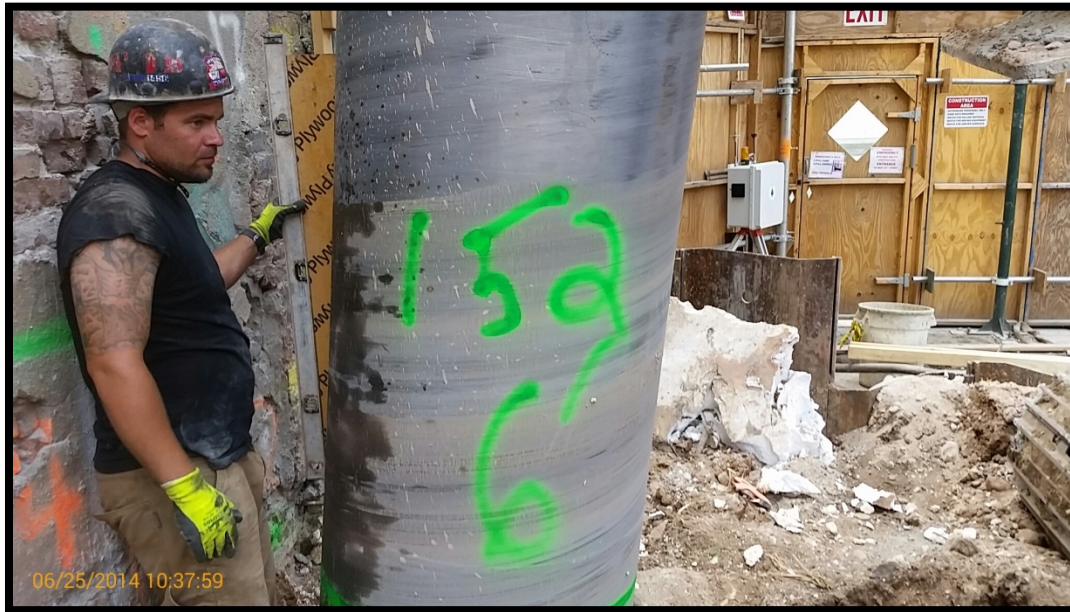
Photo 121: Battered secant pile #152S; confirming 6 degree tilt at EL +5 using a jig and bubble level.

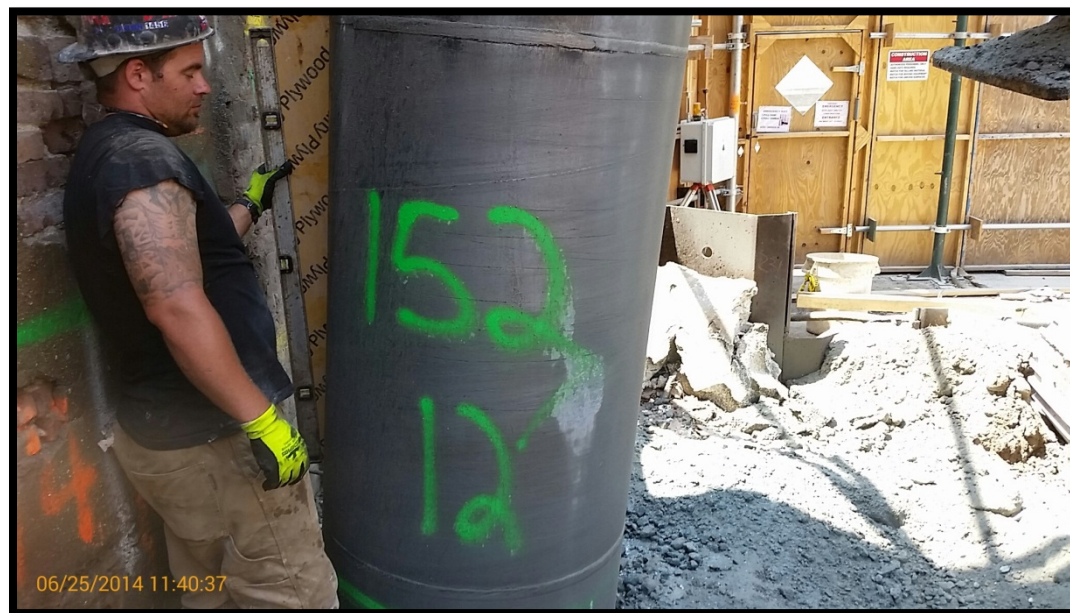
Photo 122: Battered secant pile #152S; confirming 6 degree tilt at EL +0 using a jig and bubble level.

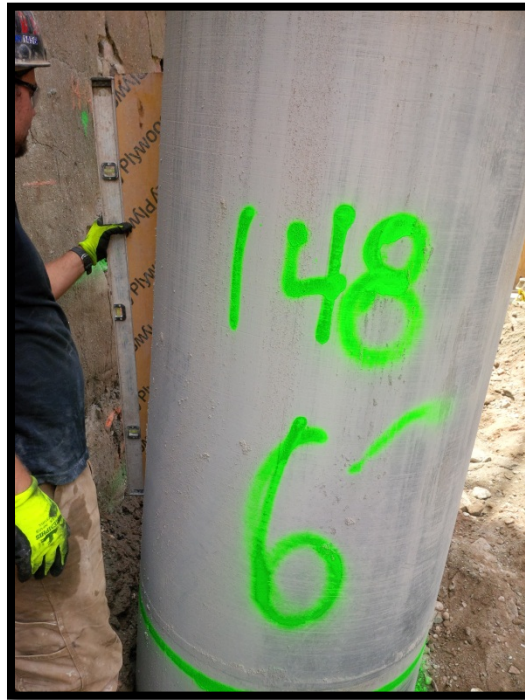
Photo 123: Battered secant pile #148S; confirming 6 degree tilt at EL +5 using a jig and bubble level.

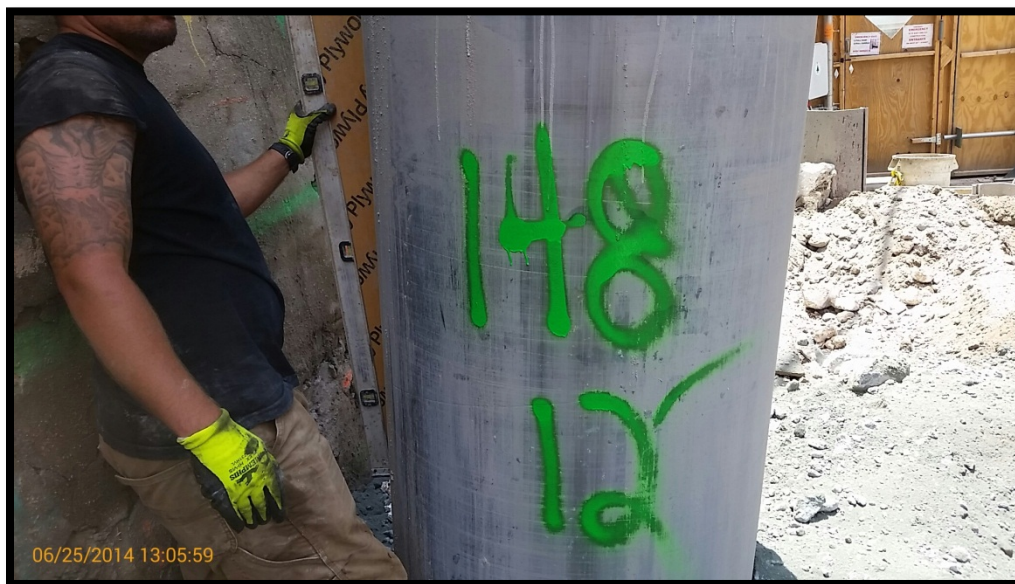
Photo 124: Battered secant pile #148S; confirming 6 degree tilt at EL +0 using a jig and bubble level.

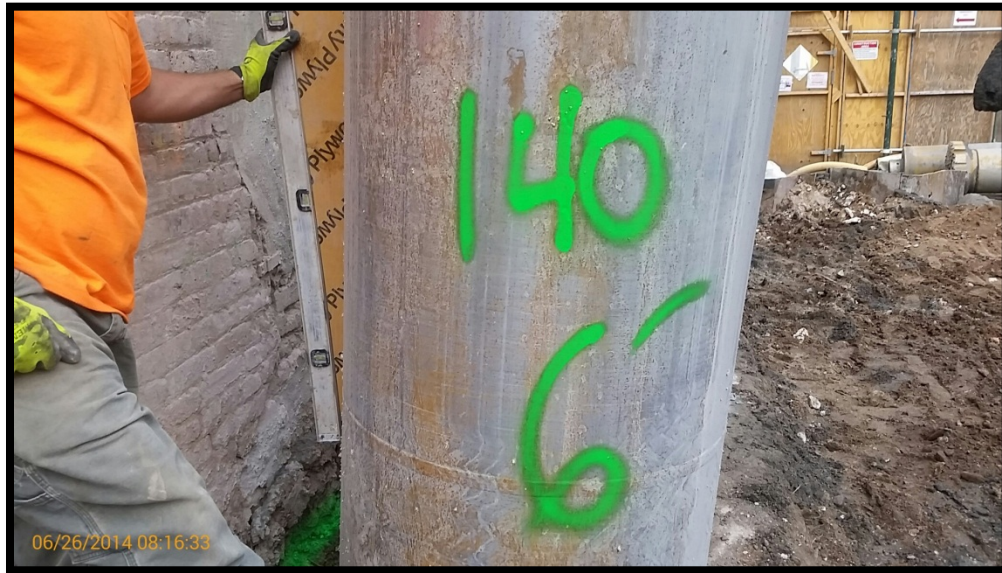
Photo 125: Battered secant pile #140S; confirming 6 degree tilt at EL +5 using a jig and bubble level.

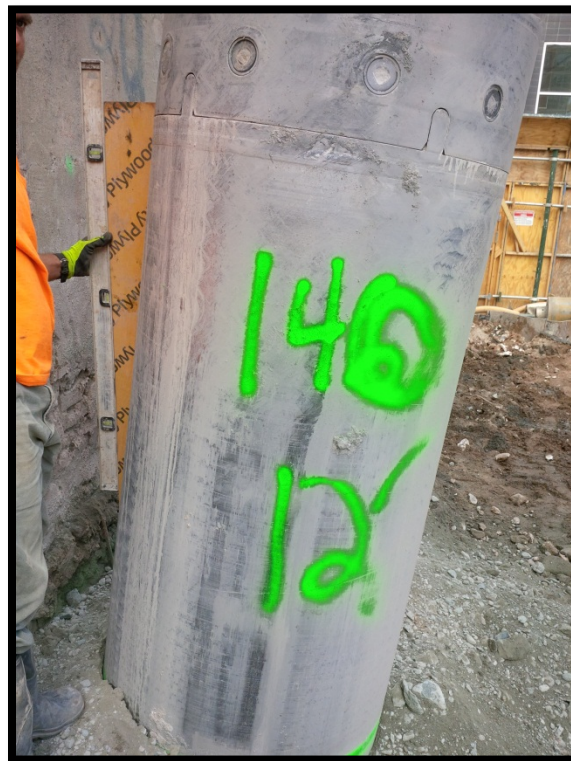
Photo 126: Battered secant pile #140S; confirming 6 degree tilt at EL +0 using a jig and bubble level.

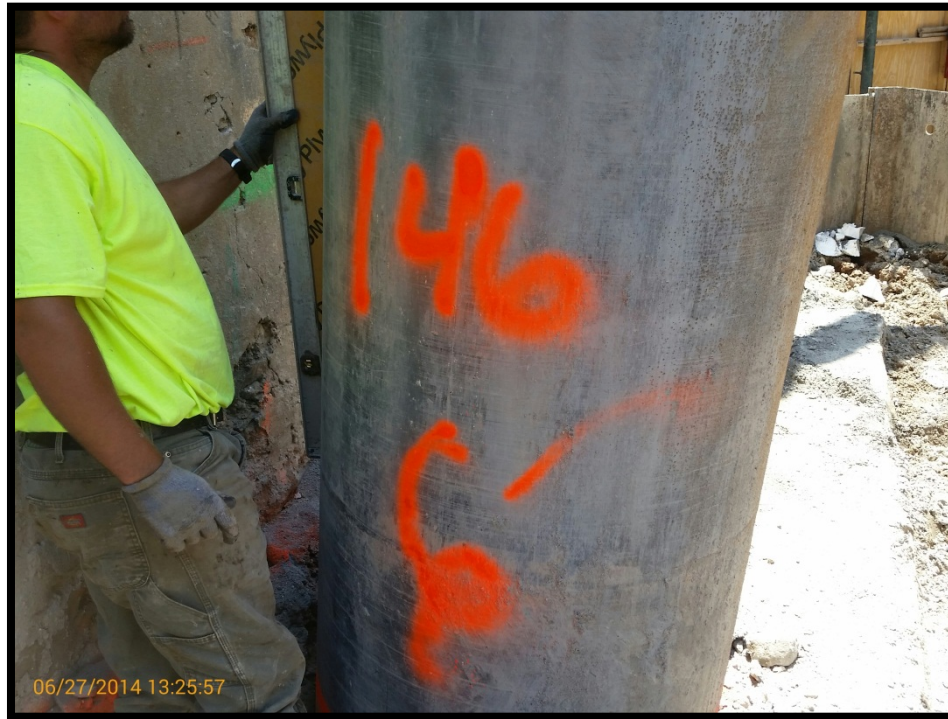
Photo 127: Battered secant pile #146S; confirming 6 degree tilt at EL +5 using a jig and bubble level.

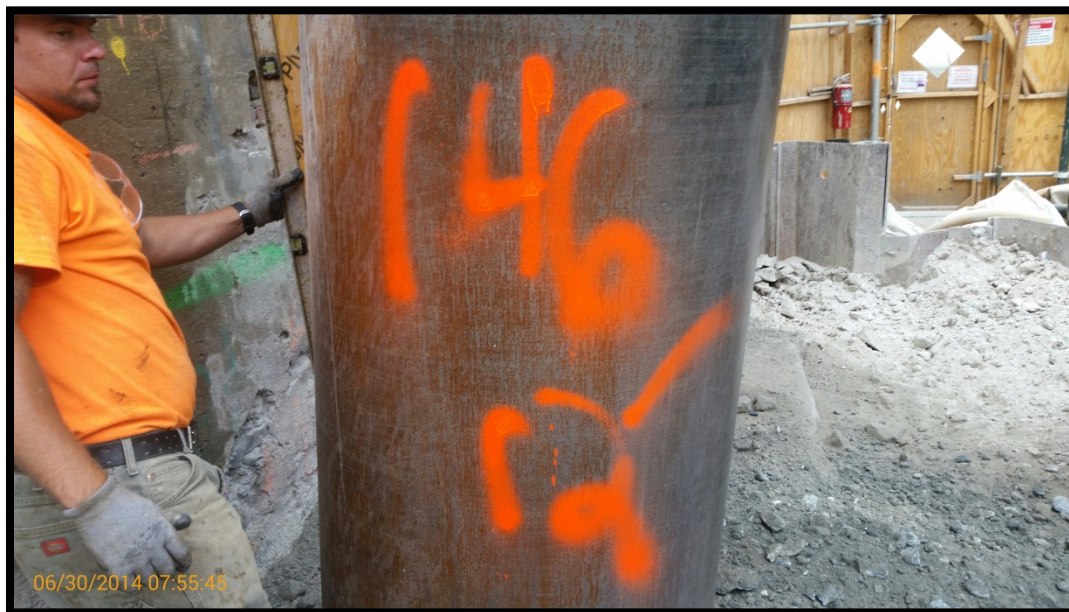
Photo 128: Battered secant pile #146S; confirming 6 degree tilt at EL +0 using a jig and bubble level.

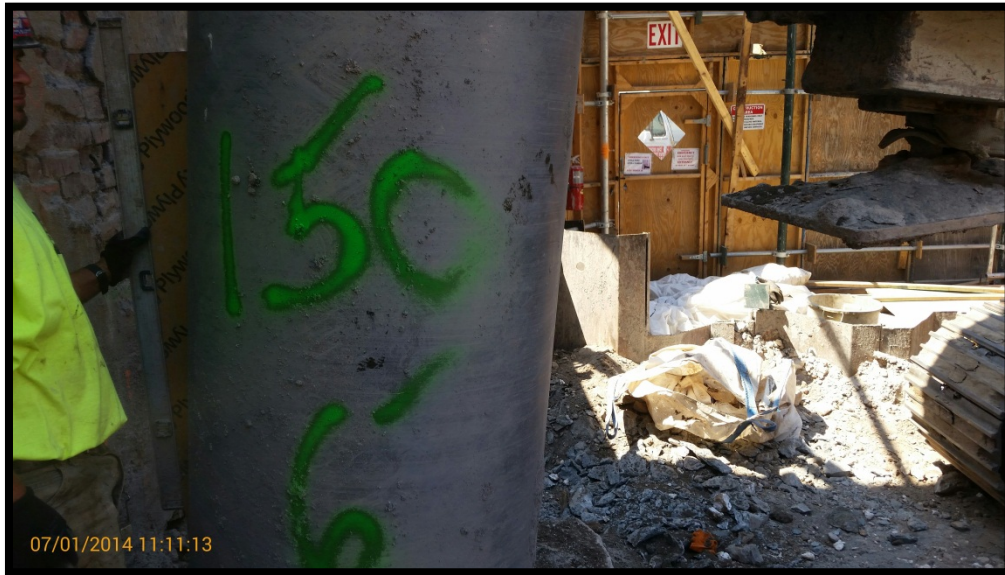
Photo 129: Battered secant pile #150S; confirming 6 degree tilt at EL +5 using a jig and bubble level.

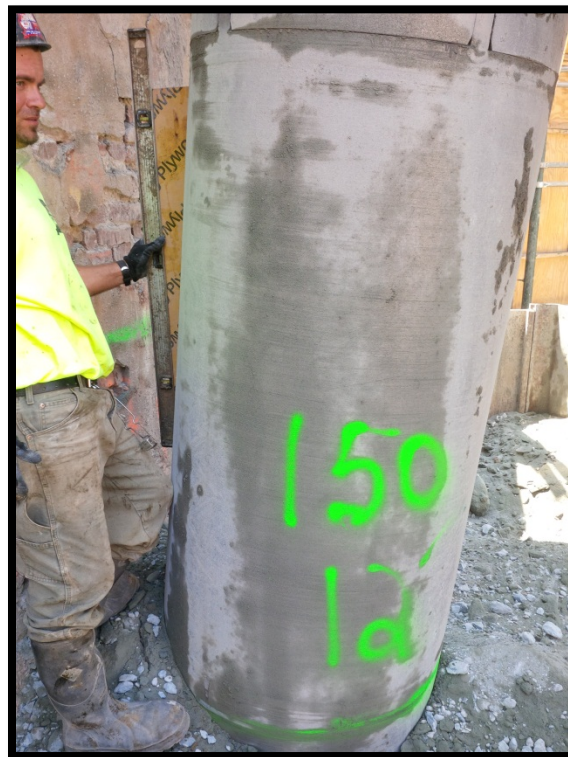
Photo 130: Battered secant pile #150S; confirming 6 degree tilt at EL +0 using a jig and bubble level.

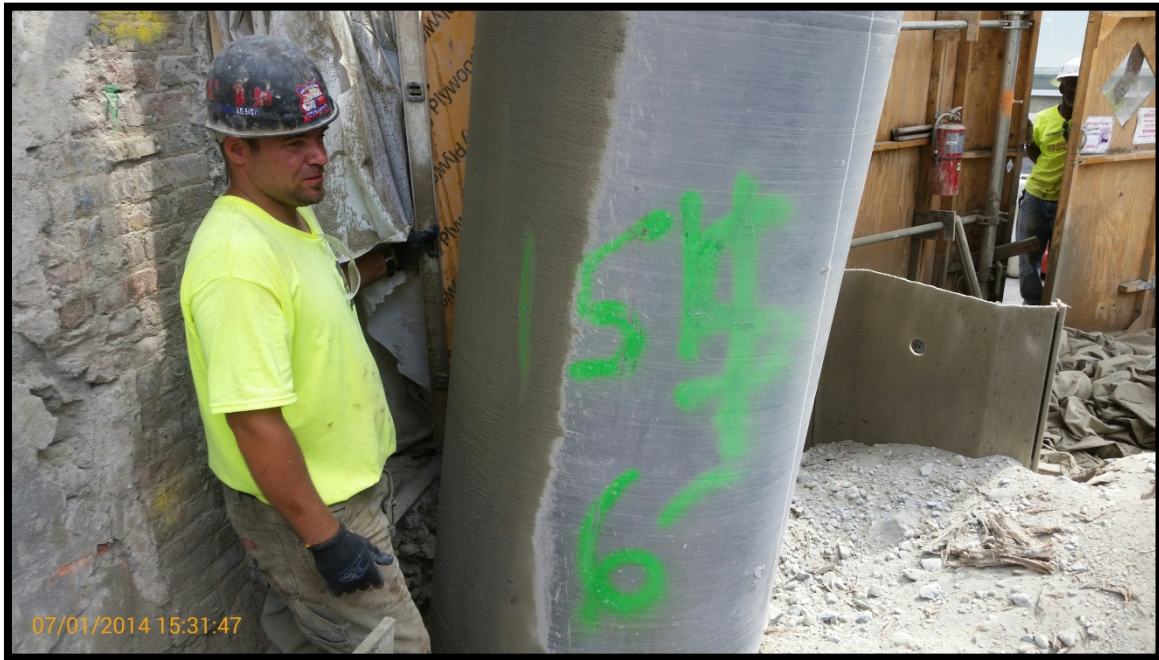
Photo 131: Battered secant pile #154S; confirming 6 degree tilt at EL +5 using a jig and bubble level.

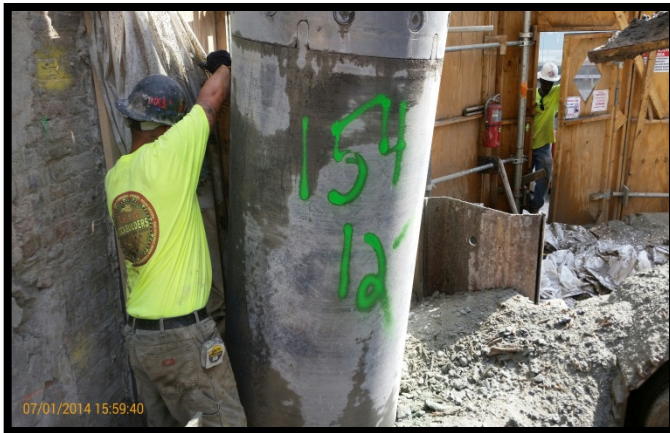
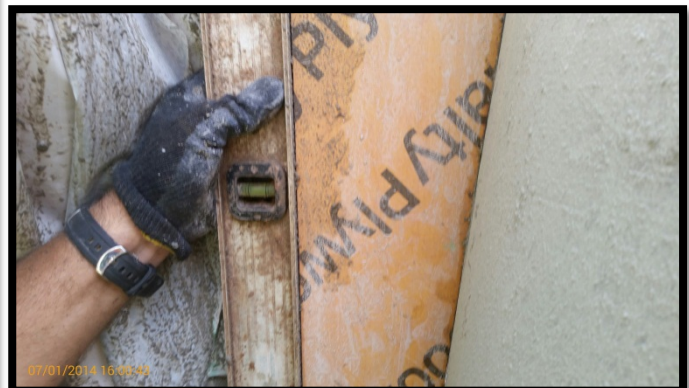
Photo 132A (left) & 132B (right): Battered secant pile #154S; confirming 6 degree tilt at EL +0 using a jig and bubble level.
