LYONS ENGINEERING, DPC.

2022-2024 PERIODIC REVIEW REPORT

NYSDEC Site Number: C704060

The EJ Victory Building
59 Lester Avenue
Johnson City, New York

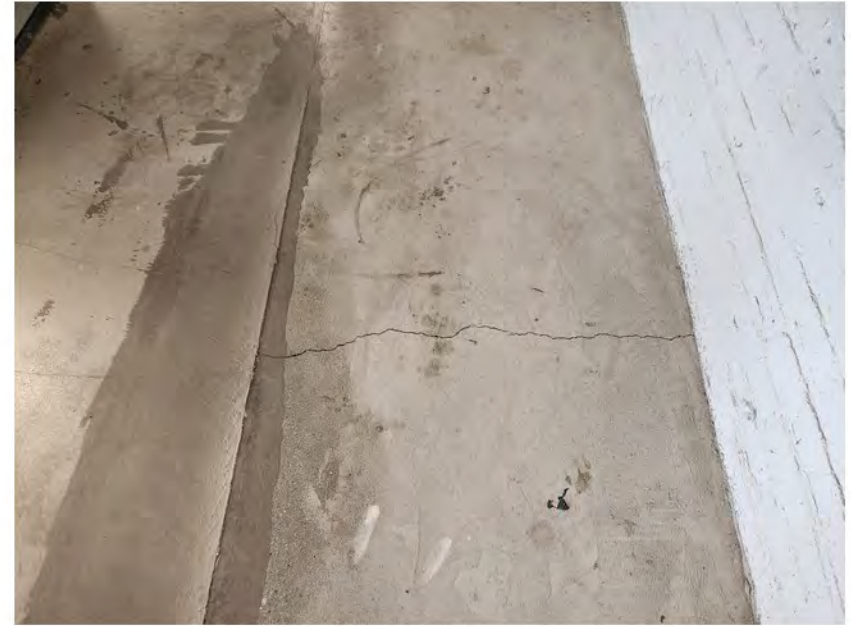
Minor crack in slab

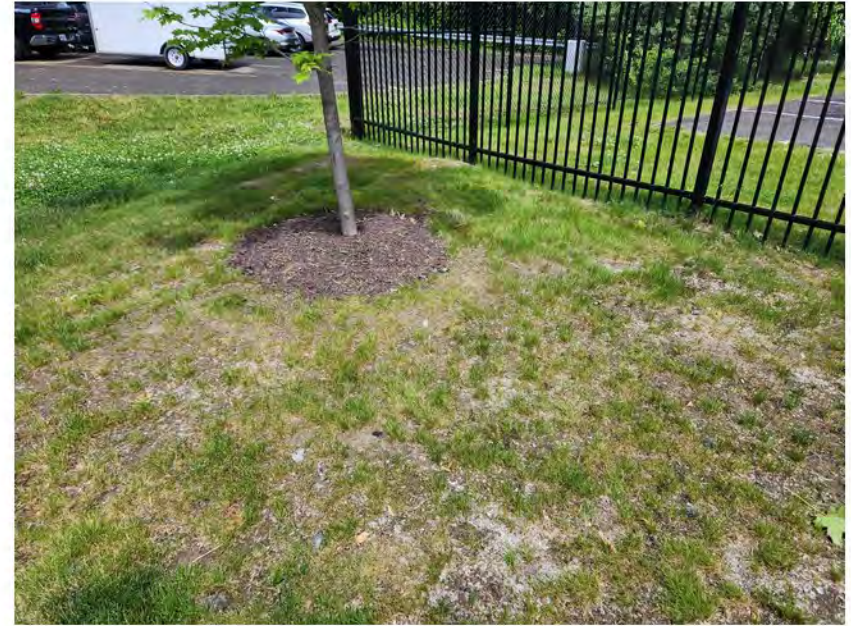
Closeup of lawn in western end of site

Recommendations:
CONSIDER OVERSEEDING THIN AREAS OF LAWN

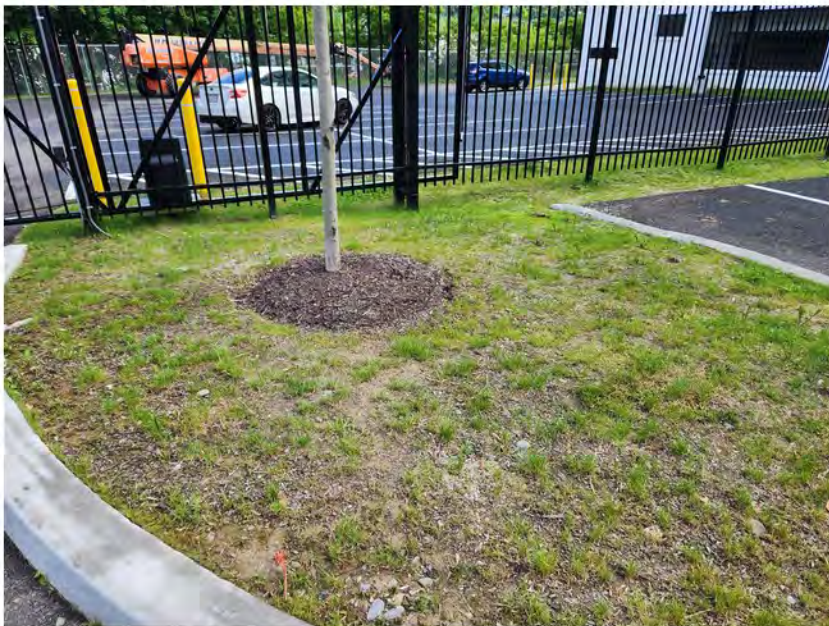
Closeup of lawn in western end of site

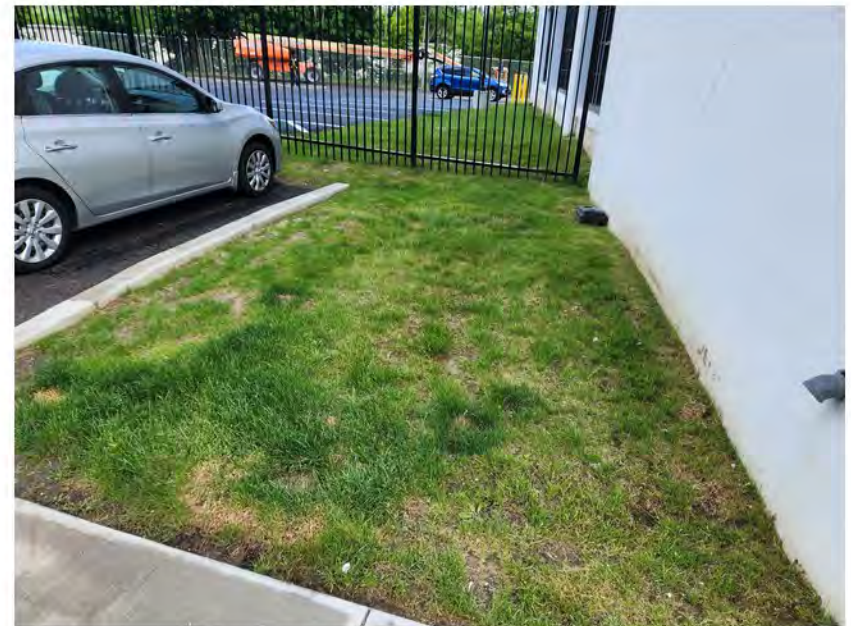
Closeup of lawn in western end of site

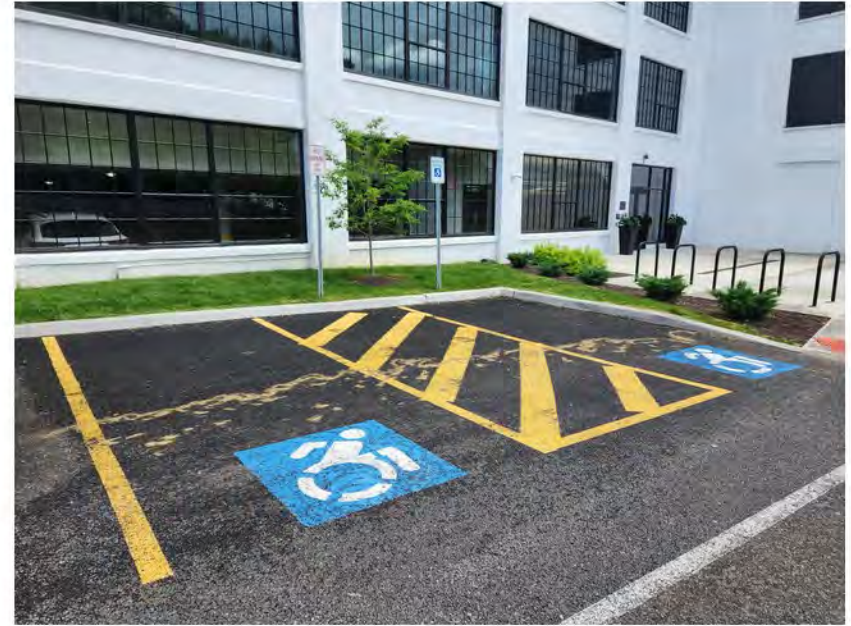
Parking lot along Helen Drive

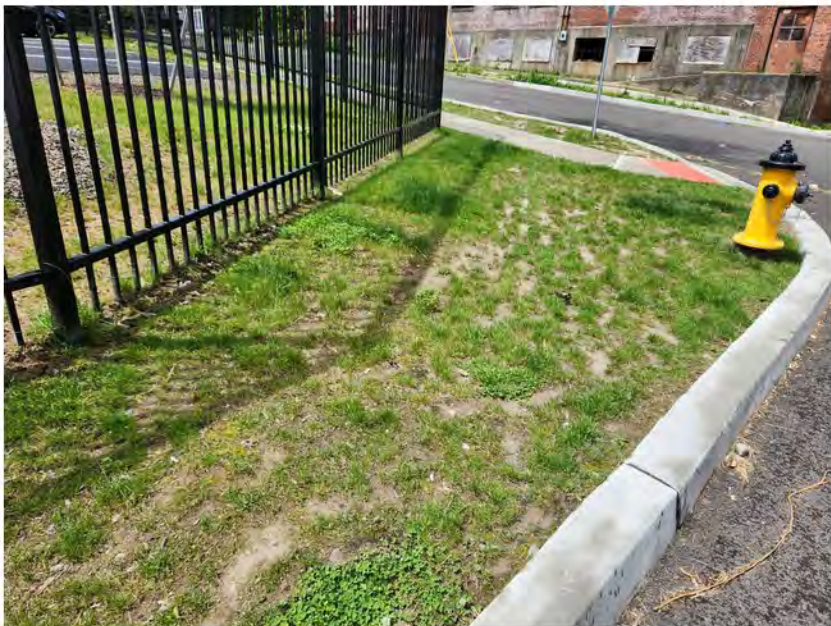
Closeup of lawn at intersection of Helen Drive and Avenue B

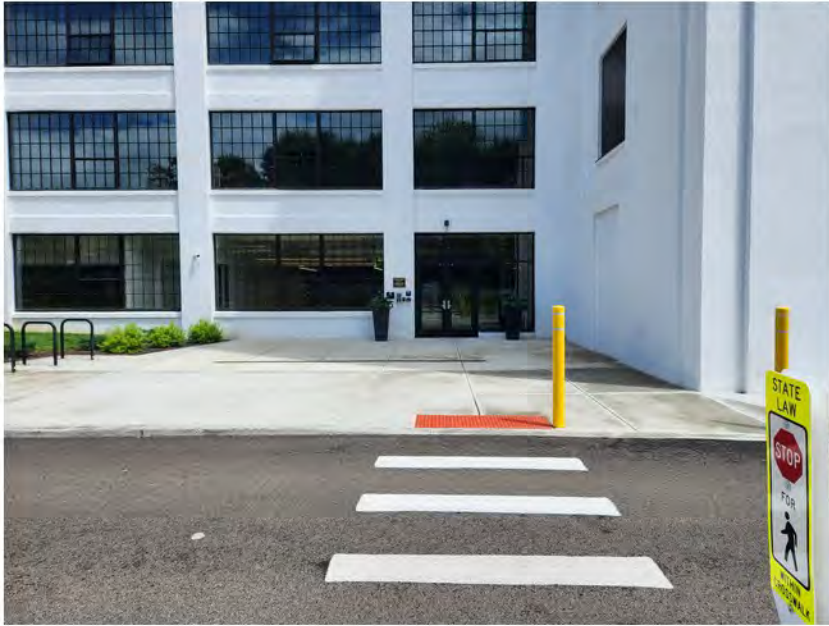
Main entrance along Helen Drive

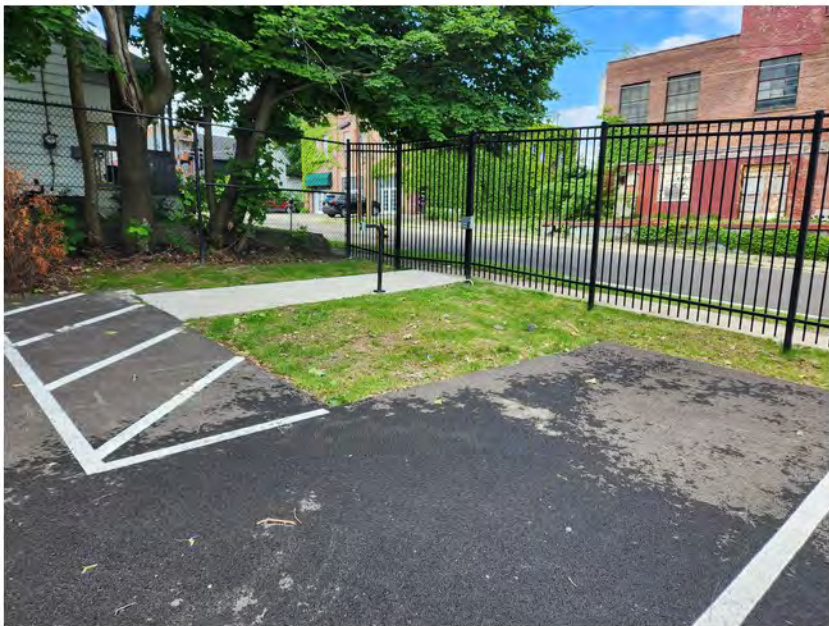
Southwestern corner of southwestern parking lot

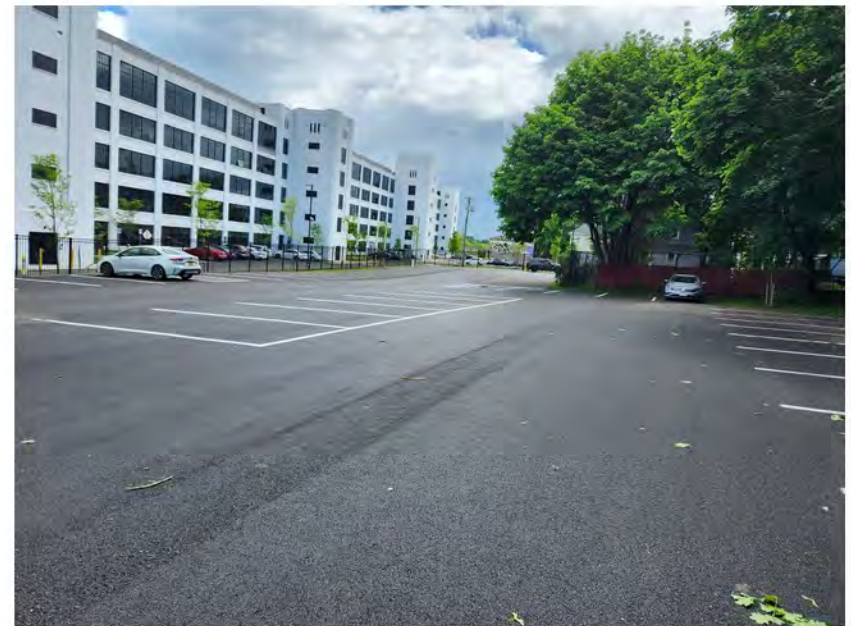
Southwestern parking lot, looking northeast

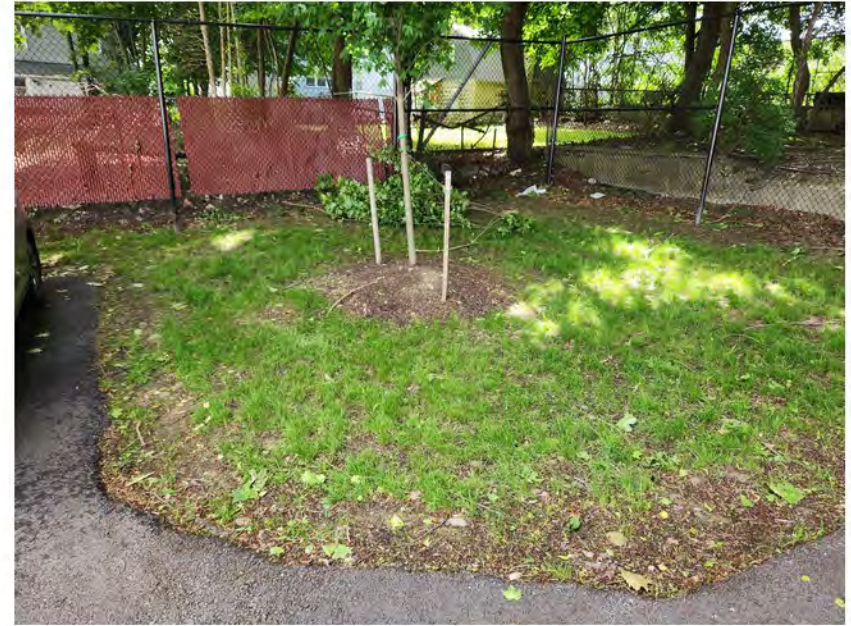
Closeup of lawn area in southern portion of southwestern parking lot

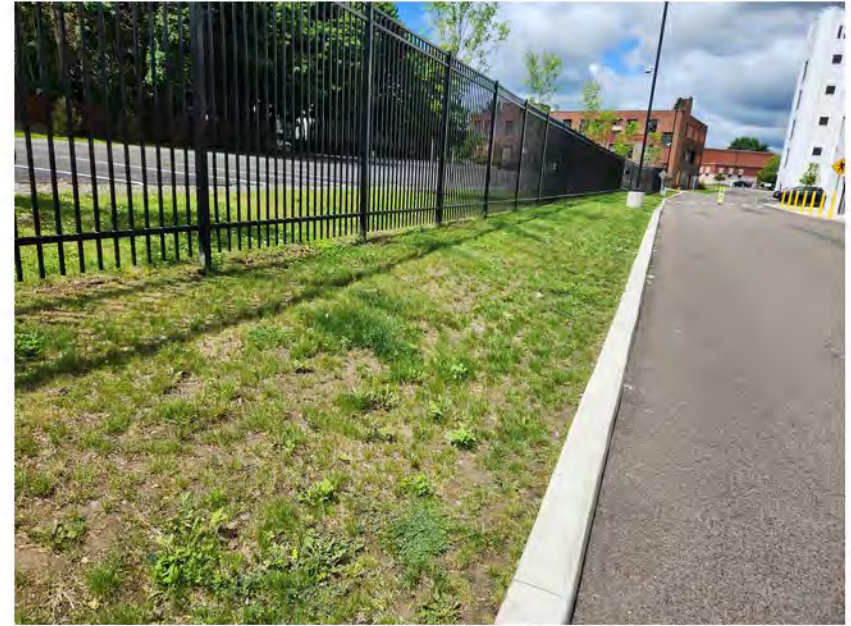
Closeup of verge between Helen Drive and southwestern parking lot

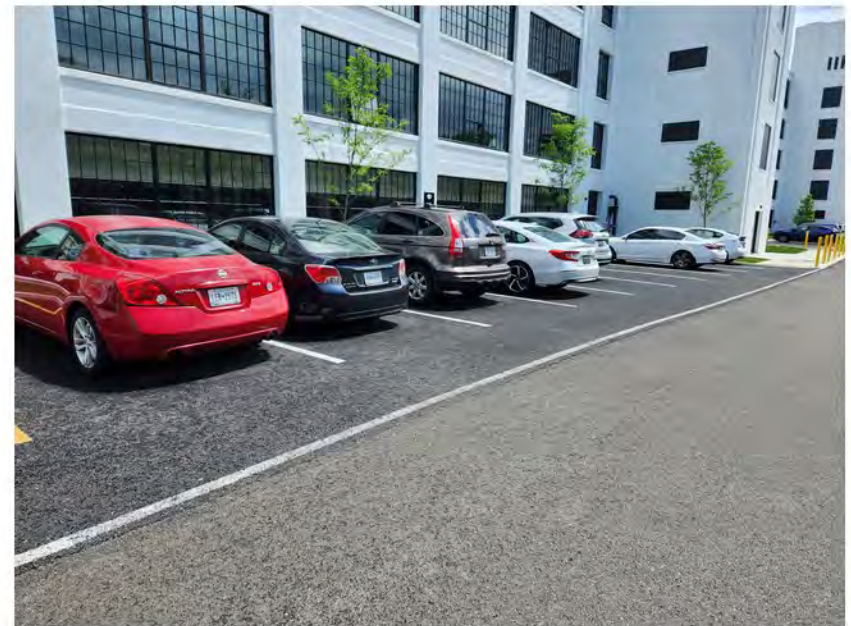
Parking lot along Helen Drive

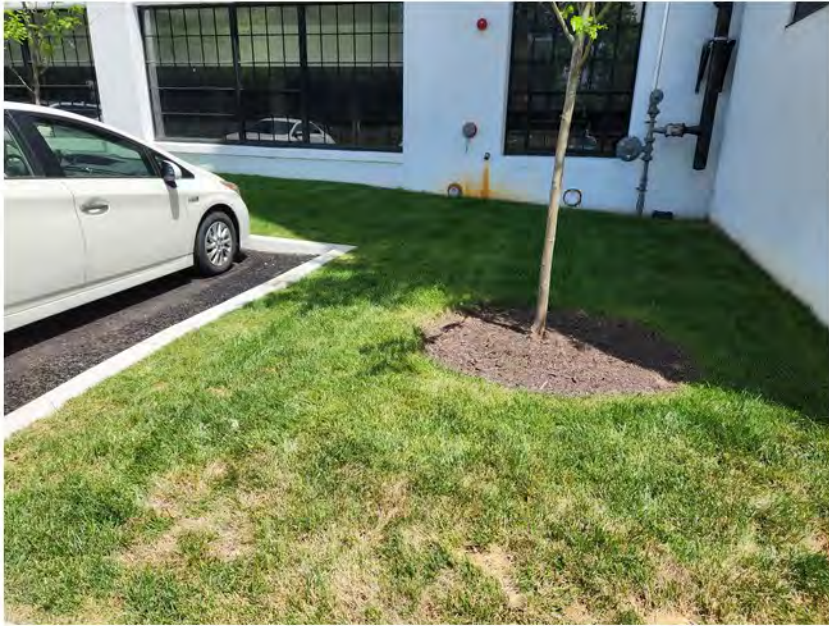
Closeup of lawn area adjacent to parking lot along Helen Drive

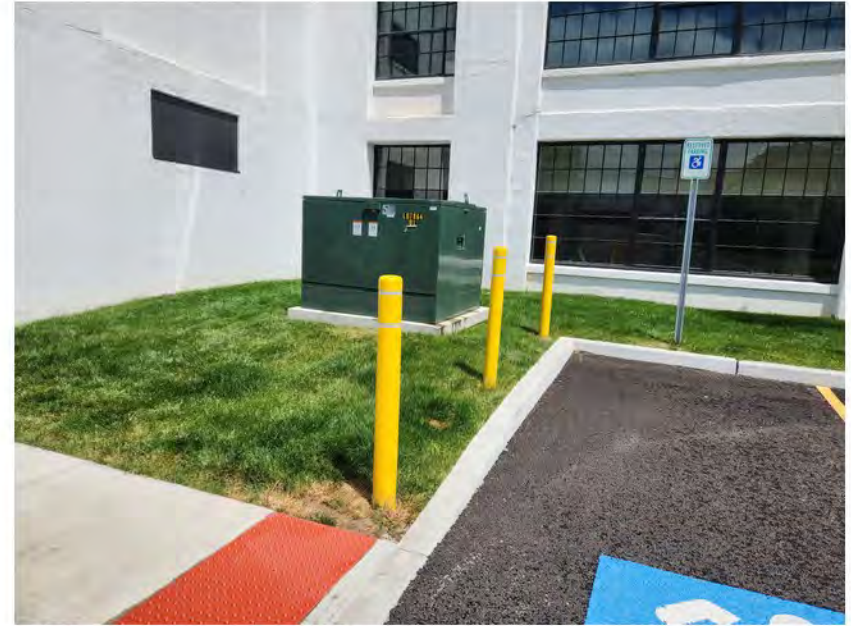
Closeup of lawn area adjacent to parking lot along Helen Drive

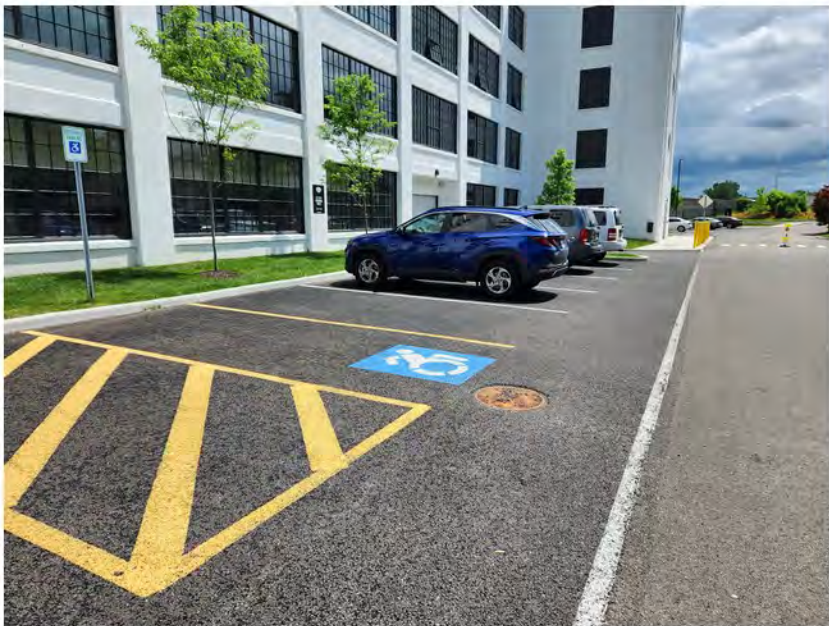
Parking lot along Helen Drive

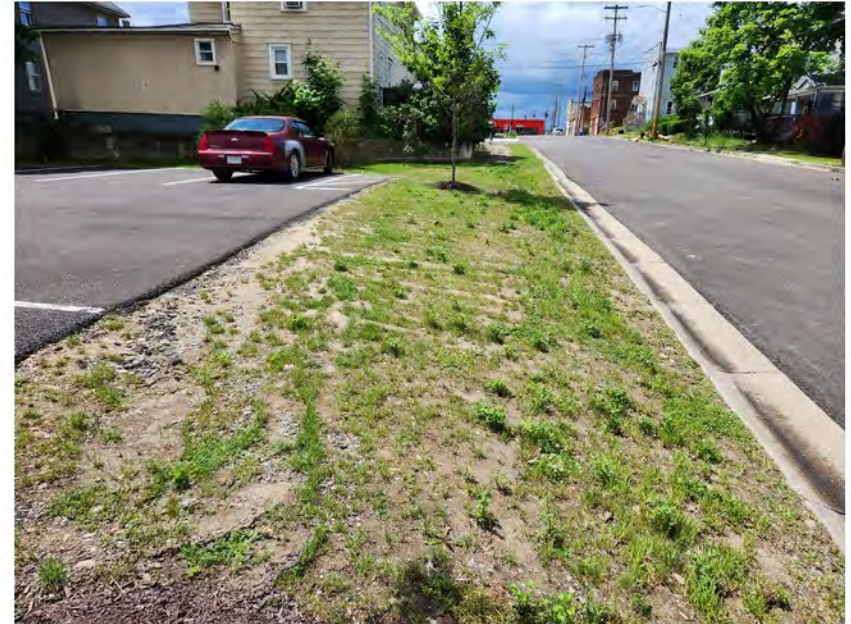
Closeup of lawn area along Avenue A

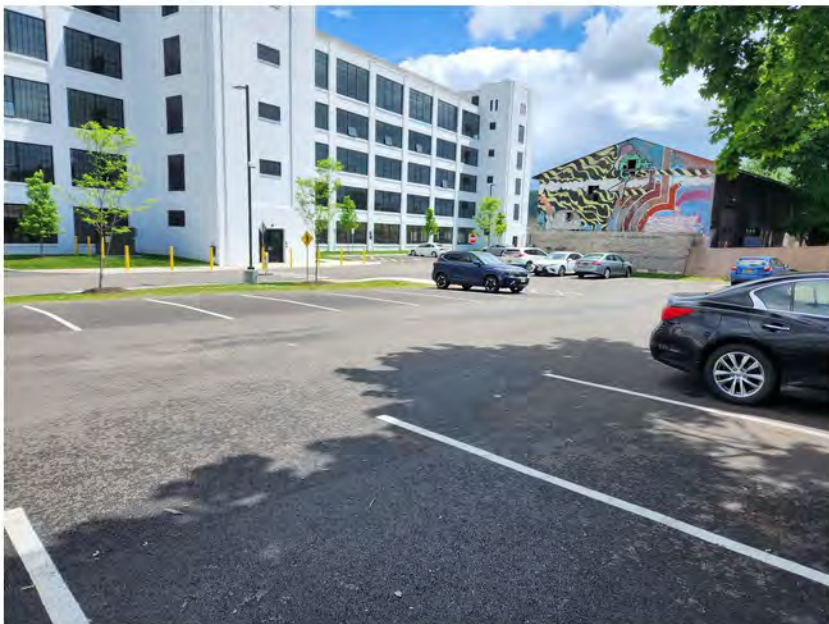
Southeastern parking lot, looking northeast

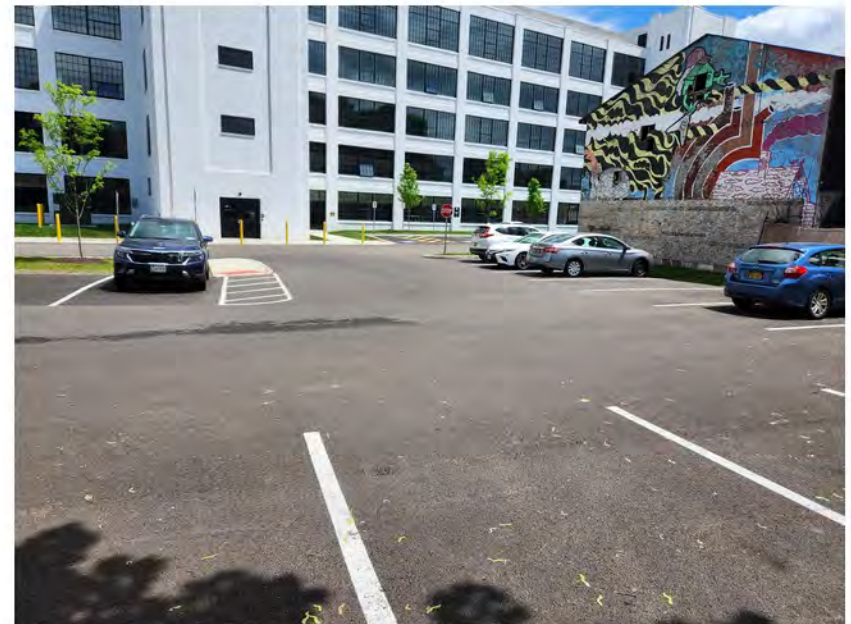
Southeastern parking lot, looking north

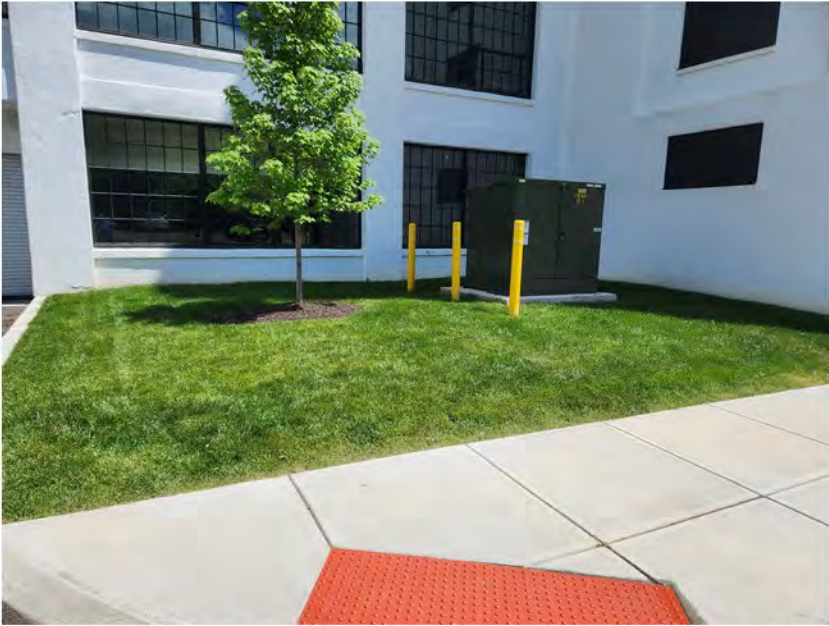
Closeup of lawn area adjacent to parking lot along Helen Drive

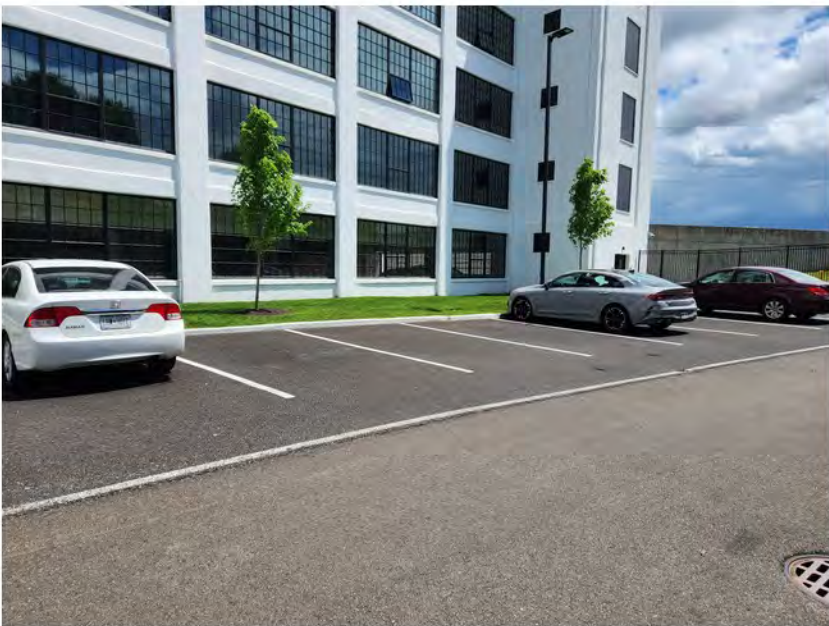
Parking lot along Helen Drive

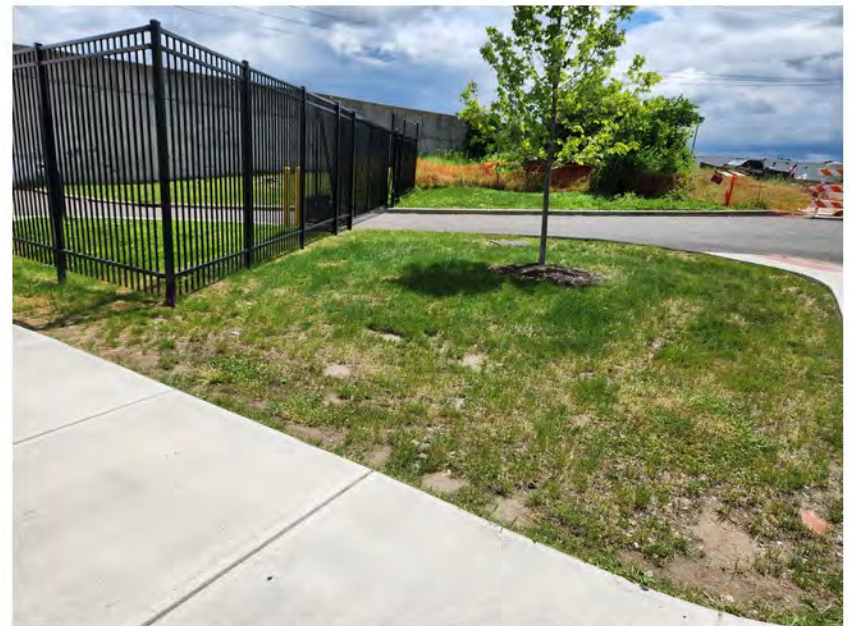
Eastern end of site along Helen Drive, looking east

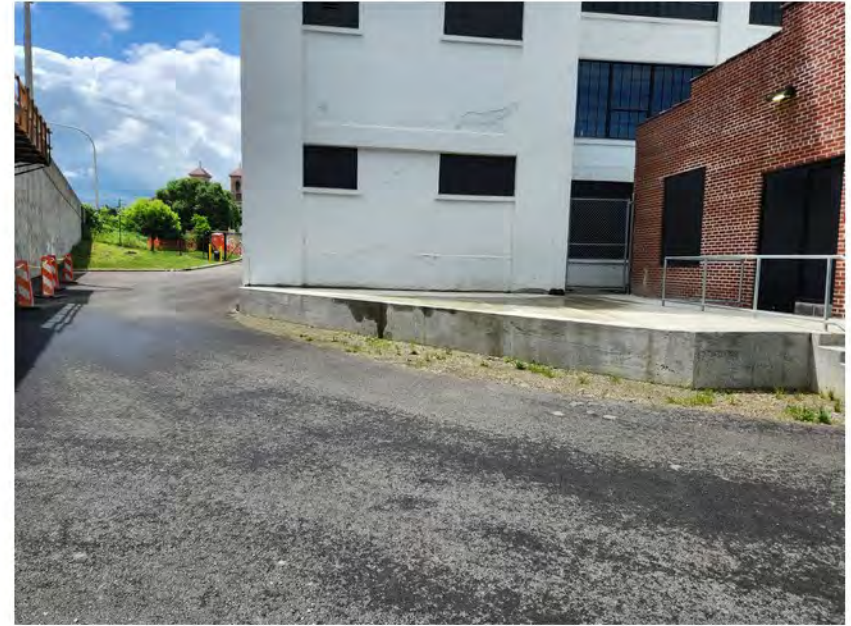
Northeastern patio

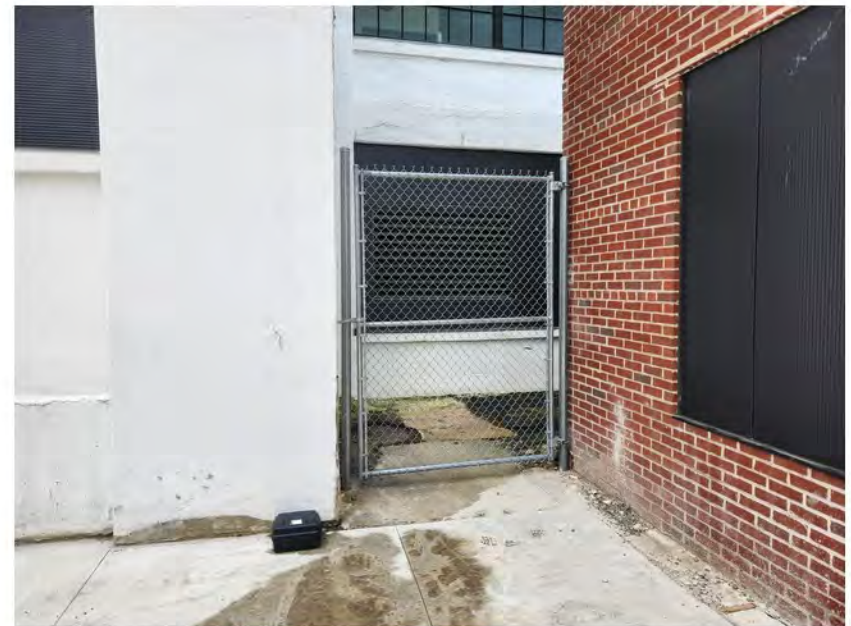
No tenant access to "courtyard" between main building and annex

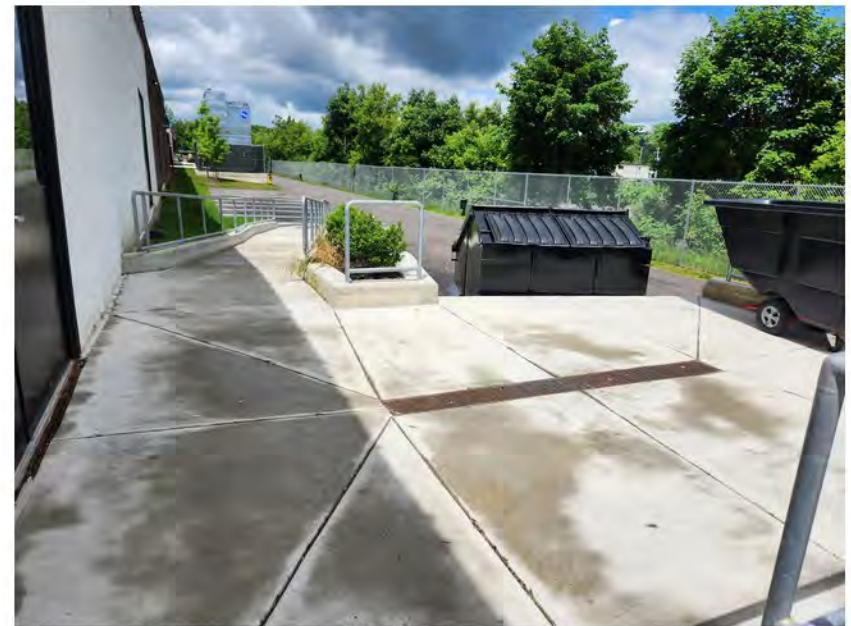
Loading dock

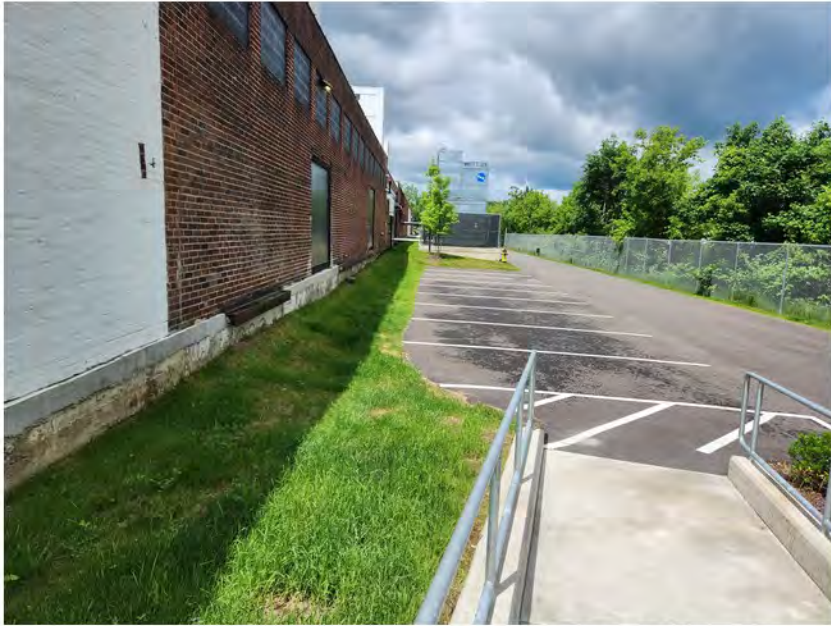
Central lawn area and parking along Avenue C, looking west

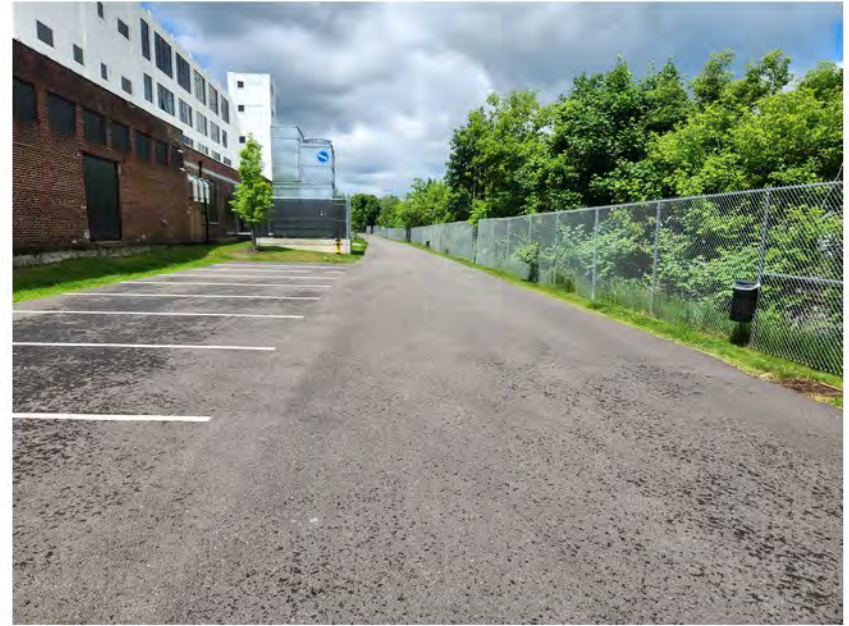
Central portion of Avenue C, looking west

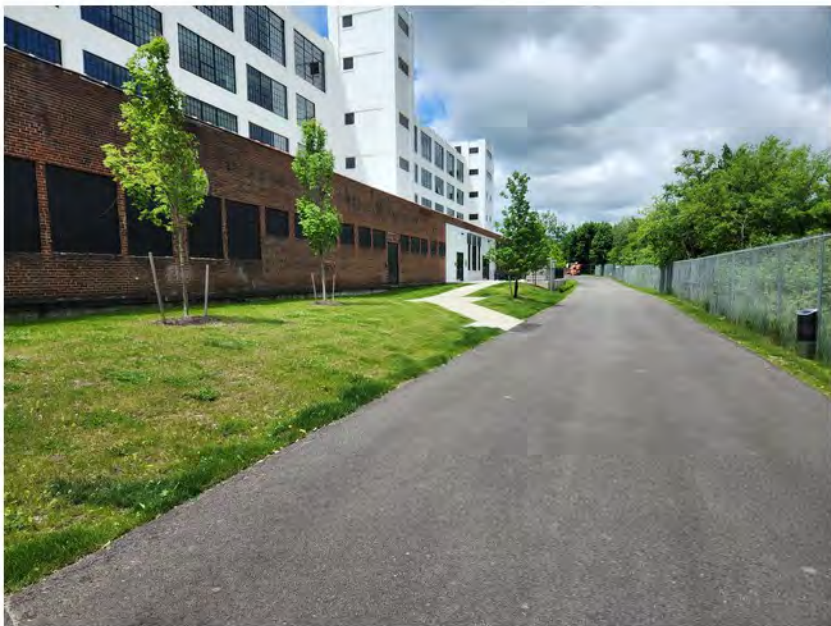
Central lawn area along Avenue C, looking west

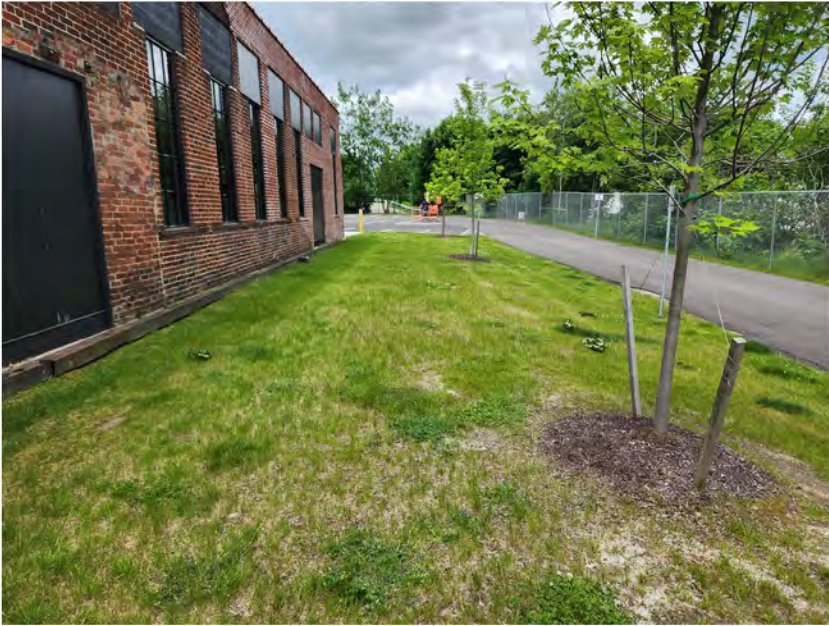
Western lawn area along Avenue C, looking west

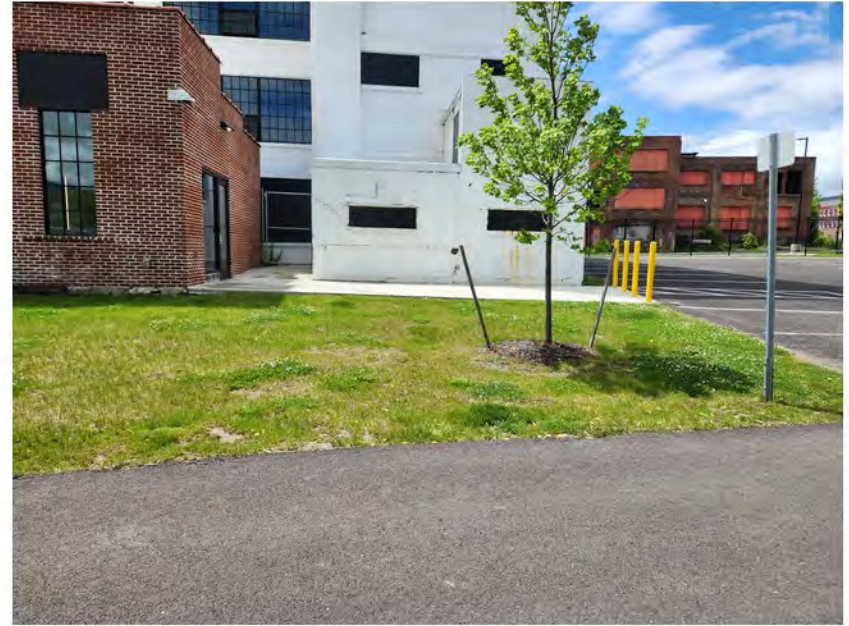
Western lawn area along Avenue C, looking south

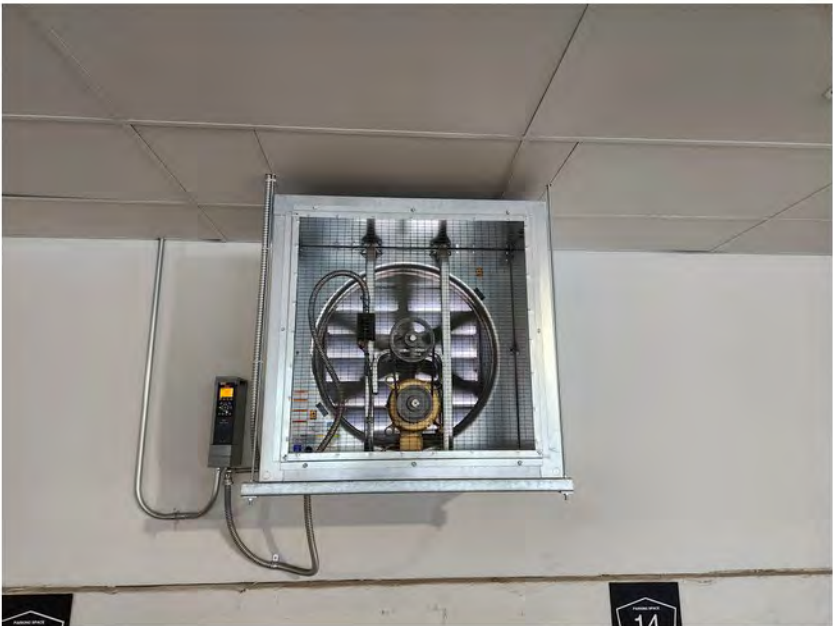
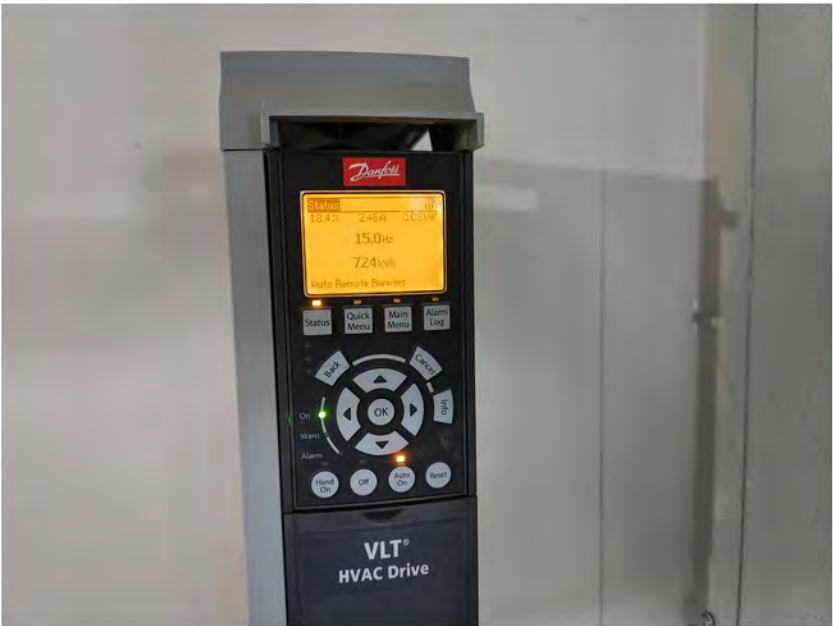
Annual inspection soon
