### Inline Camera Sewer Inspections

# SUBSURFACE UTILITY ENGINEERING PROJECT COMPLETION REPORT

DATE: 1/24/2020, **Revised 1/31/2020**

PROJECT NAME: Football Field Complex, Elmira, NY

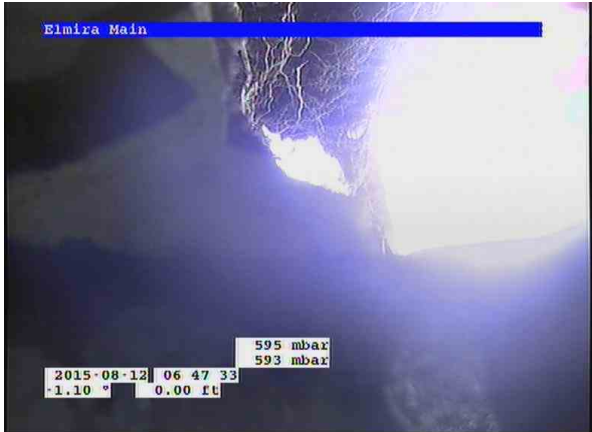
100 ft N  
CB24\_4ae89dc0-c8e6-4947-9cb7-28c155c0de88\_20191223\_125451\_040.jpg, , 0.00ft  
Special Chamber

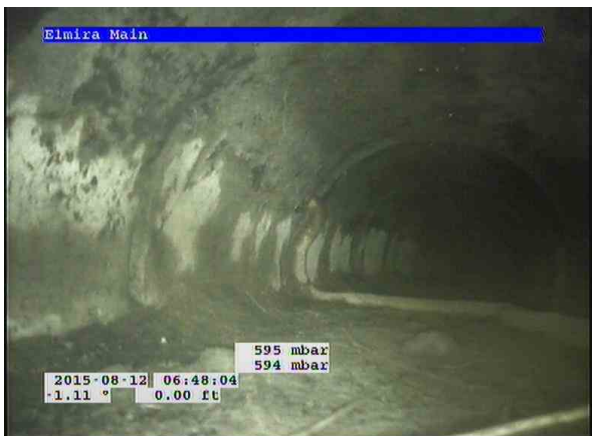
100 ft N  
CB24\_21013073-395e-4a9f-9653-138f15685da1\_20191223\_125521\_654.jpg, 00:00:00, 0.00ft  
Water Level, 0% of the vertical dimension

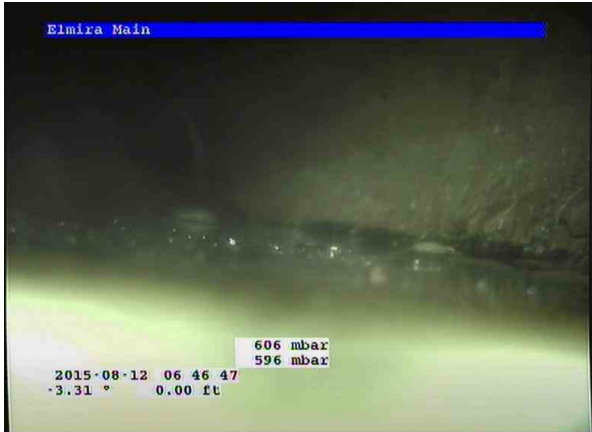
Test Pit 8 to Catch B  
8\_fe27b7a9-ccba-4e3f-817b-9bb497179d35\_20191223\_1748  
29\_312.jpg, 00:00:00, 0.00ft  
Water Level, 20% of the vertical dimension

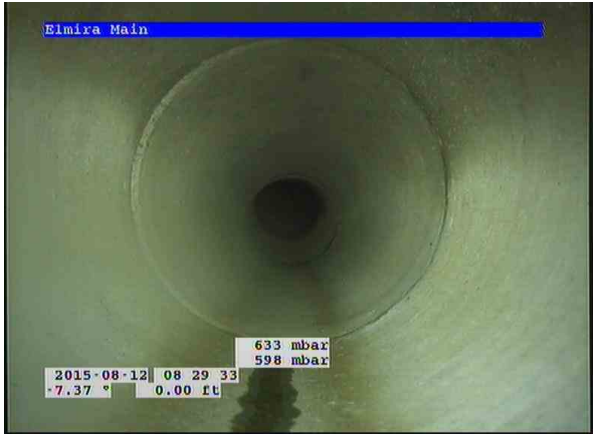
cb02 to  
west\_9c39916d-6ed8-40d5-9995-6fac183440fa\_20191227\_11  
2643\_378.jpg, 00:00:00, 0.00ft  
Water Level, 0% of the vertical dimension

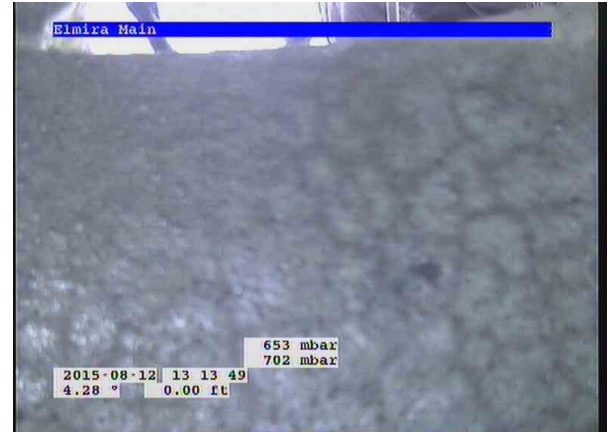
tp7  
cb1\_3b4f66bb-bb3a-4d0d-bd4b-1f04a4bb593b\_20191227\_16  
1101\_483.jpg, 00:03:39, 0.00ft  
Special Chamber / tp7 start

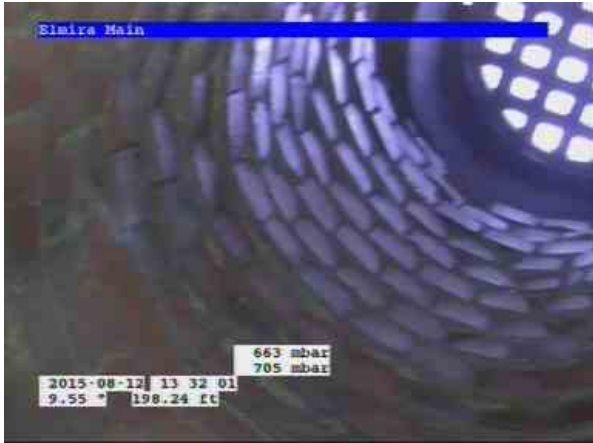
TP-07 to  
CB-24\_c6aafb36-5c98-4da9-9872-3f6ba9546c9b\_20200116\_  
211328\_968.jpg, 00:09:27, 198.32ft  
Manhole / CB24 End

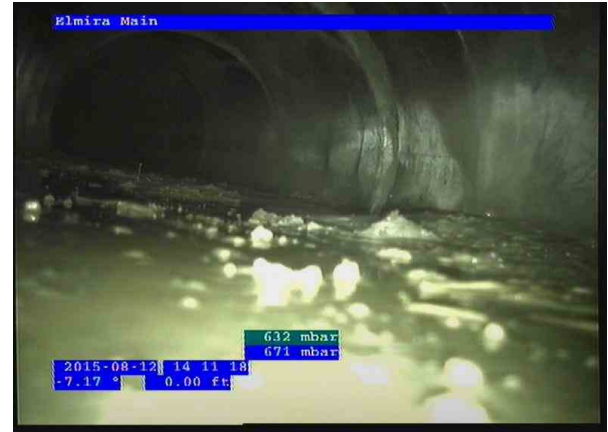
cb1 to  
tp9\_1c9dcd35-9d4f-4961-a27c-5daca9d986c6\_20191227\_171  
729\_631.jpg, 00:00:00, 0.00ft  
Water Level, 0% of the vertical dimension

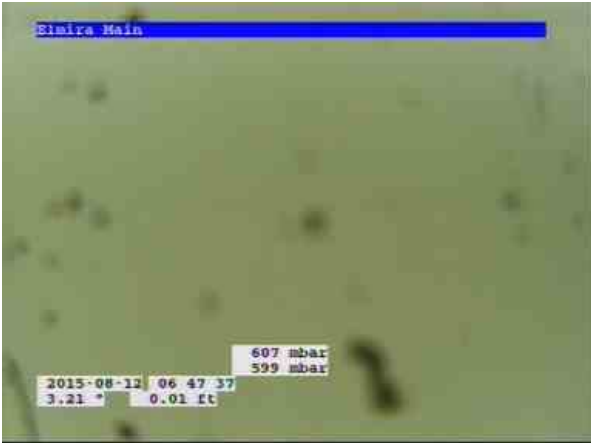
Test Pit 8 to the  
West\_426ba309-086e-4cd1-b89a-700ba22faee4\_20200130\_1  
91909\_602.jpg, 00:00:48, 0.00ft  
Water Level, 50% of the vertical dimension

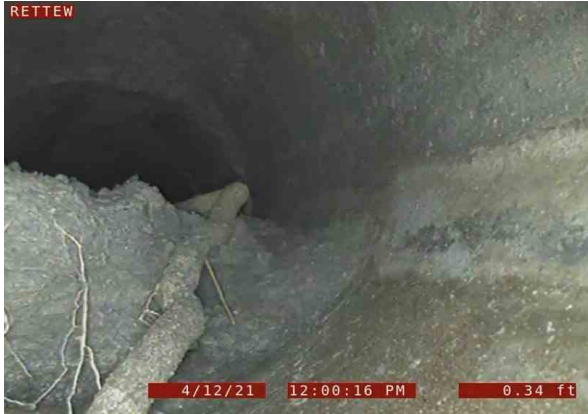
1, , 0.00ft  
Water Level, 5% of the vertical dimension

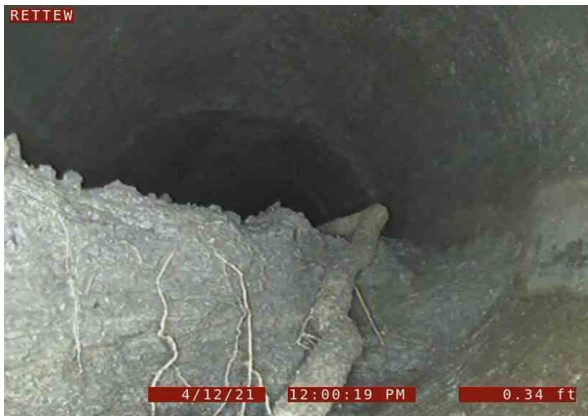
| 1:50 | Distance | Code | Observation | Grade | | | |
|---|---|---|---|---|---|---|---|
| | 4.30 | F01 | RTB | Roots Tap Barrell at 6 o'clock, 15% of cross sectional area, Finish | M3 | | |

3, 00:00:30, 0.30ft  
Roots Tap Barrell at 6 o'clock, 15% of cross sectional area, Start

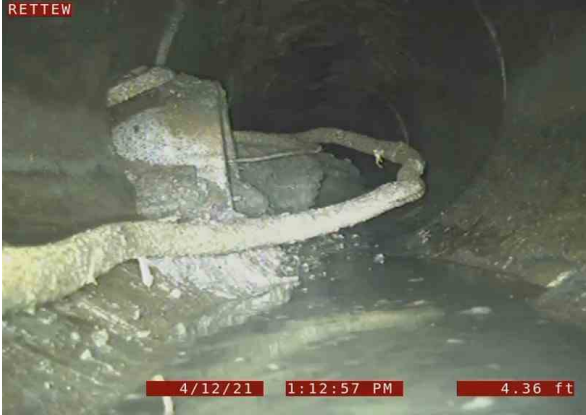
5, 00:00:30, 4.30ft  
 Roots Tap Barrell at 6 o'clock, 15% of cross sectional area,  
 Finish

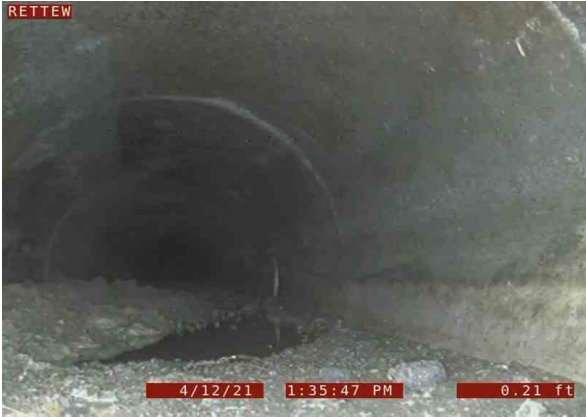
1, , 0.00ft  
Water Level, 5% of the vertical dimension

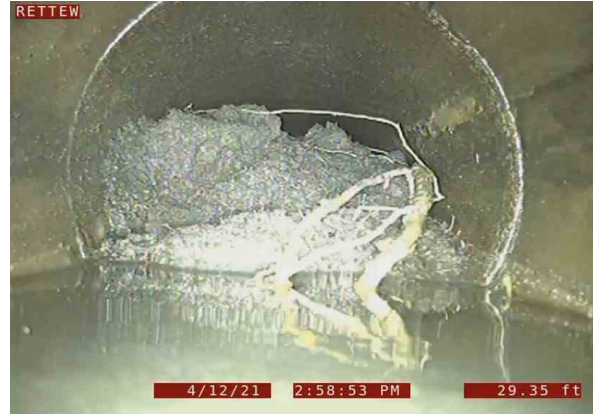
6, 00:01:08, 30.00ft  
 Survey Abandoned / OBZ

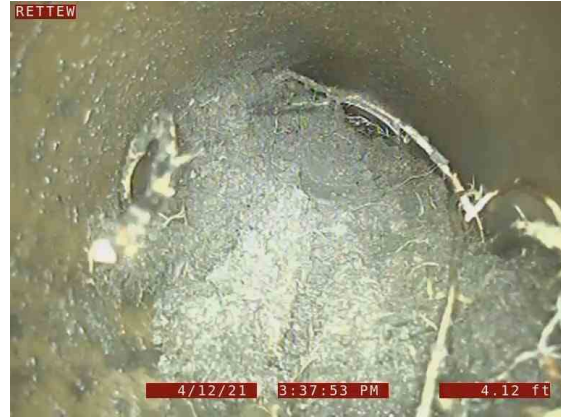
| 1:50 | Distance | Code | Observation | Grade | | | |
|---|---|---|---|---|---|---|---|
| | 4.12 | OBZ | Obstacles Other, 100% of cross sectional area from 12 o'clock to 12 o'clock / Roots and Soil | M5 | | | |

6, 00:03:32, 4.12ft  
Obstacles Other, 100% of cross sectional area from 12 o'clock to 12 o'clock / Roots and Soil

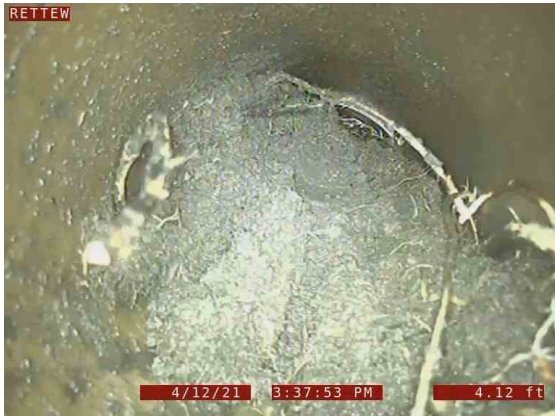
7, 00:03:32, 4.12ft  
Survey Abandoned / OBZ

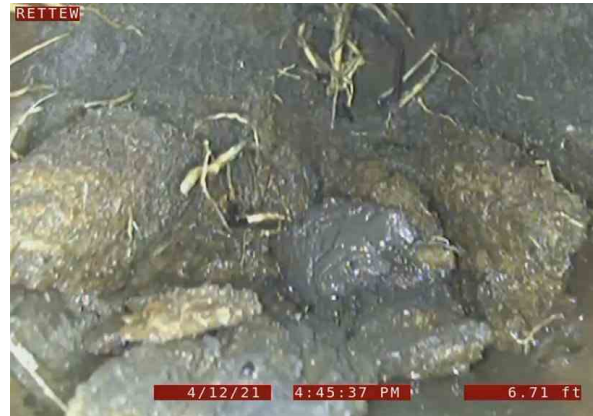
4, 00:00:20, 7.02ft  
Survey Abandoned / OBZ

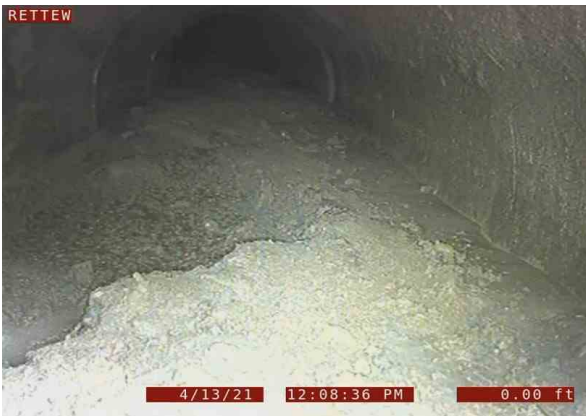
3, 00:00:12, 0.00ft  
Deposits Settled Fine, 50% of cross sectional area from 3 o'clock to 9 o'clock, Start

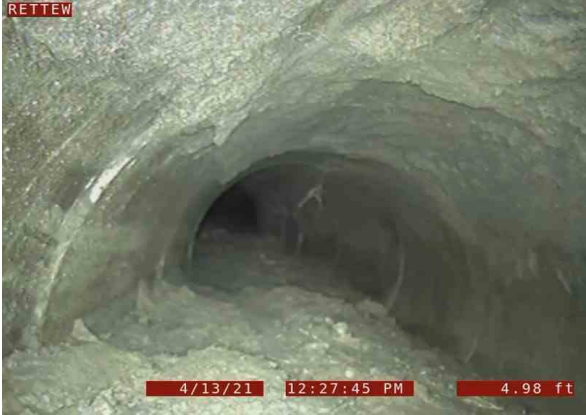
5, 00:12:58, 4.98ft  
 Survey Abandoned / DNSF

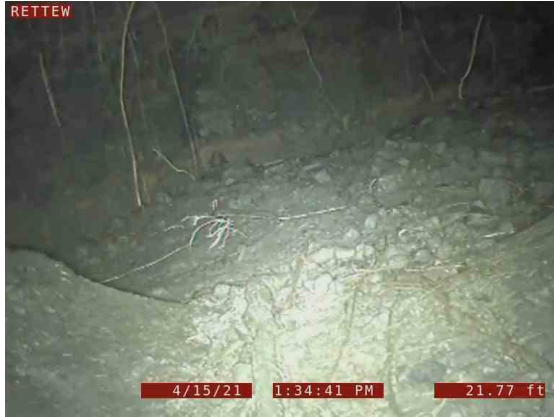
5, 00:02:57, 24.00ft  
Roots Medium Barrell from 4 o'clock to 10 o'clock, 5% lost,  
Finish

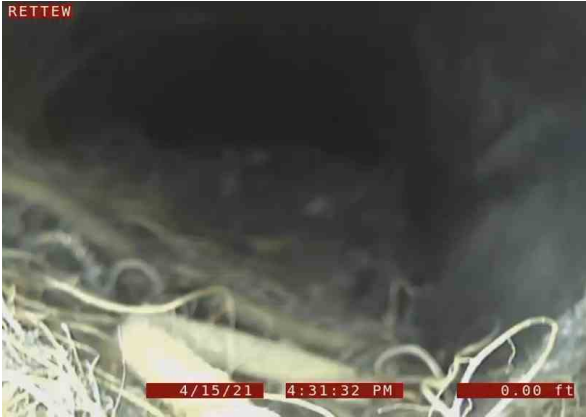
1, , 0.00ft  
Water Level, 0% of the vertical dimension

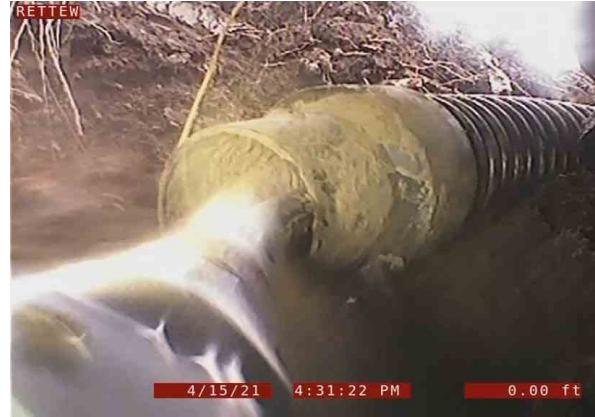
2, 00:00:00, 0.00ft  
Special Chamber / TP-C

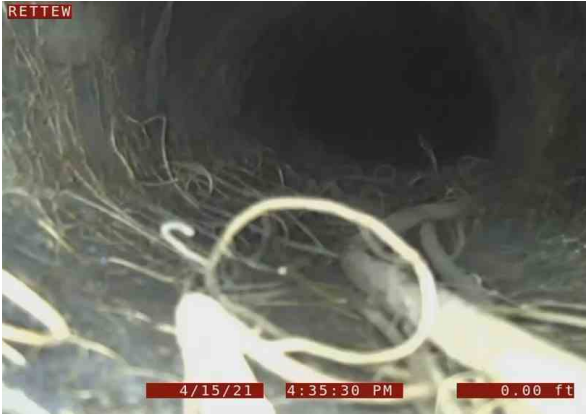
1, , 0.00ft  
Water Level, 0% of the vertical dimension

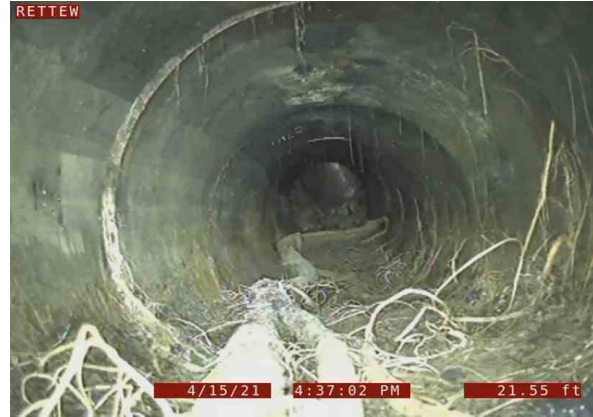
6, 00:01:44, 21.55ft  
Survey Abandoned / OBZ

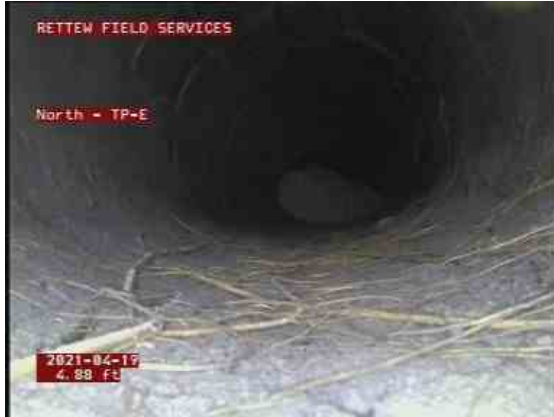
1, , 0.00ft  
Water Level, 0% of the vertical dimension

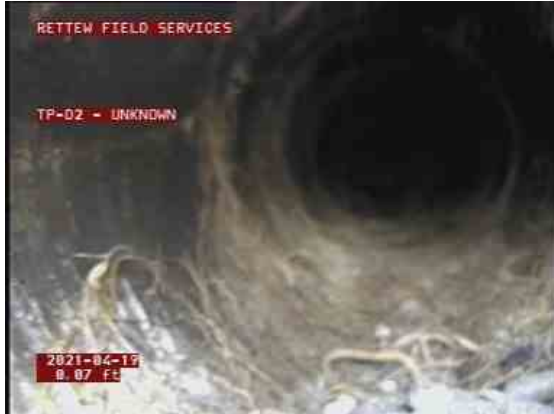
1, , 0.00ft  
Water Level, 0% of the vertical dimension

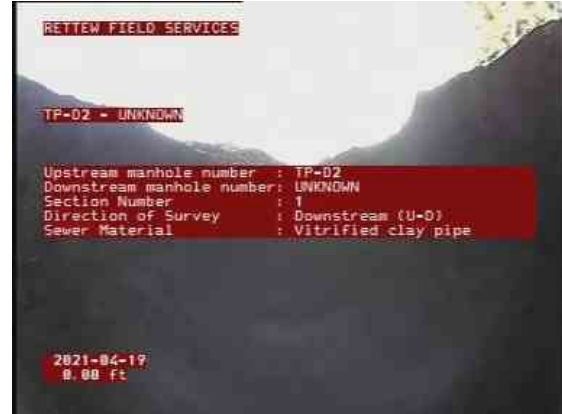
2, 00:00:00, 0.00ft  
Special Chamber / TP-D2

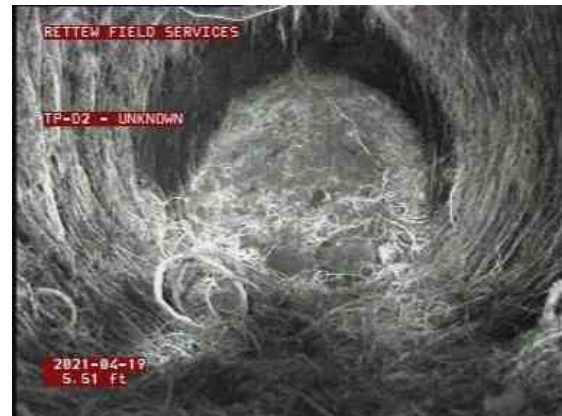
4, 00:00:30, 5.50ft  
Roots Ball Barrell from 12 o'clock to 12 o'clock, 100% lost

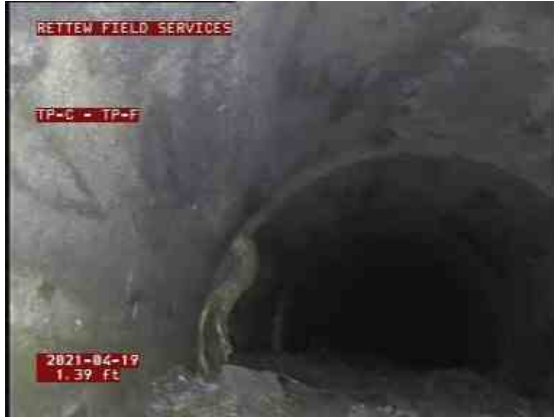
1, , 0.00ft  
Water Level, 0% of the vertical dimension

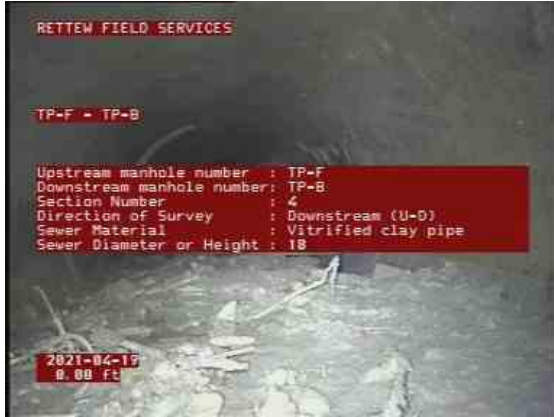
1, , 0.00ft  
Water Level, 0% of the vertical dimension
