Periodic Review Report

NYSDEC Site #C851049

October 31, 2023 to October 31, 2025

Former Corning Hospital
176 Denison Parkway East & 171 & 201 East First Street
Corning, New York

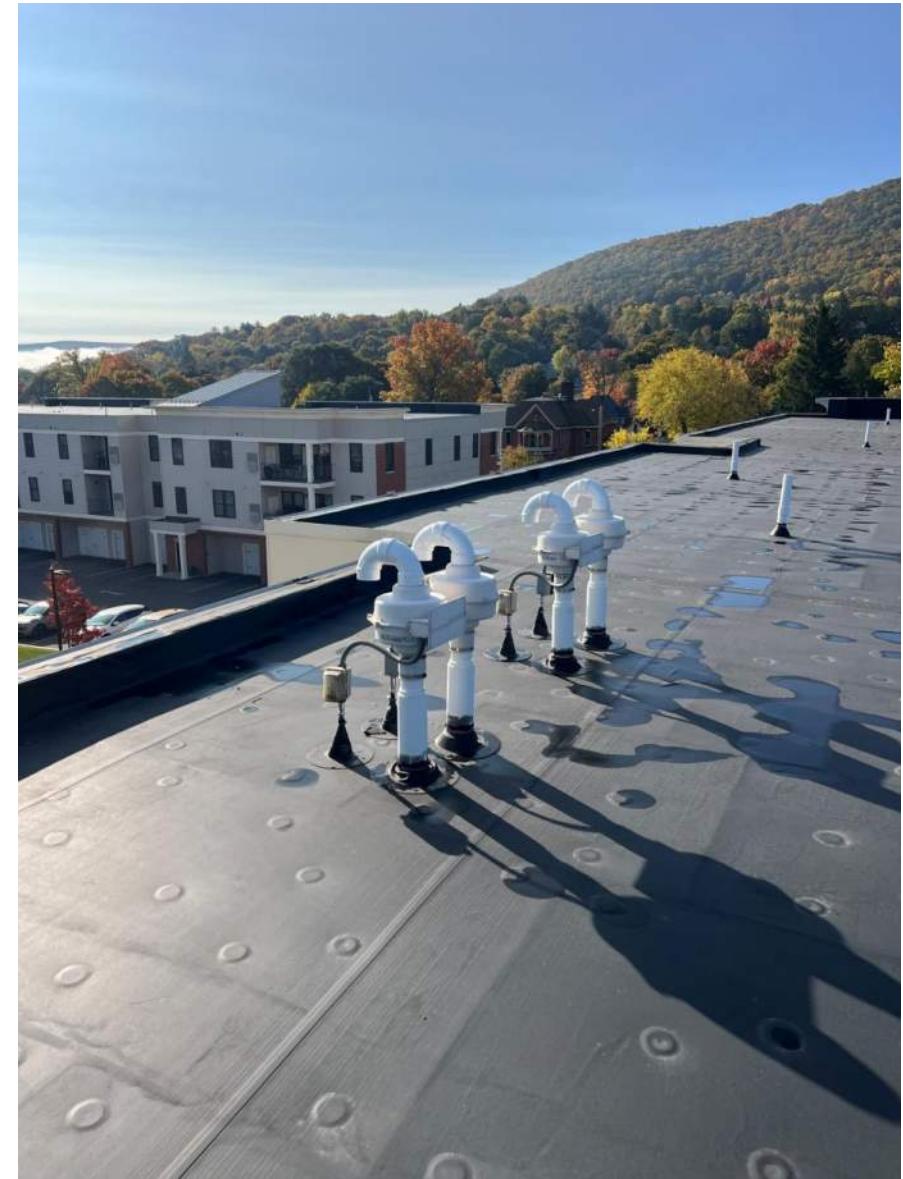
10/18/24 – Building 1 Fans

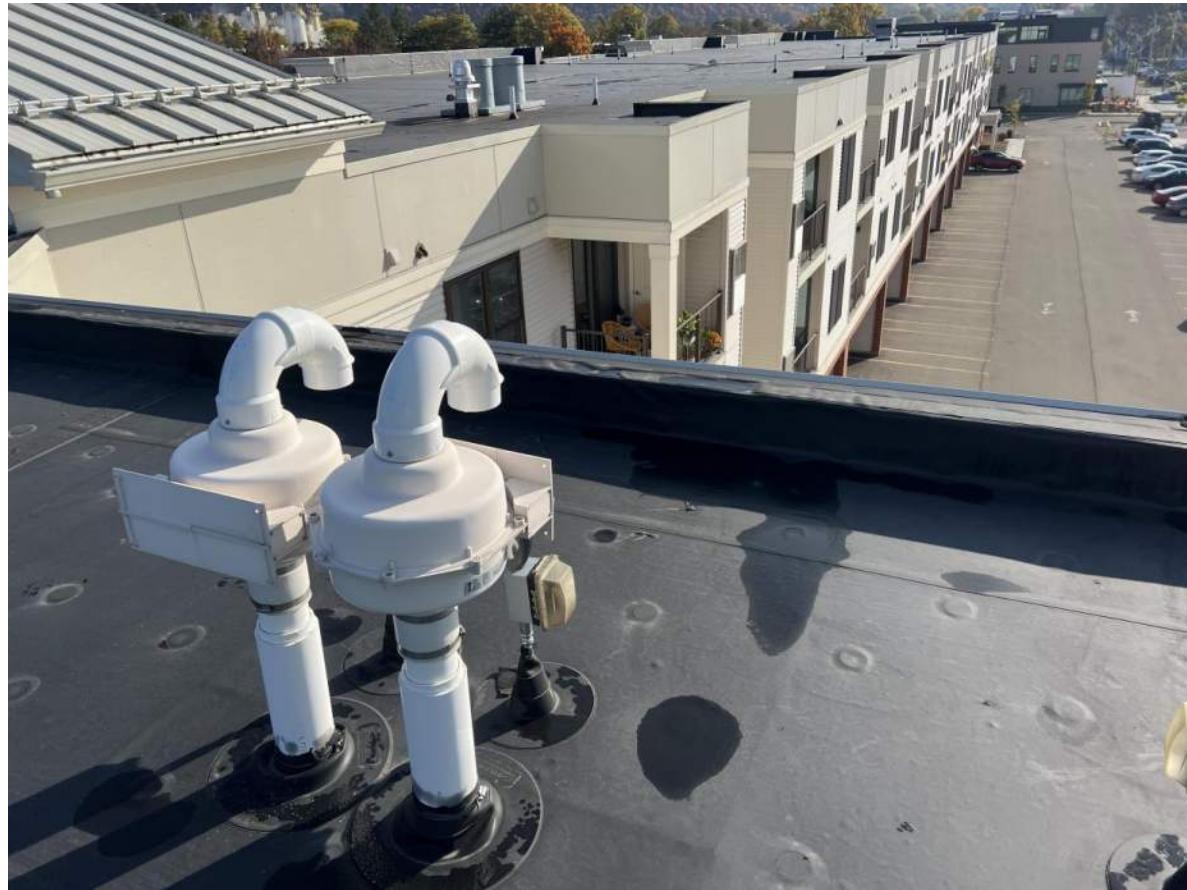
10/18/24 – Building 1 Fans

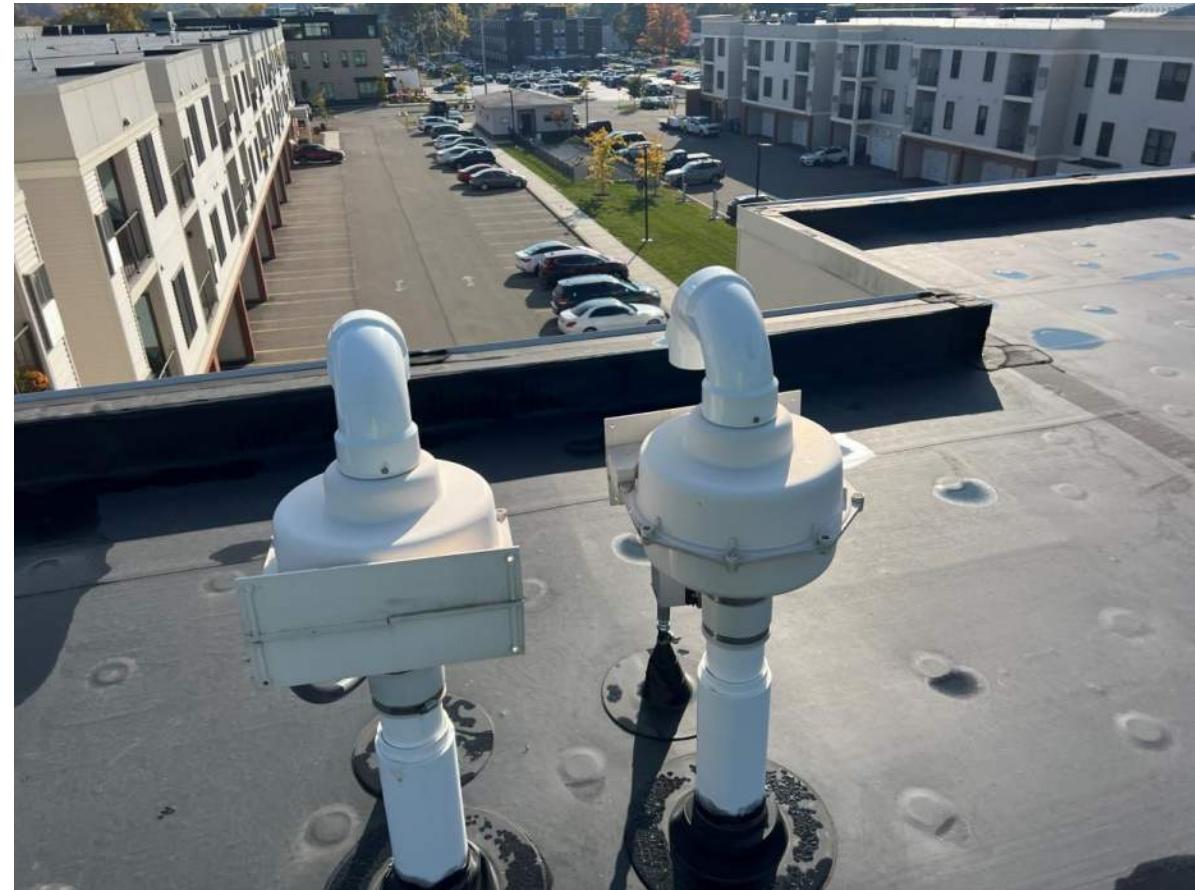
10/18/24 – Building 1 Fans

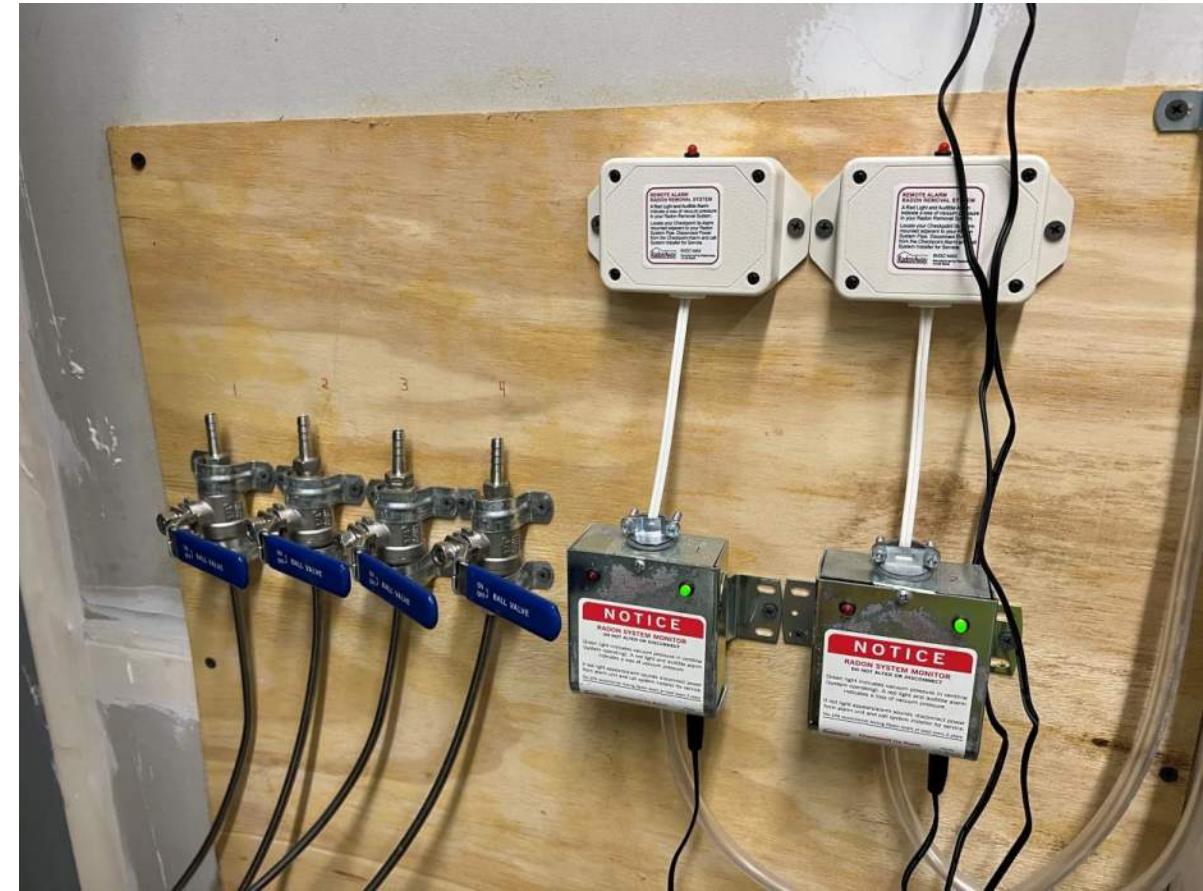
10/18/24 – Building 2 Alarms and PFE Points

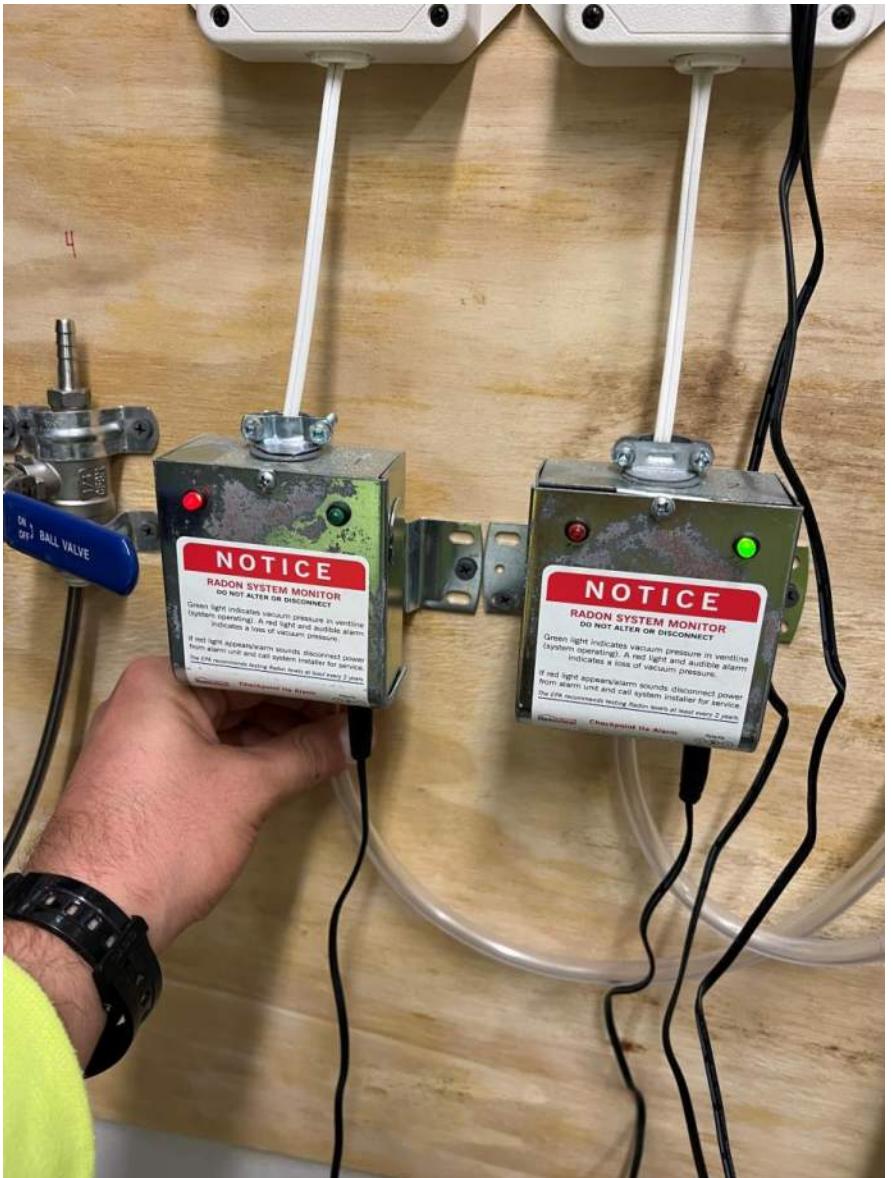
10/18/24 - Building 2 Alarms

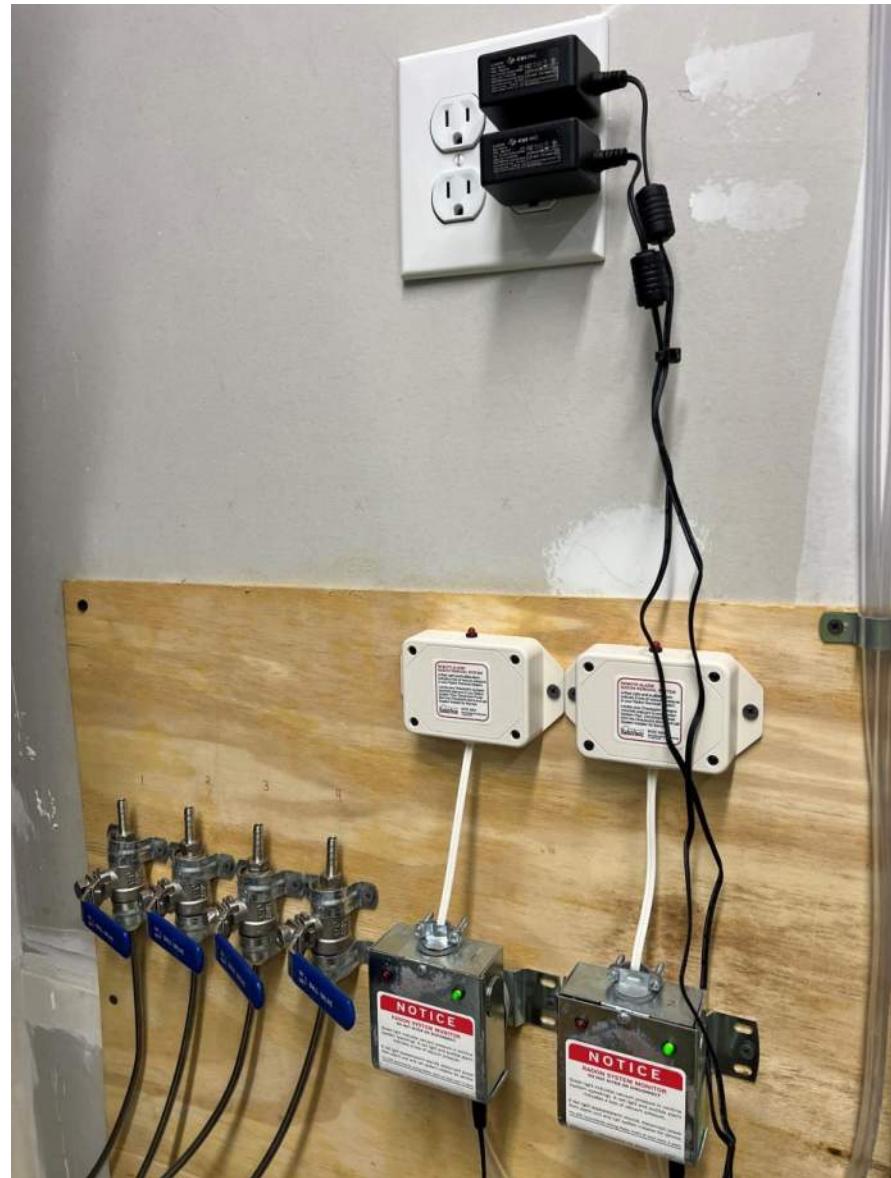
10/18/24 - Building 2 Alarms and PFE Points

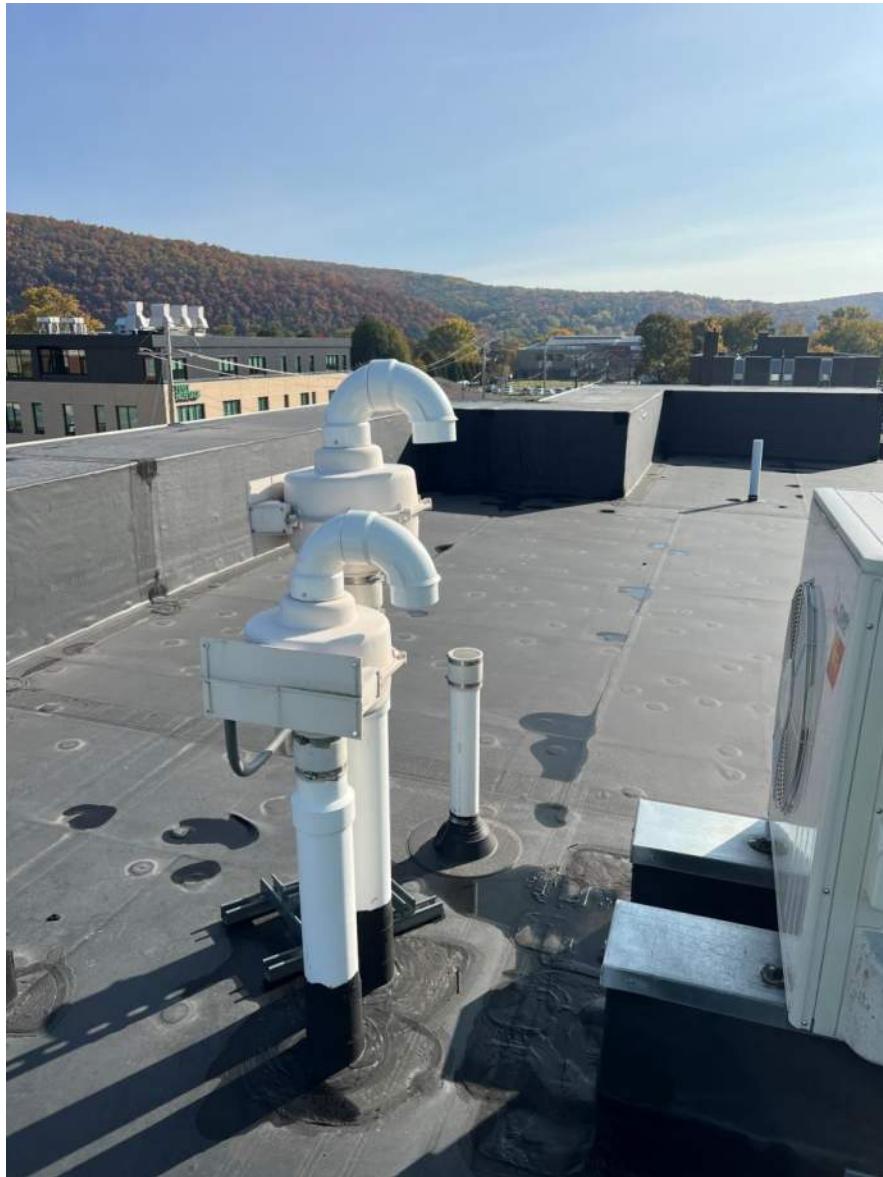
10/18/24 – Building 2 Fans

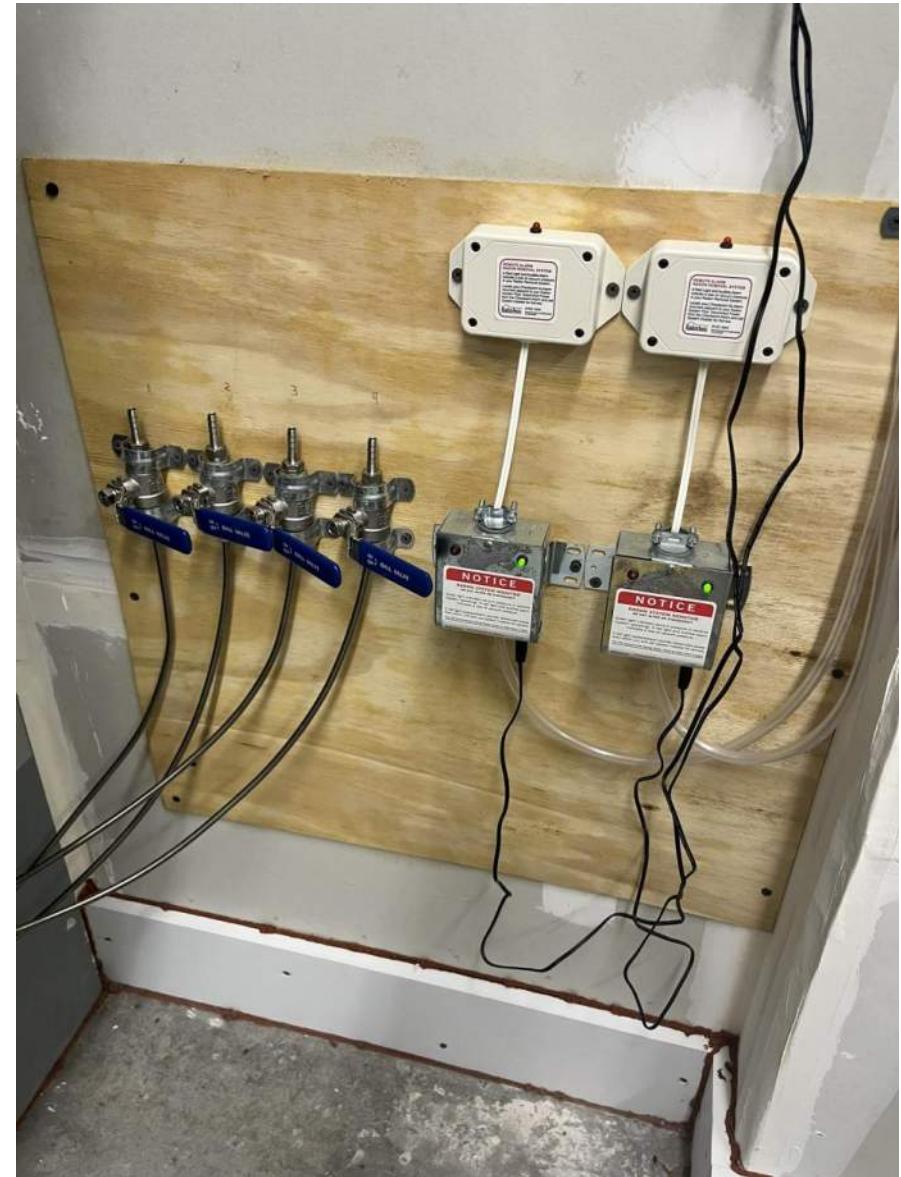
9/19/25 - View of stairwell suction point test

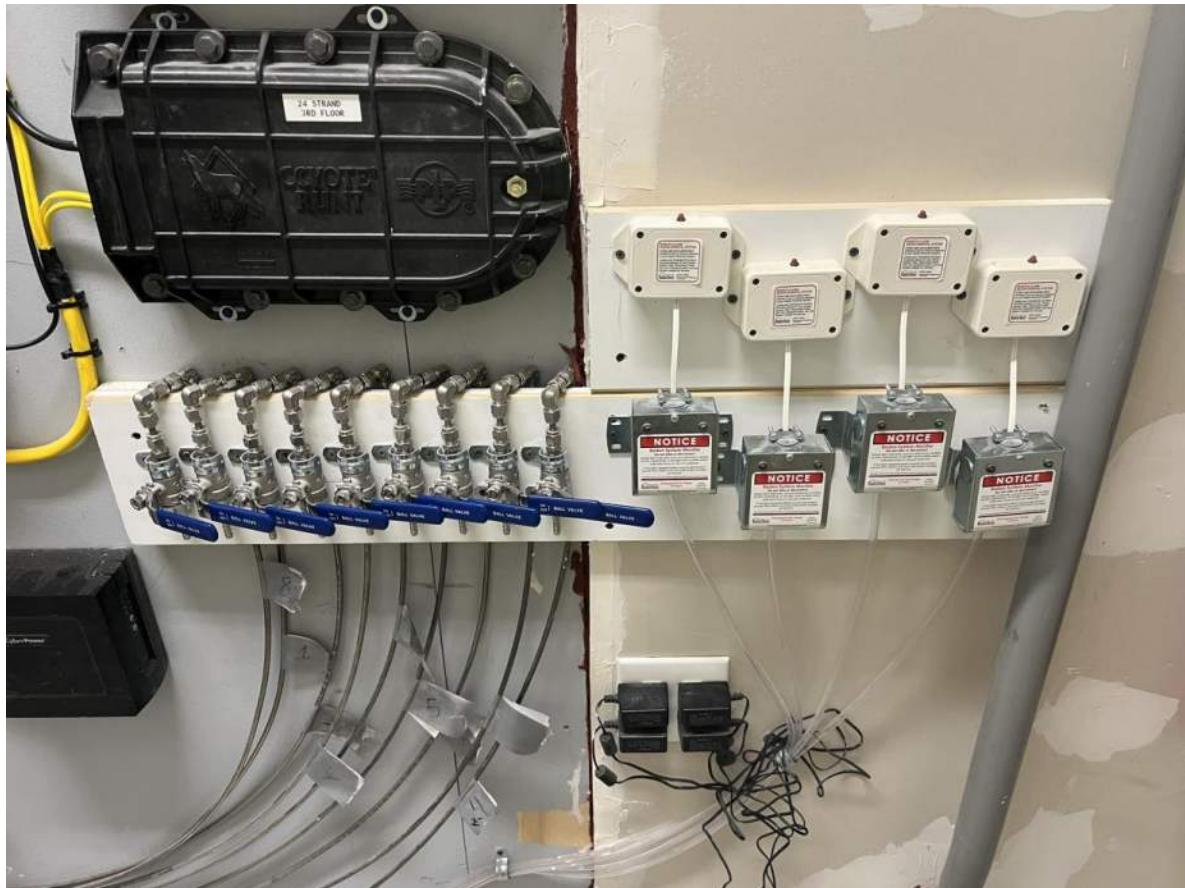
9/19/25 - View of Building 2 alarms and PFE points

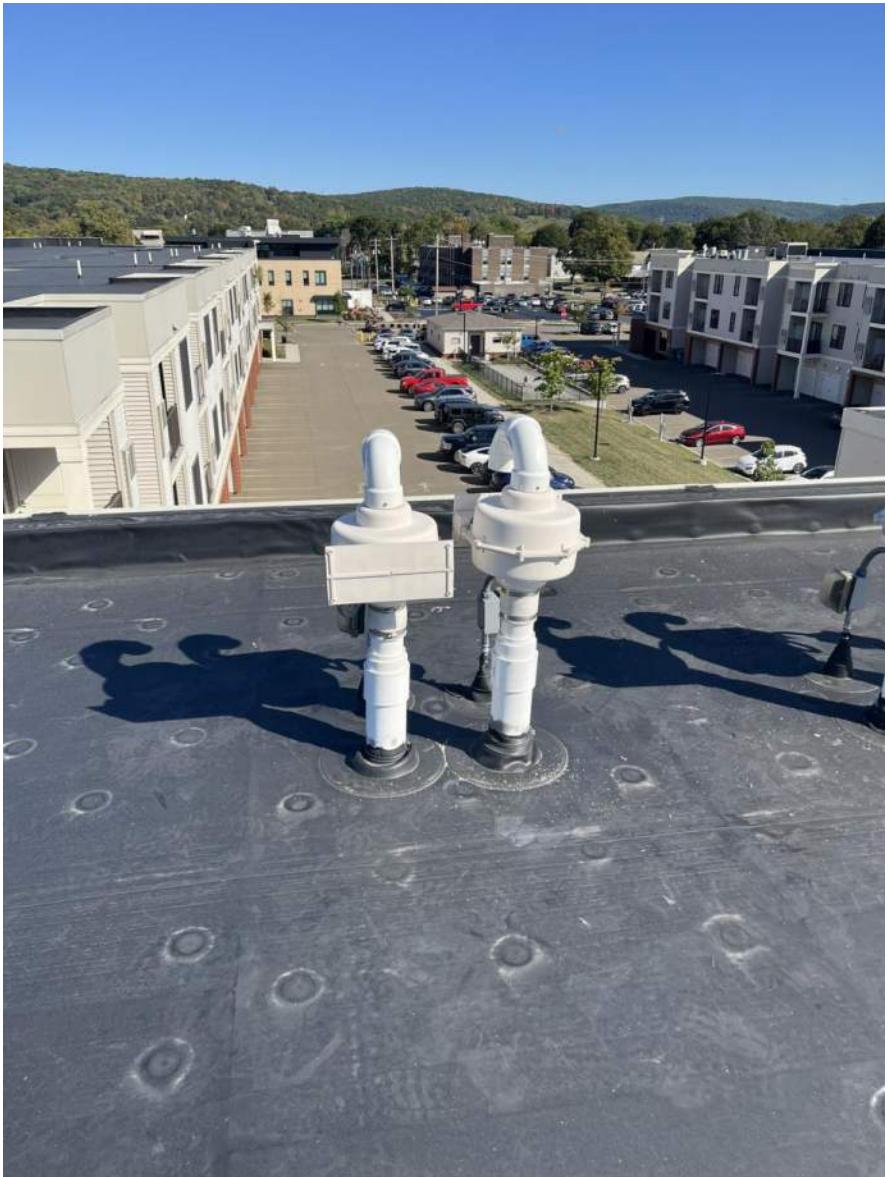
9/19/25 – Building 1 fans

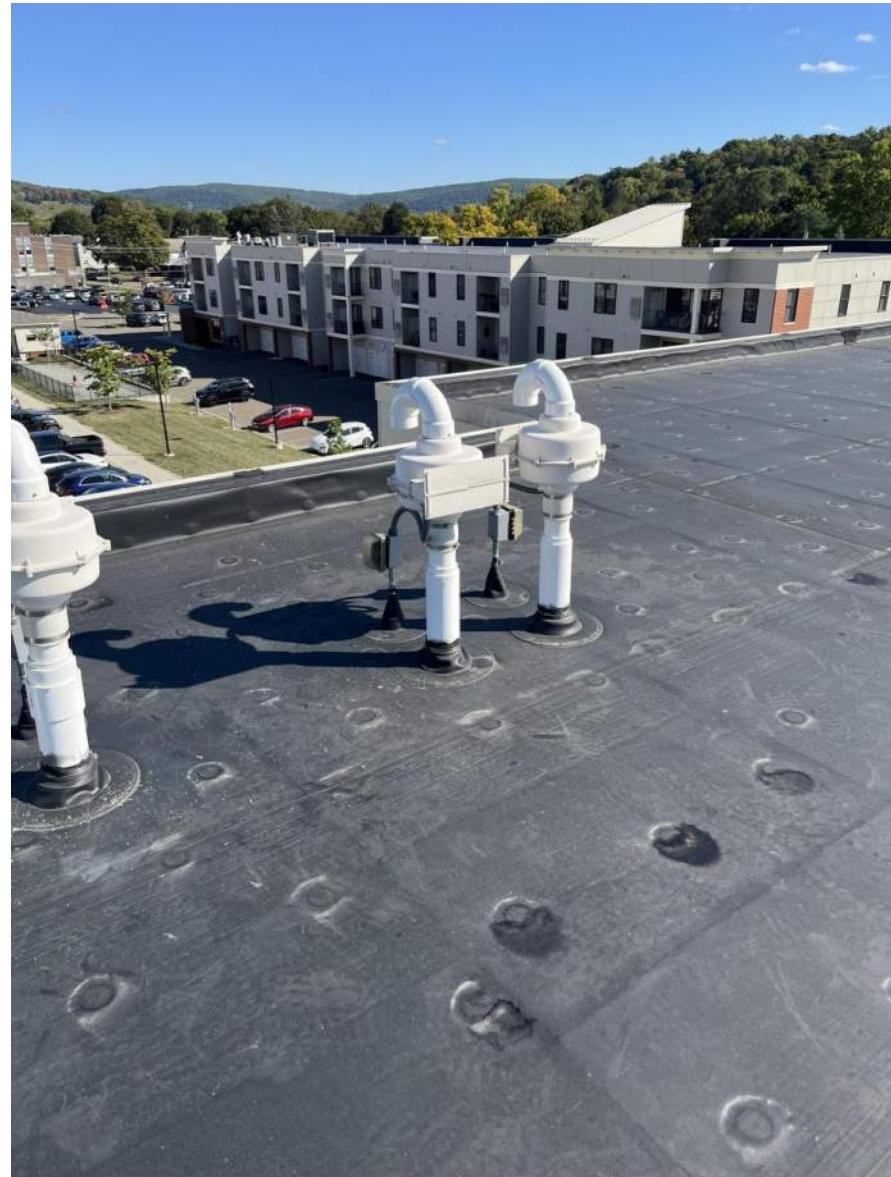
9/19/25 – Building 1 fans

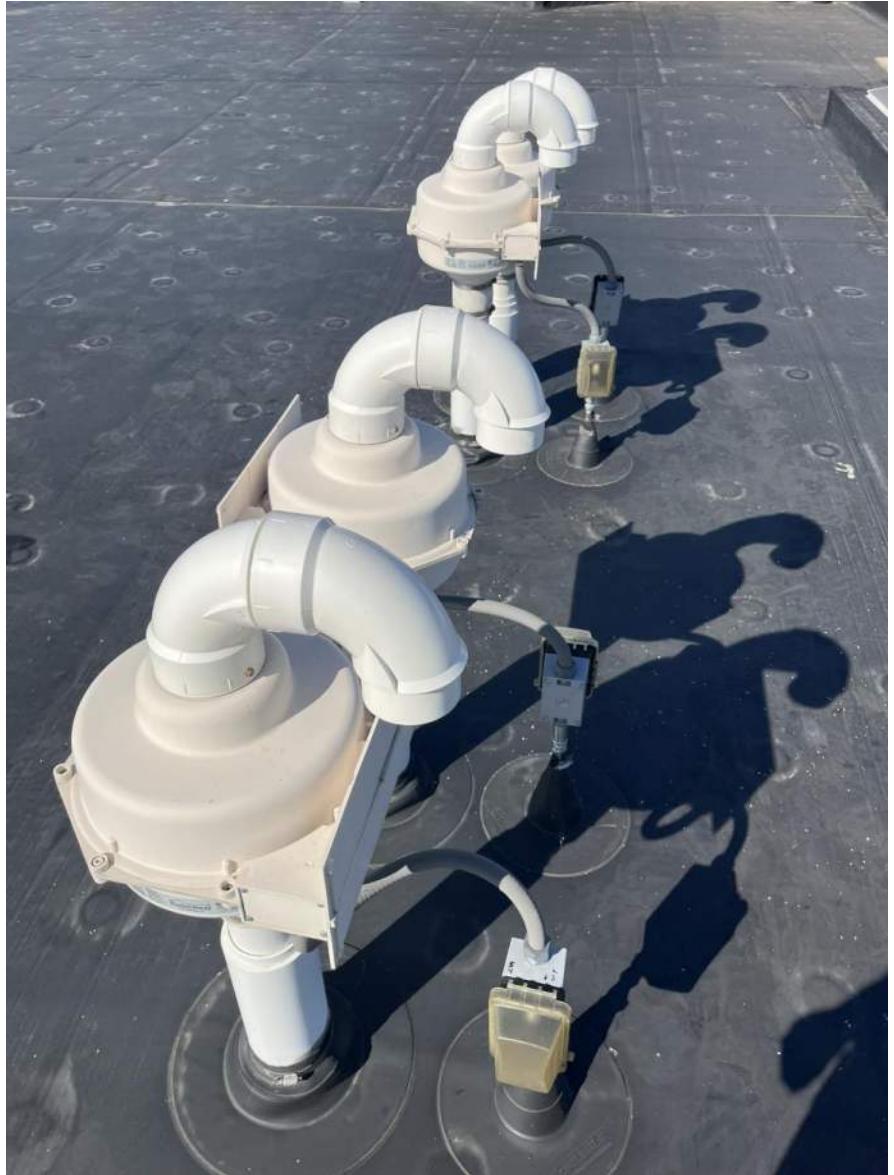
9/19/25 – Building 1 fans
