**Re: Post Remediation Hazardous Materials Inspection
Former BMHA Housing Towers – Kensington Heights**

**Post Remediation Hazardous Materials Inspection
of**

**Kensington Heights
1827 North Fillmore Avenue
Buffalo, NY 14214**

Conditions as of January 29, 2010

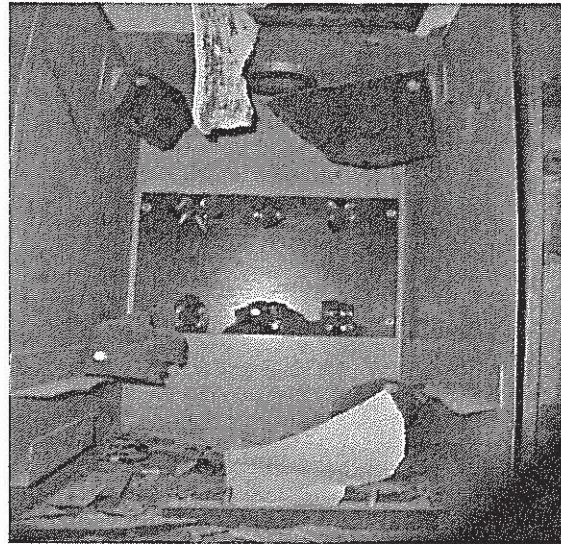
Transformer Room Cabinet with ACM Transite, Bake-Lite and Electrical Paper Debris.

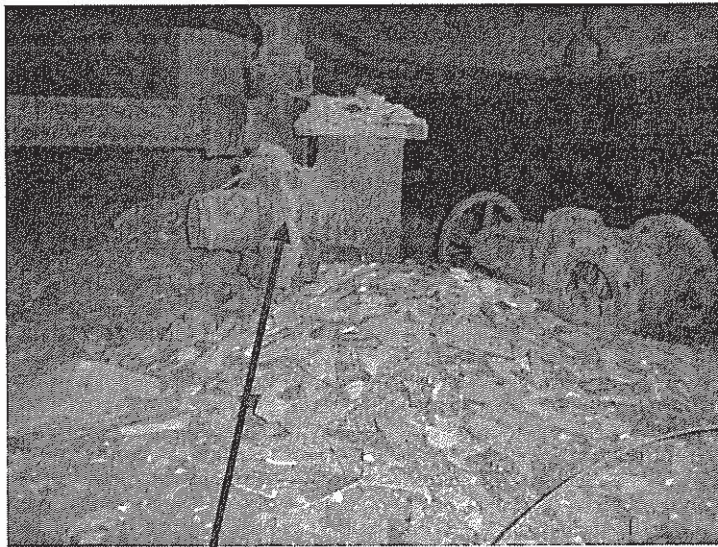
Crawlspace Soil Contaminated with ACM Floor Tile Debris.
ACM Flange Gaskets Still in Crawlspace

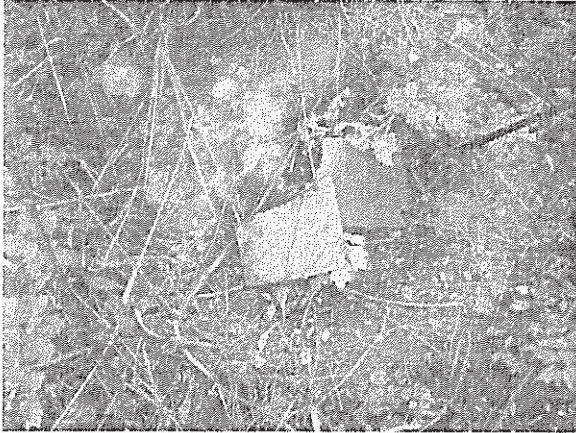
Debris of Transite Cement Board

See Floor Plans for approximate debris
locations of asbestos containing materials.

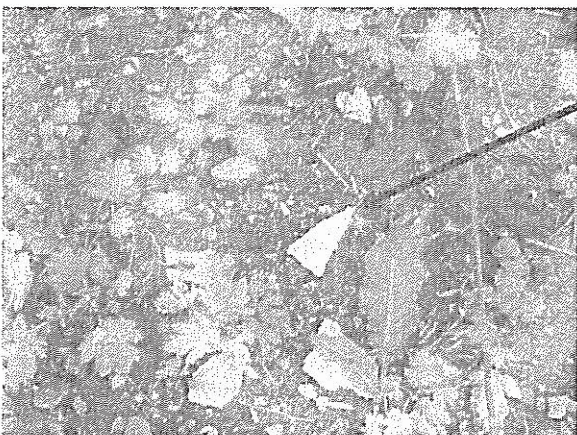
Debris of Transite Cement Board

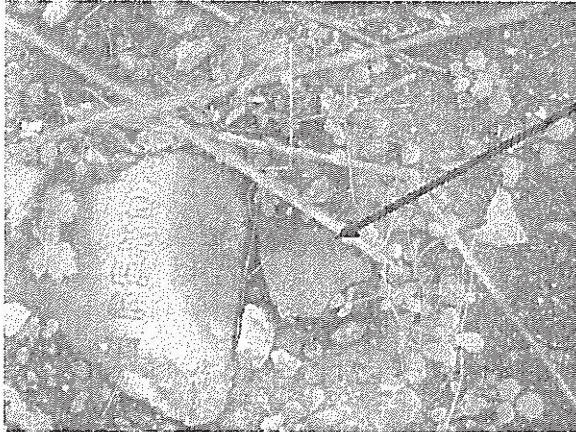
Debris of Transite Cement Board

See Floor Plans for approximate debris
locations of asbestos containing materials.

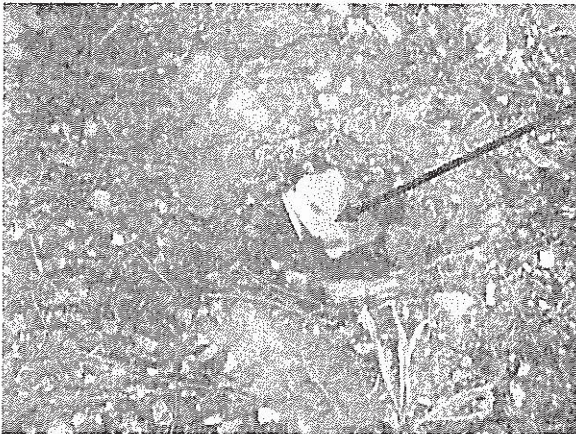
Debris of Transite Cement Board

See Floor Plans for approximate debris
locations of asbestos containing materials.

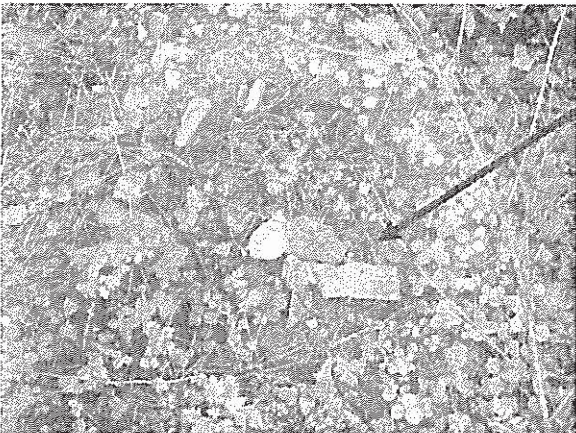
Debris of Transite Cement Board

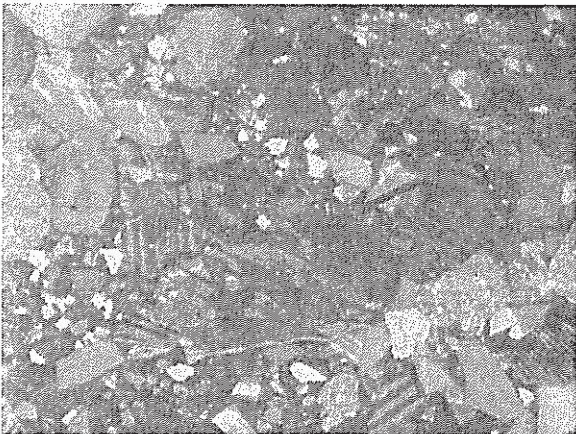
Debris of Floor Tile and Mastic

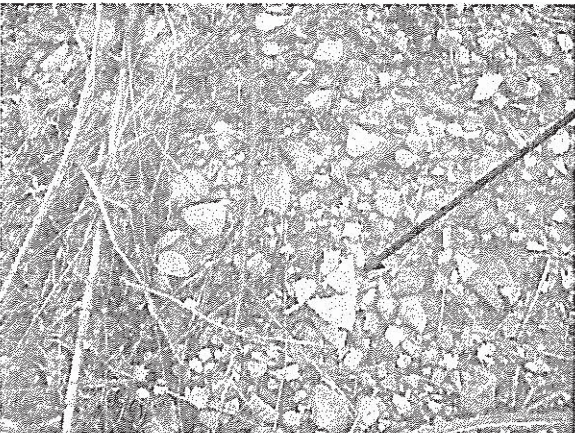
Debris of Floor Tile and Mastic

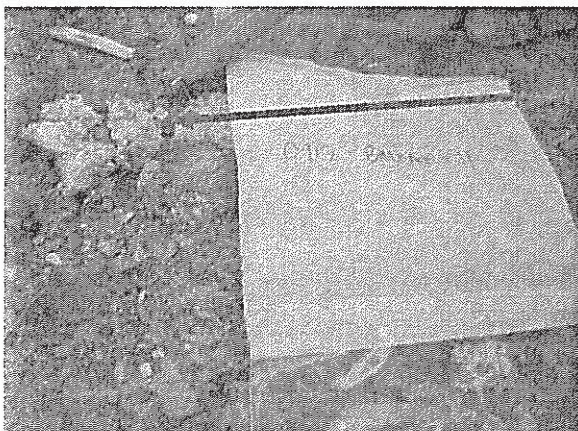
Sample 11 Friable Debris
