REMEDIAL INVESTIGATION/ALTERNATIVES ANALYSIS REPORT

31 TONAWANDA STREET SITE AND 150 TONAWANDA STREET/FORMER CSX VACANT RAIL PROPERTY BUFFALO, NEW YORK 14207 NYSDEC SITE # C915299

October 2019

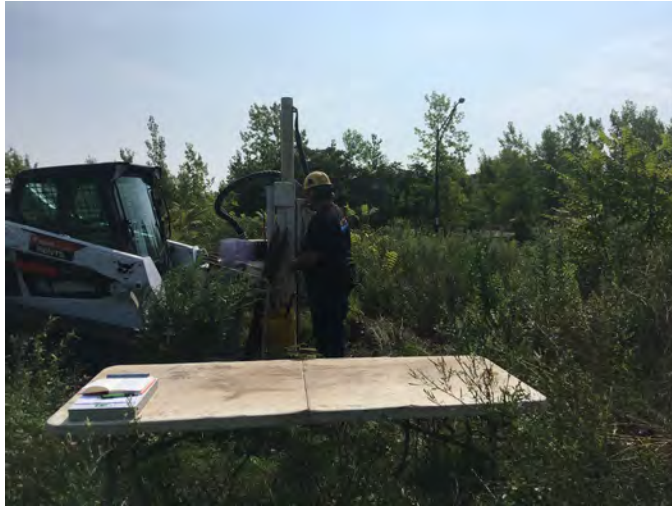
1. BH-1 soil boring. Looking east.

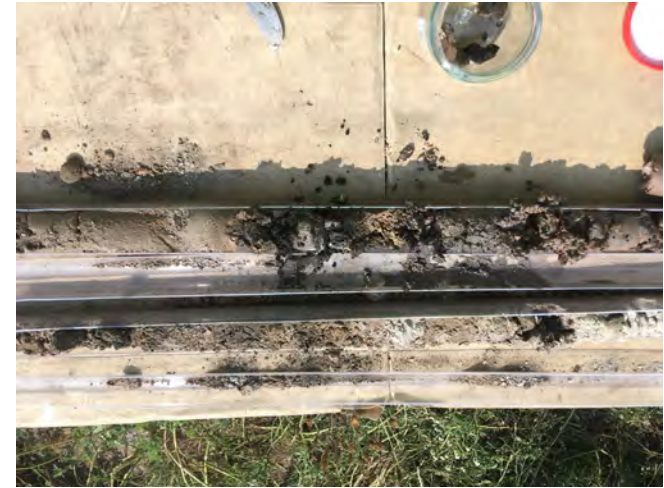
2. BH-1 soil core sample location

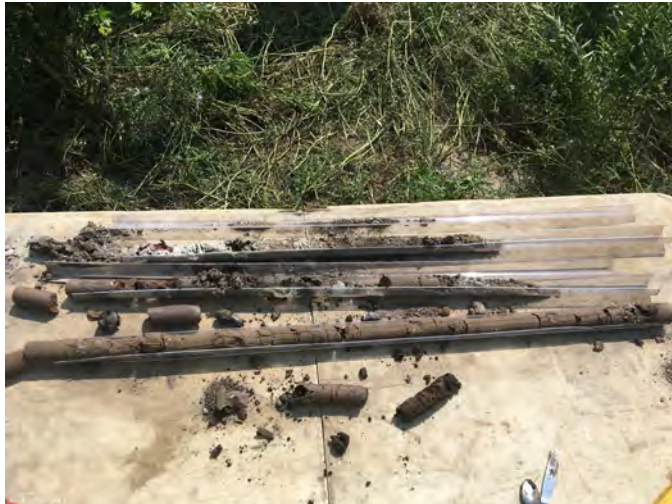
3. BH-1 soil core. 0 -12' top to bottom, left to right.

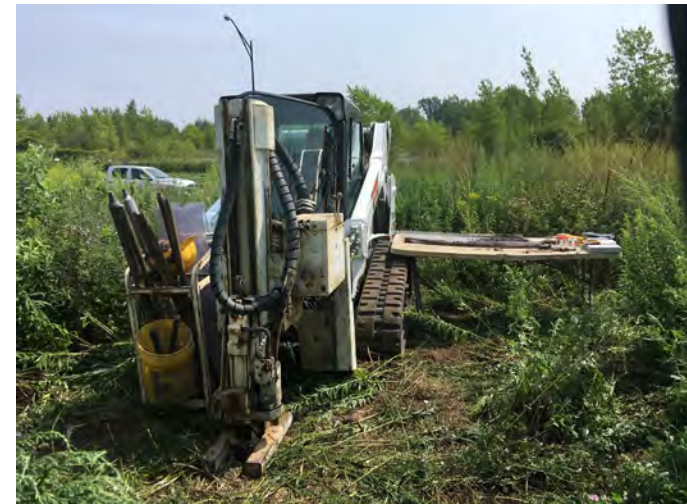
4. BH-2 boring location, looking east.

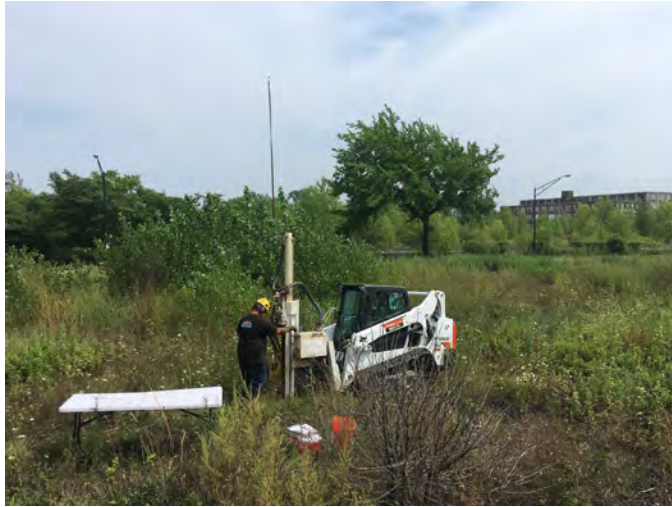
9. BH-5 boring location, looking east.

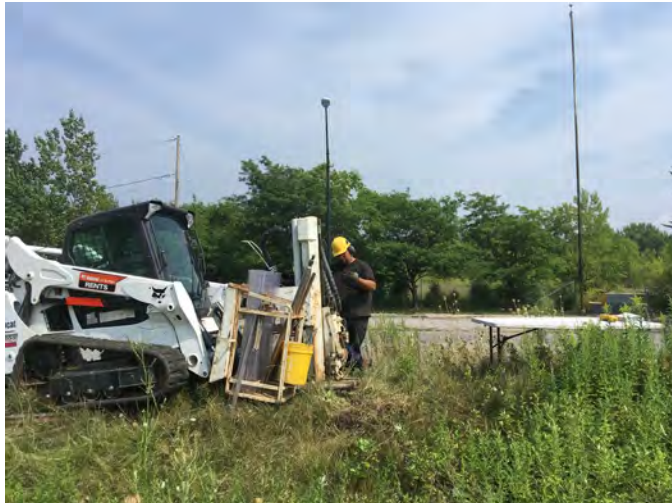
11. BH-6 boring location, looking east.

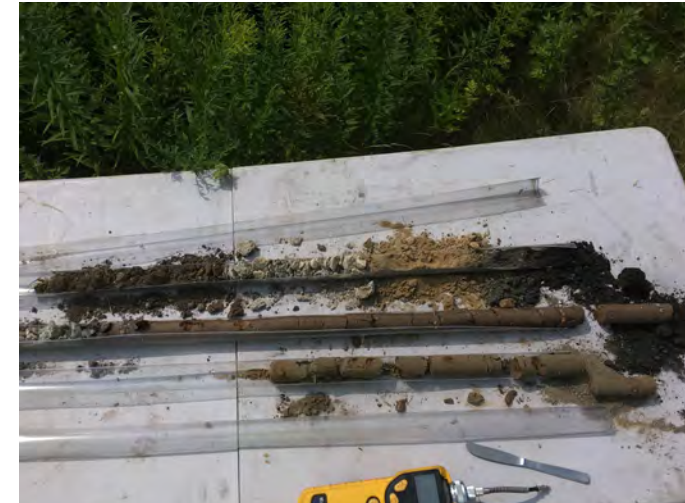
12. BH-6 Soil core. 0 – 9' top to bottom, left to right.

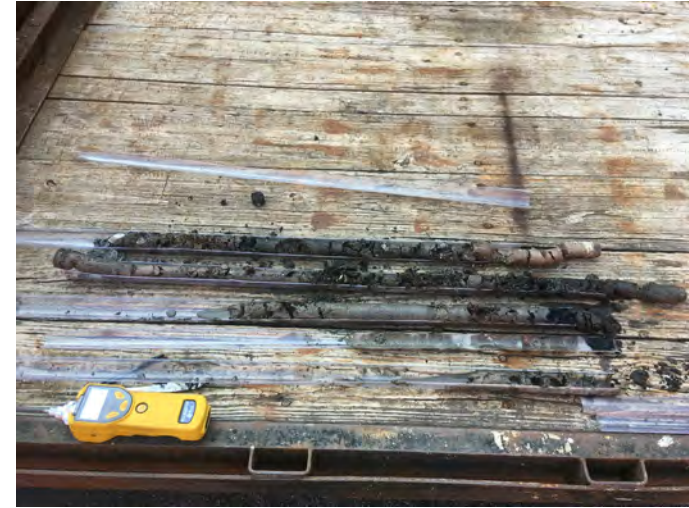
14. BH-4 soil core. 0 – 12' top to bottom, left to right.

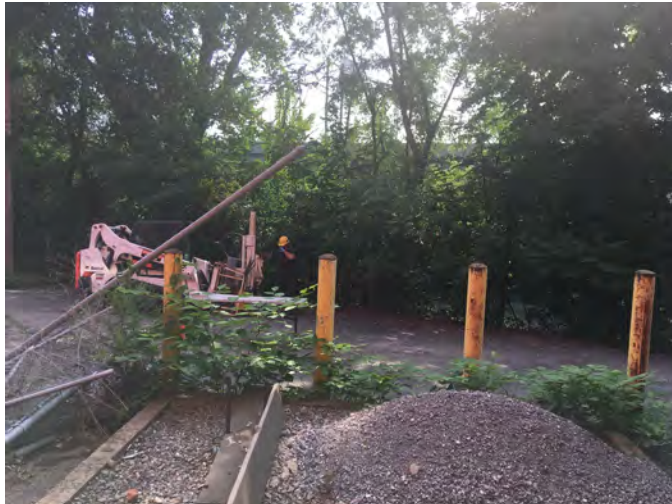
15. BH-3 boring location looking east.

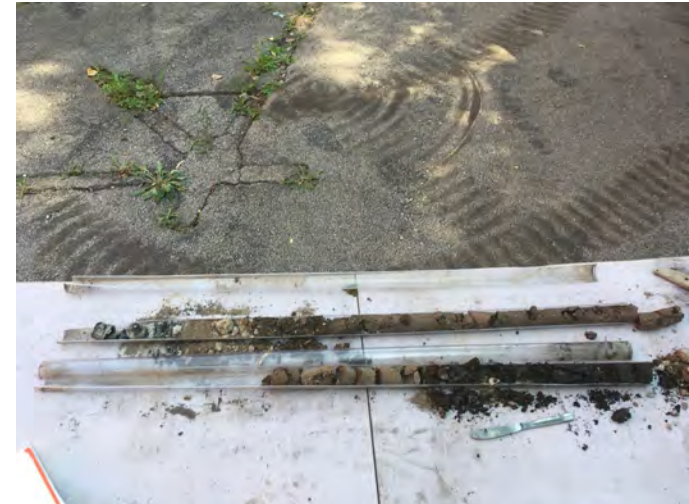
16. BH-3 soil core. 0 – 6' top to bottom, left to right.

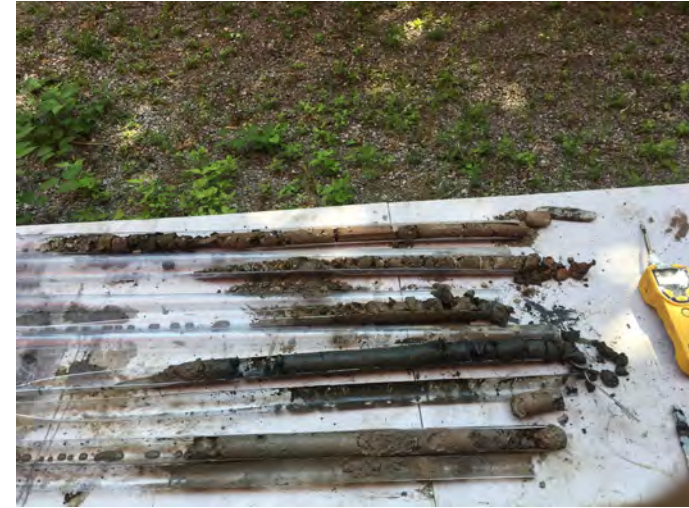
18. BH-2 soil core. 0 – 16' top to bottom, left to right.

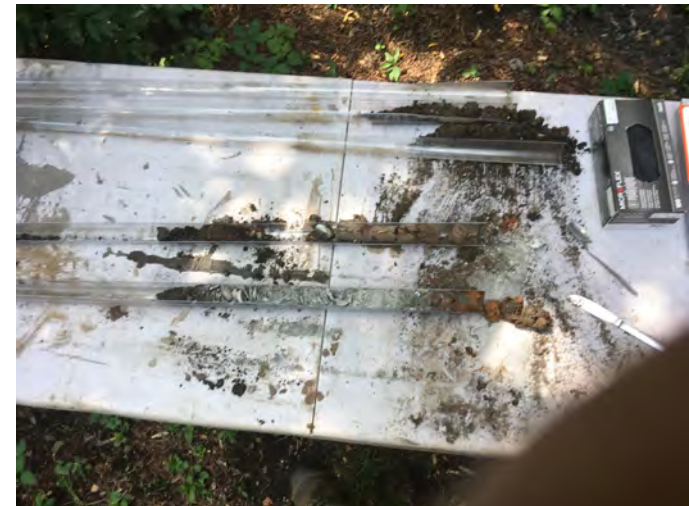
20. BH-1 soil core. 0 – 8', top to bottom, left to right.

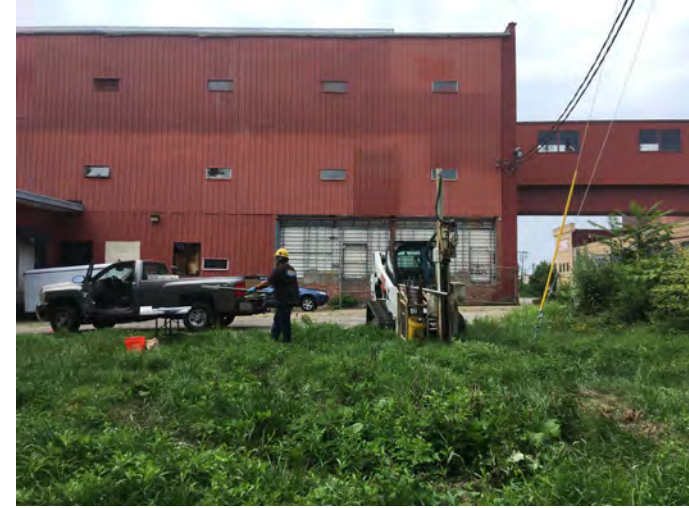
22. BH-5 boring location, looking west.

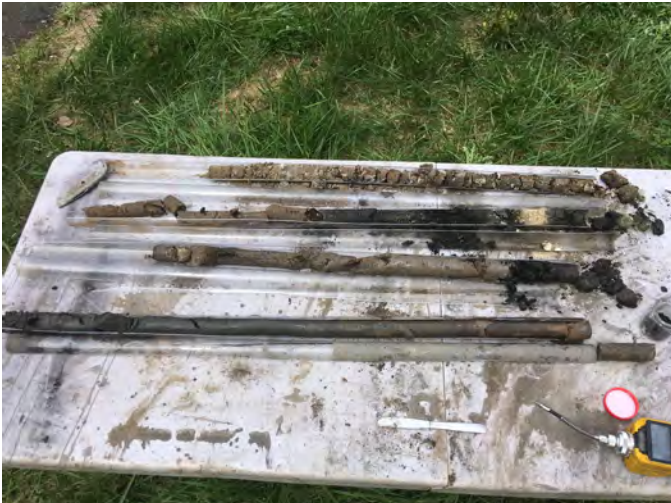
23. BH-5 soil core. 0 -16' top to bottom, left to right.

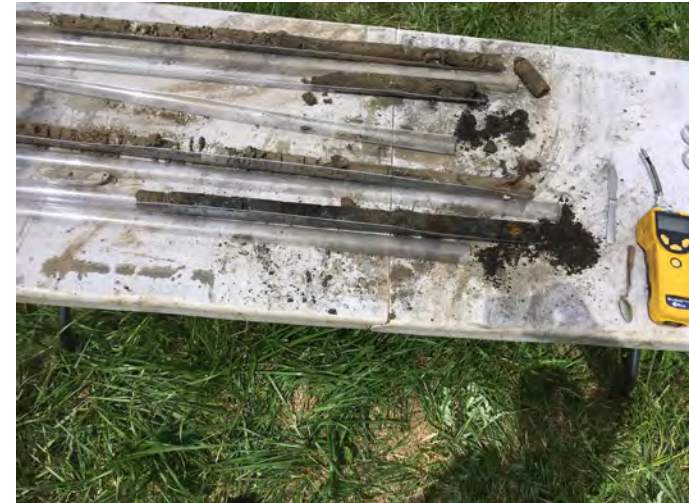
24. BH-6 soil cores. 0 – 6' top to bottom, left to right.

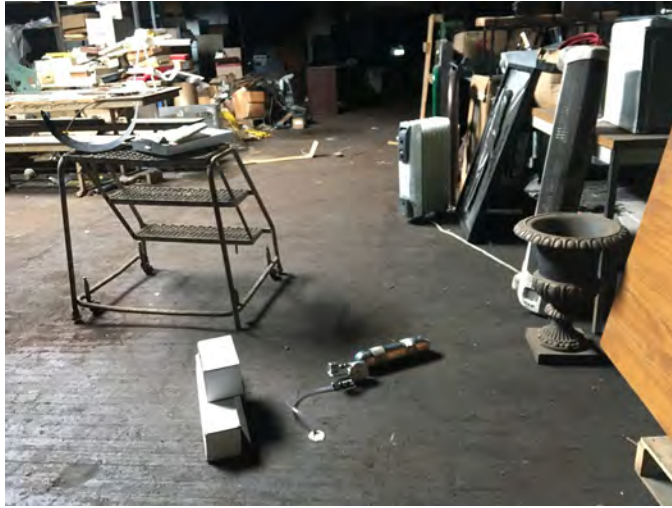
25. IA-05 sample location through floor taken from crawl space.

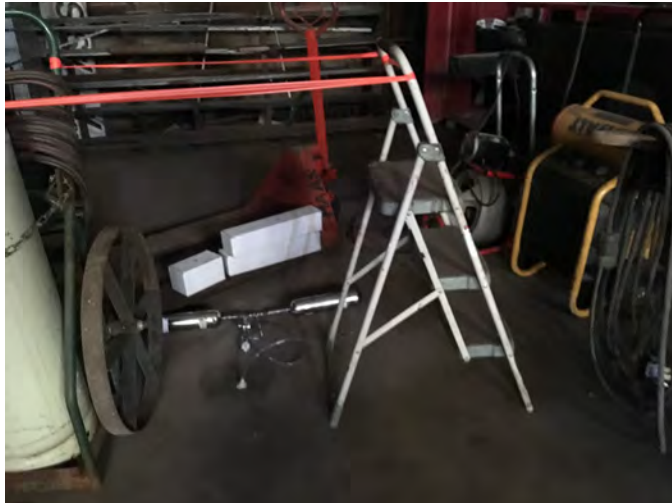
27. SS-01 sample location, northern end of high bay, slab on grade.

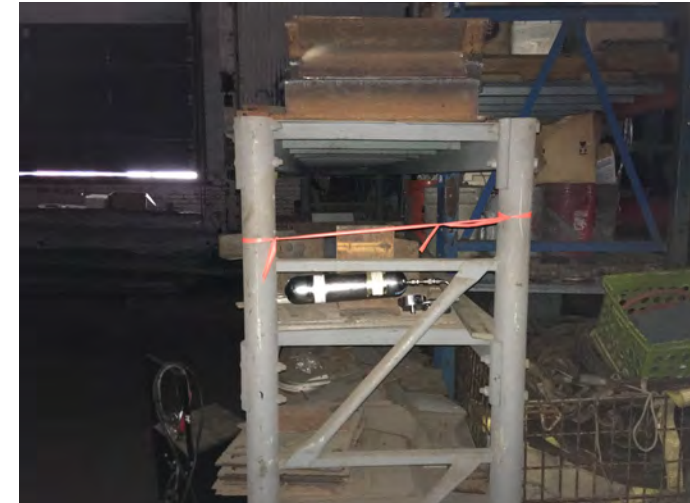
28. IA-02 sample location, northern end of high bay.

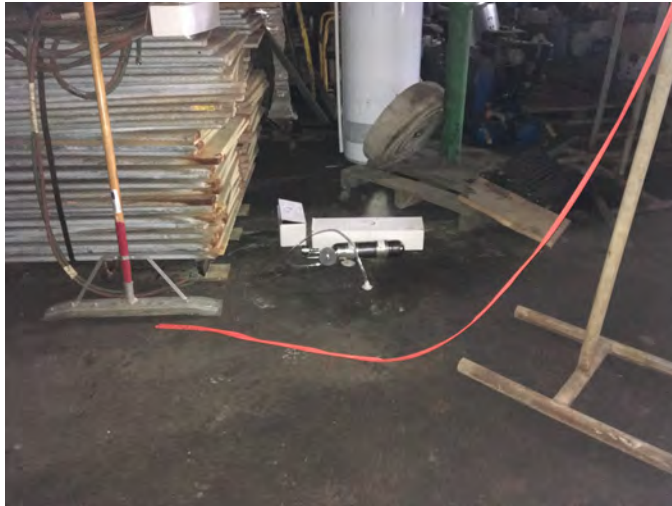
29. SS-03 sample location, northern end of high bay.

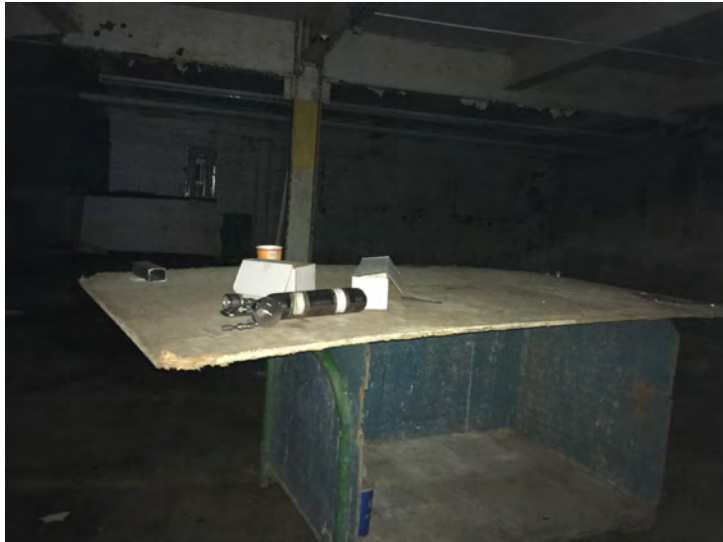
33. IA-03 sample location southern end of basement.

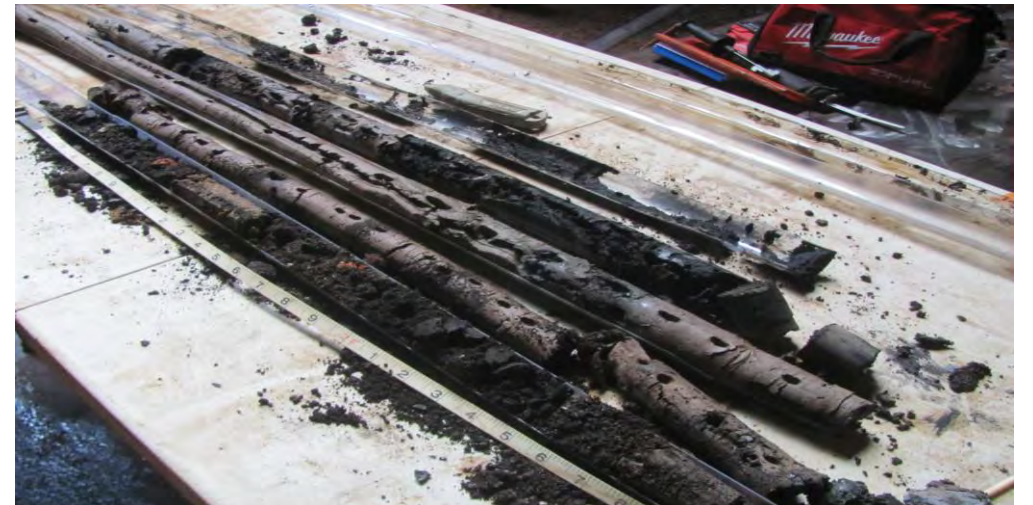
4. Borehole SBH-1 soil cores

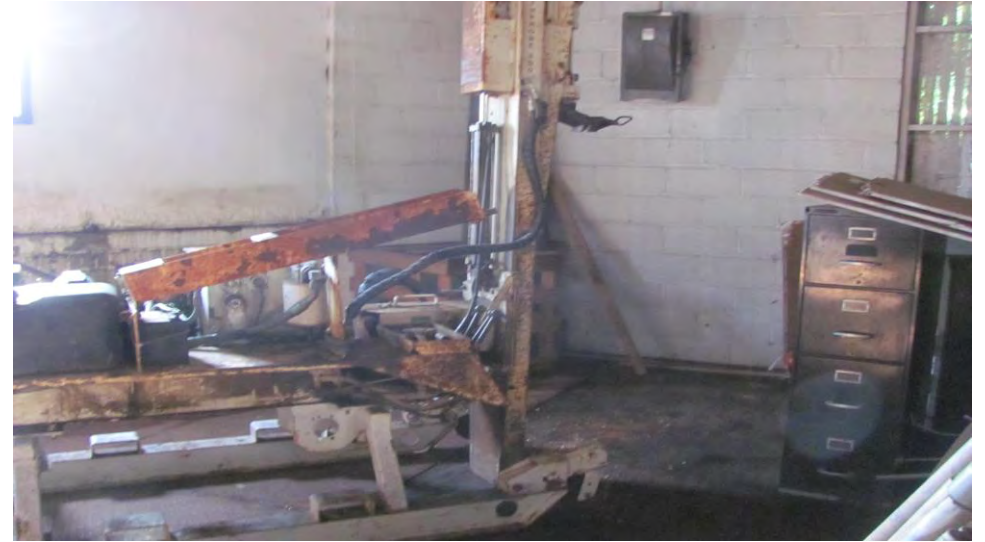
6. Location of SBH-2 facing east

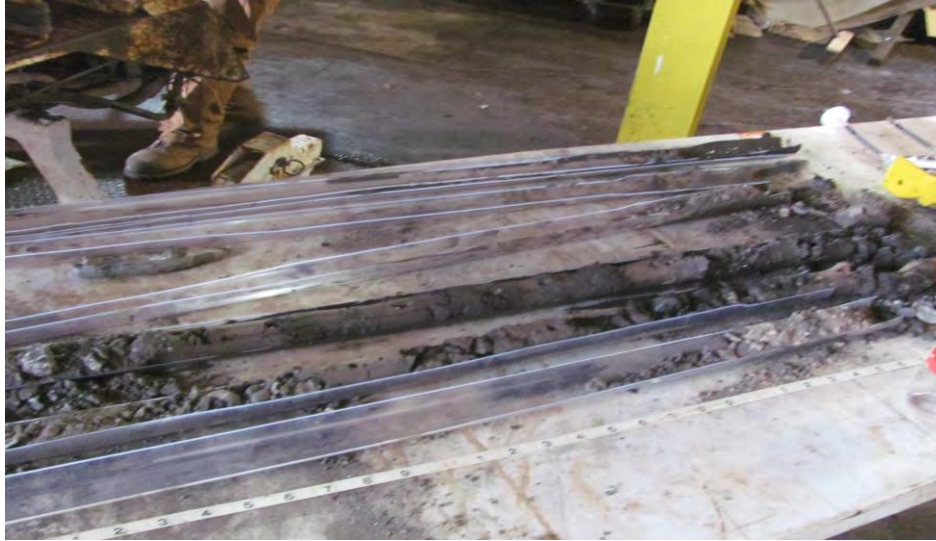
9. Soil cores from SBH-3

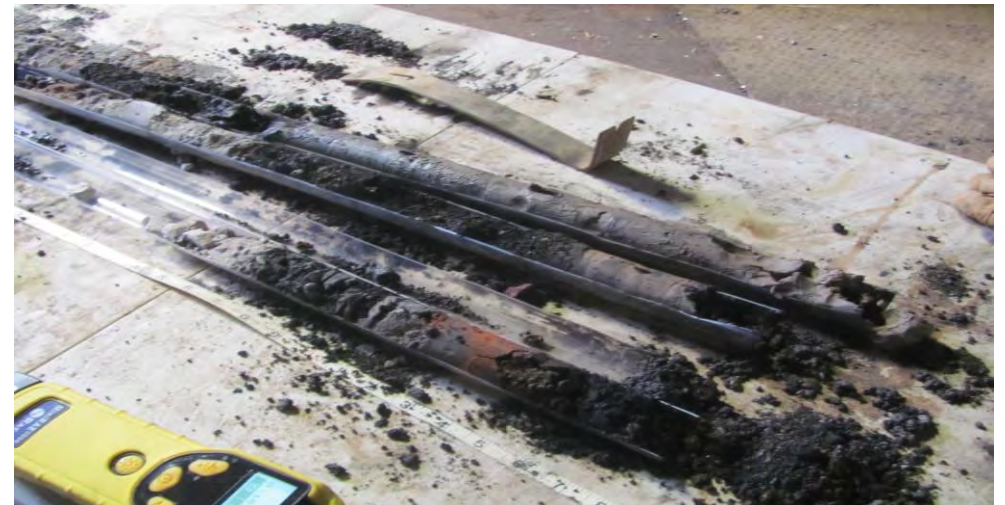
12. Soil cores from SBH-4

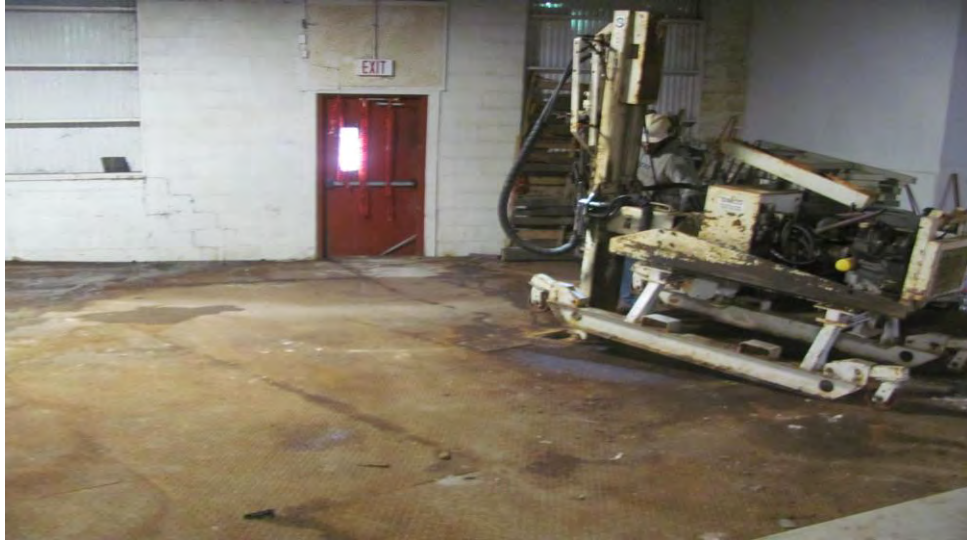
13. Location of SBH-5 facing east

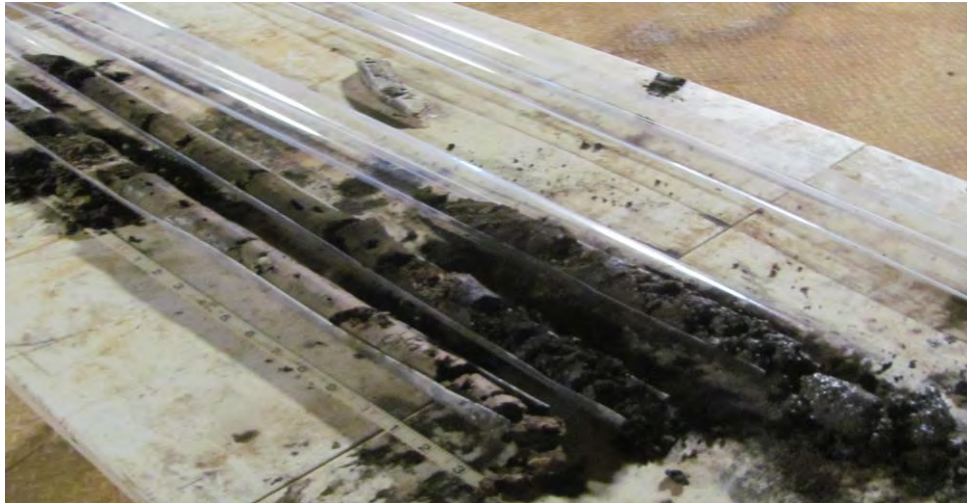
15. Soil cores from SBH-5

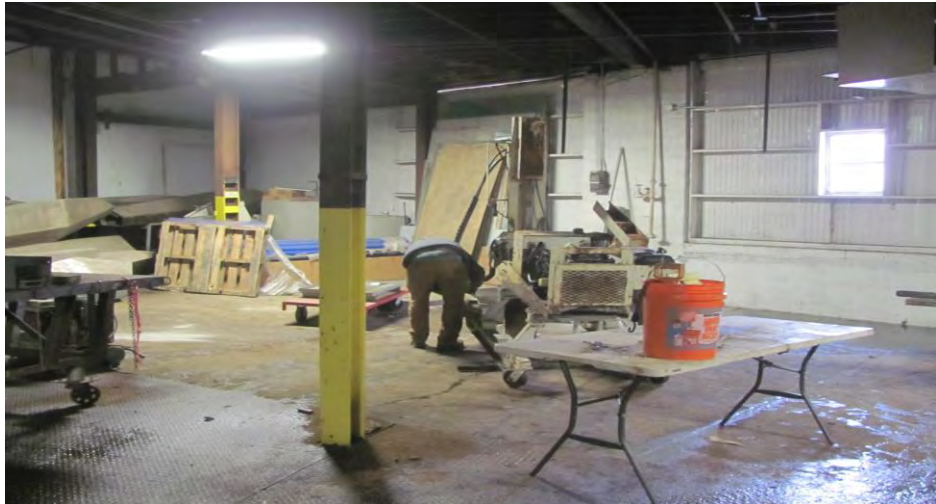
19. Location of SBH-7 facing northeast

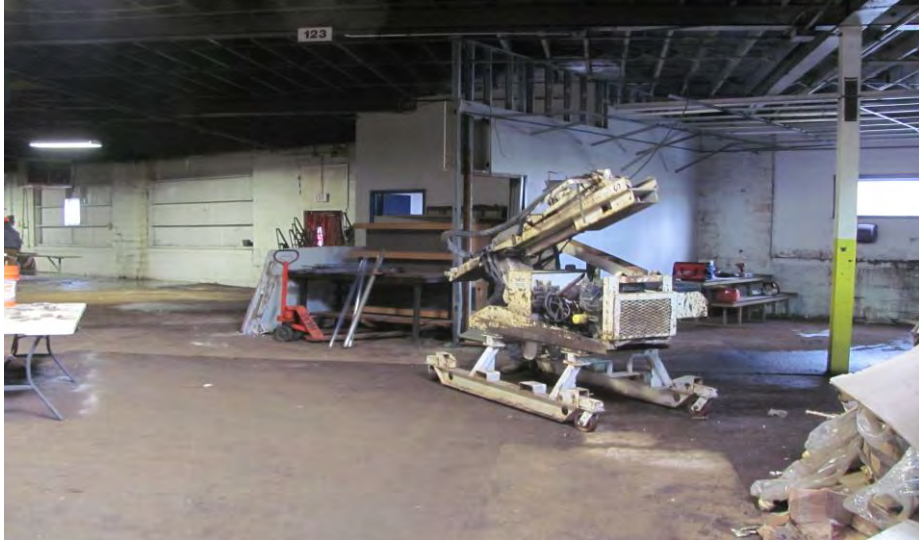
21. Location of SBH-8 facing east
