Periodic Review Report

**Reporting Period June 14, 2020 to
June 14, 2025**

2250 Factory Outlet Boulevard Site
BCP Site No. C932127
Niagara Falls, New York

June 2025

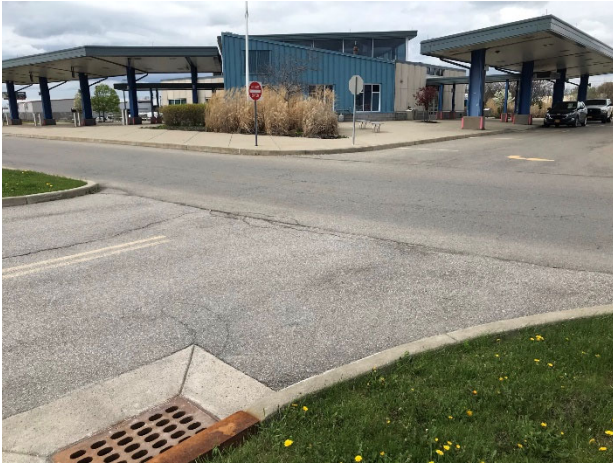
Photo 1: Exterior Site condition (looking west)

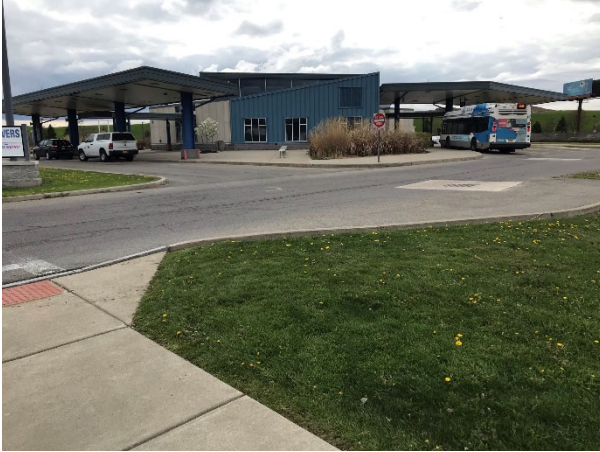
Photo 9: Exterior Site condition from eastern Site entrance (looking west)

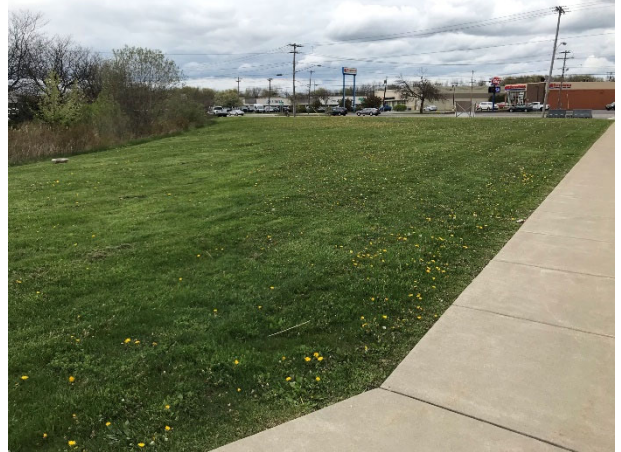
Photo 10: Exterior Site conditions from eastern Site entrance showing landscaping (looking north)

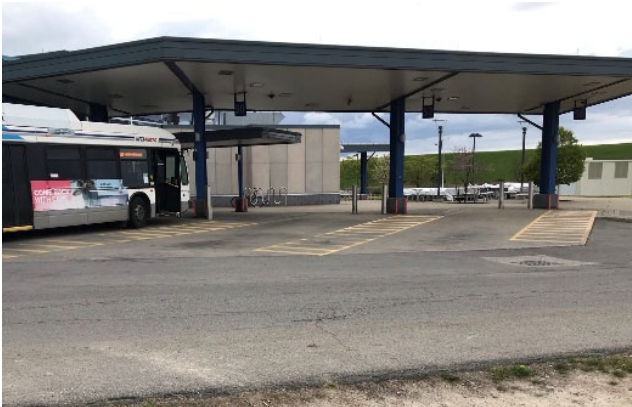
Photo 11: Exterior Site conditions from eastern side of building showing asphalt and concrete surfaces (looking southwest)

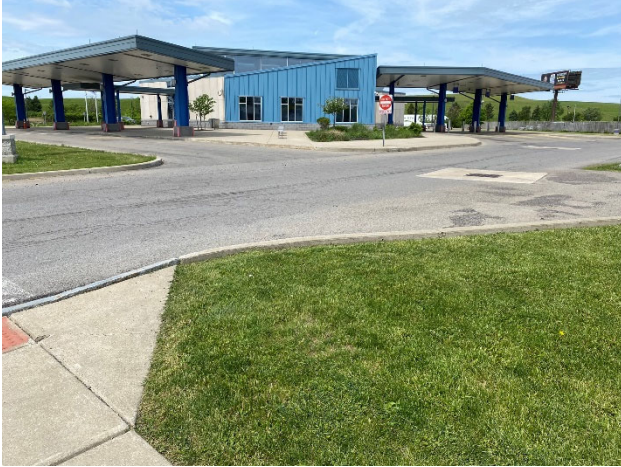
Photo 9: Exterior Site condition from eastern Site entrance (looking west)
