### STORM SEWER SAMPLING REPORT BCP SITE NOS. C932138, C932139, C932140 LOCKPORT (C) NIAGARA COUNTY, NEW YORK

Reason of inspection : <b>gen. condition control</b>	Pipe shape : <b>round</b>
Section type : <b>storm water</b>	Pipe size : <b>12 inch</b>
Area : <b>bldg 7-10</b>	Pipe material : <b>clay tile</b>
Lining :

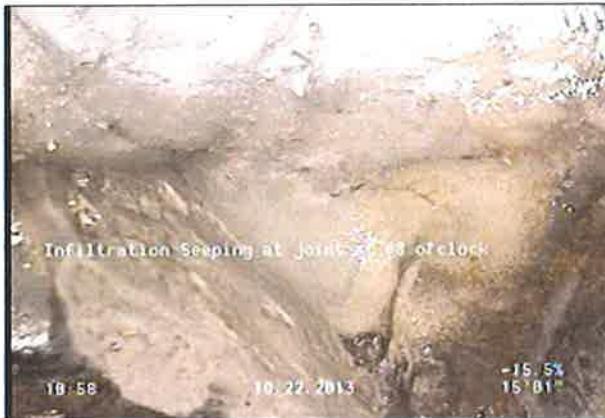
Photo: MH-1\_2-16\_2\_22102013\_110401\_A.JPG  
Infiltration Seeping at joint at 08 o'clock

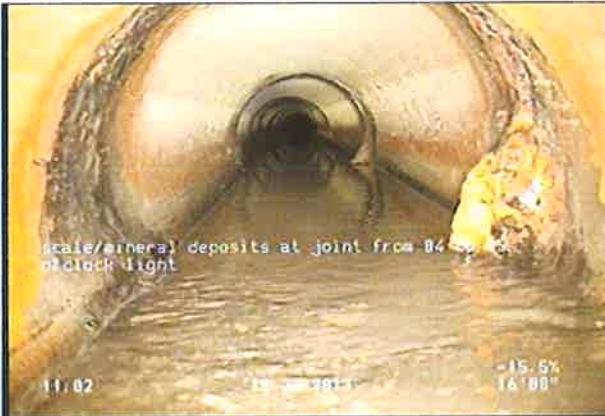
Photo: MH-1\_2-16\_3\_22102013\_110802\_B.JPG  
scale/mineral deposits at joint from 04 to 05 o'clock light

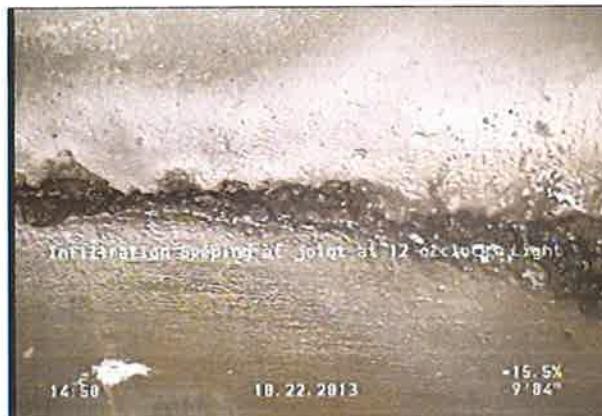
Photo: 2-16\_MH-3\_2\_22102013\_145515\_A.JPG  
Infiltration Seeping at joint at 12 o'clock / Light

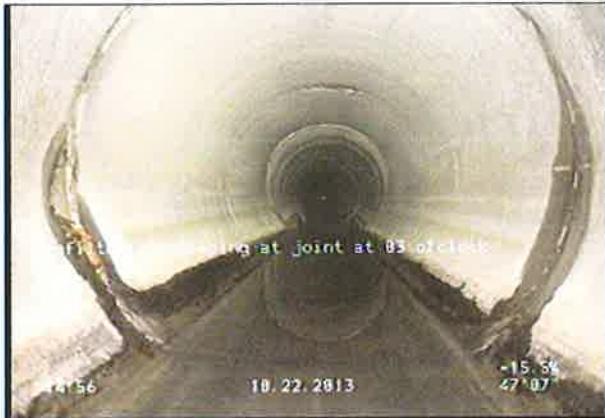
Photo: 2-16\_MH-3\_6\_22102013\_150116\_A.JPG  
Infiltration Seeping at joint at 03 o'clock

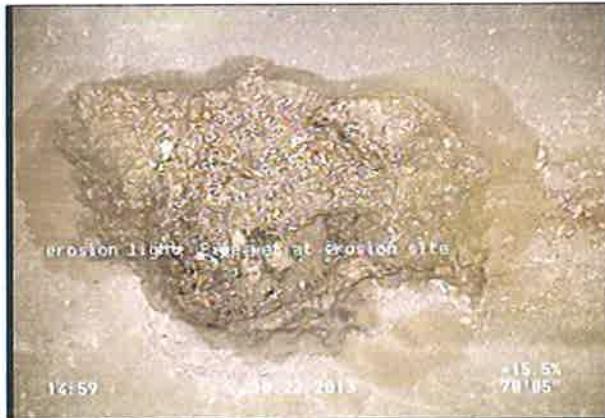
Photo: 2-16\_MH-3\_9\_22102013\_150452\_A.JPG  
erosion light / Pipe wet at erosion site

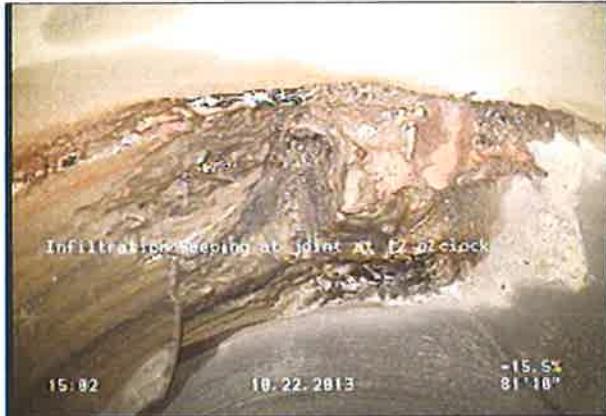
Photo: 2-16\_MH-3\_11\_22102013\_150715\_A.JPG  
Infiltration Seeping at joint at 12 o'clock

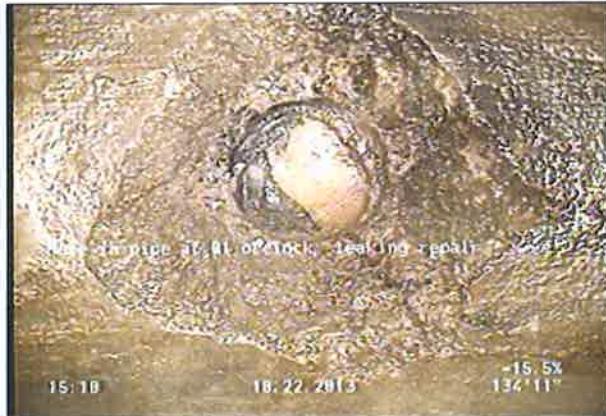
Photo: 2-16\_MH-3\_18\_22102013\_151516\_A.JPG  
Hole in pipe at 01 o'clock / leaking repair

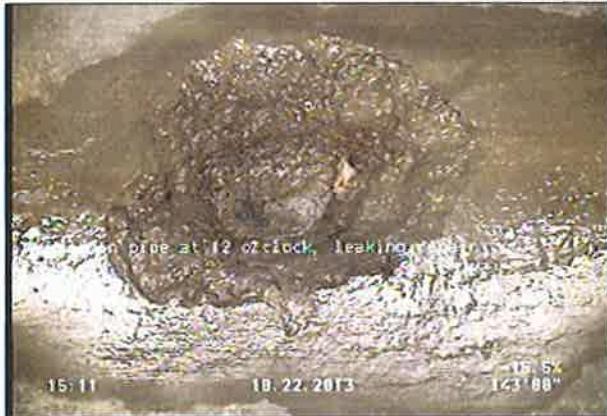
Photo: 2-16\_MH-3\_20\_22102013\_151705\_A.JPG  
Hole in pipe at 12 o'clock / leaking repair

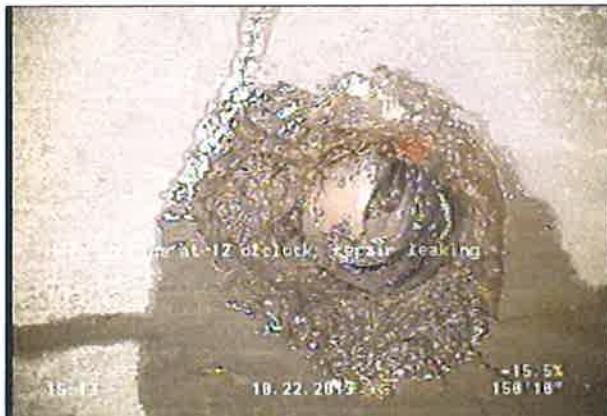
Photo: 2-16\_MH-3\_22\_22102013\_151902\_A.JPG  
Hole in pipe at 12 o'clock / repair leaking

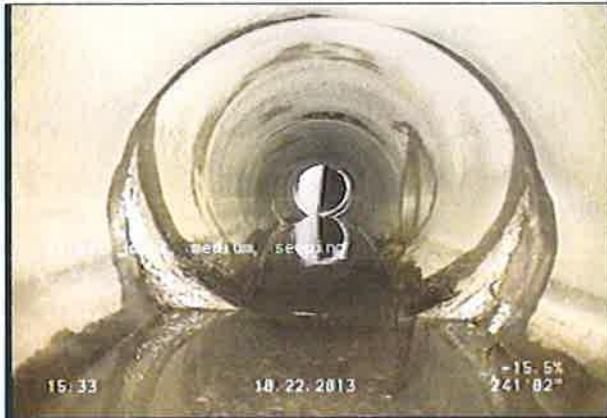
Photo: 2-16\_MH-3\_39\_22102013\_153859\_B.JPG  
offset joint, medium / seeping

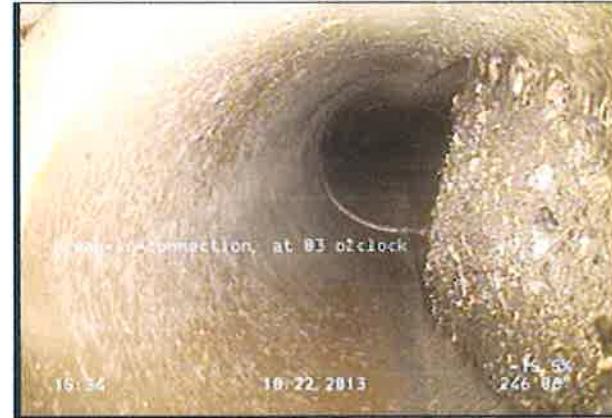
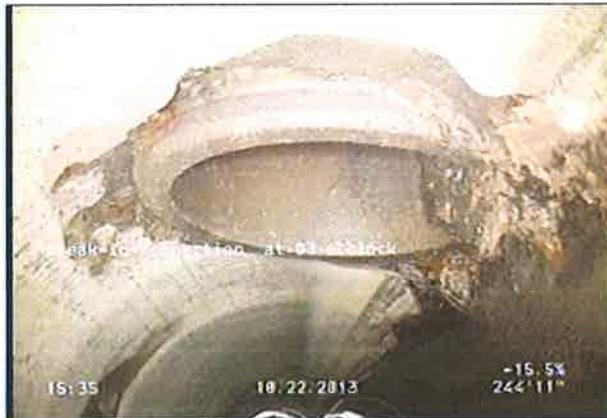
Photo: 2-16\_MH-3\_40\_22102013\_153951\_A.JPG  
break-in-connection, at 03 o'clock

Photo: 2-16\_MH-3\_40\_22102013\_154011\_B.JPG  
break-in-connection, at 03 o'clock

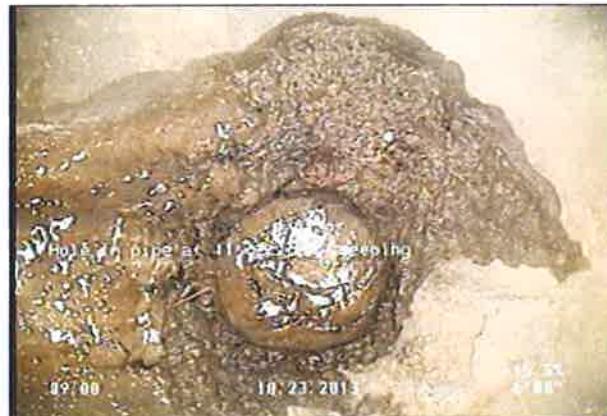
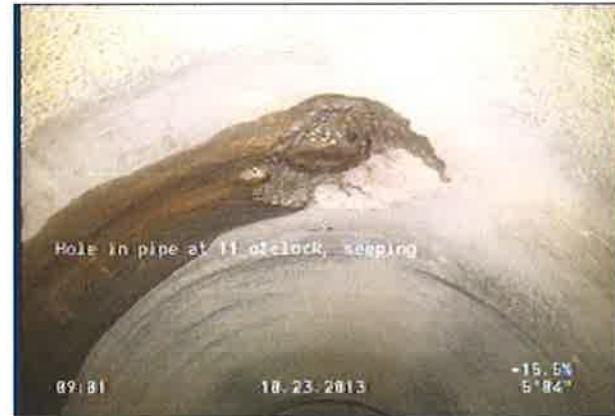
Photo: 10-3\_10-4\_2\_23102013\_090558\_A.JPG  
Hole in pipe at 11 o'clock / seeping

Photo: 10-3\_10-4\_2\_23102013\_090618\_B.JPG  
Hole in pipe at 11 o'clock / seeping

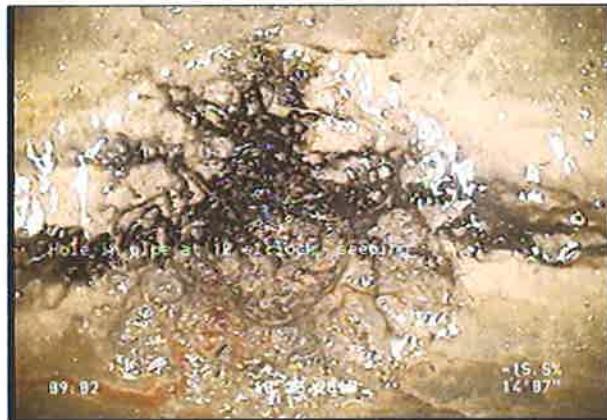
Photo: 10-3\_10-4\_4\_23102013\_090806\_A.JPG  
Hole in pipe at 12 o'clock / seeping

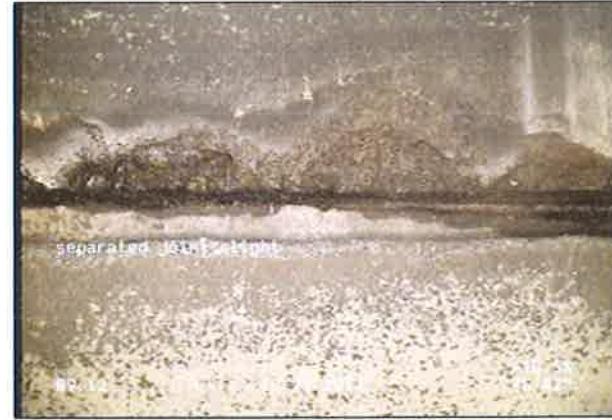
Photo: 10-3\_10-4\_11\_23102013\_091724\_A.JPG  
separated joint slight

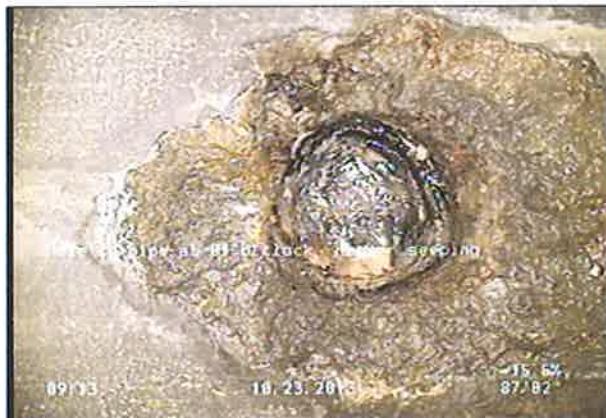
Photo: 10-3\_10-4\_12\_23102013\_091859\_A.JPG  
Hole in pipe at 01 o'clock / repair seeping

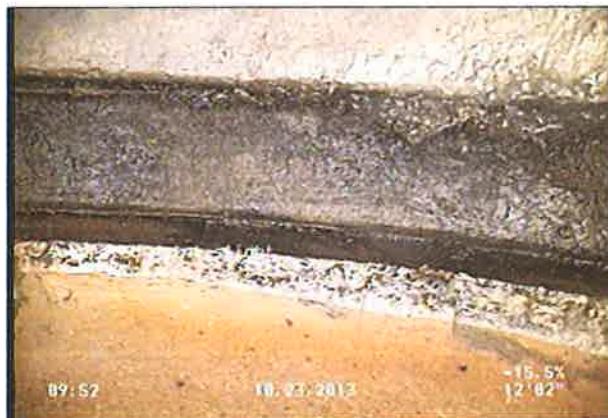
Photo: 10-1\_10-2-16\_2\_23102013\_095756\_A.JPG  
separated joint slight

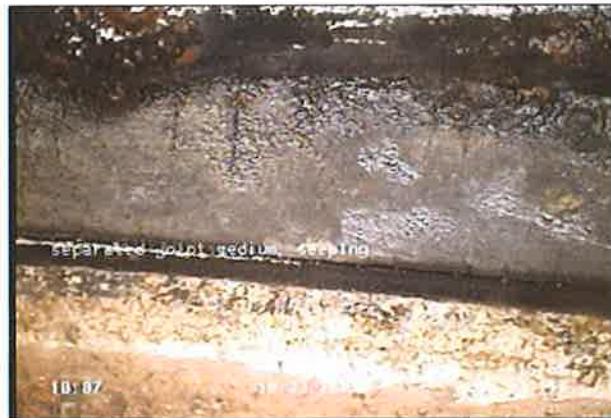
Photo: 10-1\_10-2-16\_11\_23102013\_101234\_A.JPG  
separated joint medium / seeping

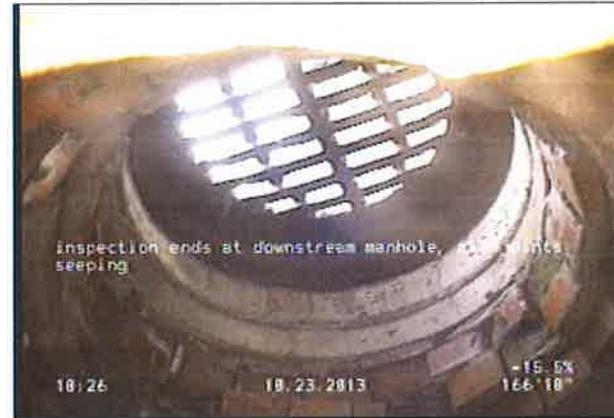
Photo: 10-1\_10-2-16\_25\_23102013\_103125\_A.JPG  
inspection ends at downstream manhole / all joints seeping

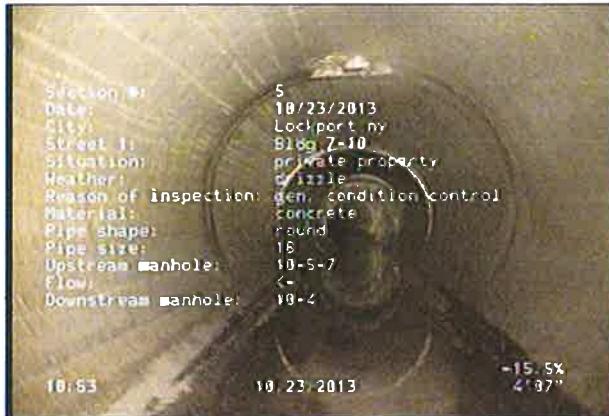
Photo: 10-5-7\_10-4\_1\_23102013\_105829\_A.JPG  
inspection begins at downstream manhole / light flow

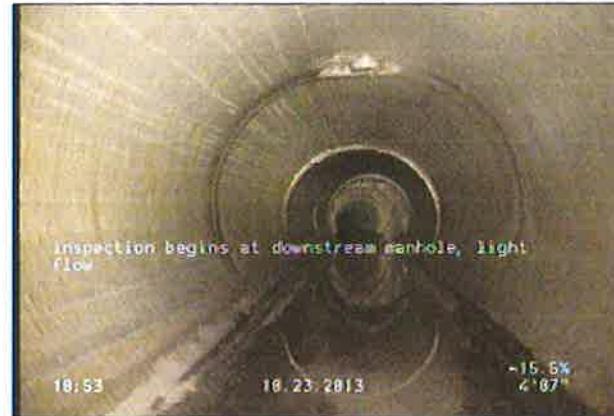
Photo: 10-5-7\_10-4\_1\_23102013\_105903\_B.JPG  
inspection begins at downstream manhole / light flow

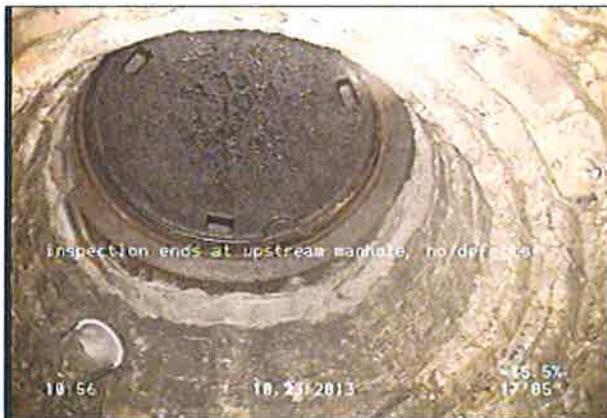
Photo: 10-5-7\_10-4\_2\_23102013\_110128\_A.JPG  
inspection ends at upstream manhole / no defects

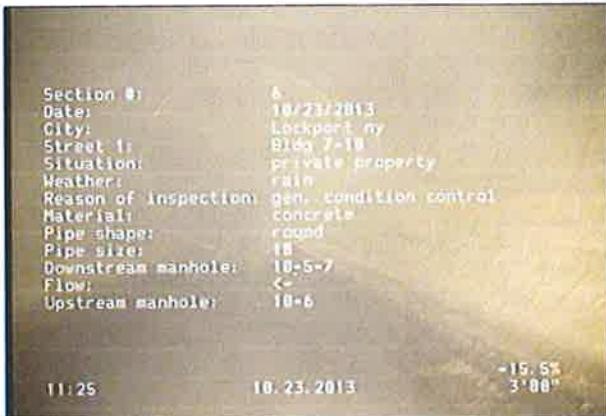
Photo: 10-6\_10-5-7\_1\_23102013\_113045\_A.JPG  
inspection begins at upstream manhole

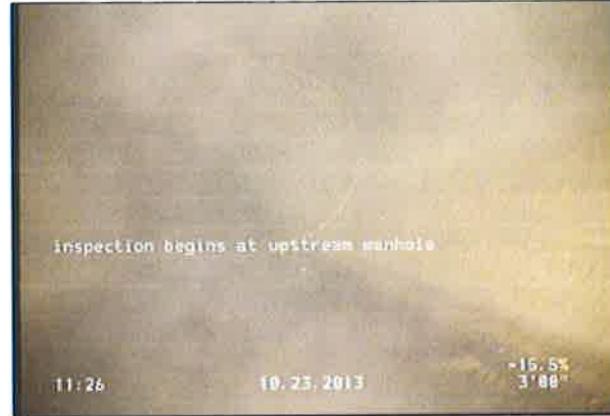
Photo: 10-6\_10-5-7\_1\_23102013\_113116\_B.JPG  
inspection begins at upstream manhole

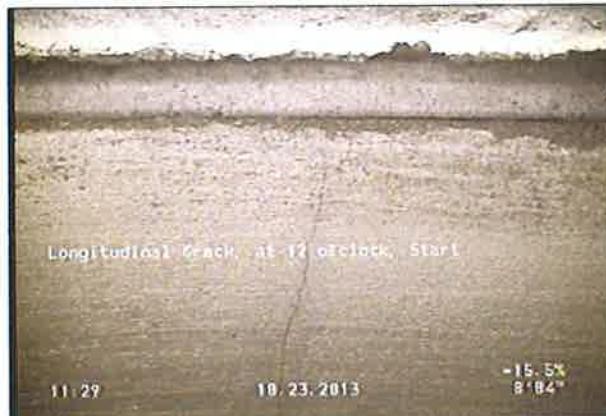
Photo: 10-6\_10-5-7\_2\_23102013\_113458\_A.JPG  
Longitudinal Crack, at 12 o'clock, Start

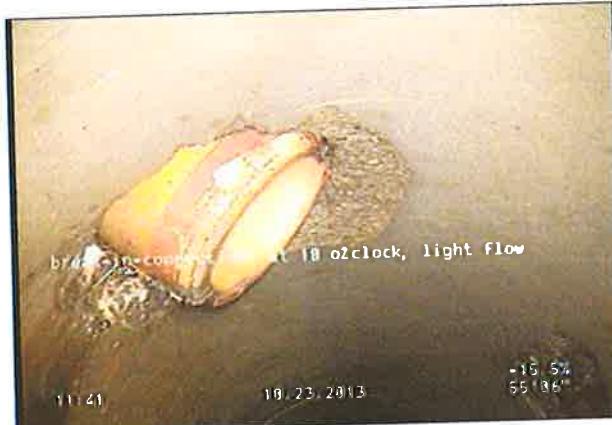
Photo: 10-6\_10-5-7\_5\_23102013\_114639\_B.JPG  
break-in-connection, at 10 o'clock / light flow

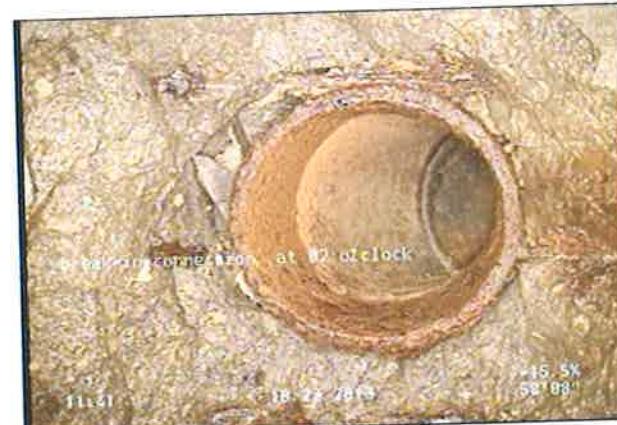
Photo: 10-6\_10-5-7\_6\_23102013\_114705\_A.JPG  
break-in-connection, at 02 o'clock

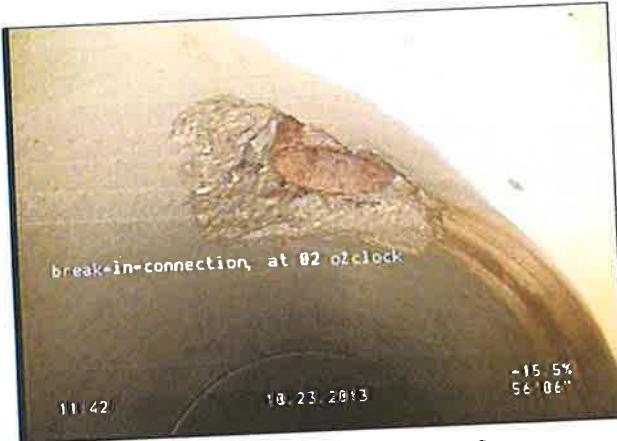
Photo: 10-6\_10-5-7\_6\_23102013\_114717\_B.JPG  
break-in-connection, at 02 o'clock

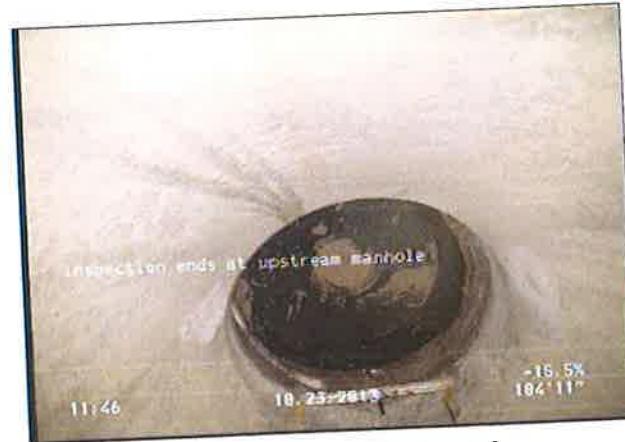
Photo: 10-6\_10-5-7\_7\_23102013\_115151\_A.JPG  
inspection ends at upstream manhole

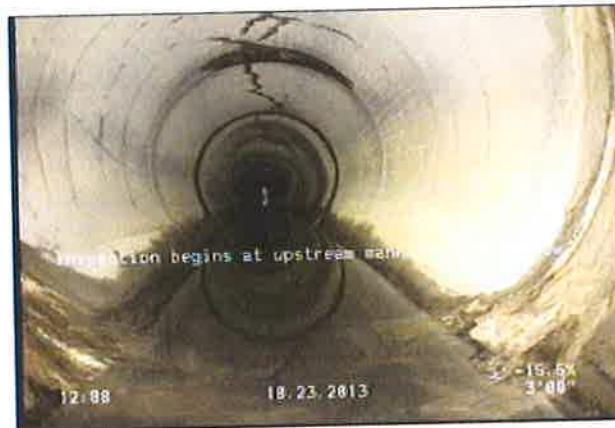
Photo: 10-5-7\_10-7-21\_1\_23102013\_121357\_B.JPG  
inspection begins at upstream manhole / light flow

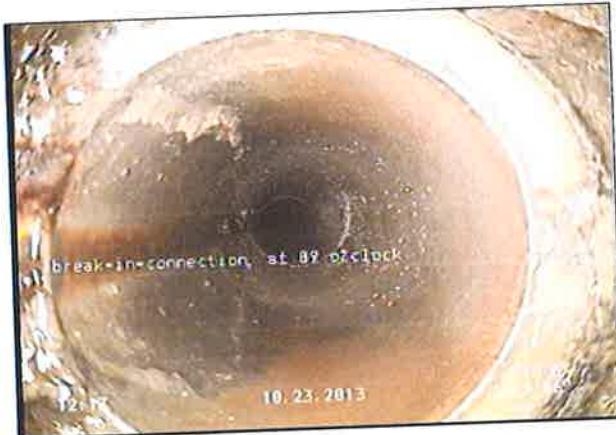
Photo: 10-5-7\_10-7-21\_6\_23102013\_122208\_A.JPG  
 break-in-connection, at 09 o'clock

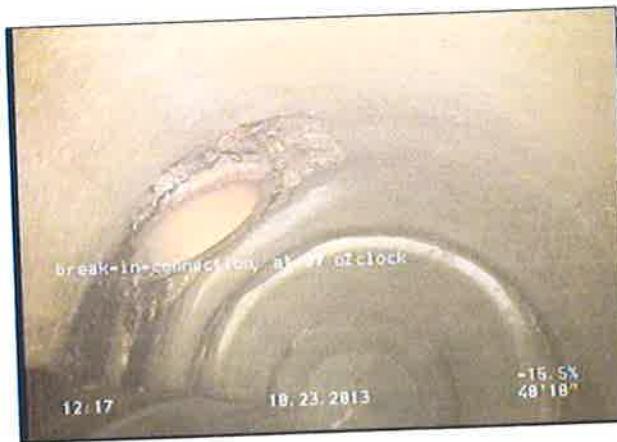
Photo: 10-5-7\_10-7-21\_6\_23102013\_122225\_B.JPG  
 break-in-connection, at 09 o'clock

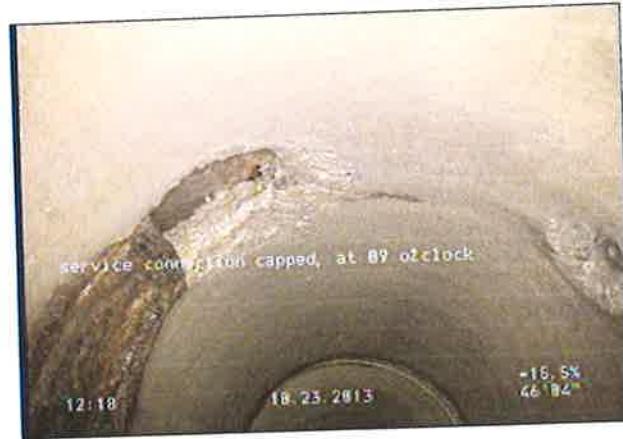
Photo: 10-5-7\_10-7-21\_7\_23102013\_122407\_B.JPG  
 service connection capped, at 09 o'clock

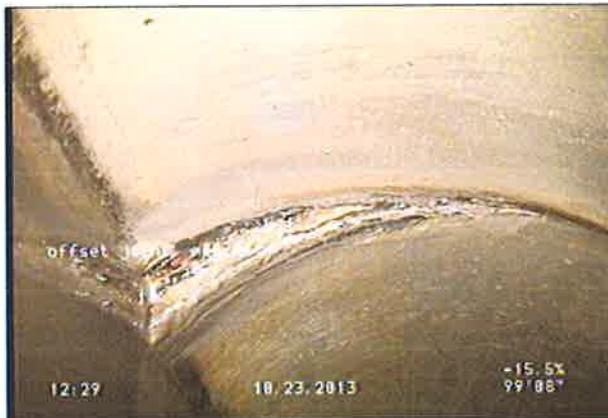
Photo: 10-5-7\_10-7-21\_10\_23102013\_123411\_A.JPG  
offset joint, medium

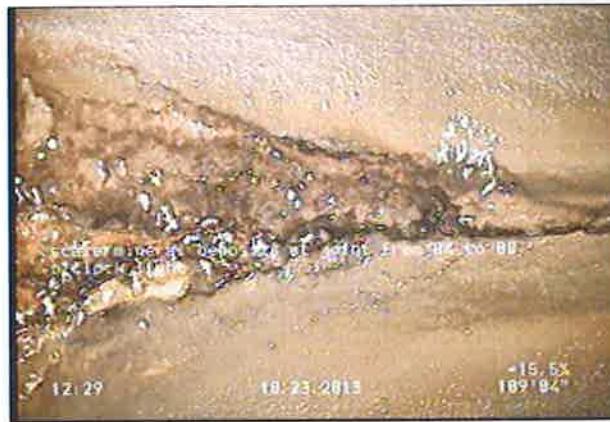
Photo: 10-5-7\_10-7-21\_11\_23102013\_123502\_A.JPG  
scale/mineral deposits at joint from 04 to 08 o'clock light

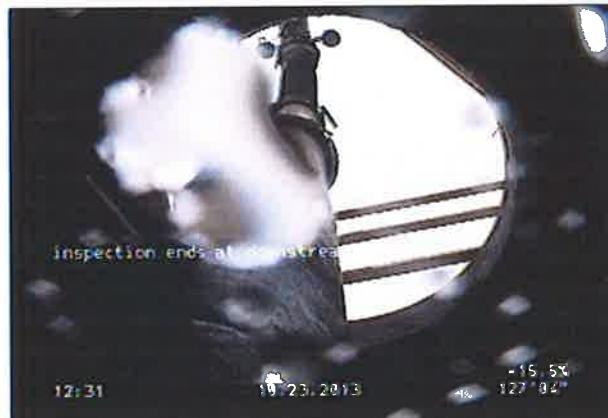
Photo: 10-5-7\_10-7-21\_12\_23102013\_123650\_A.JPG  
inspection ends at downstream manhole

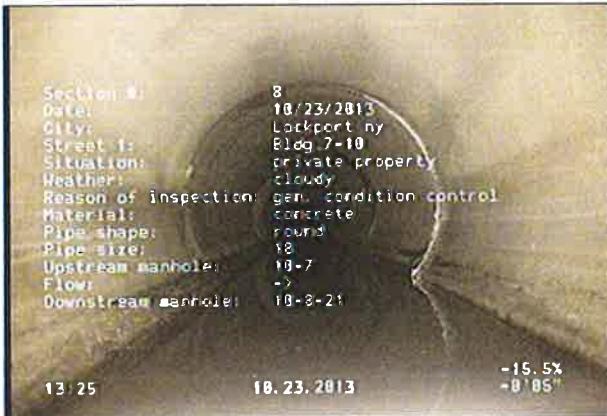
Photo: 10-7\_10-8-21\_1\_23102013\_132909\_A.JPG  
 inspection begins at upstream manhole

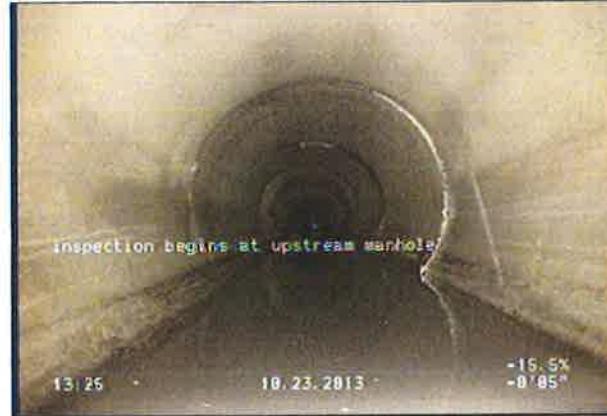
Photo: 10-7\_10-8-21\_1\_23102013\_132930\_B.JPG  
 inspection begins at upstream manhole

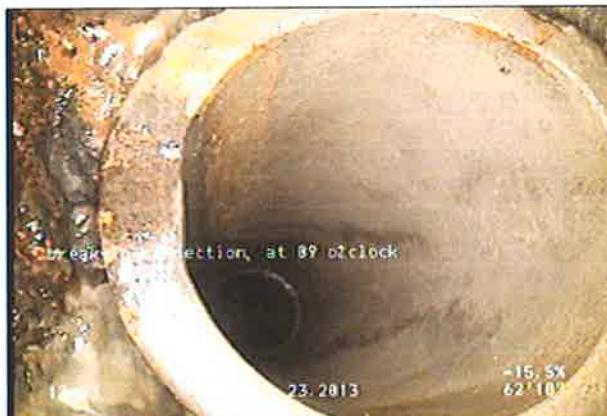
Photo: 10-7\_10-8-21\_3\_23102013\_133905\_A.JPG  
 break-in-connection, at 09 o'clock

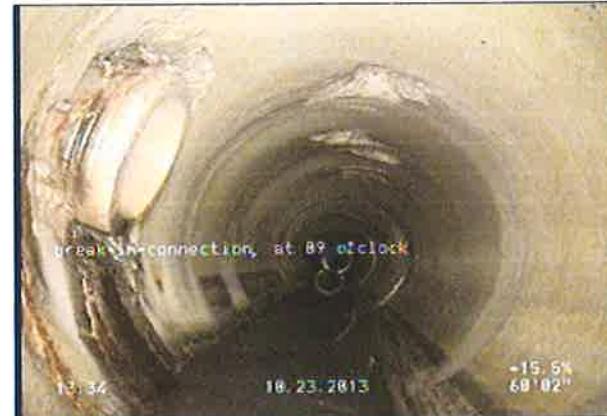
Photo: 10-7\_10-8-21\_3\_23102013\_133920\_B.JPG  
 break-in-connection, at 09 o'clock

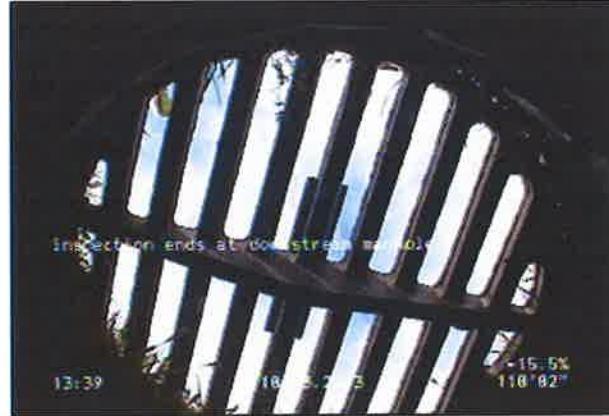
Photo: 10-7\_10-8-21\_7\_23102013\_134409\_A.JPG  
inspection ends at downstream manhole

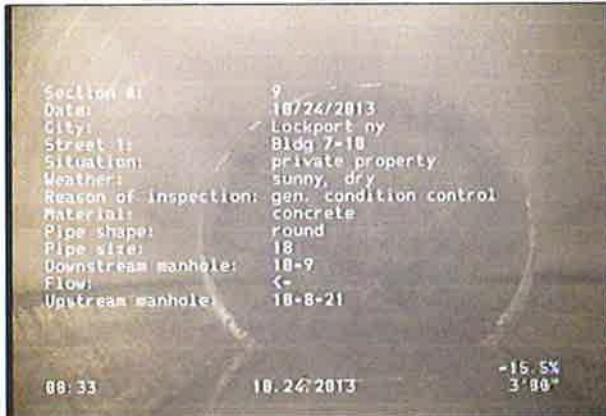
Photo: 10-8-21\_10-9\_1\_24102013\_083813\_A.JPG  
inspection begins at downstream manhole / light steam and flow

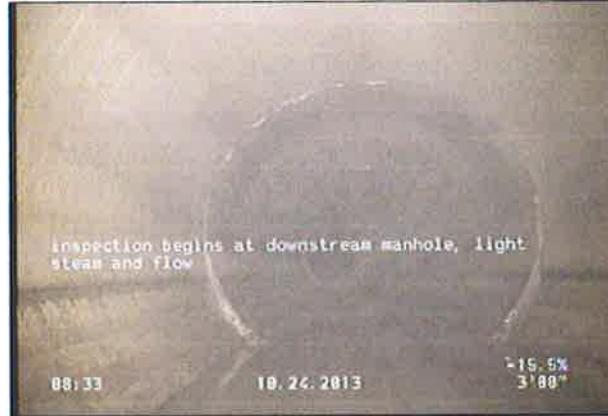
Photo: 10-8-21\_10-9\_1\_24102013\_083845\_B.JPG  
inspection begins at downstream manhole / light steam and flow

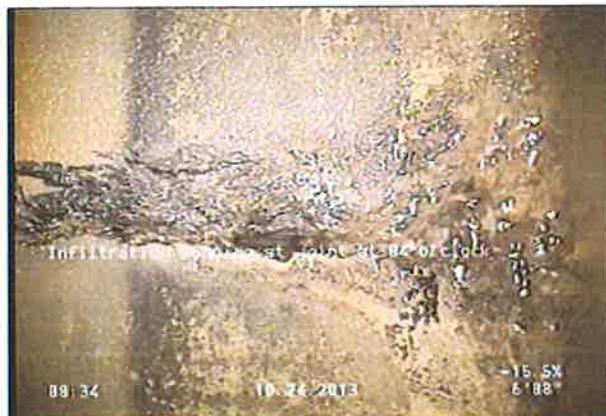
Photo: 10-8-21\_10-9\_2\_24102013\_083933\_A.JPG  
Infiltration Running at joint at 04 o'clock

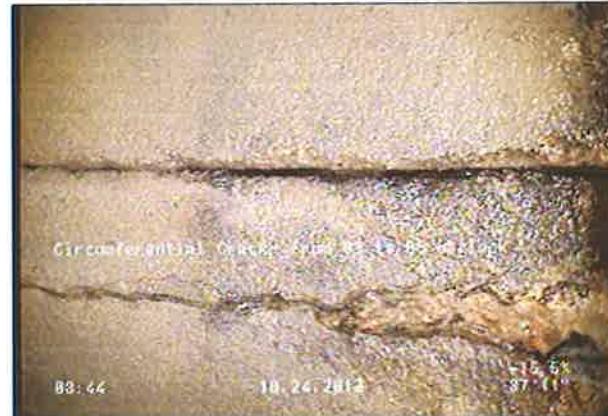
Photo: 10-8-21\_10-9\_3\_24102013\_084918\_A.JPG  
Circumferential Crack, from 03 to 05 o'clock

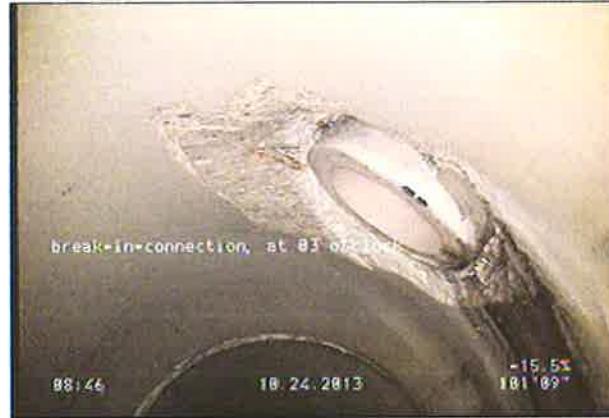
Photo: 10-8-21\_10-9\_4\_24102013\_085130\_B.JPG  
break-in-connection, at 03 o'clock

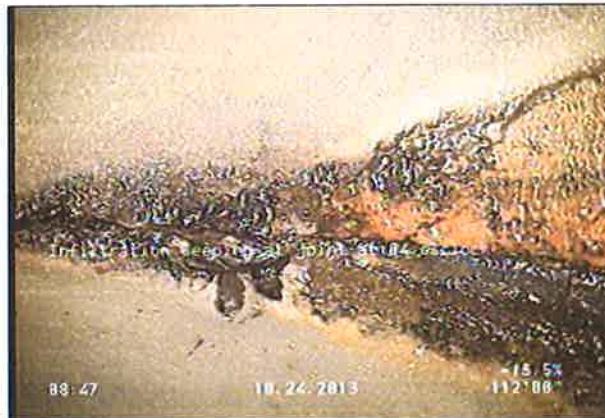
Photo: 10-8-21\_10-9\_5\_24102013\_085252\_A.JPG  
Infiltration Seeping at joint at 04 o'clock

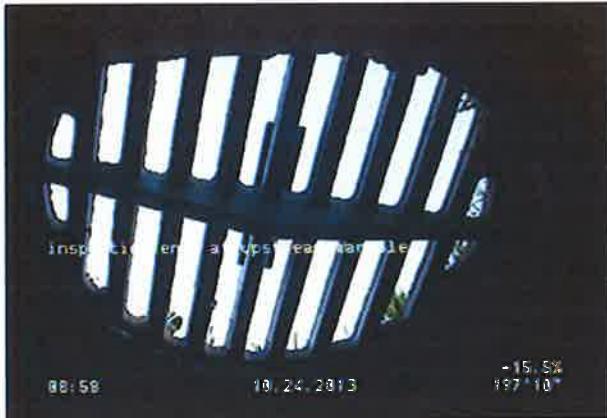
Photo: 10-8-21\_10-9\_12\_24102013\_090400\_A.JPG  
inspection ends at upstream manhole

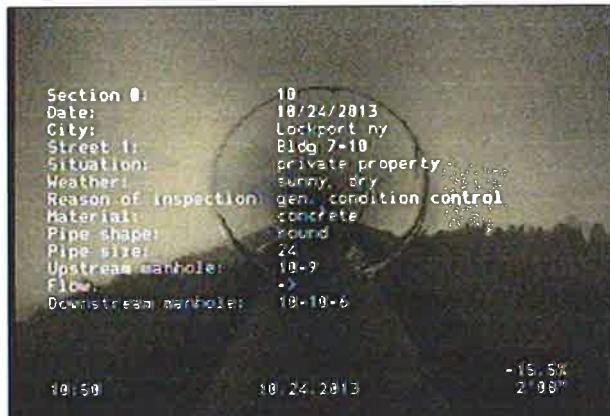
Photo: 10-9\_10-10-6\_1\_24102013\_105555\_A.JPG  
inspection begins at upstream manhole / light flow

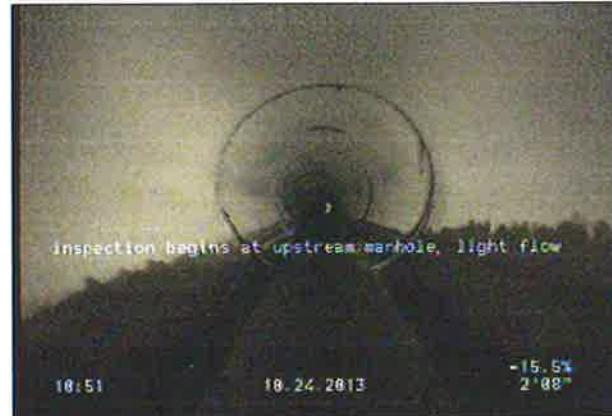
Photo: 10-9\_10-10-6\_1\_24102013\_105613\_B.JPG  
inspection begins at upstream manhole / light flow

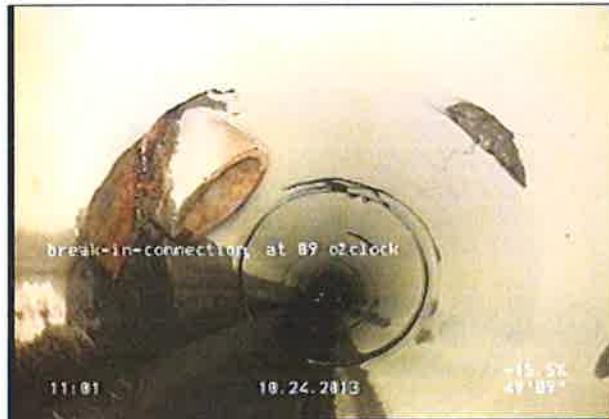
Photo: 10-9\_10-10-6\_6\_24102013\_110648\_B.JPG  
break-in-connection, at 09 o'clock

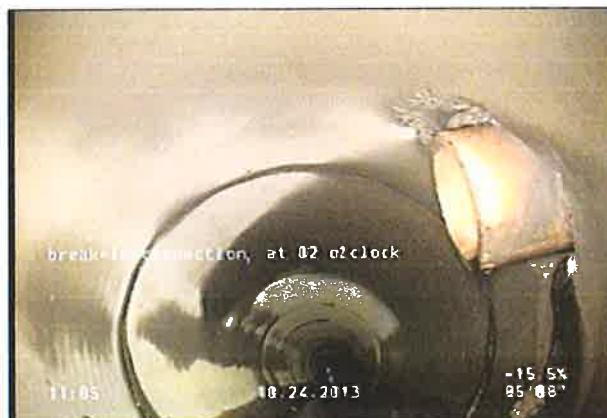
Photo: 10-9\_10-10-6\_11\_24102013\_111104\_B.JPG  
break-in-connection, at 02 o'clock

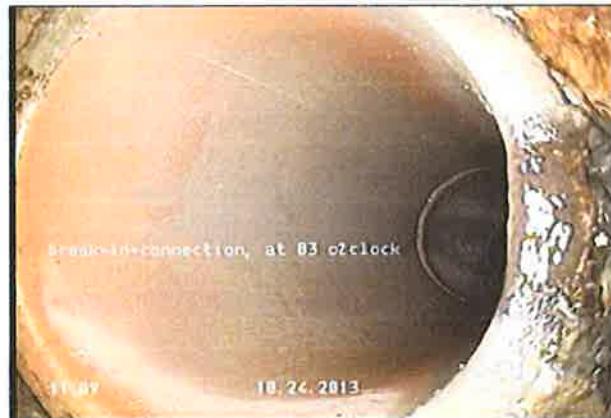
Photo: 10-9\_10-10-6\_12\_24102013\_111412\_A.JPG  
break-in-connection, at 03 o'clock

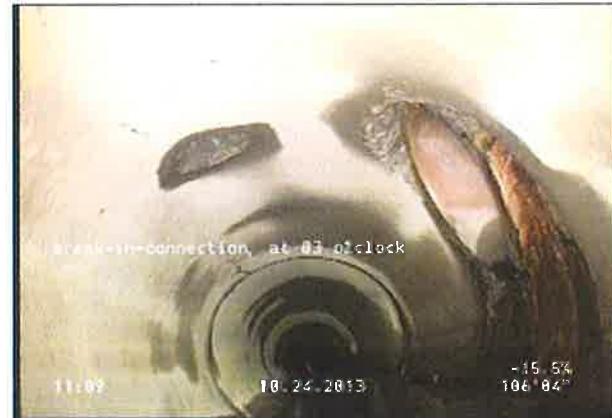
Photo: 10-9\_10-10-6\_12\_24102013\_111433\_B.JPG  
break-in-connection, at 03 o'clock

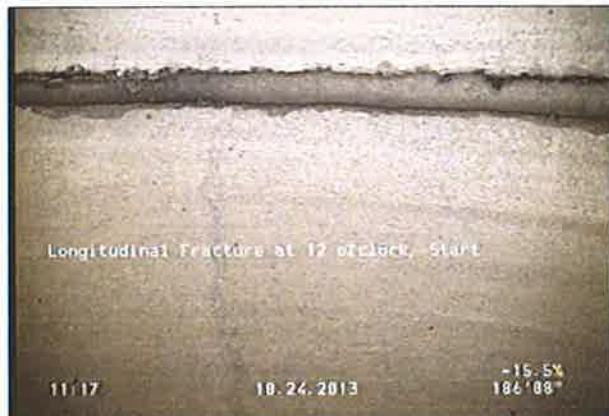
Photo: 10-9\_10-10-6\_16\_24102013\_112259\_A.JPG  
Longitudinal Fracture at 12 o'clock, Start

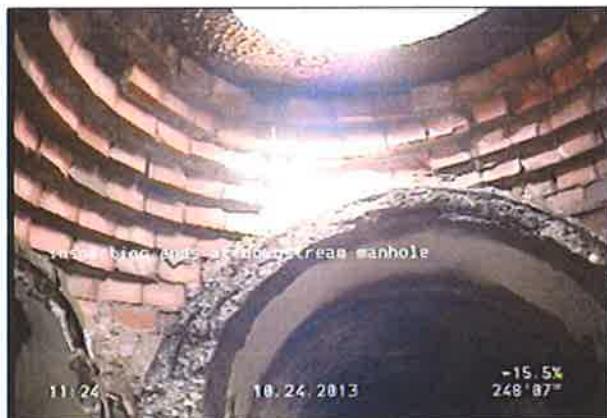
Photo: 10-9\_10-10-6\_22\_24102013\_112927\_A.JPG  
inspection ends at downstream manhole

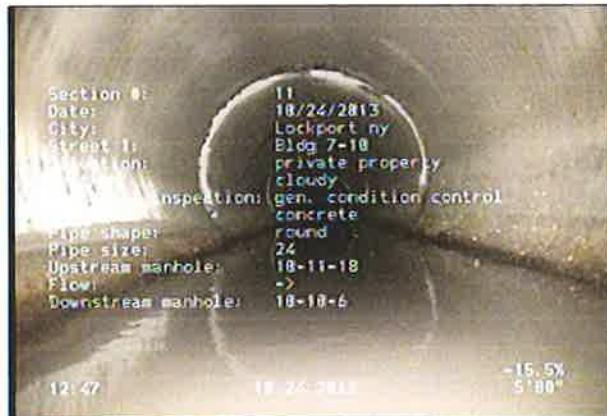
Photo: 10-11-18\_10-10-6\_1\_24102013\_125256\_A.JPG  
inspection begins at downstream manhole

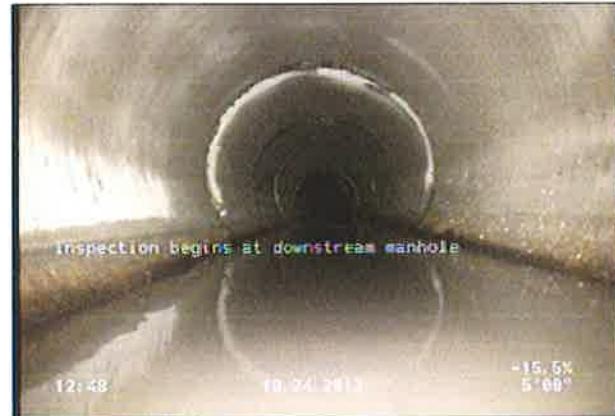
Photo: 10-11-18\_10-10-6\_1\_24102013\_125311\_B.JPG  
inspection begins at downstream manhole
