**RE: Phase I Environmental Site Assessment
4185 Military Road, Niagara, New York
LaBella Project No. 2151439**

Phase I Environmental Site Assessment

4185 Military Road
Niagara, New York

LaBella Project No. 2151439

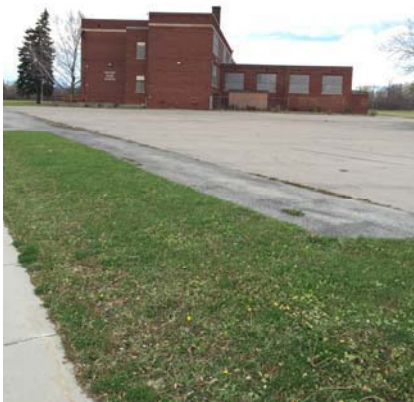
Site

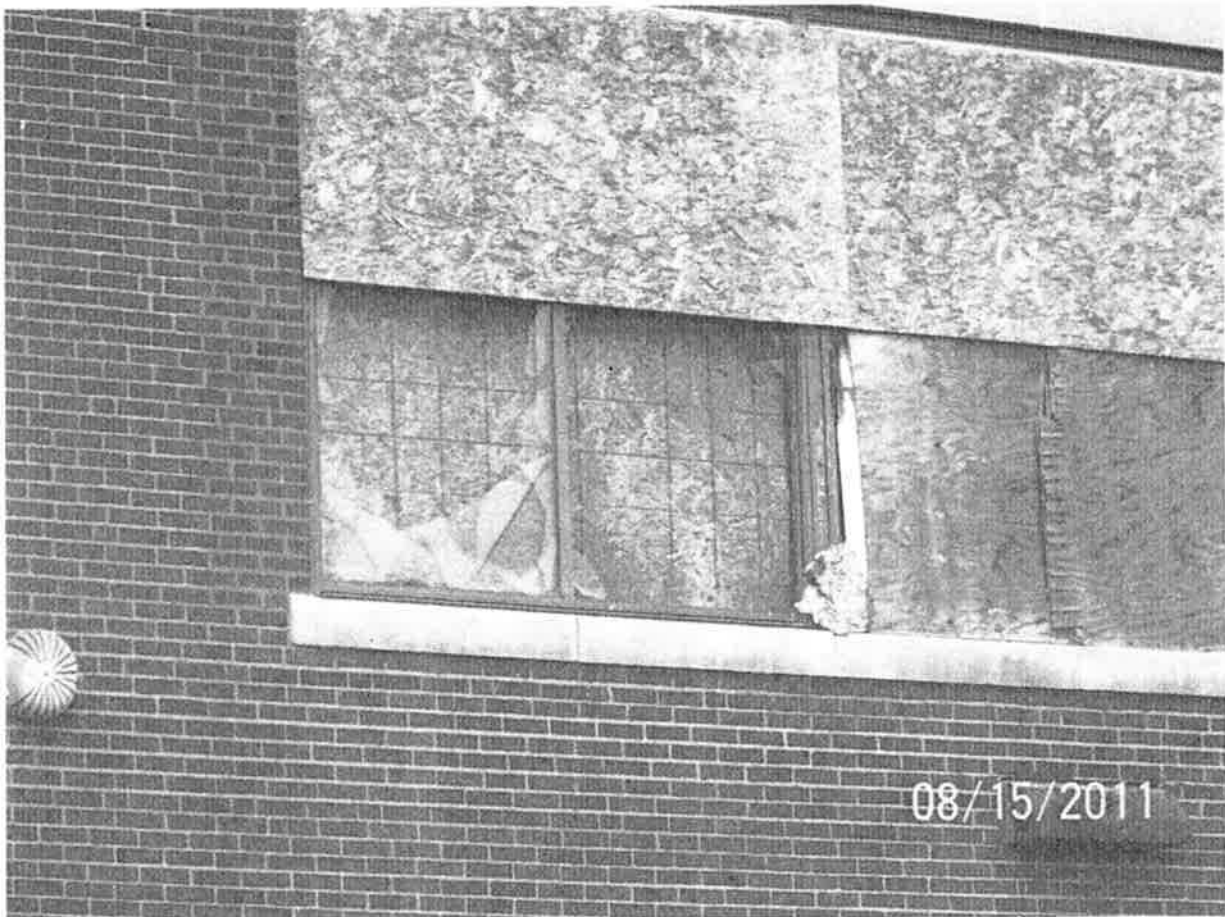
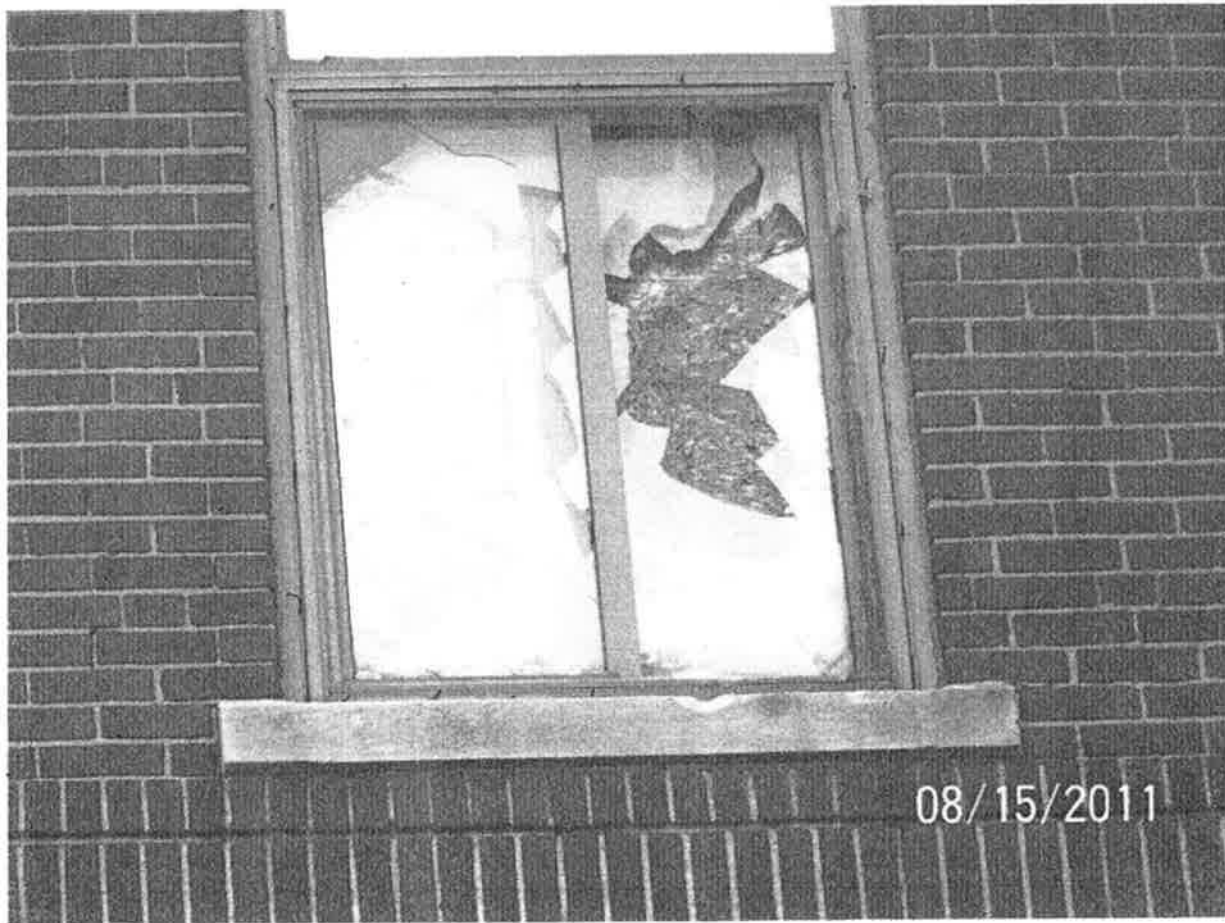
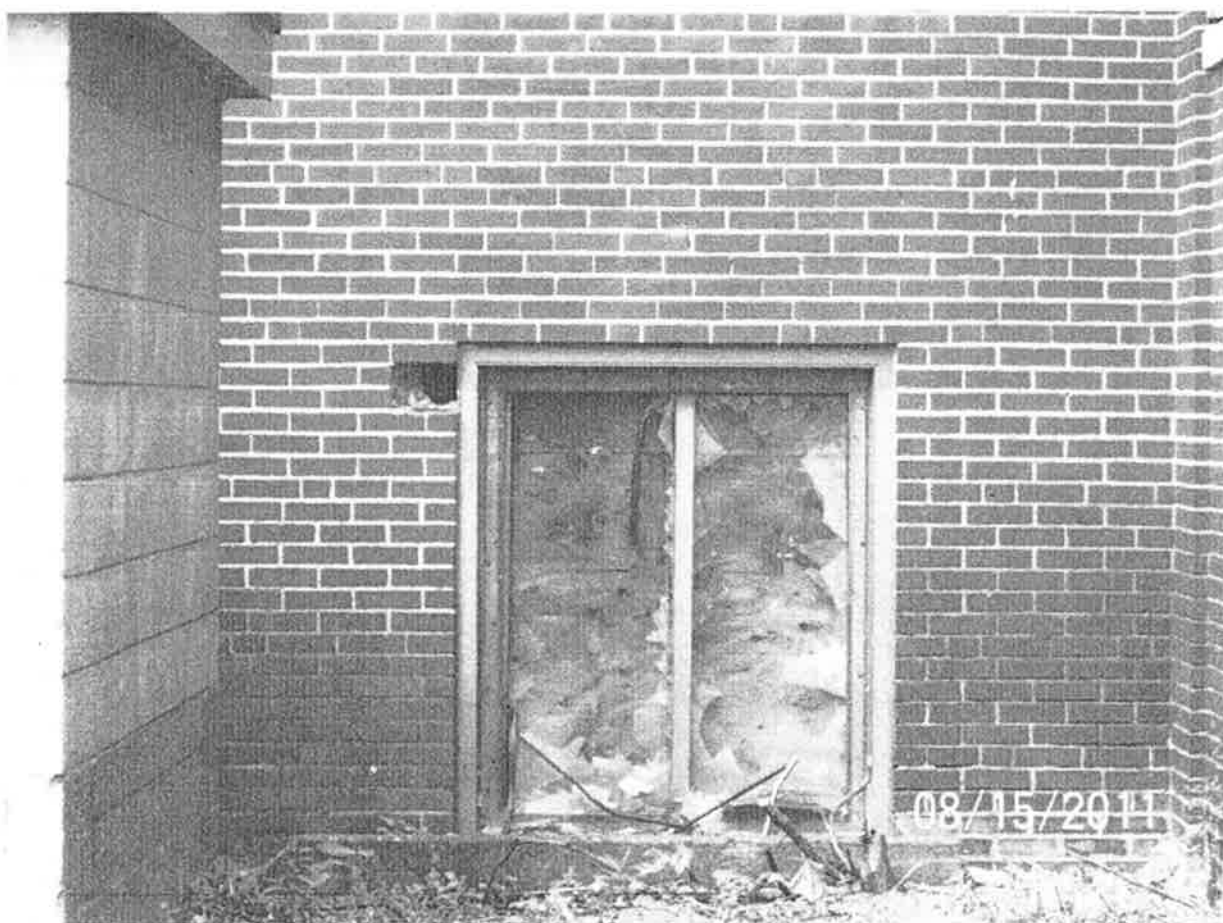
- Exterior vacant lot, to include court yard, playground area, parking lot area, dumpster enclosure has dried weeds, grasses, bushes, trees that is capable of being ignited and endangering property; a violation of the Fire Code of New York State Chapter 3, (general precautions against fire) 304 (combustible waste material) sub §304.1.1 (waste material) and §304.1.2 (vegetation unsafe) as defined by Town of Niagara Code Chapter 121, §121-1 (D), (I), (J);
- A window located to the rear, east side of the building is broken and has left the building unsecure, allowing for unauthorized entry; a violation of the Fire Code of New York State Chapter 3 (general precautions against fire) §311 (vacant premises), sub §311.2.1 (security), unsafe as defined by Town of Niagara Code Chapter 121, §121-1 (D), (E), (H), (I), (J);

- Fire alarm has been disabled prior to the building being removed of all combustible debris and materials, nor authorization by the authority having jurisdiction; a violation of the Fire Code of New York State Chapter 3 (general precautions against fire), §311 (vacant premises), sub §311.2.1 (fire protection) unsafe as defined by Town of Niagara Code Chapter 121, §121-1 (F), (G), (I), (J).

- Several exterior windows are broken. Shard's of glass are posed to fall; violation of the Property Maintenance Code of New York State Chapter 3, (general requirements) §304 (exterior structure), §304.13 and §304.13.1. Unsafe as defined by Town of Niagara Code Chapter 121, §121.1 (D), (E), (H), (I), (J)

- Interior staircase in need of repair (Fire Damage); a violation of the Property Maintenance Code of New York State Chapter 3 (general requirements), §305 (interior structure) sub §305.4. Unsafe as defined by Town of Niagara Code Chapter 121, §121-1 (D), (E), (G), (H), (I), (J).

- Exterior man doors and garage door in need of repair; a violation of the Property Maintenance Code Chapter 3, (general requirements), §304 (exterior structure) sub §304.2 (protective treatment). Unsafe as defined by Town of Niagara Code §121.1 (D), (E), (F), (G), (I), (J);

- The required emergency escape windows are not maintained; a violation of the Property Maintenance Code Chapter 7 (fire safety requirements), §702 (means of egress), sub §702.4 (emergency escape openings). Unsafe as defined by Town of Niagara Chapter 121, §121-1 (D), (E), (G), (I) (J);
