August 9, 2019

Reference No. 11137172

**Re:    Monitoring Well Assessment and LNAPL Gauging Event Letter Report  
        Southern Terminals  
        Cold Springs Terminal Site, Hillside Road  
        Lysander, New York**

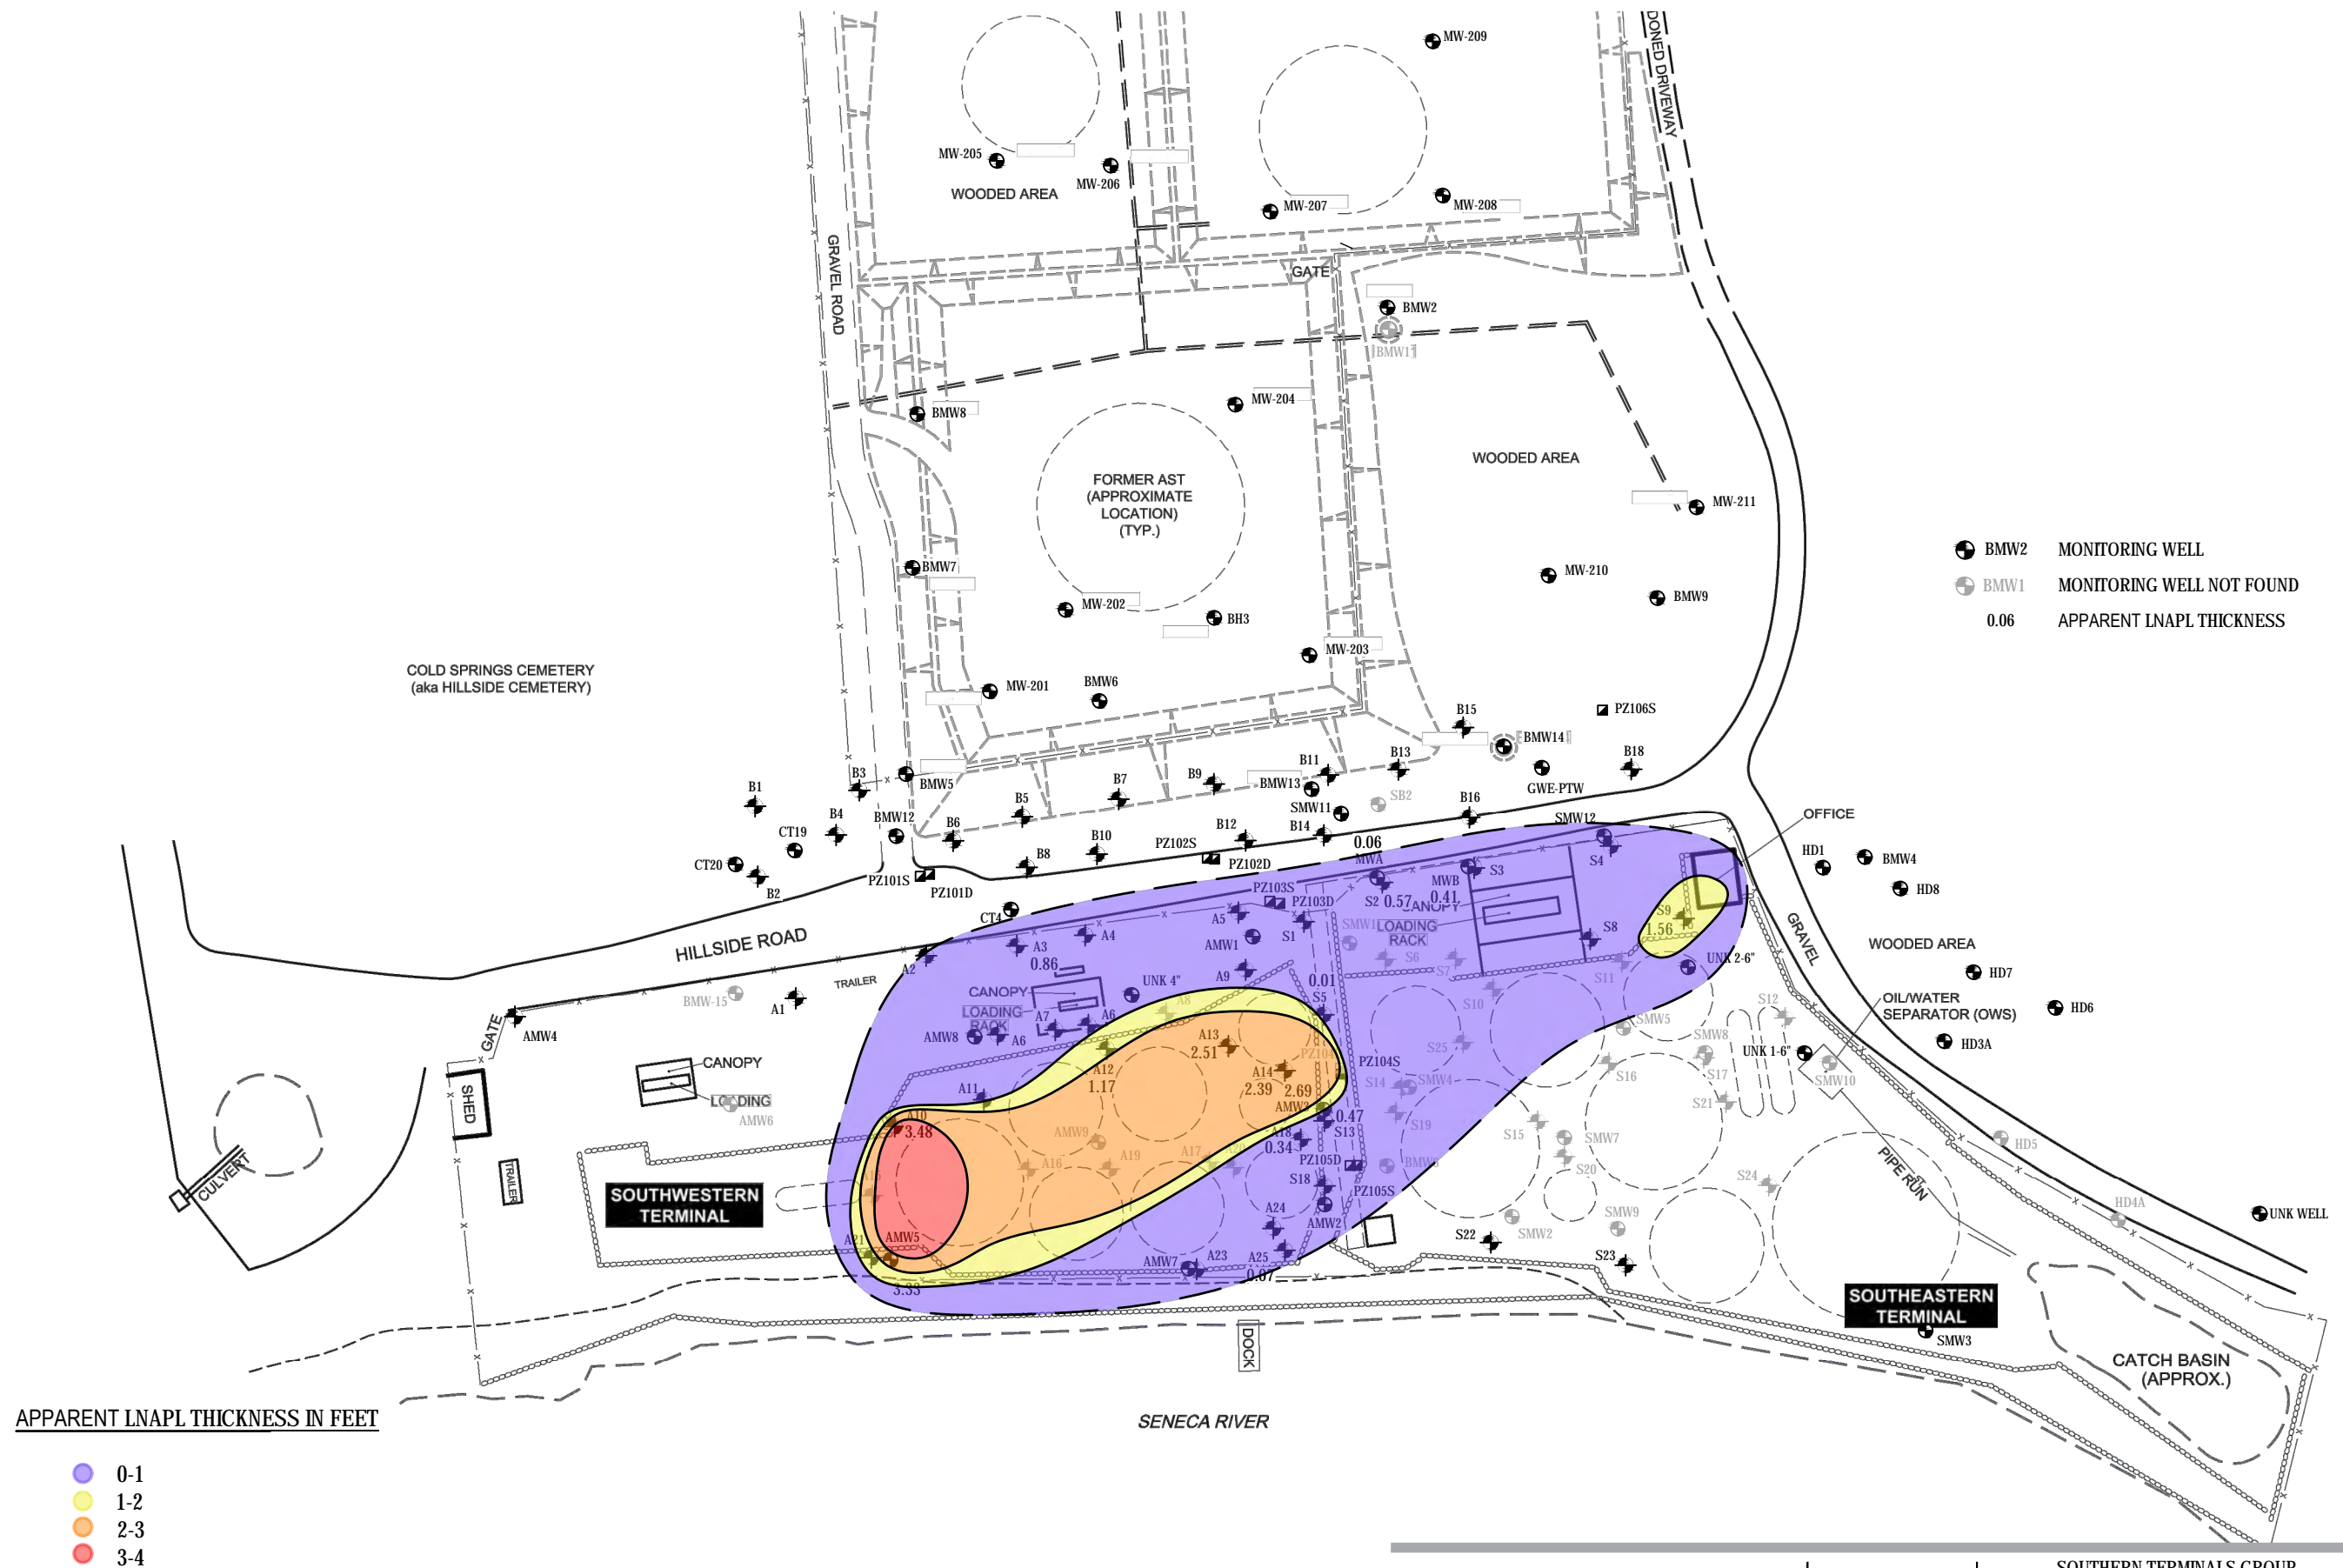
FIGURE 4

Approximately half of the monitoring wells previously located on the ST portion of the Site were located and were in sufficient condition to be gauged during this field effort. Of those wells, 15 contained measurable thicknesses of LNAPL ranging from 0.01 to 3.48 feet, which is consistent with previous observations.

SOUTHERN TERMINALS GROUP  
COLD SPRINGS TERMINAL SITE  
HILLSIDE ROAD, LYSANDER, NEW YORK  
LNAPL THICKNESS IN FEET  
JUNE 6-7, 2019

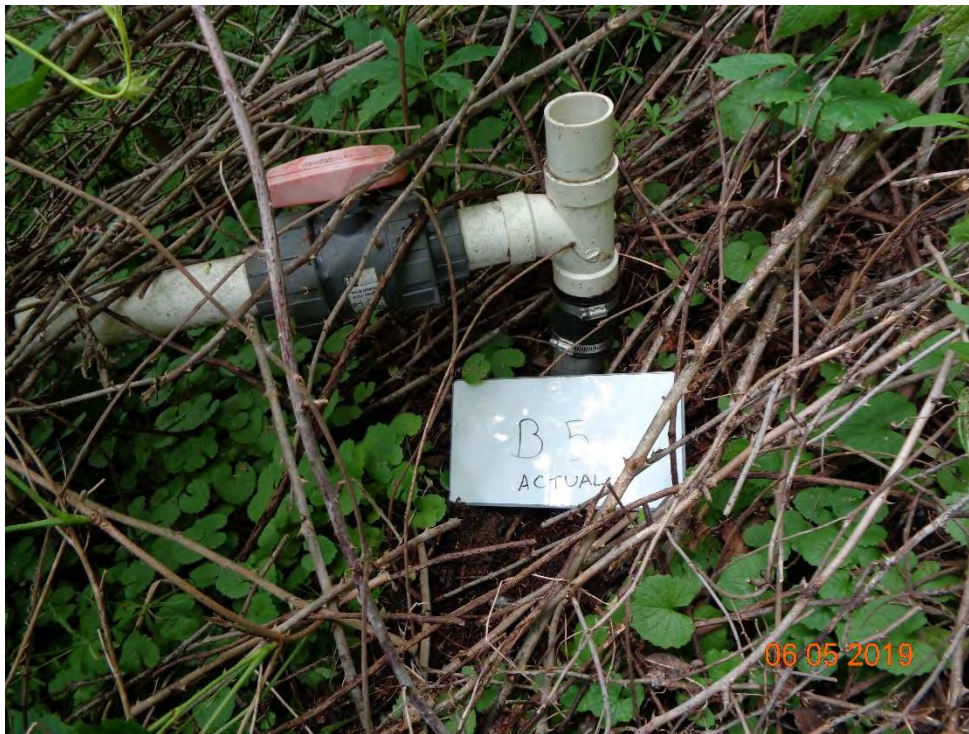
Photo 39 - View of Northern Terminal B5

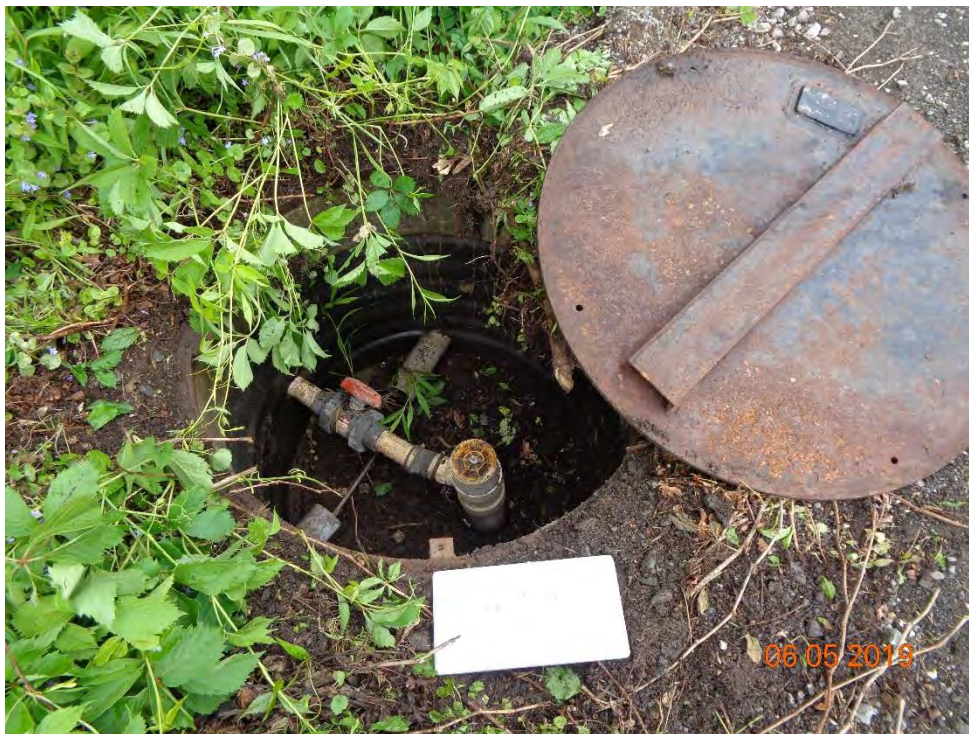
Photo 40 - View of Northern Terminal B10

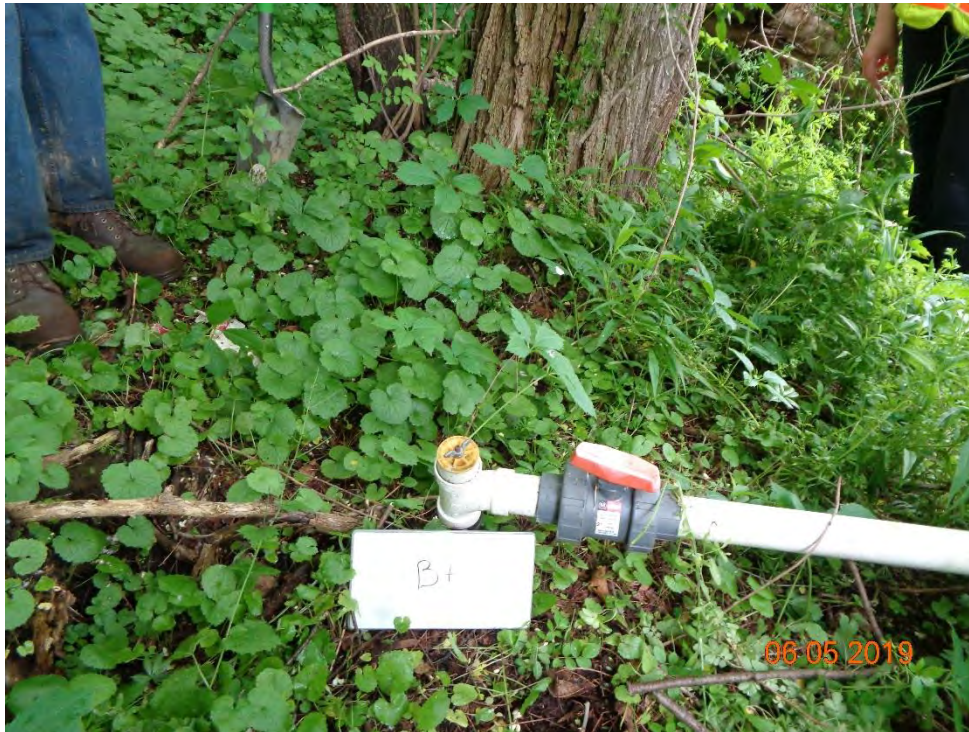
Photo 41 - View of Northern Terminal B7

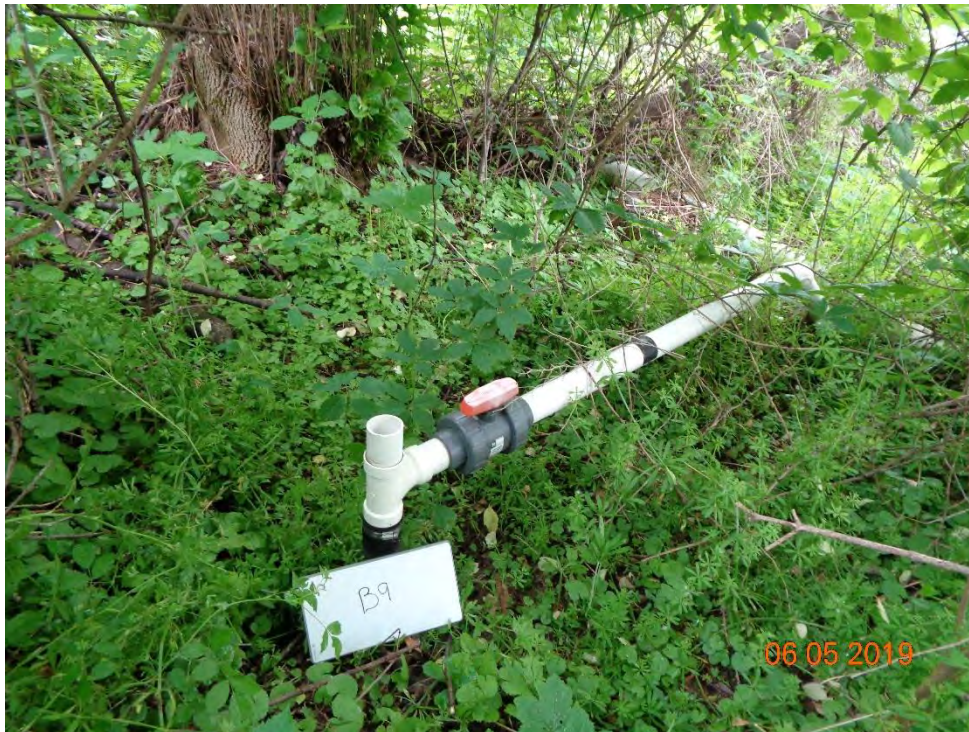
Photo 42 - View of Northern Terminal B9

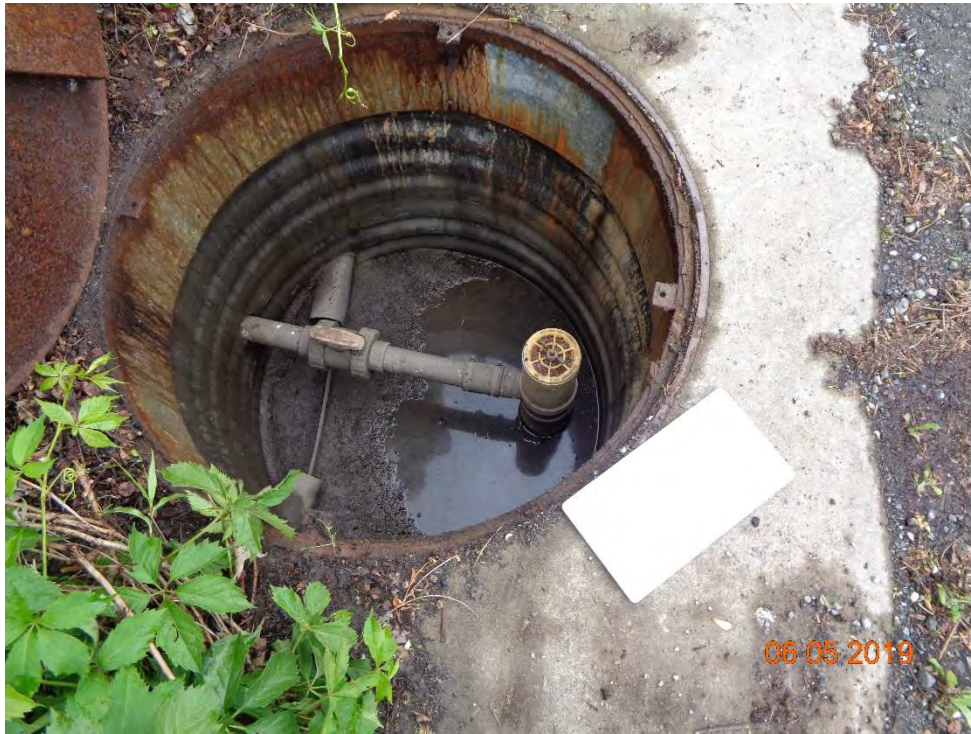
Photo 43 - View of Northern Terminal B12

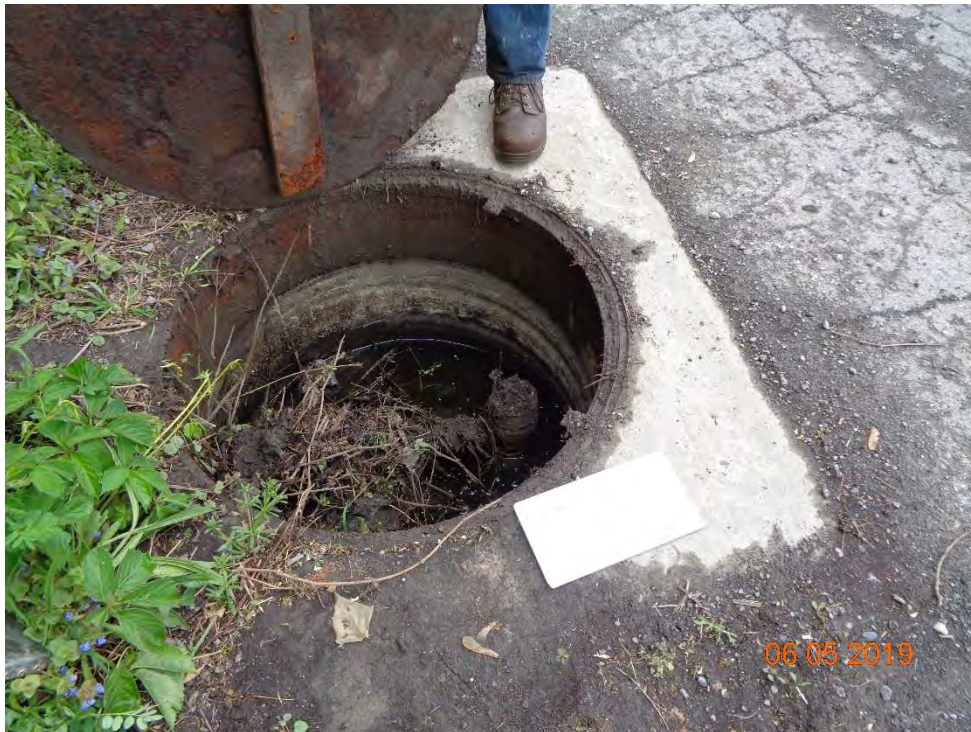
Photo 44 - View of Northern Terminal B14

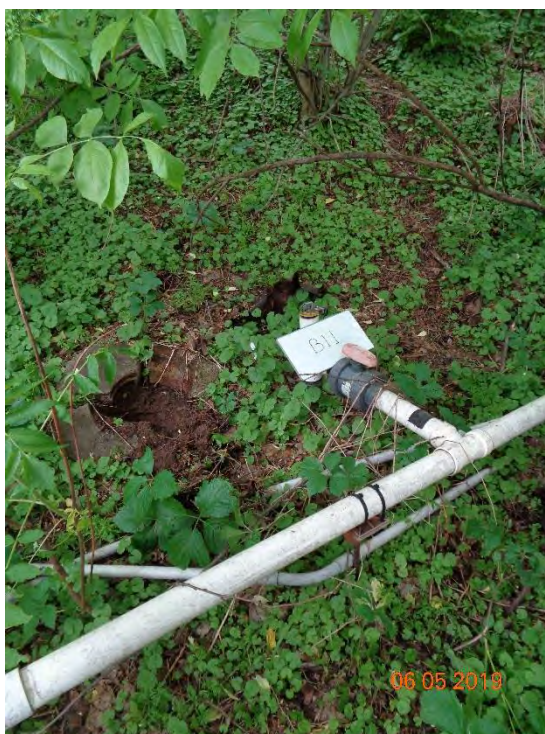
Photo 45 - View of Northern Terminal B11

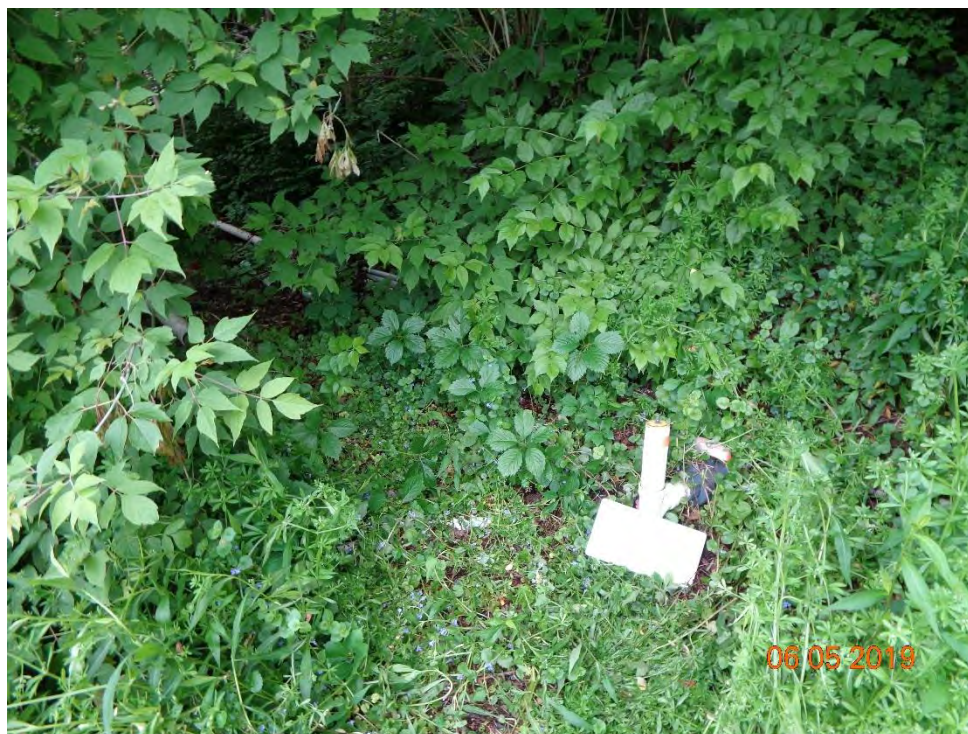
Photo 46 - View of Northern Terminal B13

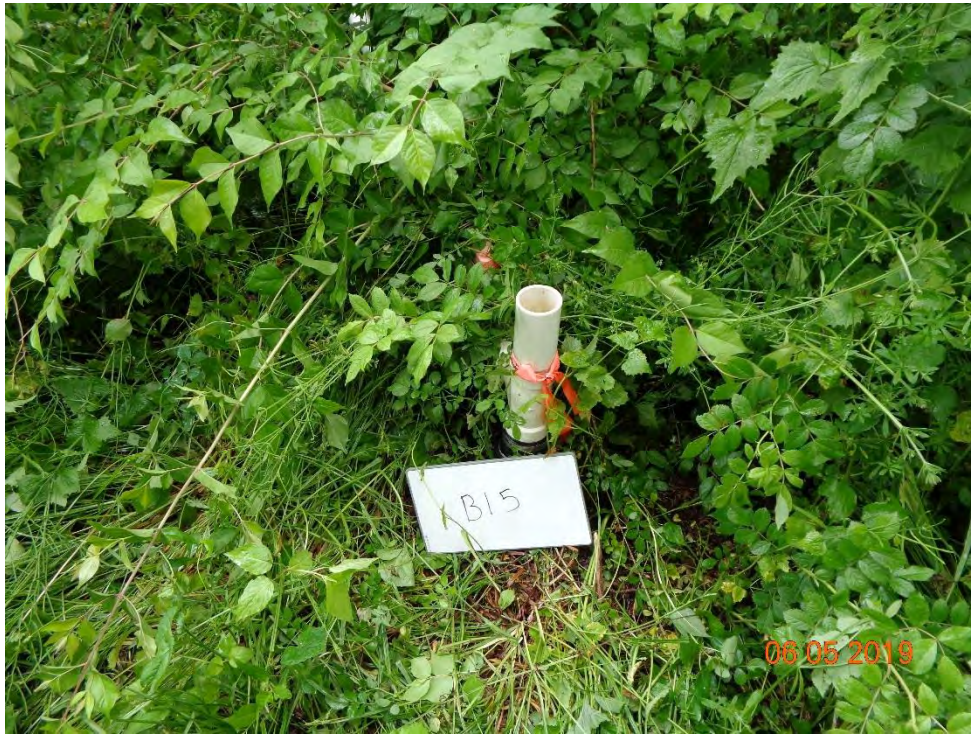
Photo 47 - View of Northern Terminal B15

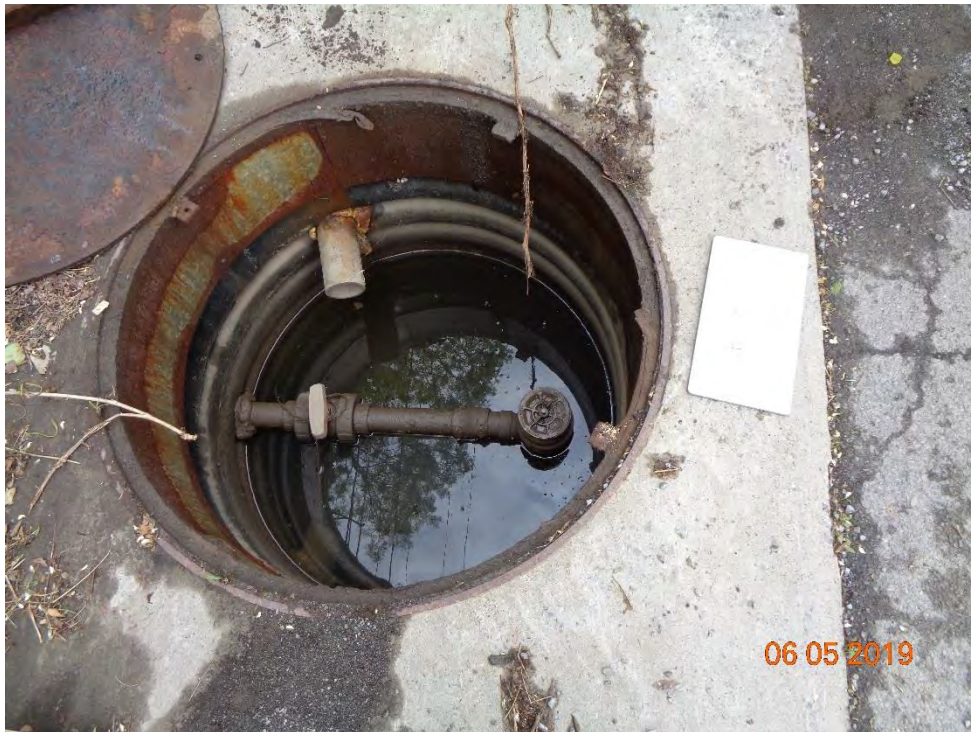
Photo 48 - View of Northern Terminal B16

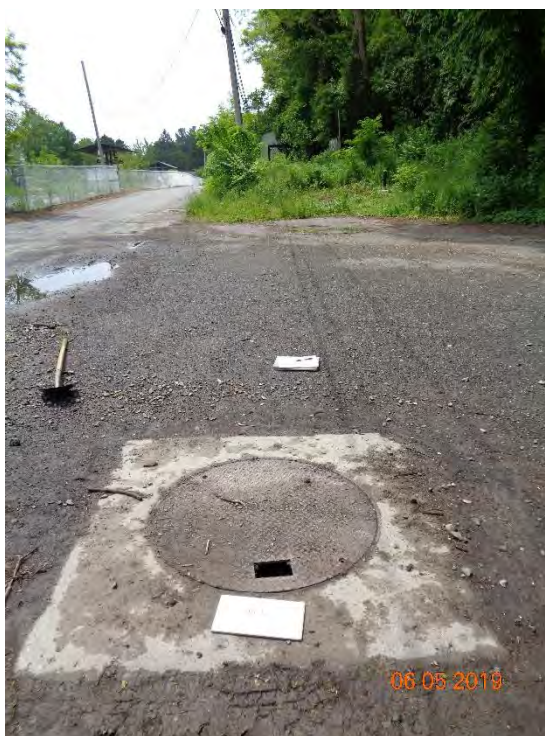
Photo 49 - View of Northern Terminal B18

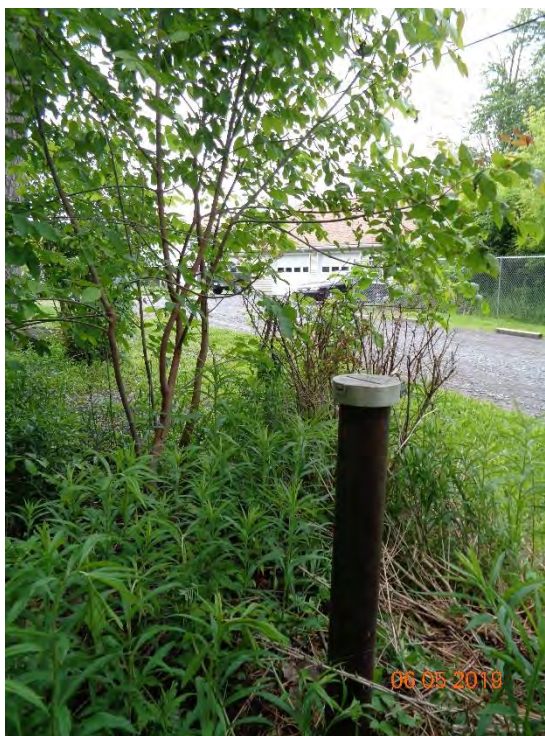
Photo 50 - View of Northern Terminal unknown well near southeastern corner of property

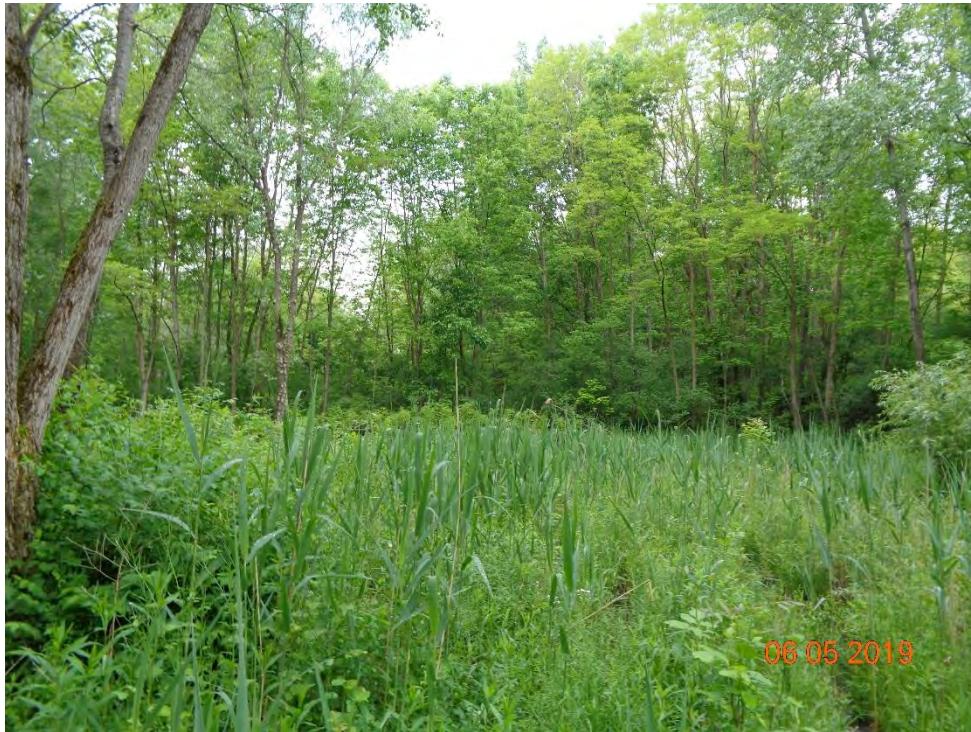
Photo 51 - View of Northern Terminal site in vicinity of MW209

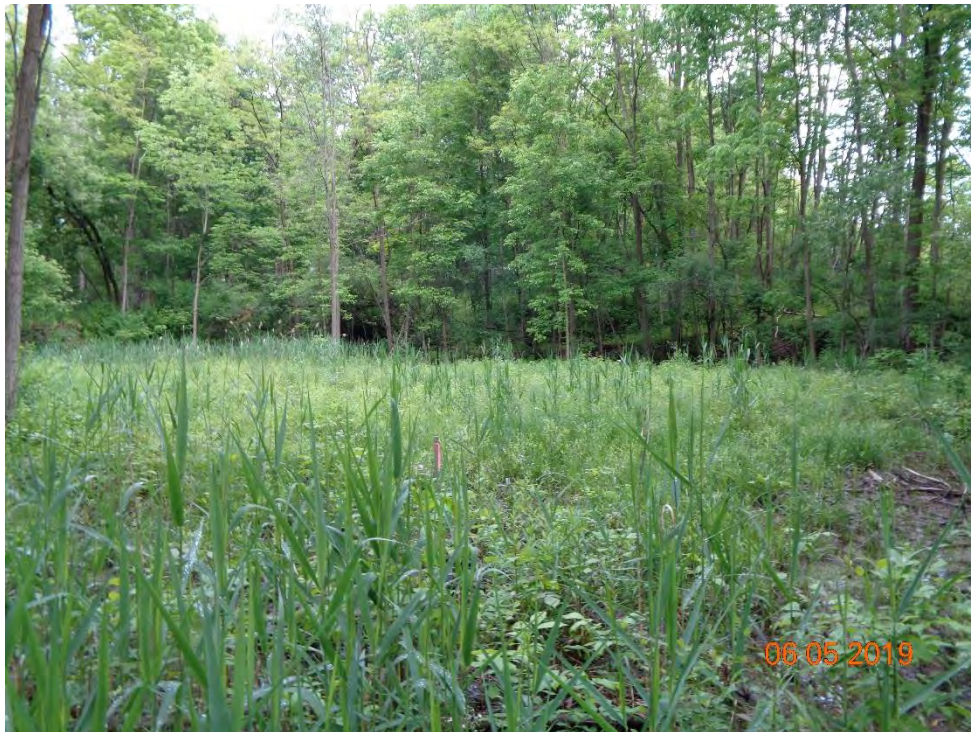
Photo 52 - View of Northern Terminal site in vicinity of MW206

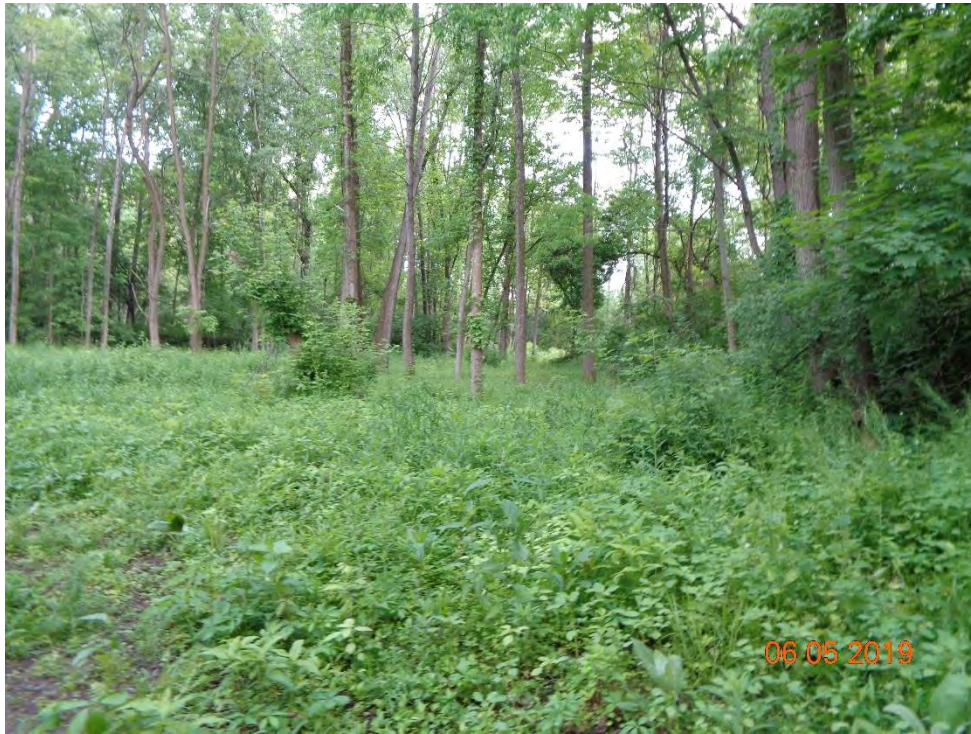
Photo 53 - View of Northern Terminal site north of MW203

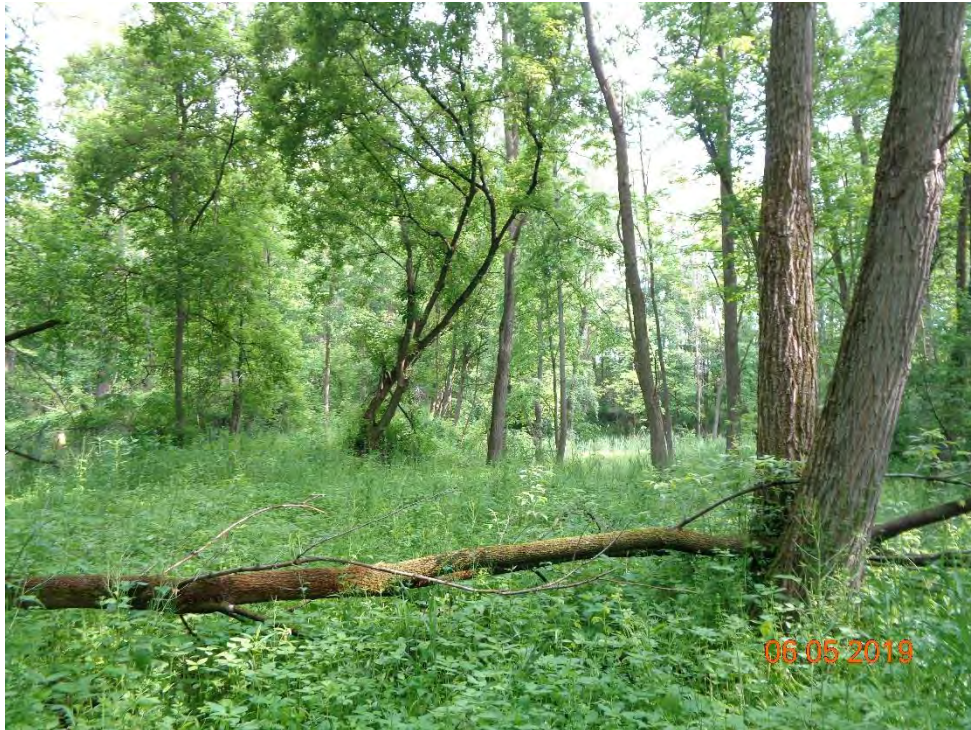
Photo 54 - View of Northern Terminal site east of BMW8

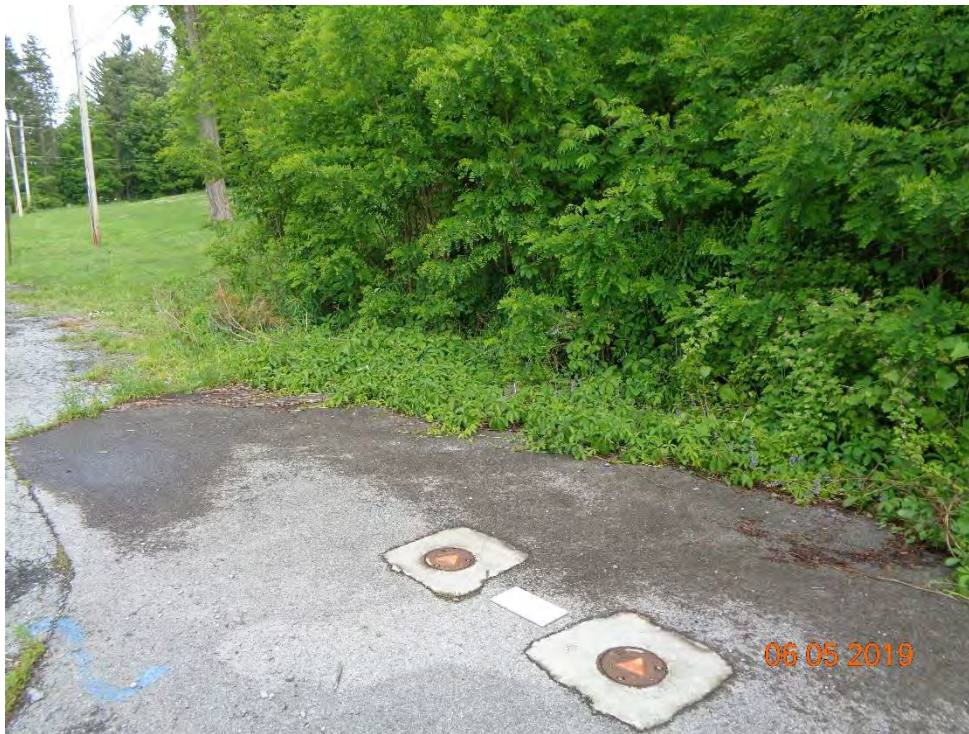
Photo 1 - View of PZ101S (left) and PZ101D (right)

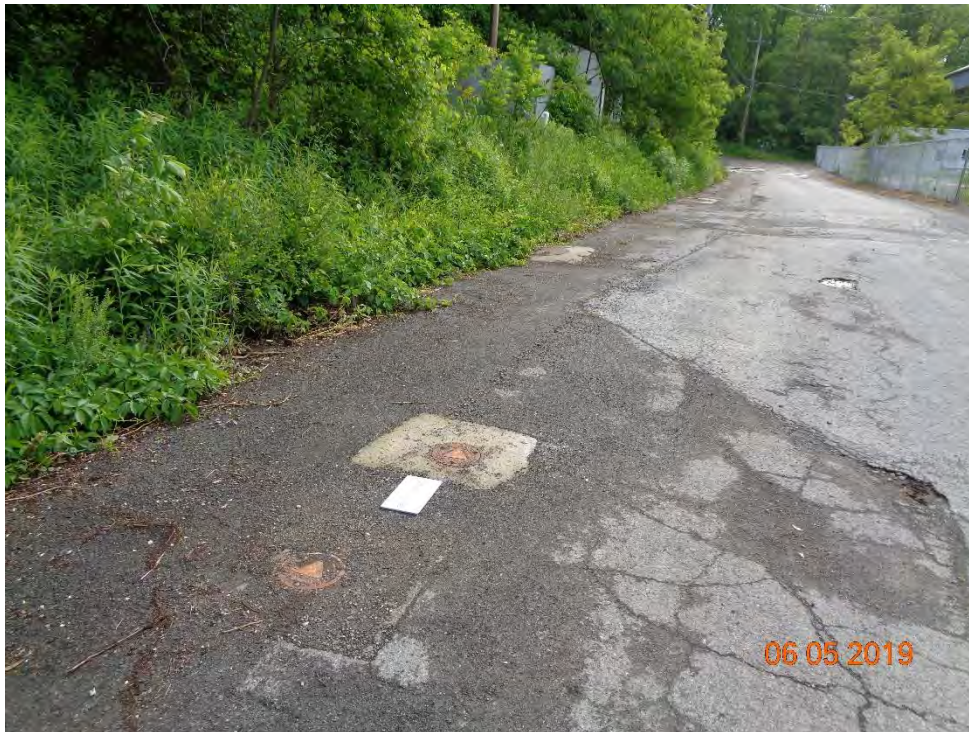
Photo 2 - View of PZ102S (left) and PZ102D (right)

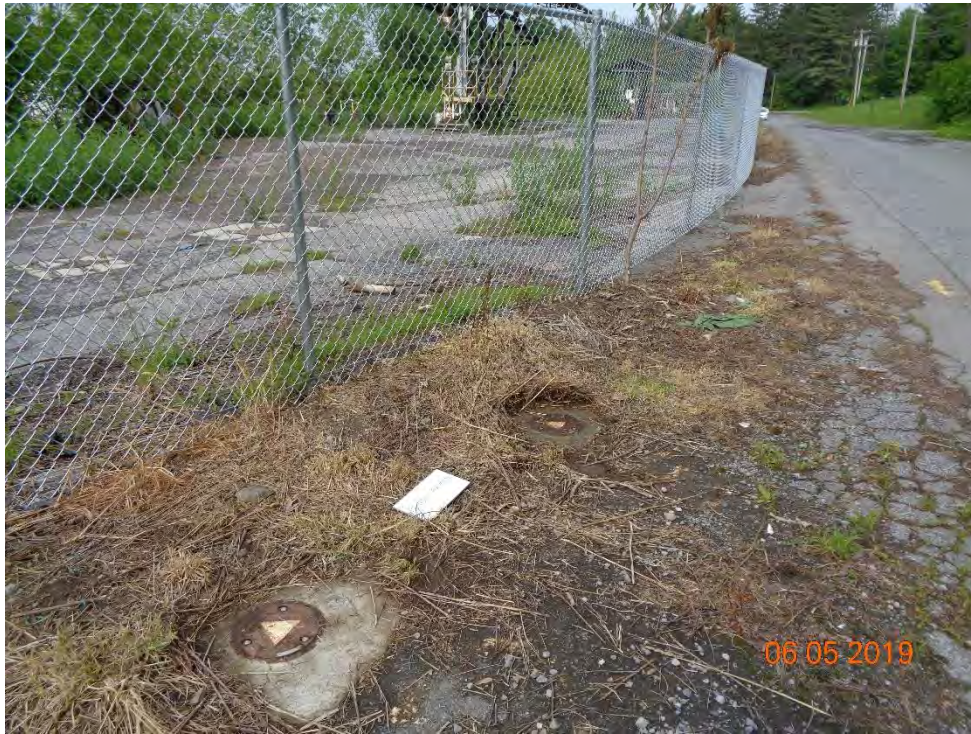
Photo 3 - View of PZ103D (left) and PZ103S (right)

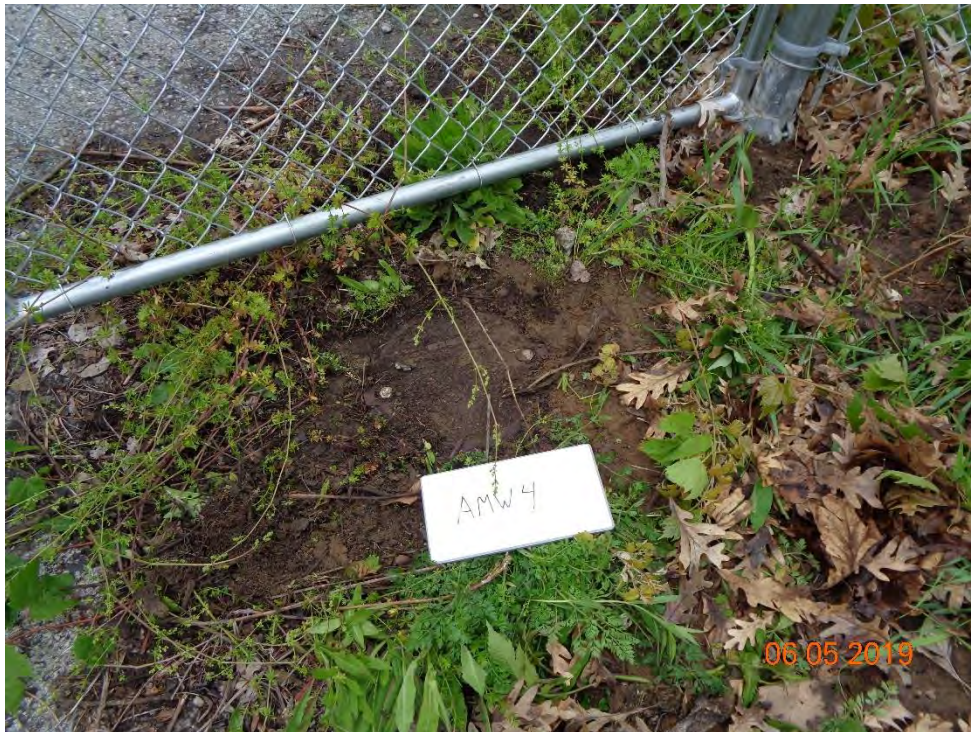
Photo 4 - View of AMW4

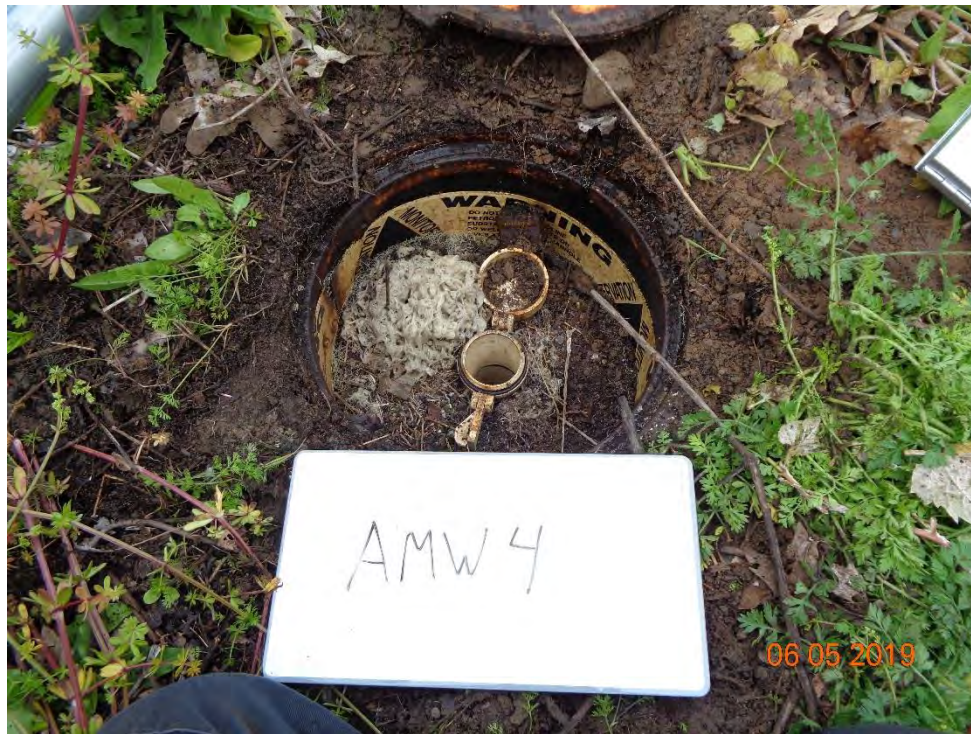
Photo 5 - View of AMW4 interior

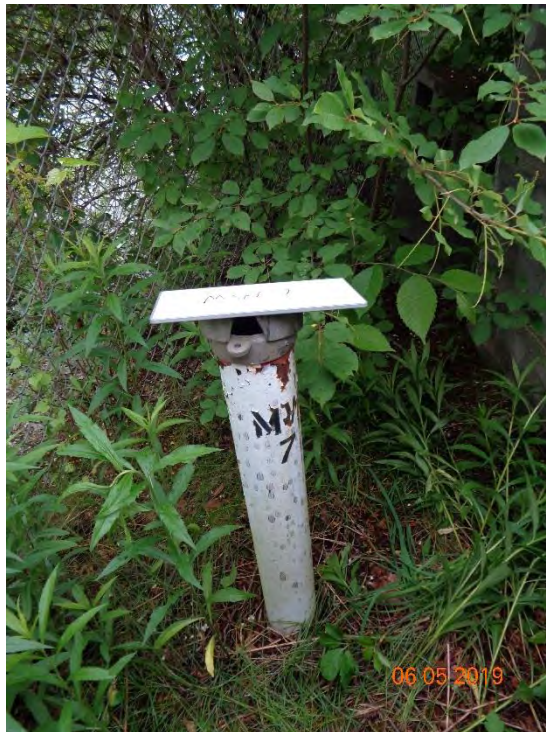
Photo 10 - View of AMW7

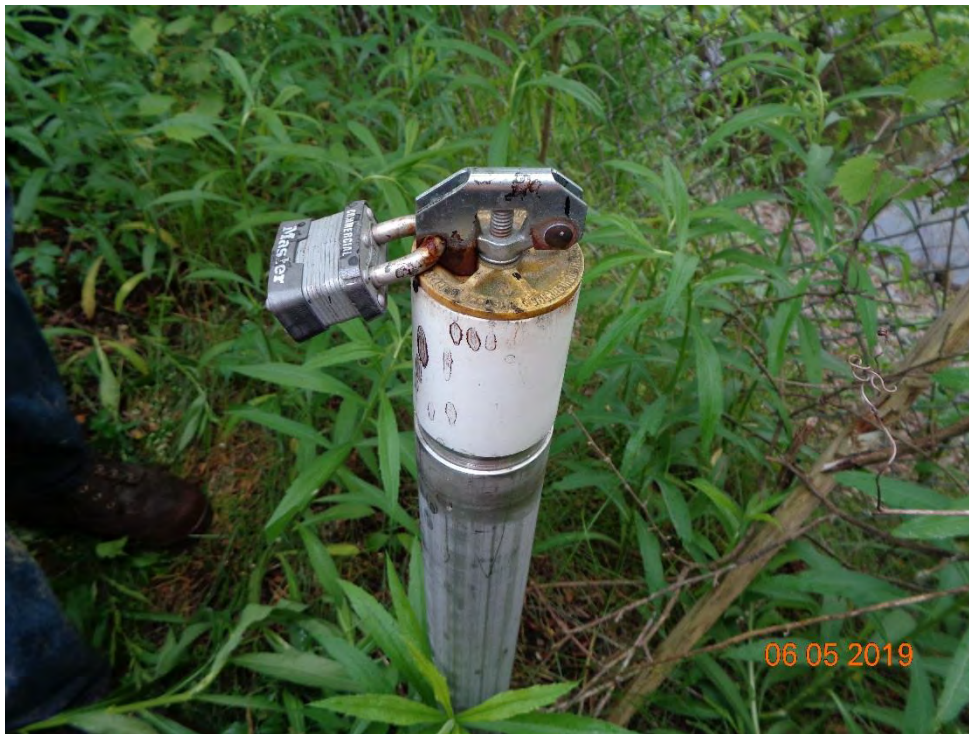
Photo 11 - View of A23

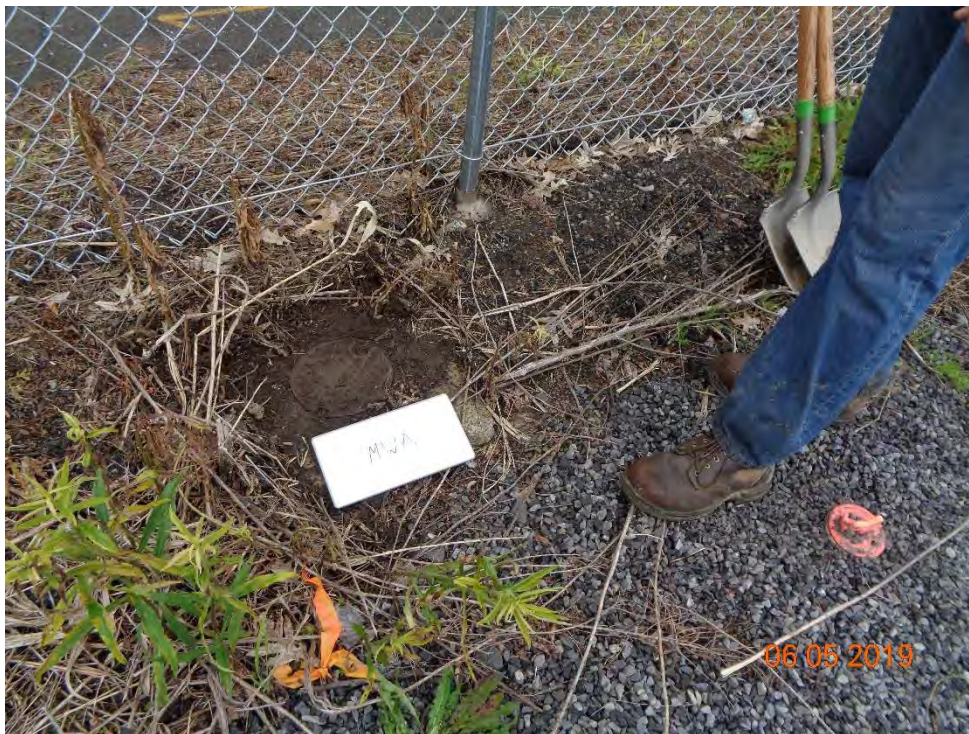
Photo 12 - View of MWA

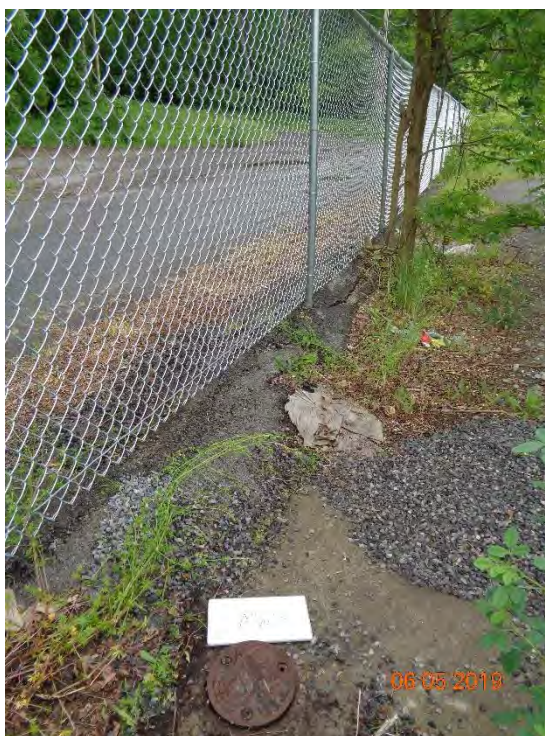
Photo 13 - View of MWB

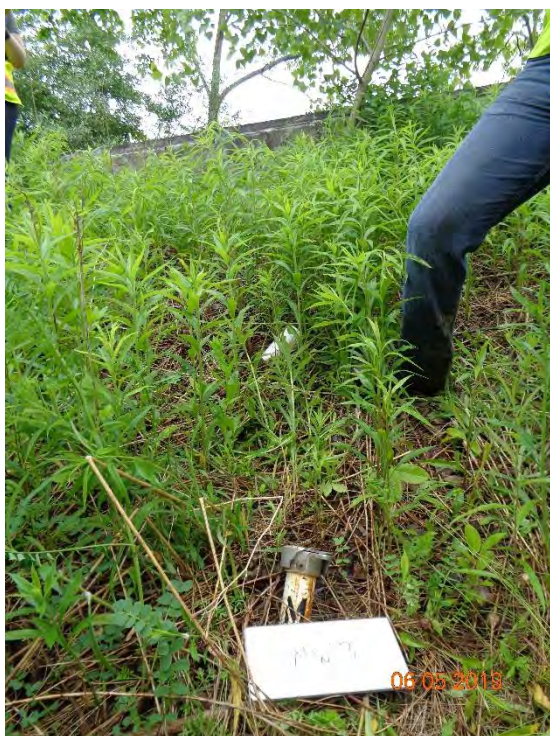
Photo 15 - View of SMW3

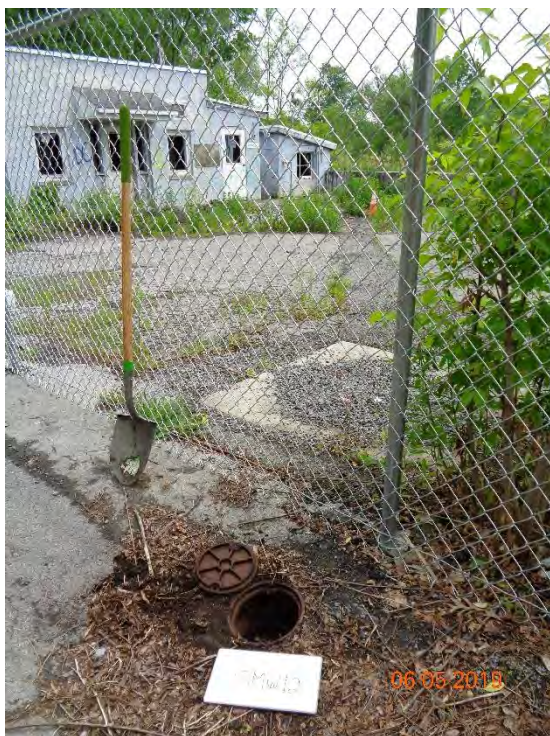
Photo 16 - View of SMW12

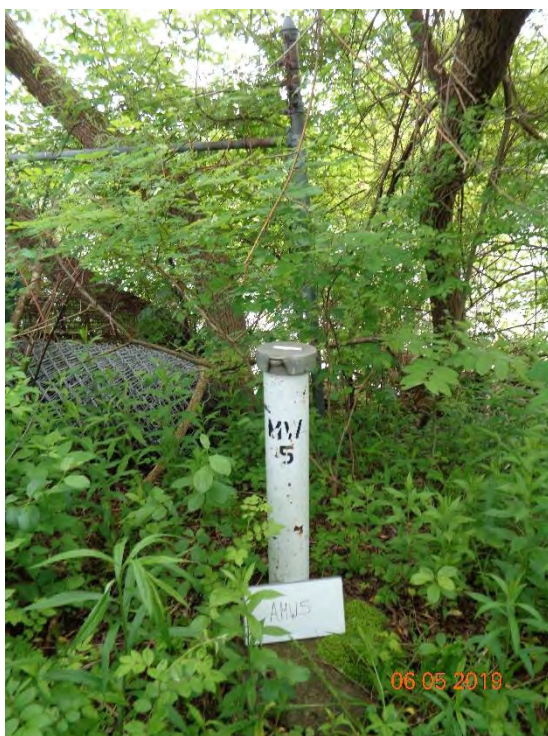
Photo 17 - View of AMW5

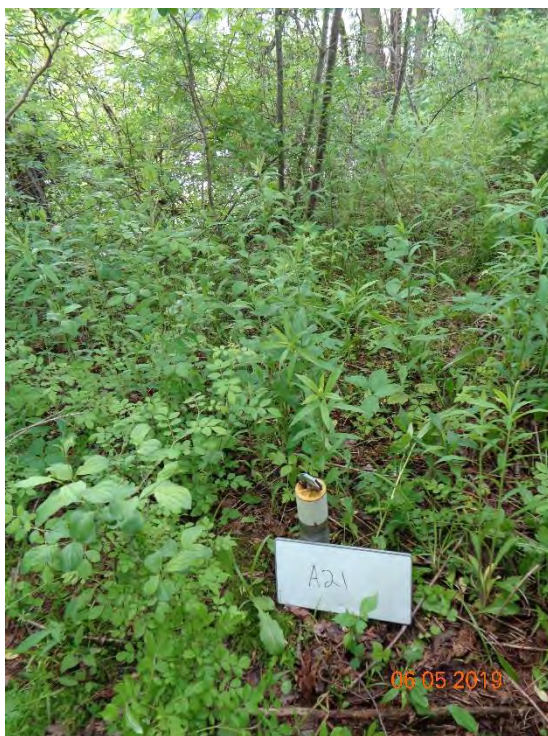
Photo 18 - View of A21

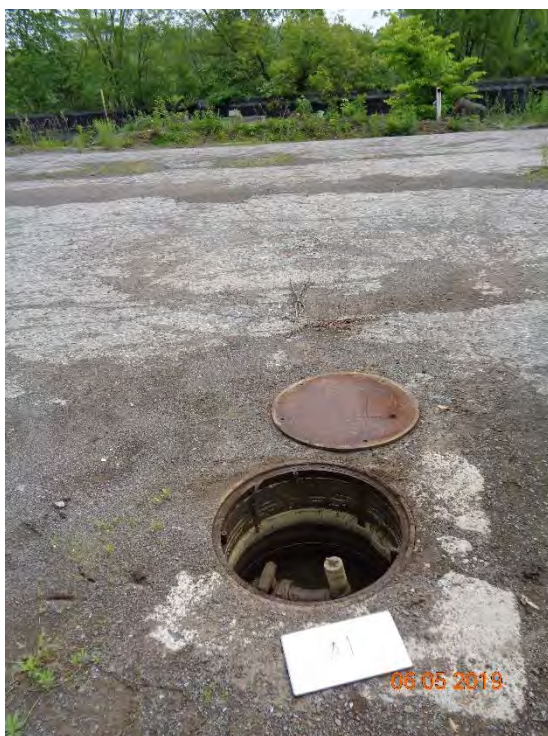
Photo 19 - View of A1

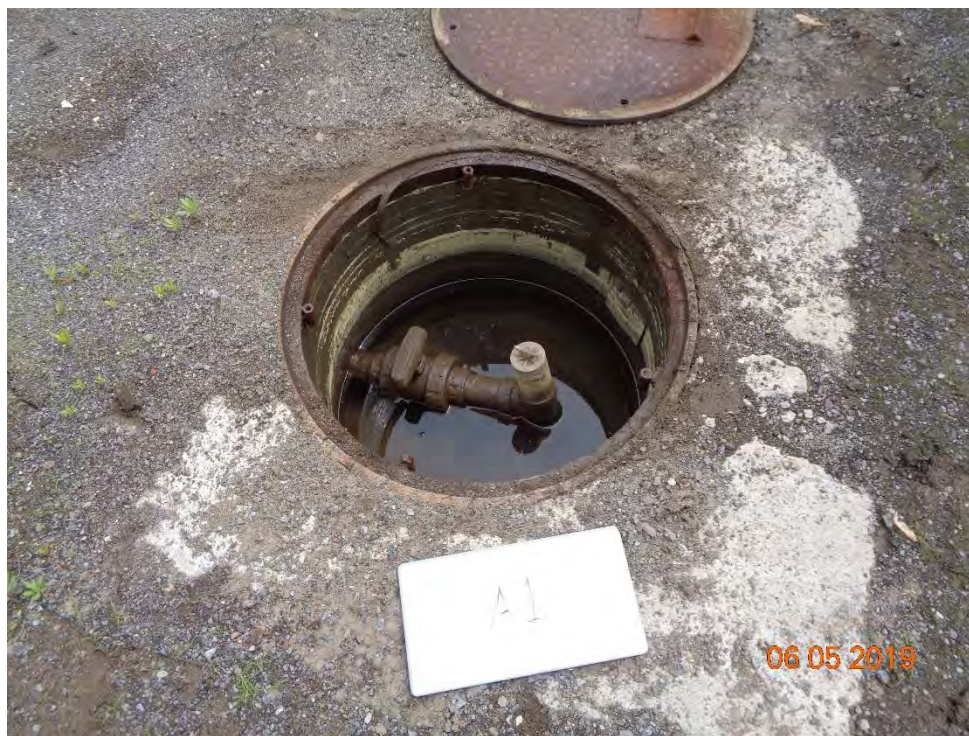
Photo 20 - View of A1, showing ponded water
