August 9, 2019

Reference No. 11137172

**Re:    Monitoring Well Assessment and LNAPL Gauging Event Letter Report  
        Southern Terminals  
        Cold Springs Terminal Site, Hillside Road  
        Lysander, New York**

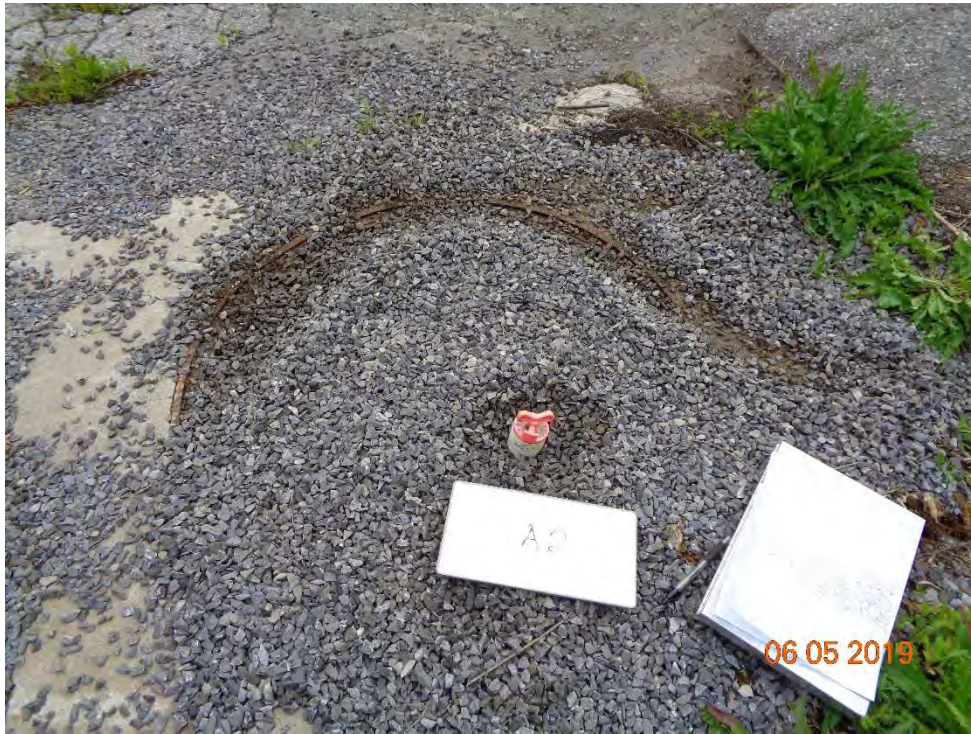
Photo 21 - View of A2

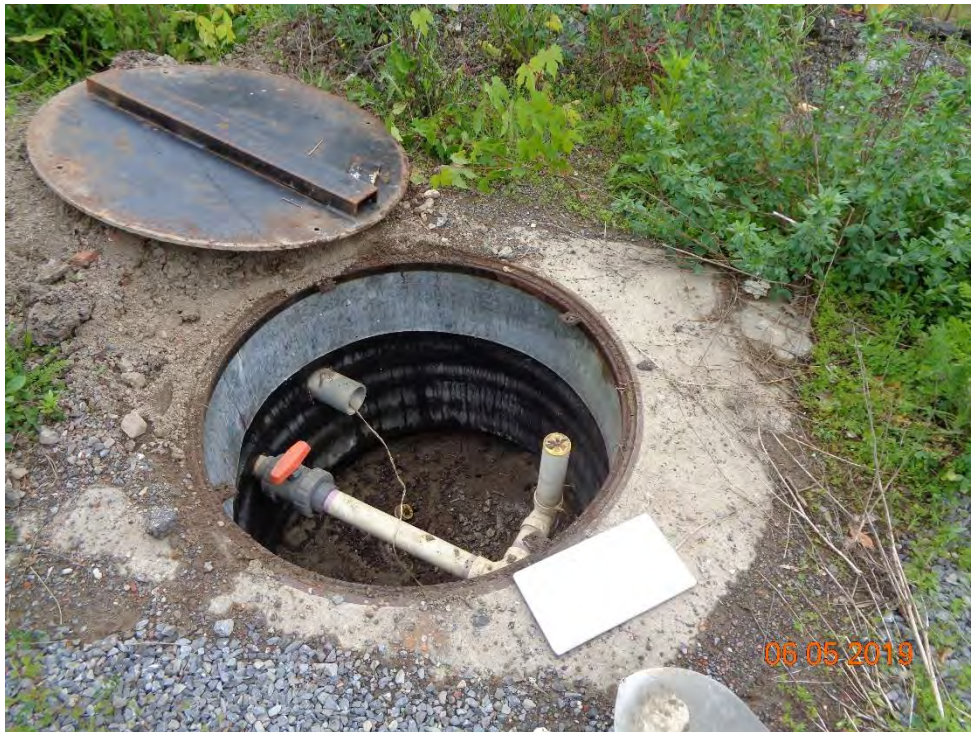
Photo 22 - View of A6

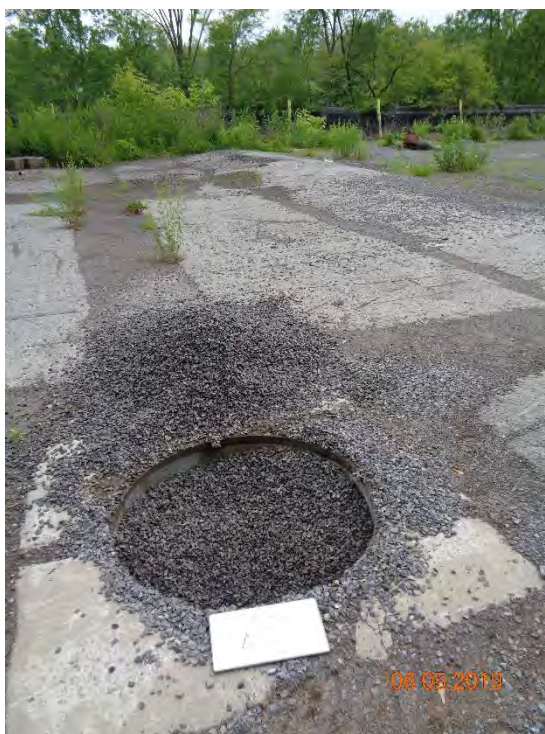
Photo 23 - View of A3 prior to digging out stone

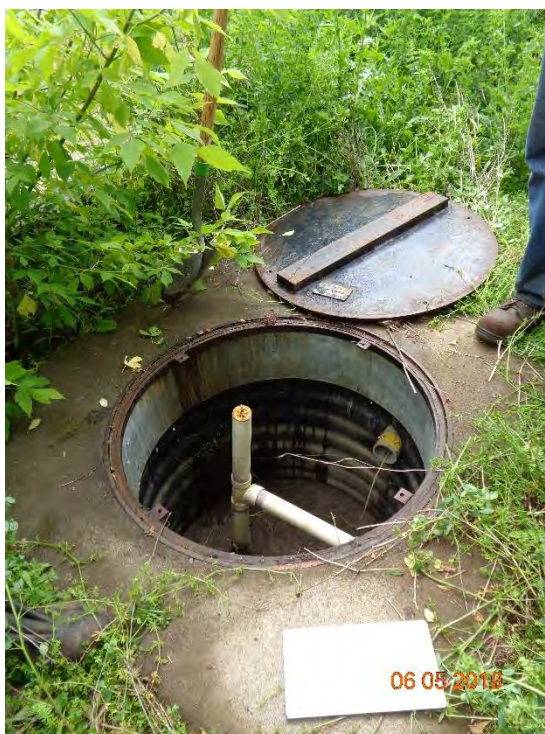
Photo 25 - View of A7

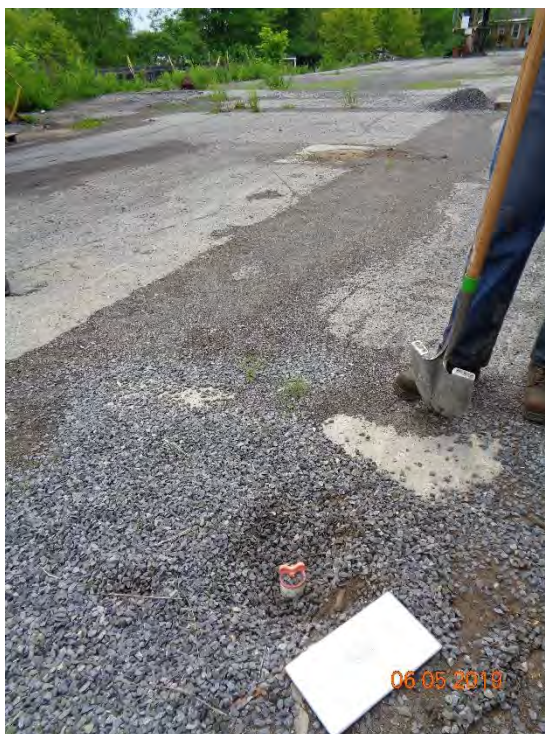
Photo 26 - View of A4

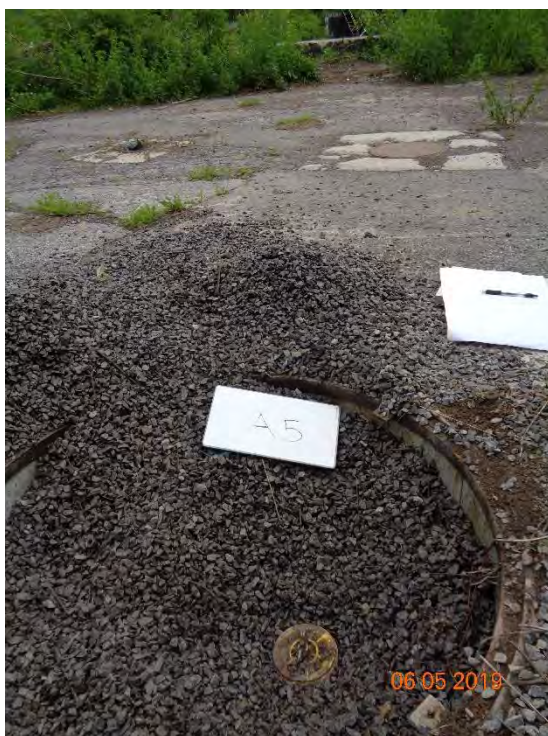
Photo 27 - View of A5 after digging out stone

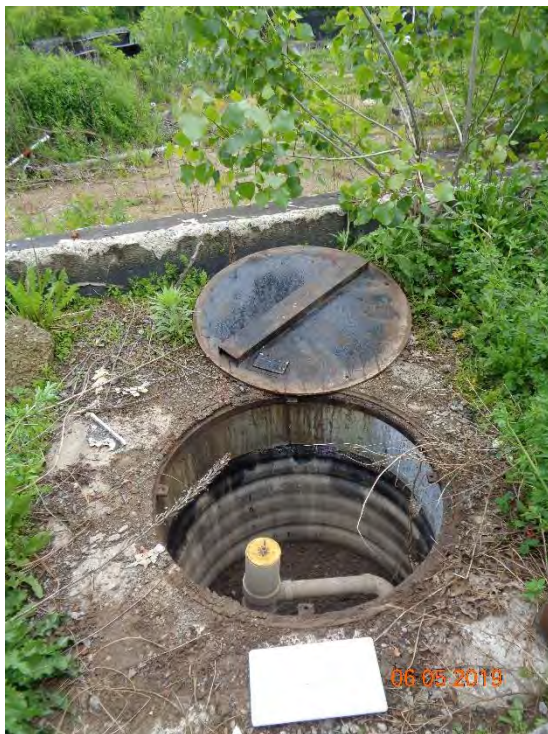
Photo 28 - View of A9

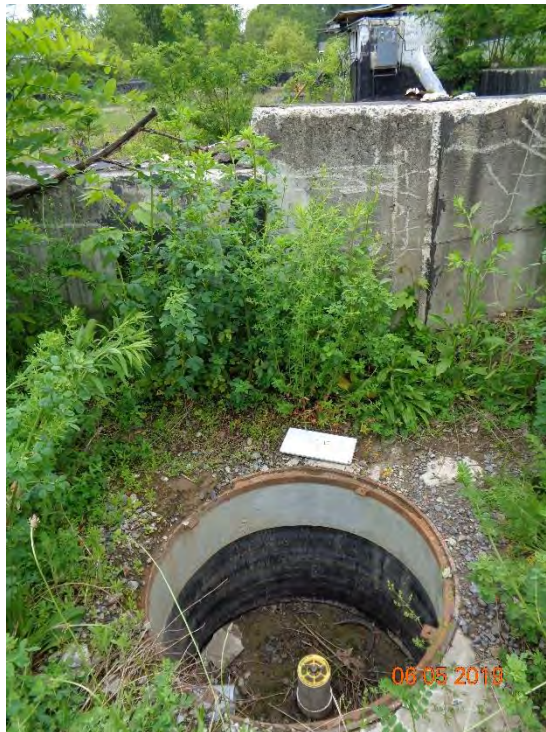
Photo 30 - View of S5

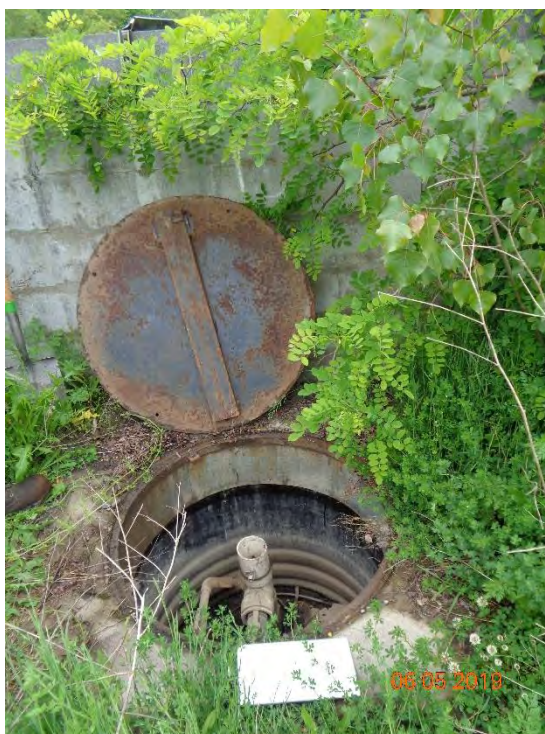
Photo 31 - View of S13

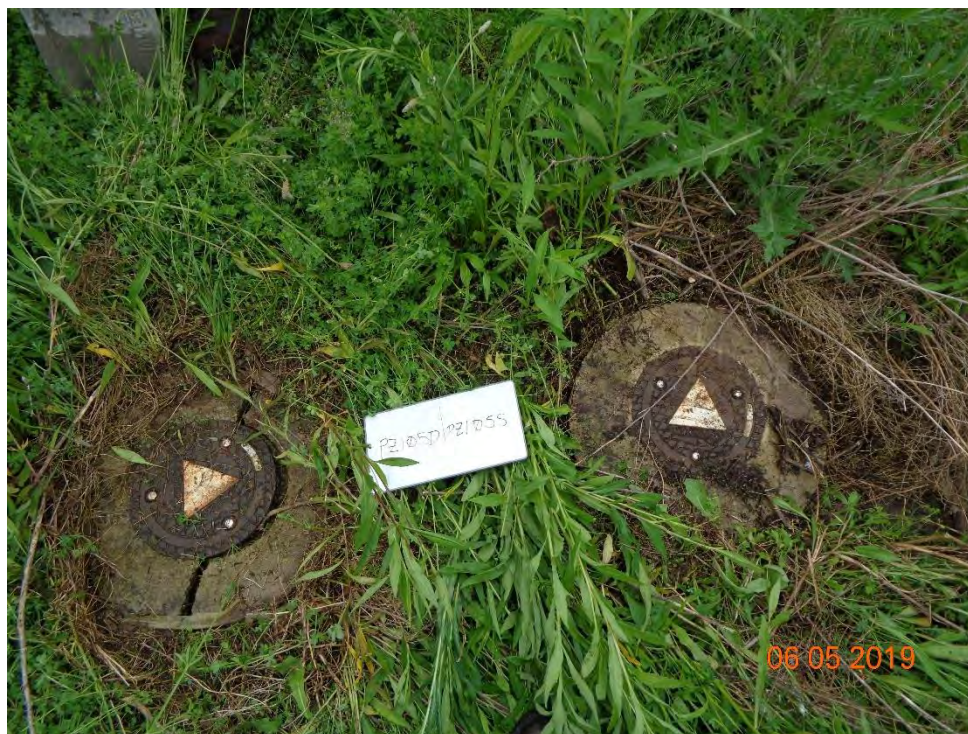
Photo 32 - View of PZ105D (left) and PZ105S (right)

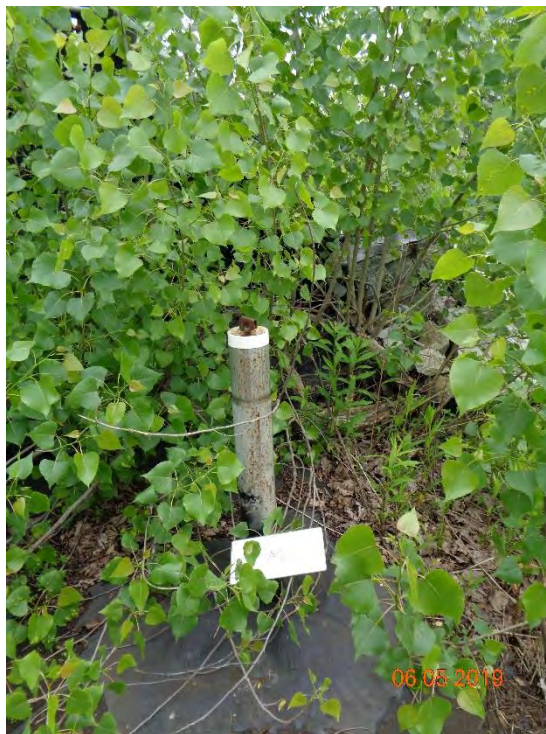
Photo 34 - View of A18

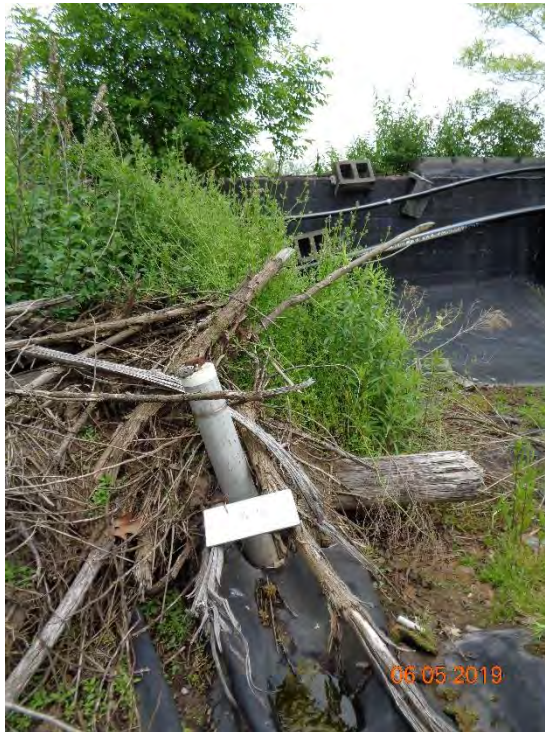
Photo 35 - View of A14

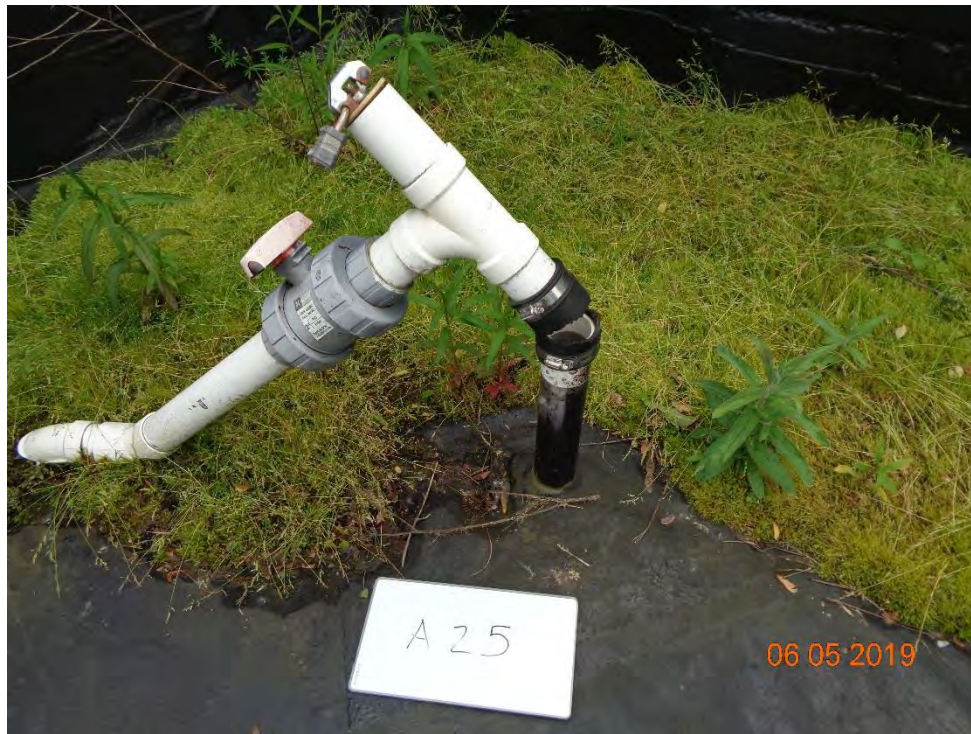
Photo 37 - View of A25

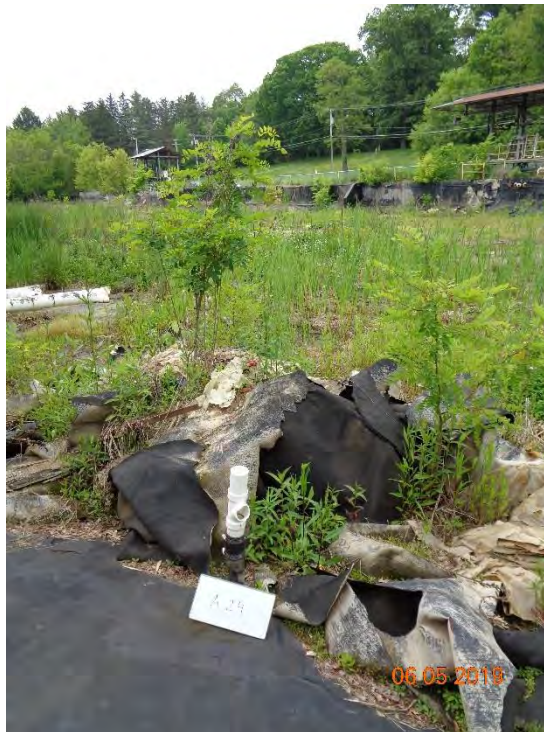
Photo 38 - View of A24

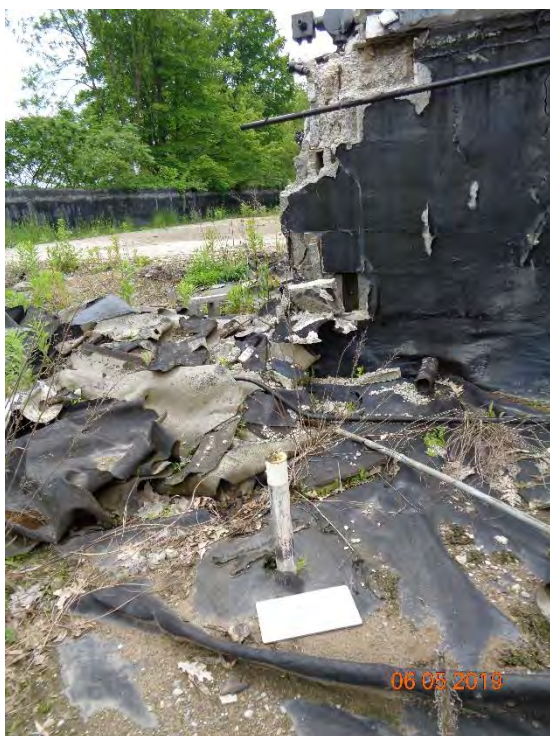
Photo 39 - View of A10

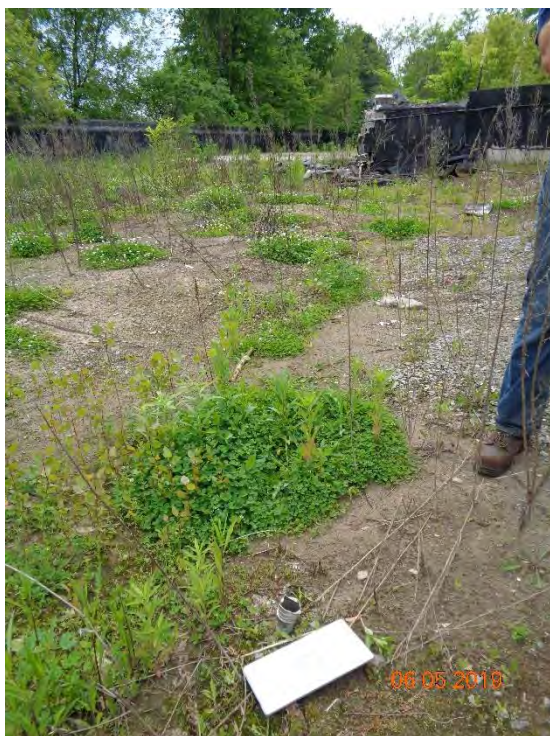
Photo 40 - View of A11

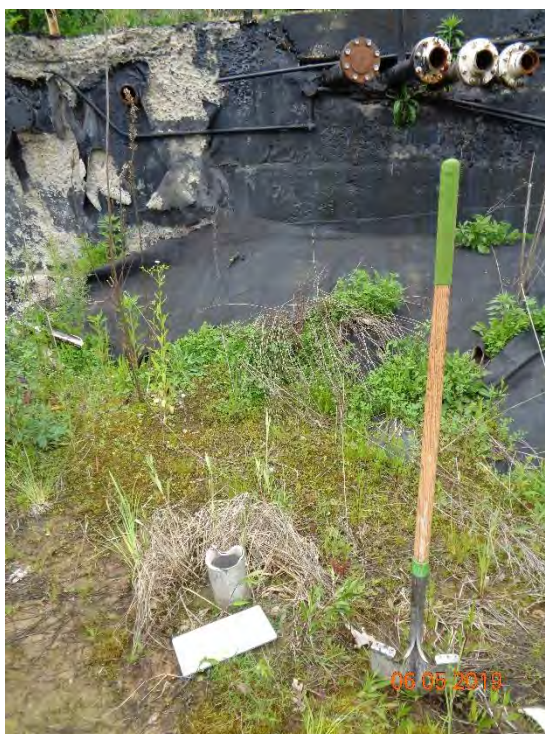
Photo 41 - View of A12

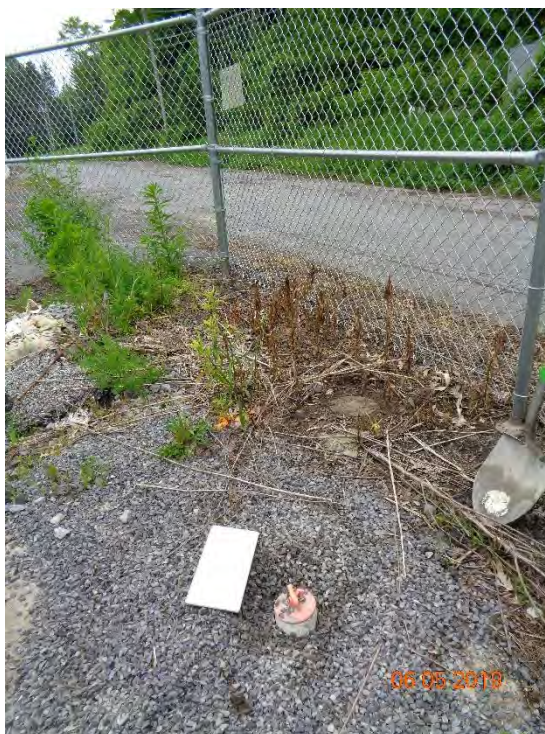
Photo 42 - View of S2

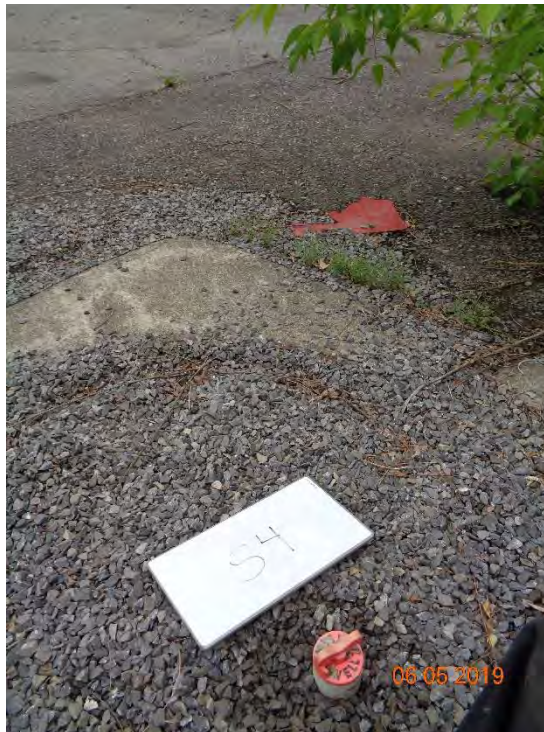
Photo 44 - View of S4

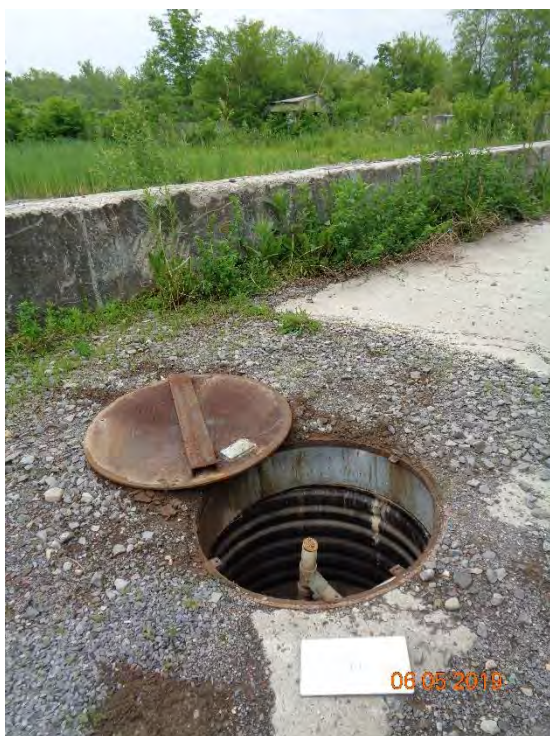
Photo 45 - View of S8

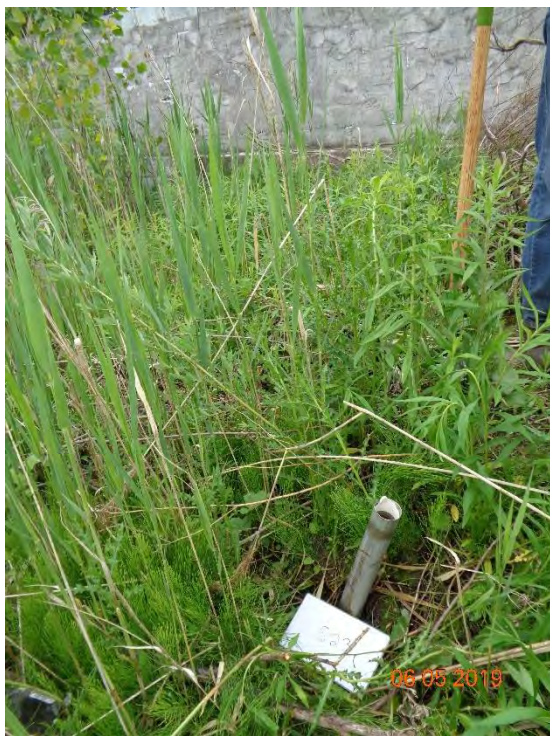
Photo 46 - View of S23

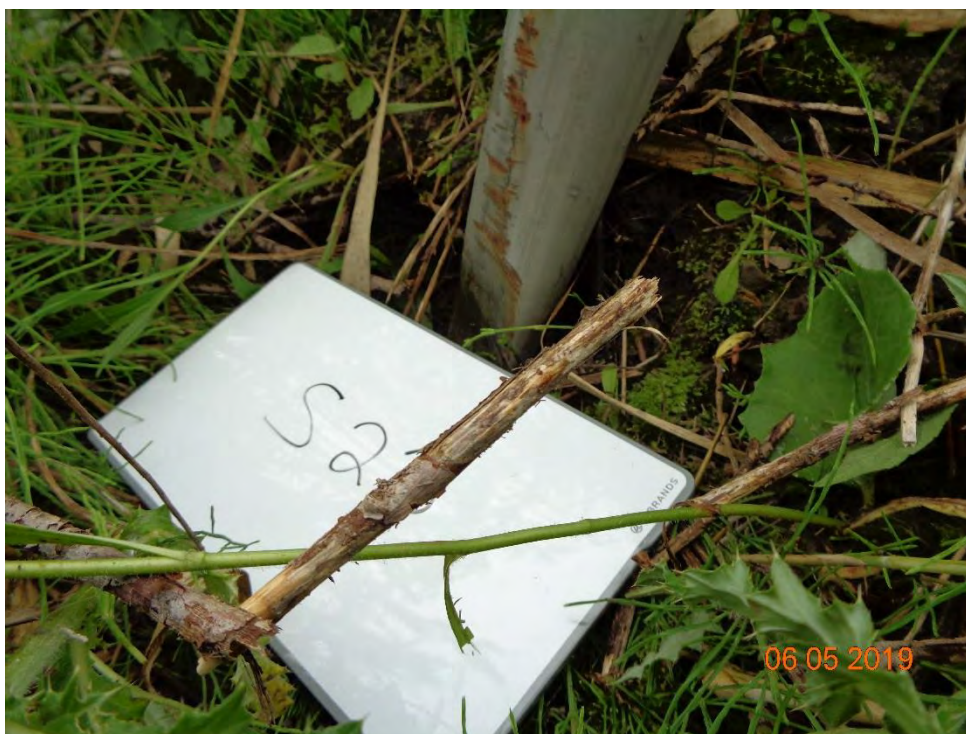
Photo 47 - View of S23, close-up of crushed casing

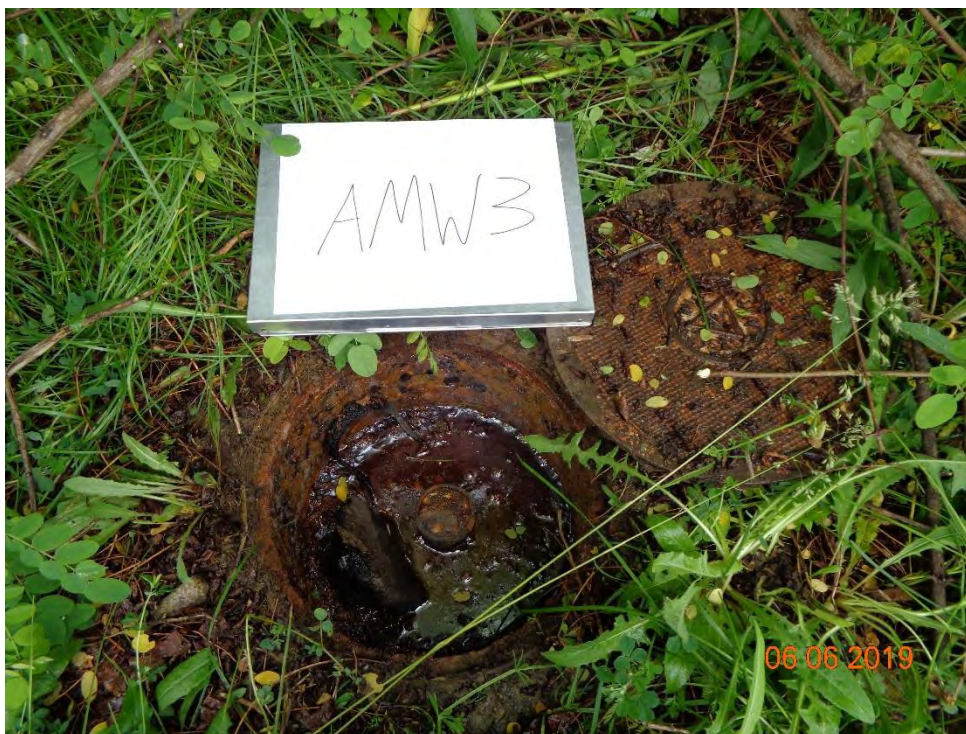
Photo 48 - View of AMW3

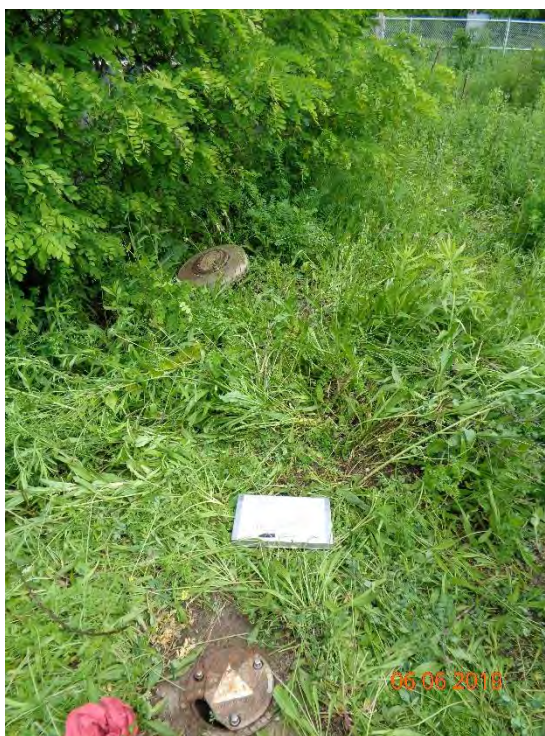
Photo 49 - View of PZ104S (foreground) and PZ104D (dislodged cover in background, could not locate well)

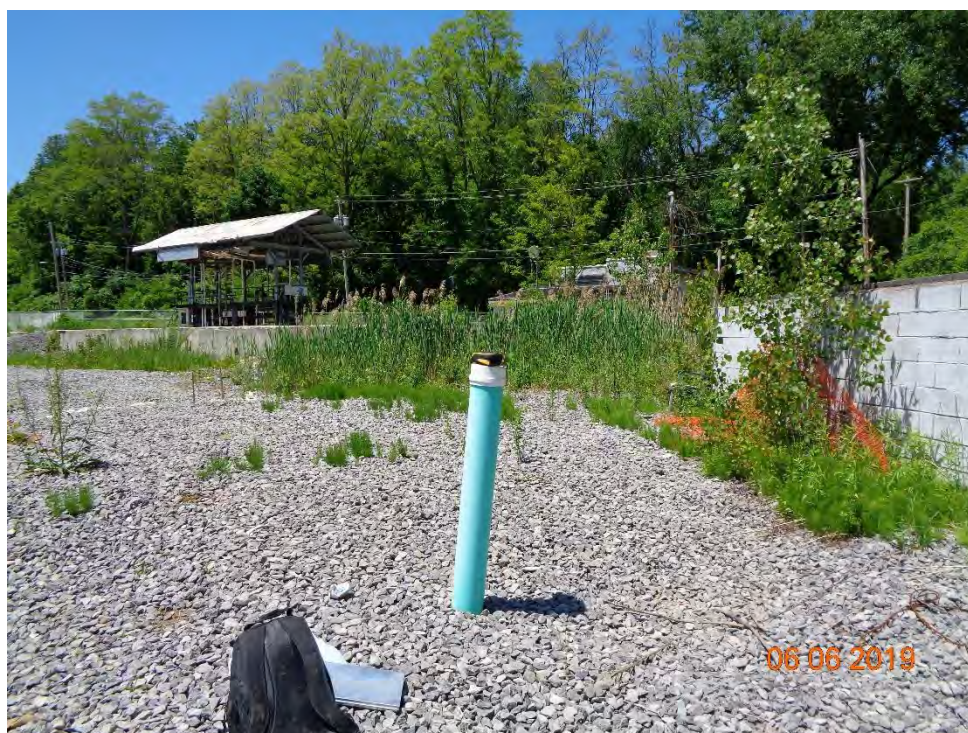
Photo 50 - View of Unknown 1

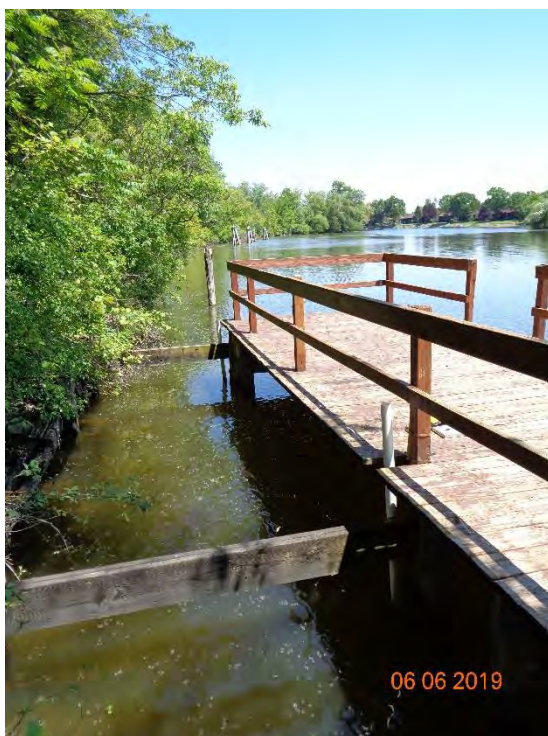
Photo 51 - View of SG1 (background) and SG2 (foreground)

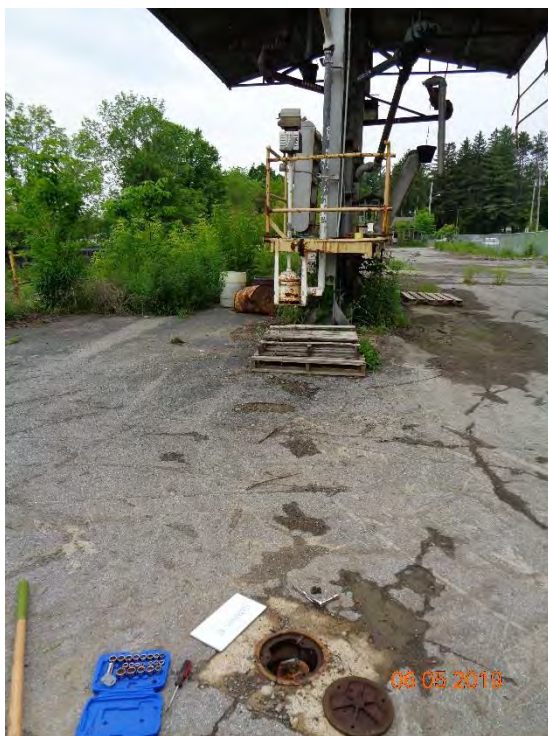
Photo 52 - View of unknown 4-inch diameter well east of central dispenser

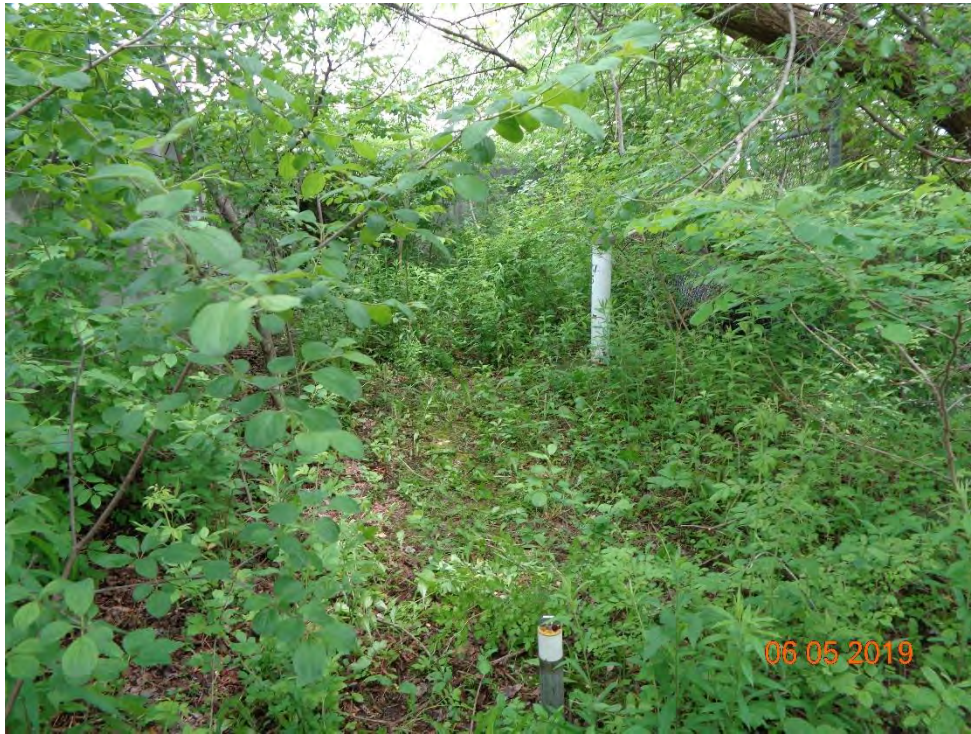
Photo 53 - View of site south of containment area in vicinity of AMW5 and A21

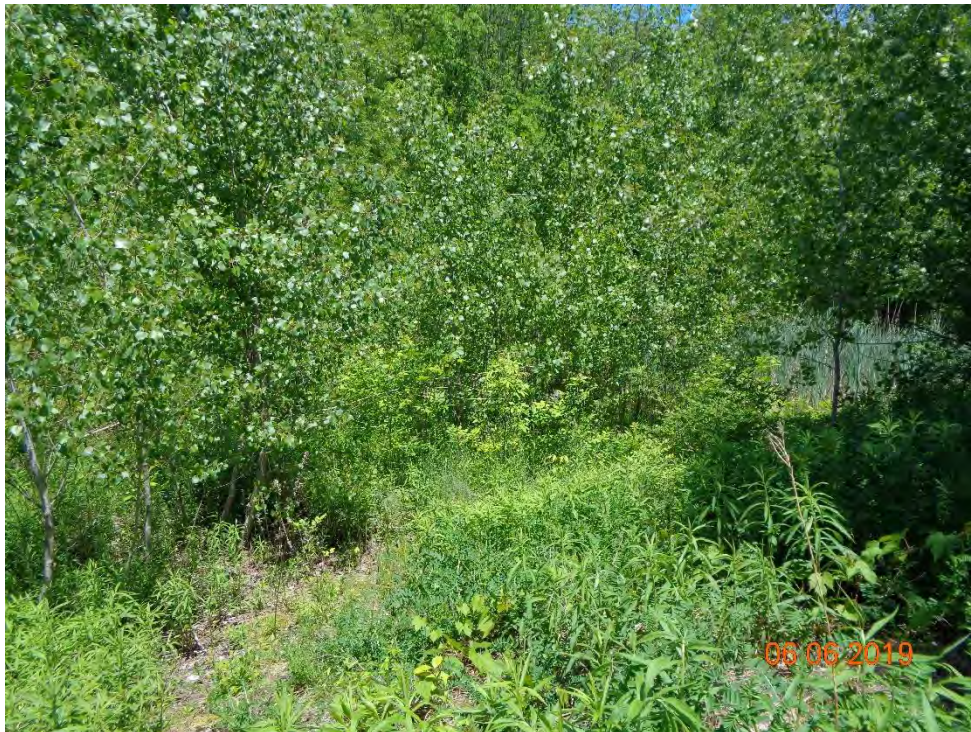
Photo 54 - View of site east of SMW3

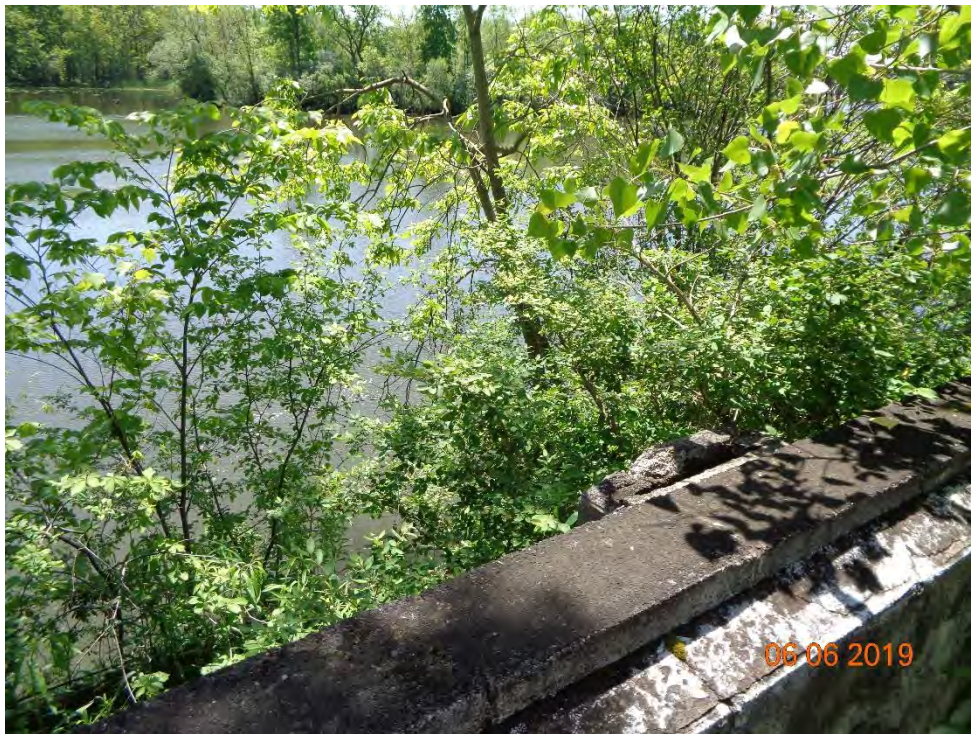
Photo 55 - View of river adjacent to site south of SMW3

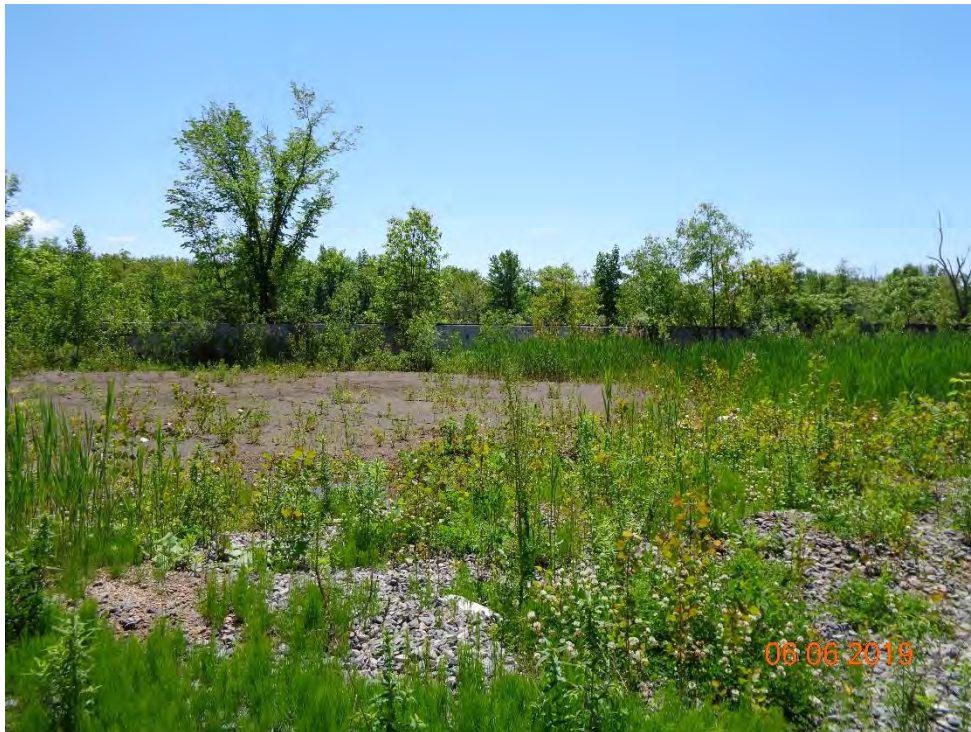
Photo 56 - View of former Tank 7 area

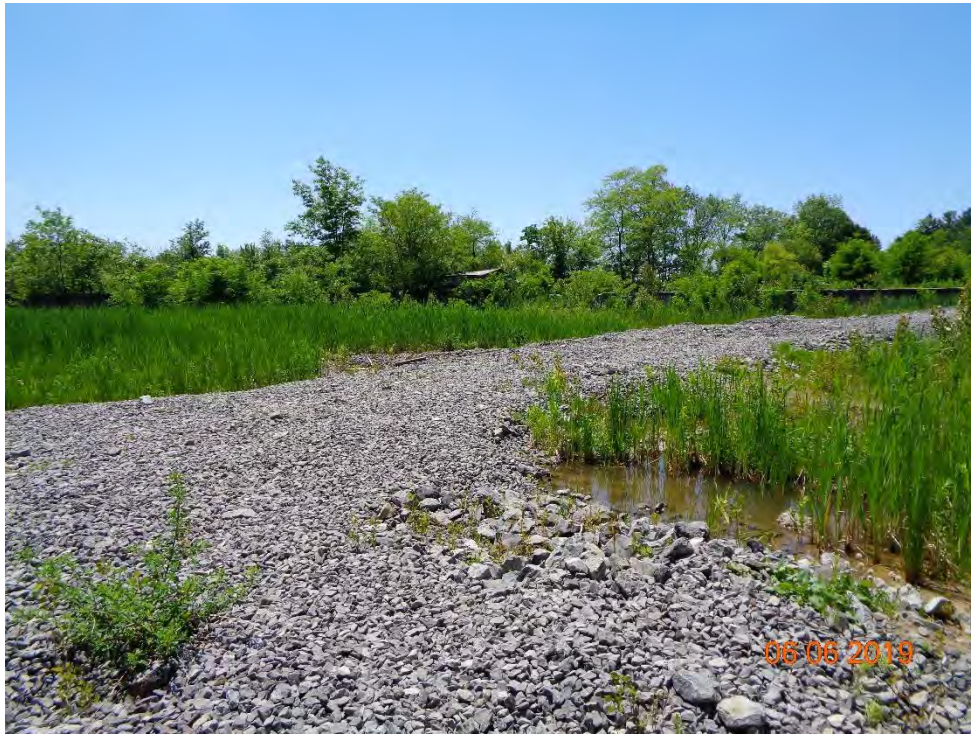
Photo 57 - View of southeastern terminal containment area looking southwest

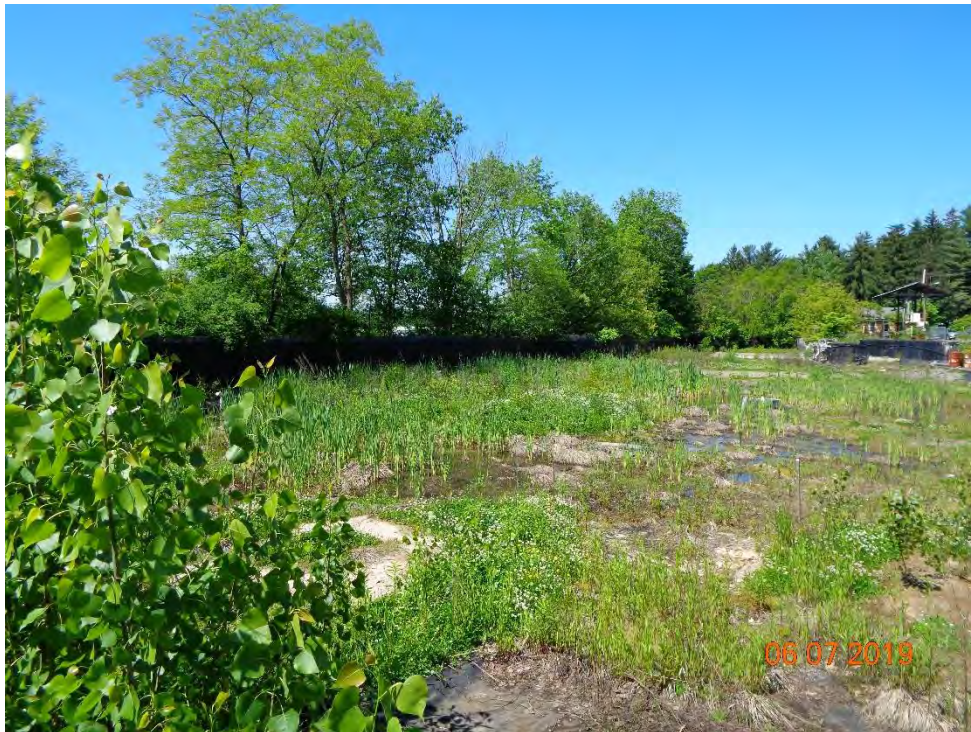
Photo 58 - View of southwestern terminal containment area looking west from eastern edge

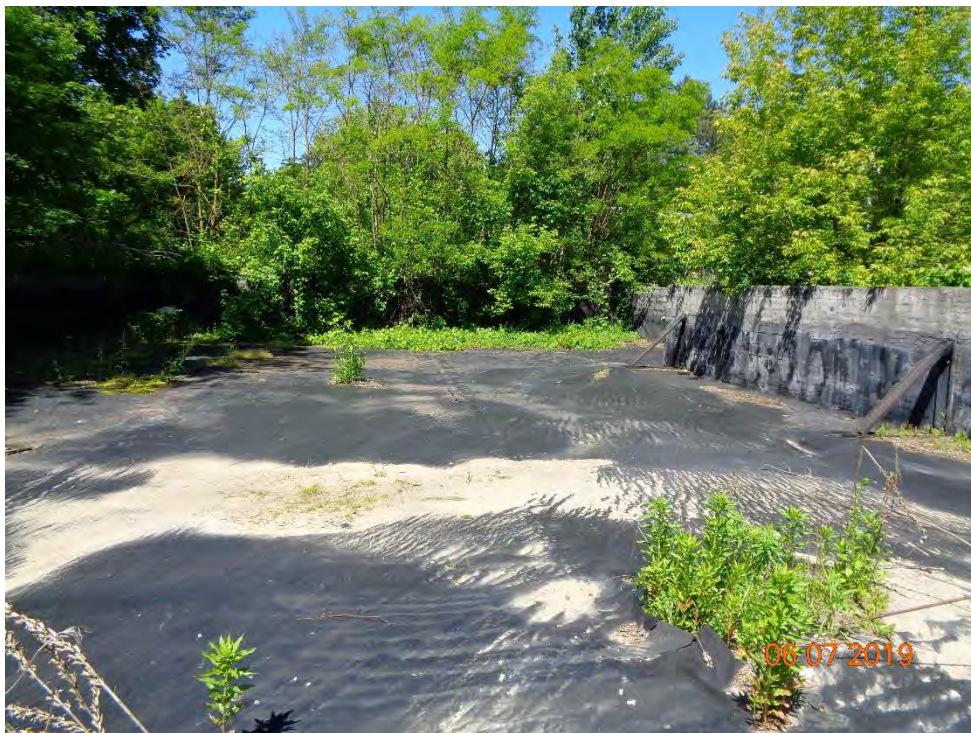
Photo 60 - View of western end of southwestern terminal containment area

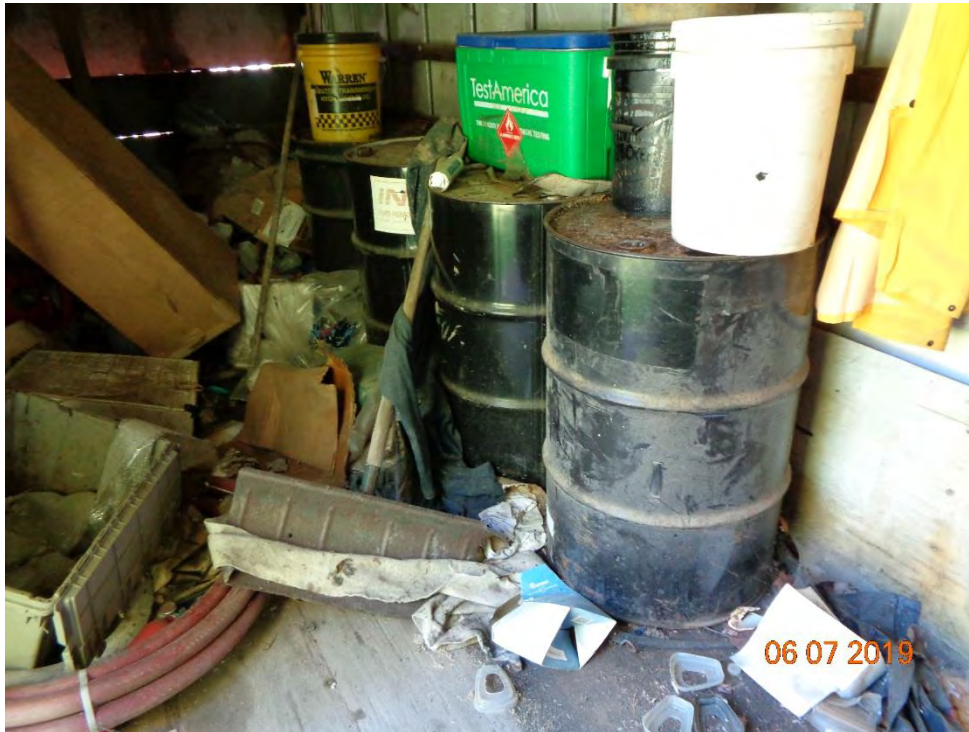
Photo 61 - View of drums and various materials located in storage trailer near western edge of site

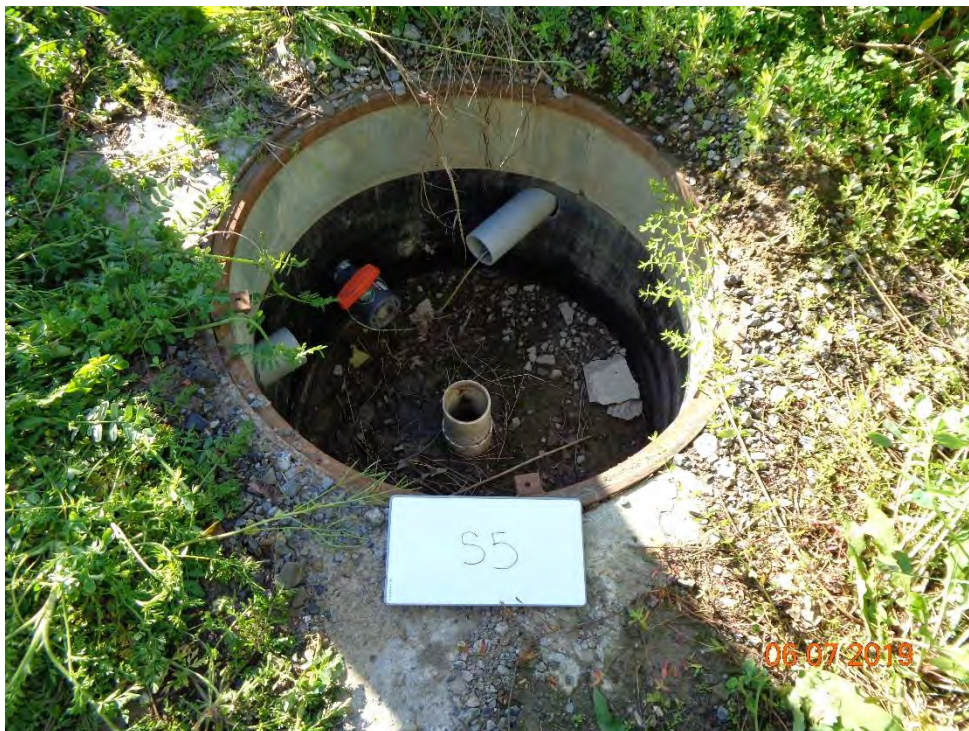
Photo 62 - View of S5 prior to extending and backfilling manhole

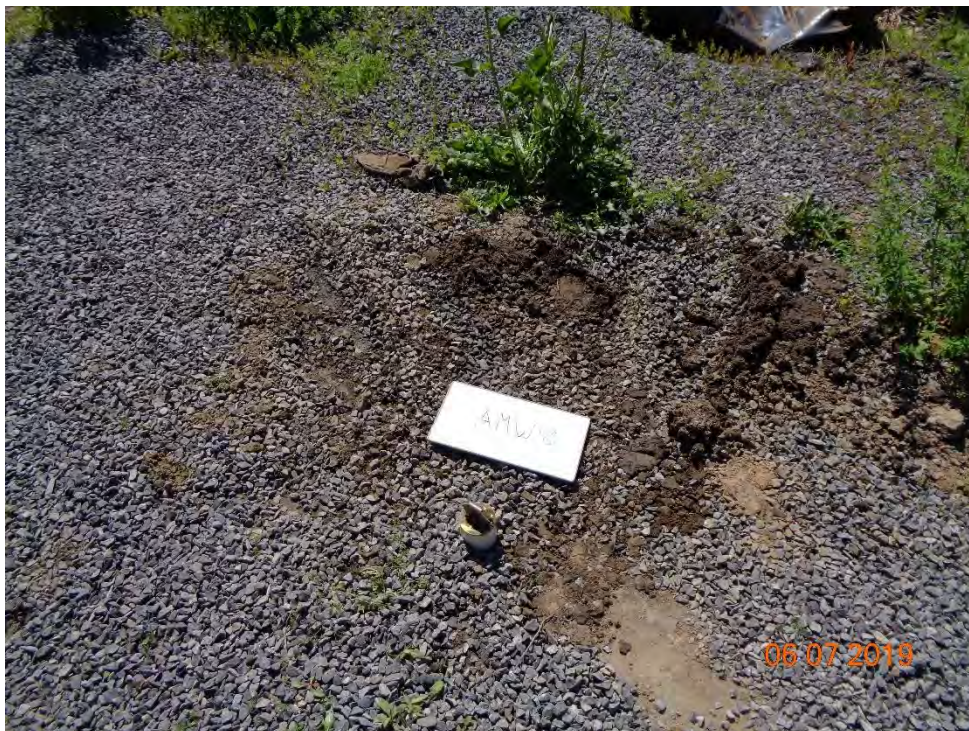
Photo 78 - View of AMW8 after backfilling with stone
